Sears Point Tidal Marsh Restoration Project

Monitoring and Management Status Report

October 2015 to June 2017

Sears Point Tidal Marsh Restoration Project
Monitoring and Management Status Report, Year 1
October 2015 to June 2017

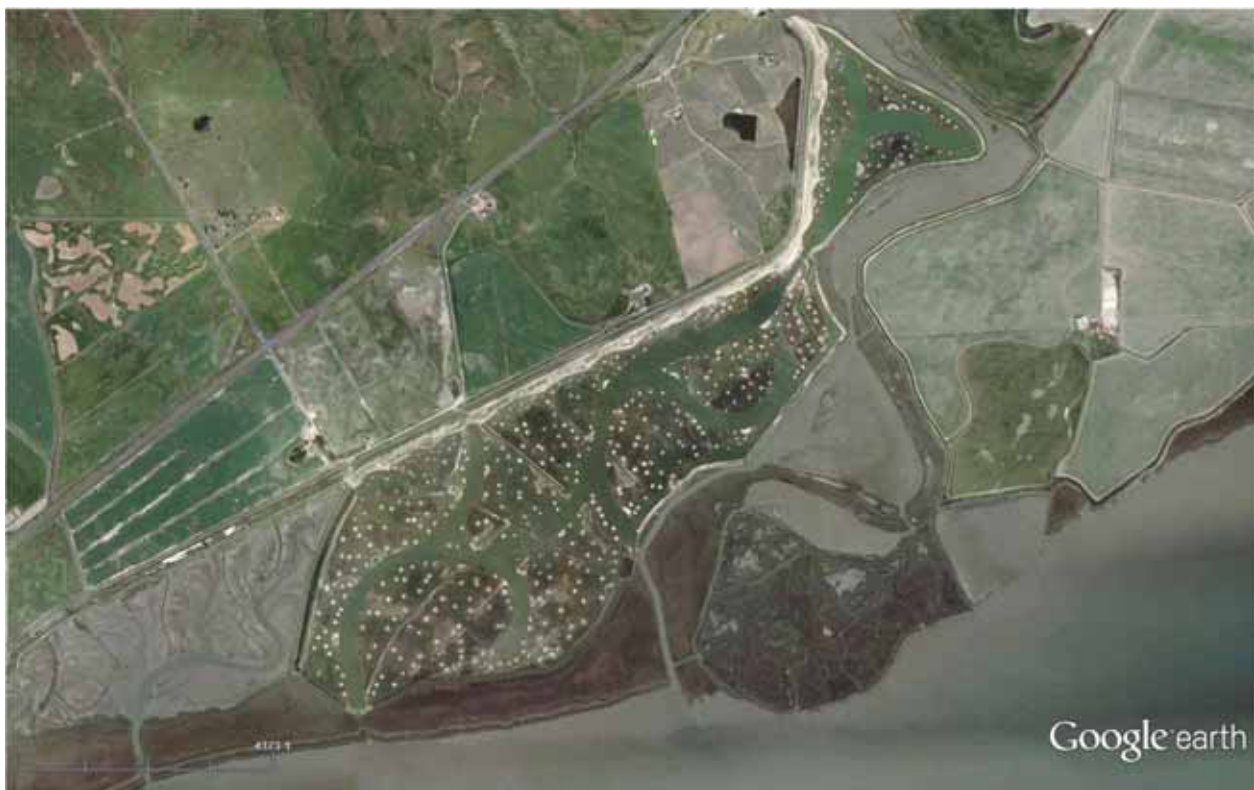
Figure 5. Baseline Air Photo, April 1, 2015 Google Earth

The as-built air photo is from Google Earth, flown April 1, 2015 (Figure 5). This photo precedes the October 2015 levee breach but follows winter rains and thus has standing water in the excavated large channel network. All the constructed marsh mounds, sidecast ridges, and the habitat levee are visible in the image.

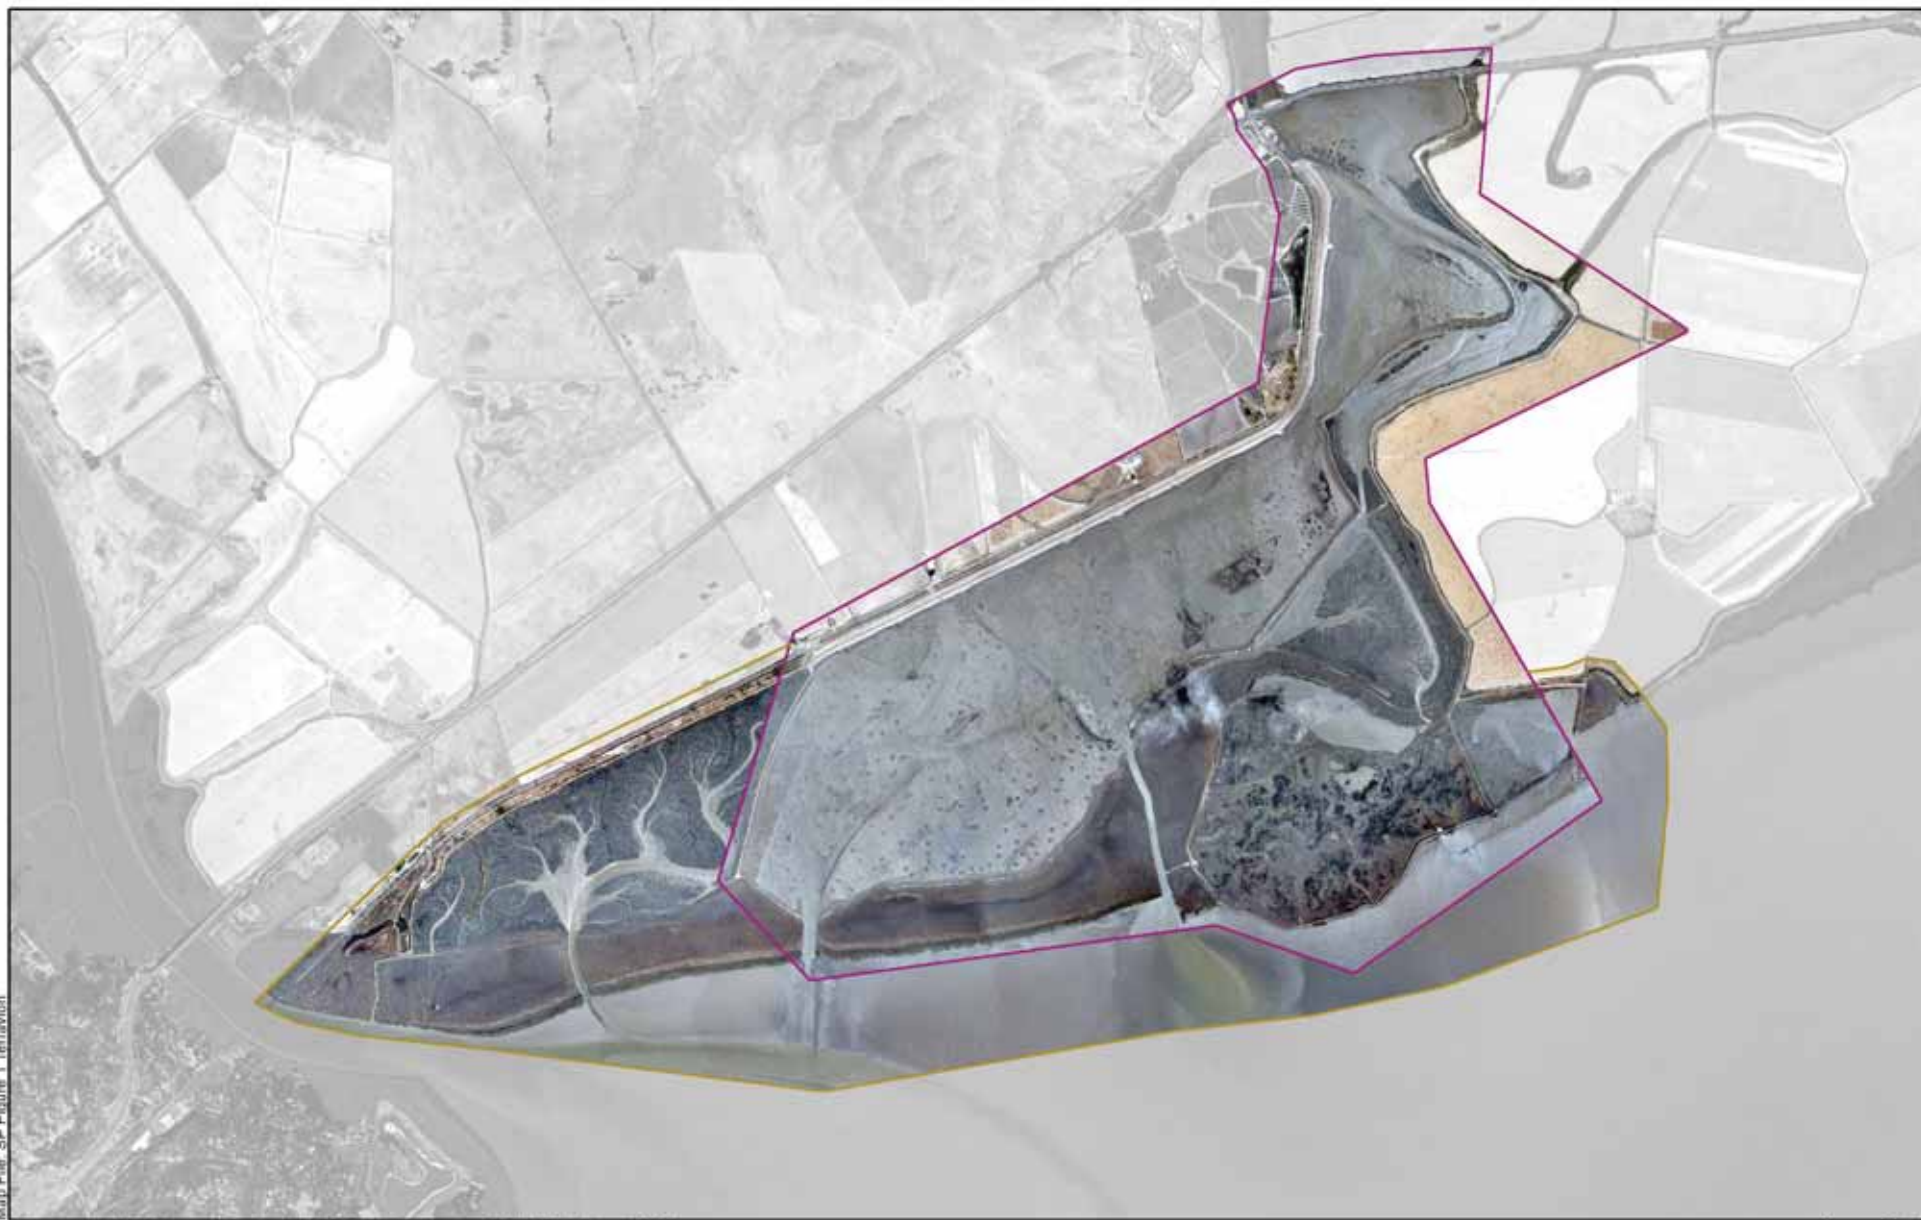
- 1) July 6, 2016 6:41 pm PDT and July 21, 2016 5:26 pm PDT – Terravion, Inc. – natural color and color infrared imagery and automated processing of vegetation and thermal signature. Contracted by NERR on behalf of SLT. See Figure 8 for the natural color image and Figure 9 for the color infrared image.
- 2) August 23, 2016 12:22 pm PDT – Digital Globe WV02 satellite natural color. Commercially available imagery acquired by SLT. See Figure 10.
- 3) November 17, 2016 about 3:00 pm PST – Digital Globe WV01 satellite black-and-white. Commercially available imagery acquired by SLT. See Figure 11.

Data sources: Aerial Imagery, Terravion July 2016, Satellite Imagery, DigitalGlobe August 2016

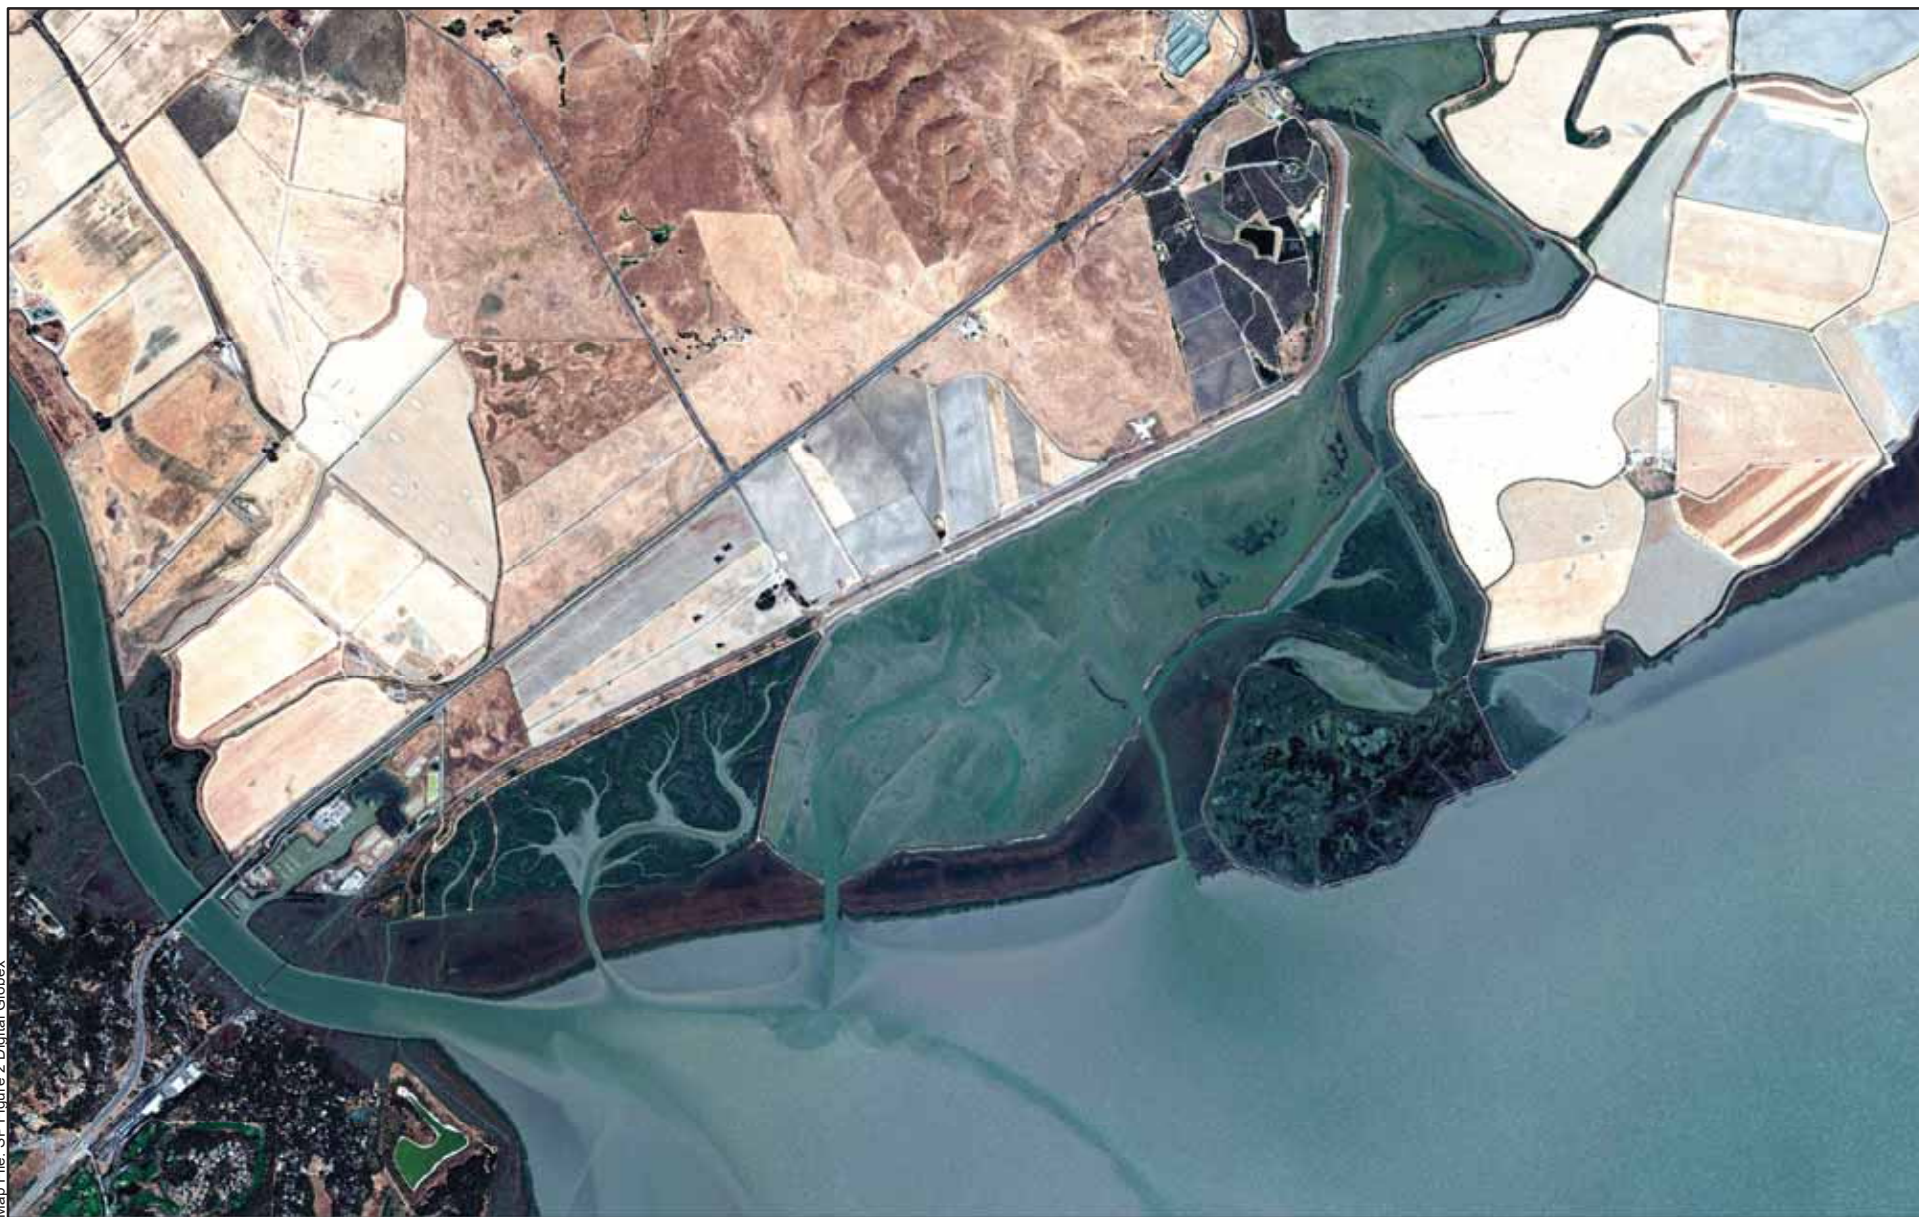
Data sources: Satellite Imagery, DigitalGlobe August 2016

Satellite Image:Digital Globe WV02, Natural Color, August 23rd 2016 | 12:22

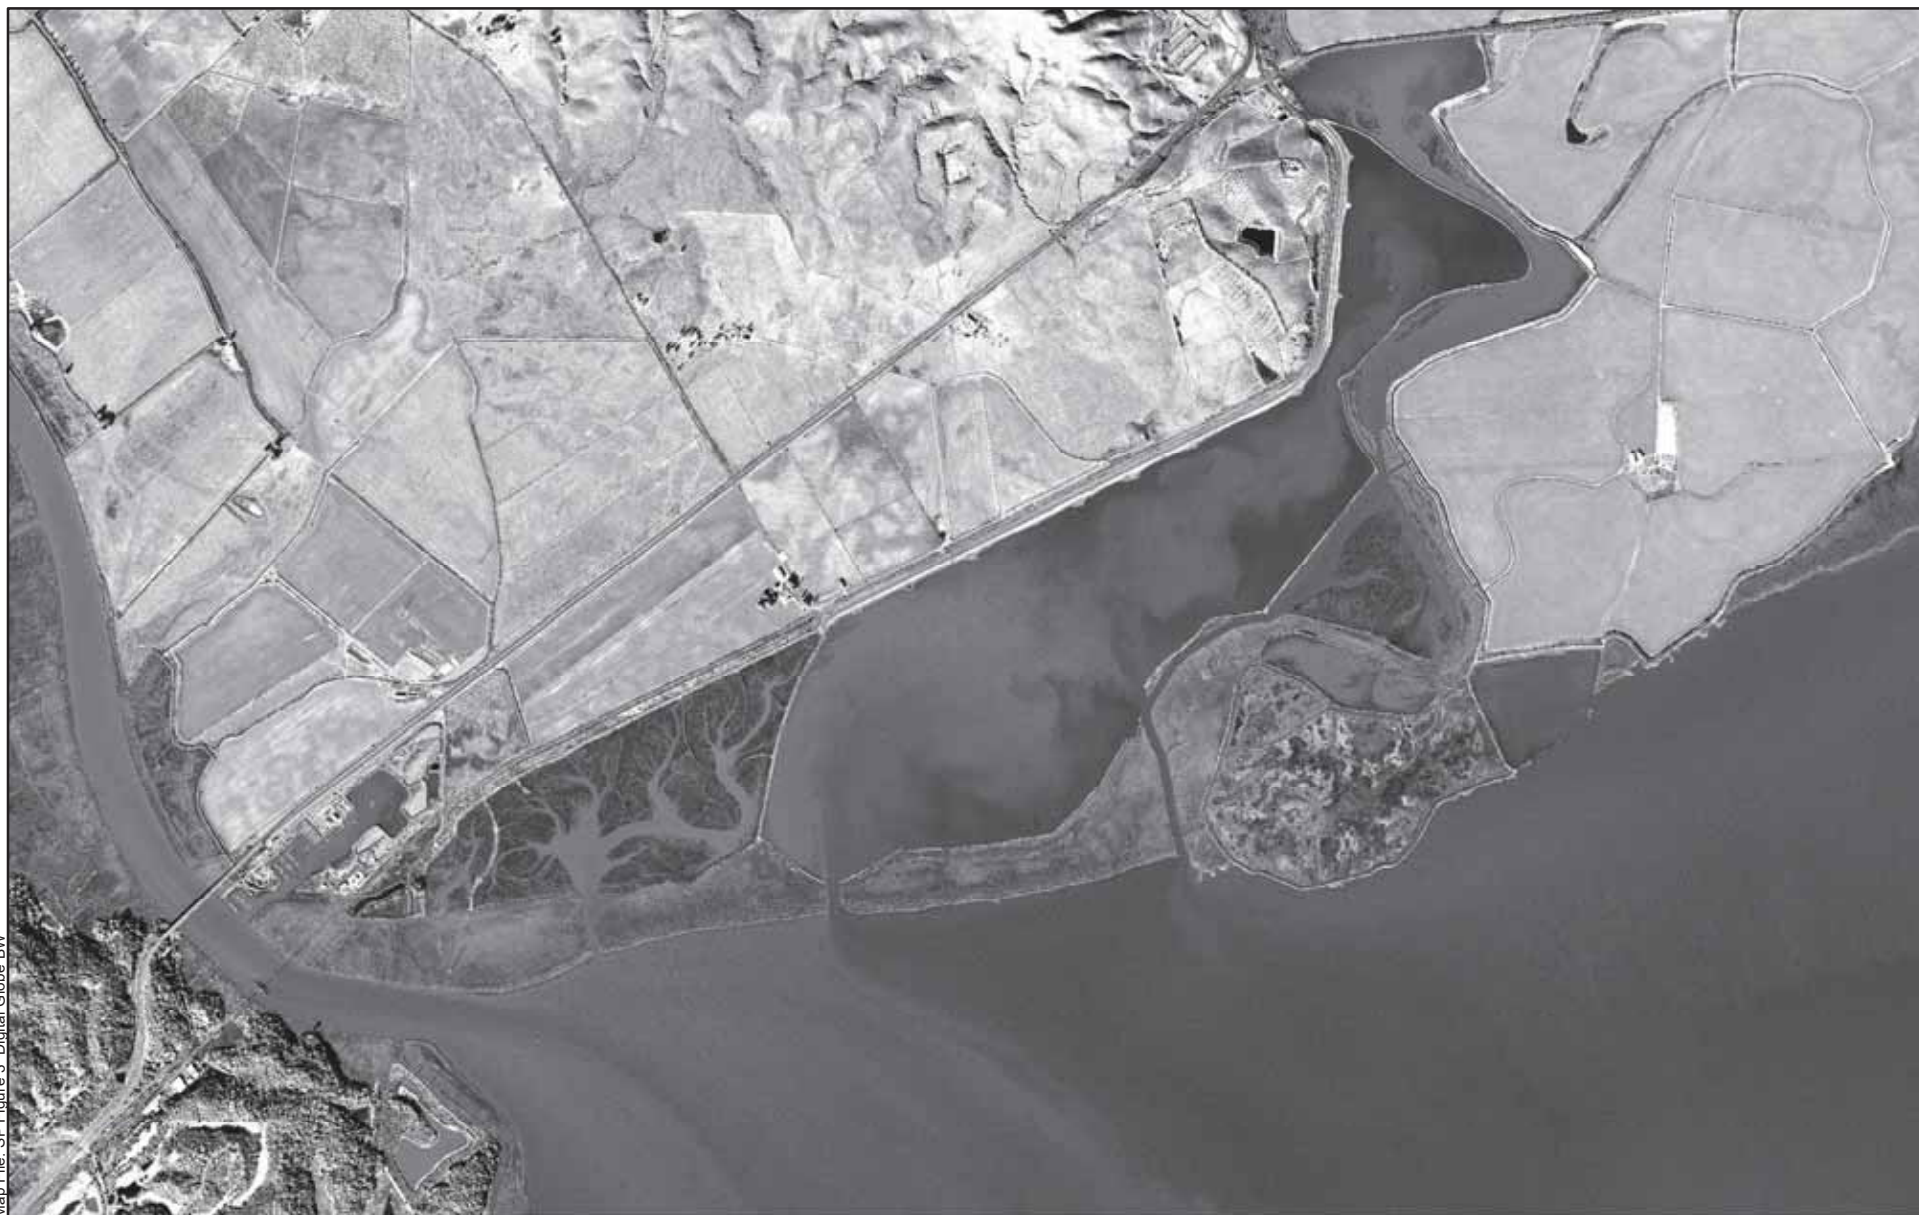
Data sources: Satellite Imagery, DigitalGlobe November 2016

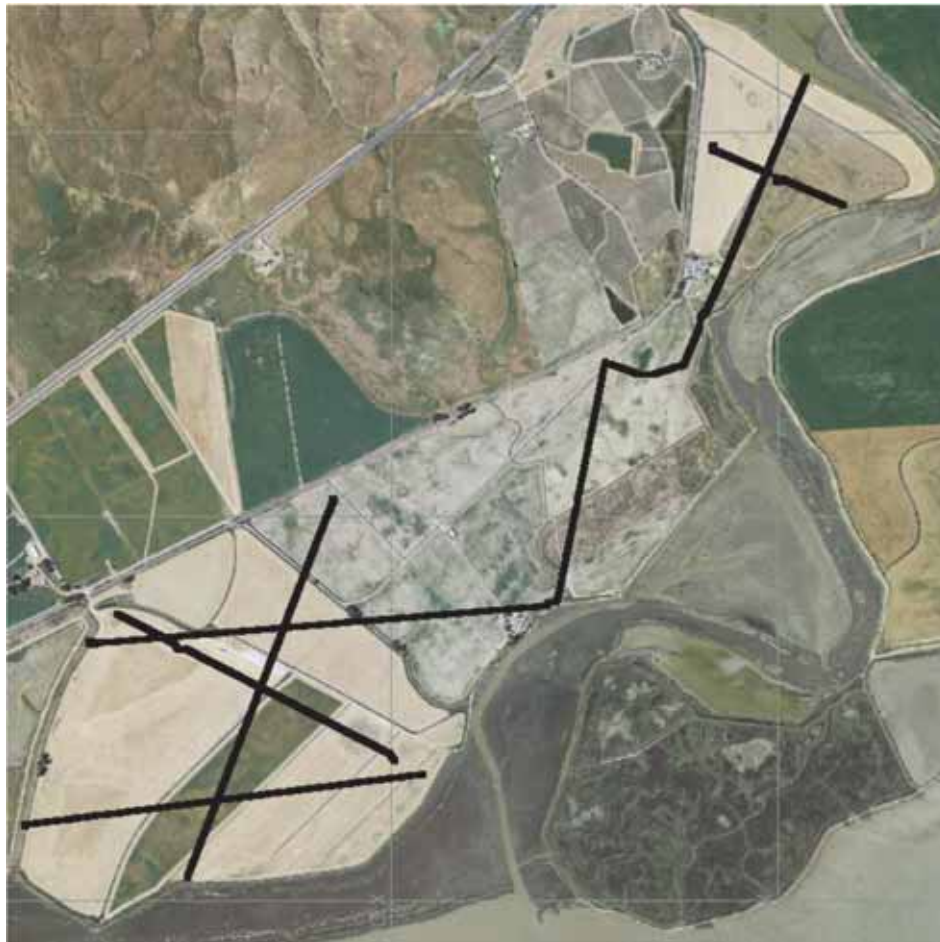
Figure 12. Location of Bathymetric Transects Surveyed February 2017

A small boat-based bathymetric survey of six transects across the site (Figure 12) was collected in February 2017 during the extreme high tides that took place that month. Findings are presented in Appendix D. Data from these transects will be compared to the USACE baseline topographic survey to yield sedimentation data.

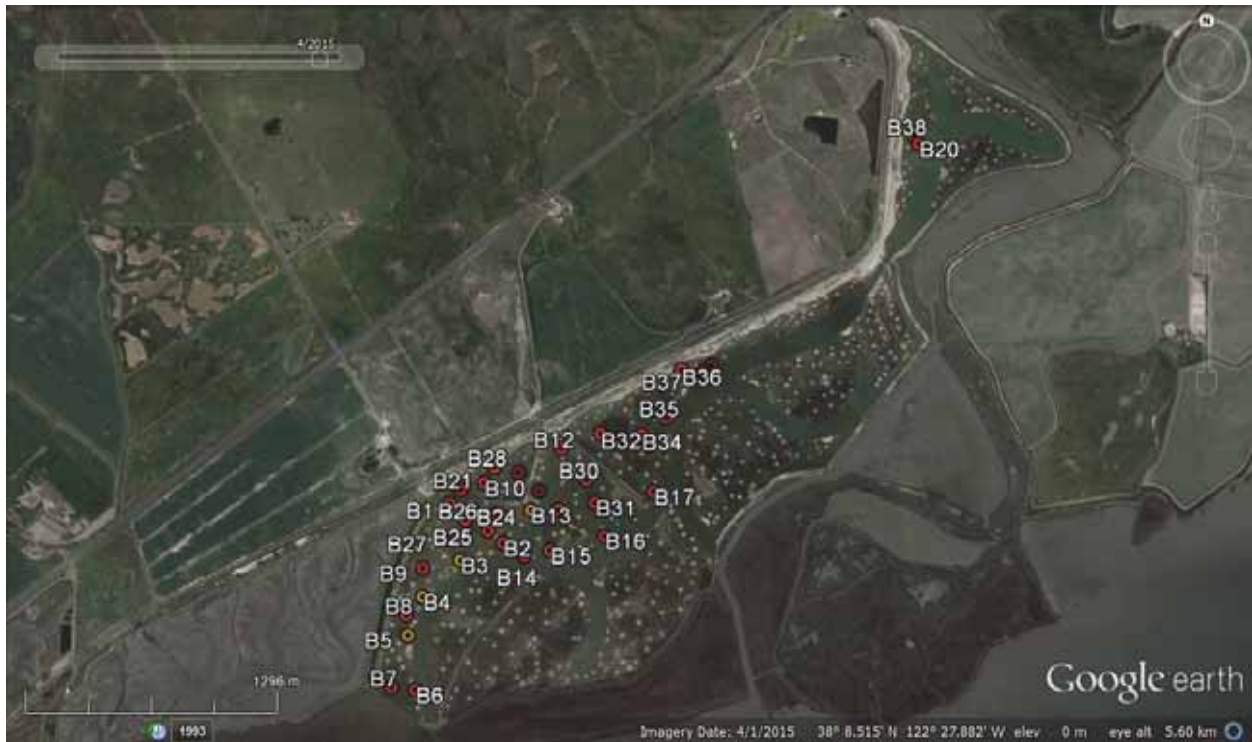
Figure 13. Location of Marsh Mounds Monitored for Erosion

Note that mounds in orange were included in early erosion measurements, but were transferred to use as experimental mounds in spring 2016. Mounds used for erosion monitoring are located on the north side of the channel due to access at the time of installation, and therefore may not represent erosional effects throughout the entire site.

Three aspects of the mounds have been observed. First, mound tops have been significantly eroded – 1 to 2 feet in places (Figure 14). Second, eroded materials appear to be depositing nearby the mounds, in effect widening and flattening the mounds. Third, the mounds appear to be promoting localized deposition in their “flow shadows,” an intention of their design. The mounds were built by local excavation of compacted, more coarse-grained sediments (comprised largely of clumped silts and clays) in a matrix of fine sediments from the compacted soils that made up the former pasture and hay field.

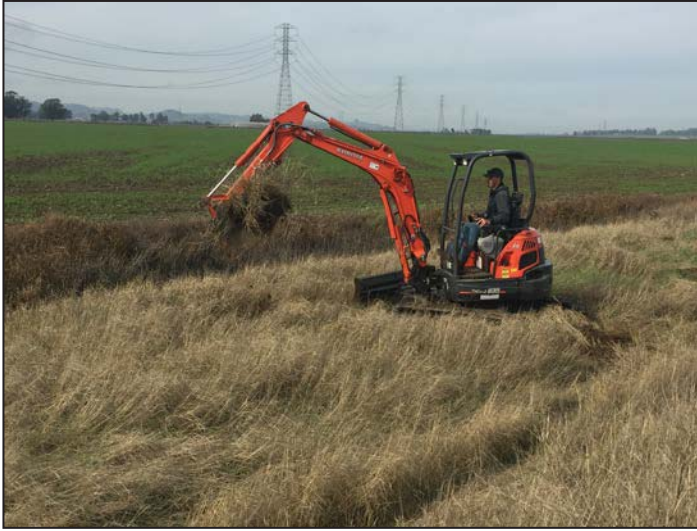
SLT rented a small excavator to harvest clumps of *Elymus triticoides* from a nearby source population to transplant rhizomes at the Sears Point levee.

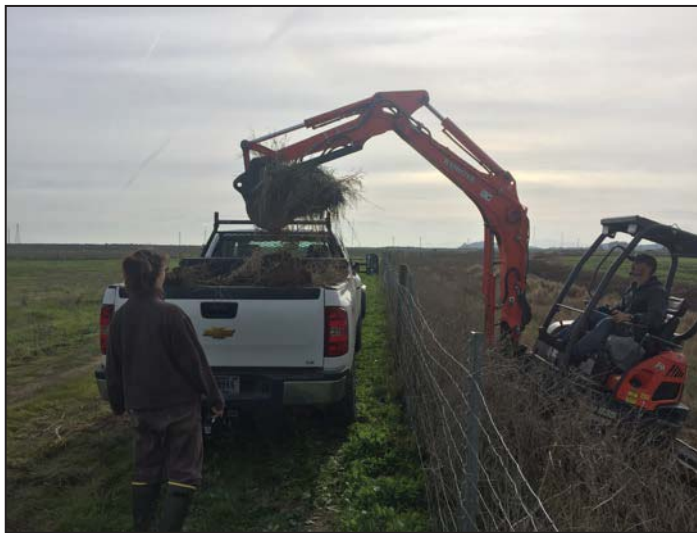
Harvested *E. triticoides* was loaded into pickup trucks and transported to the planting site.

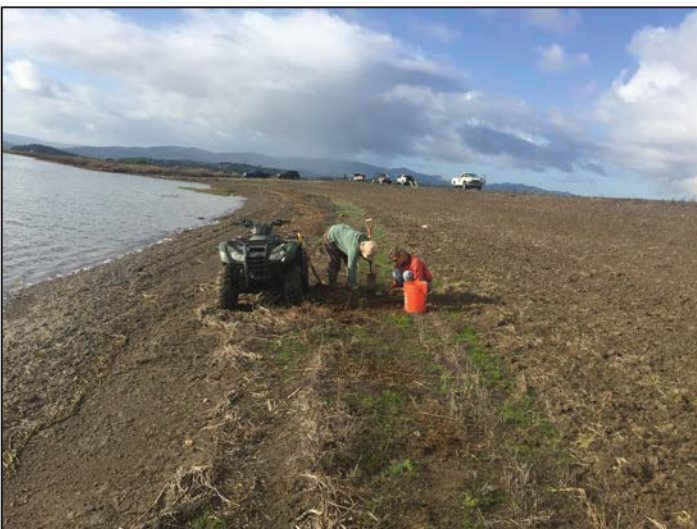
Rhizome planting just above the high tide rack line on the Sears Point levee.

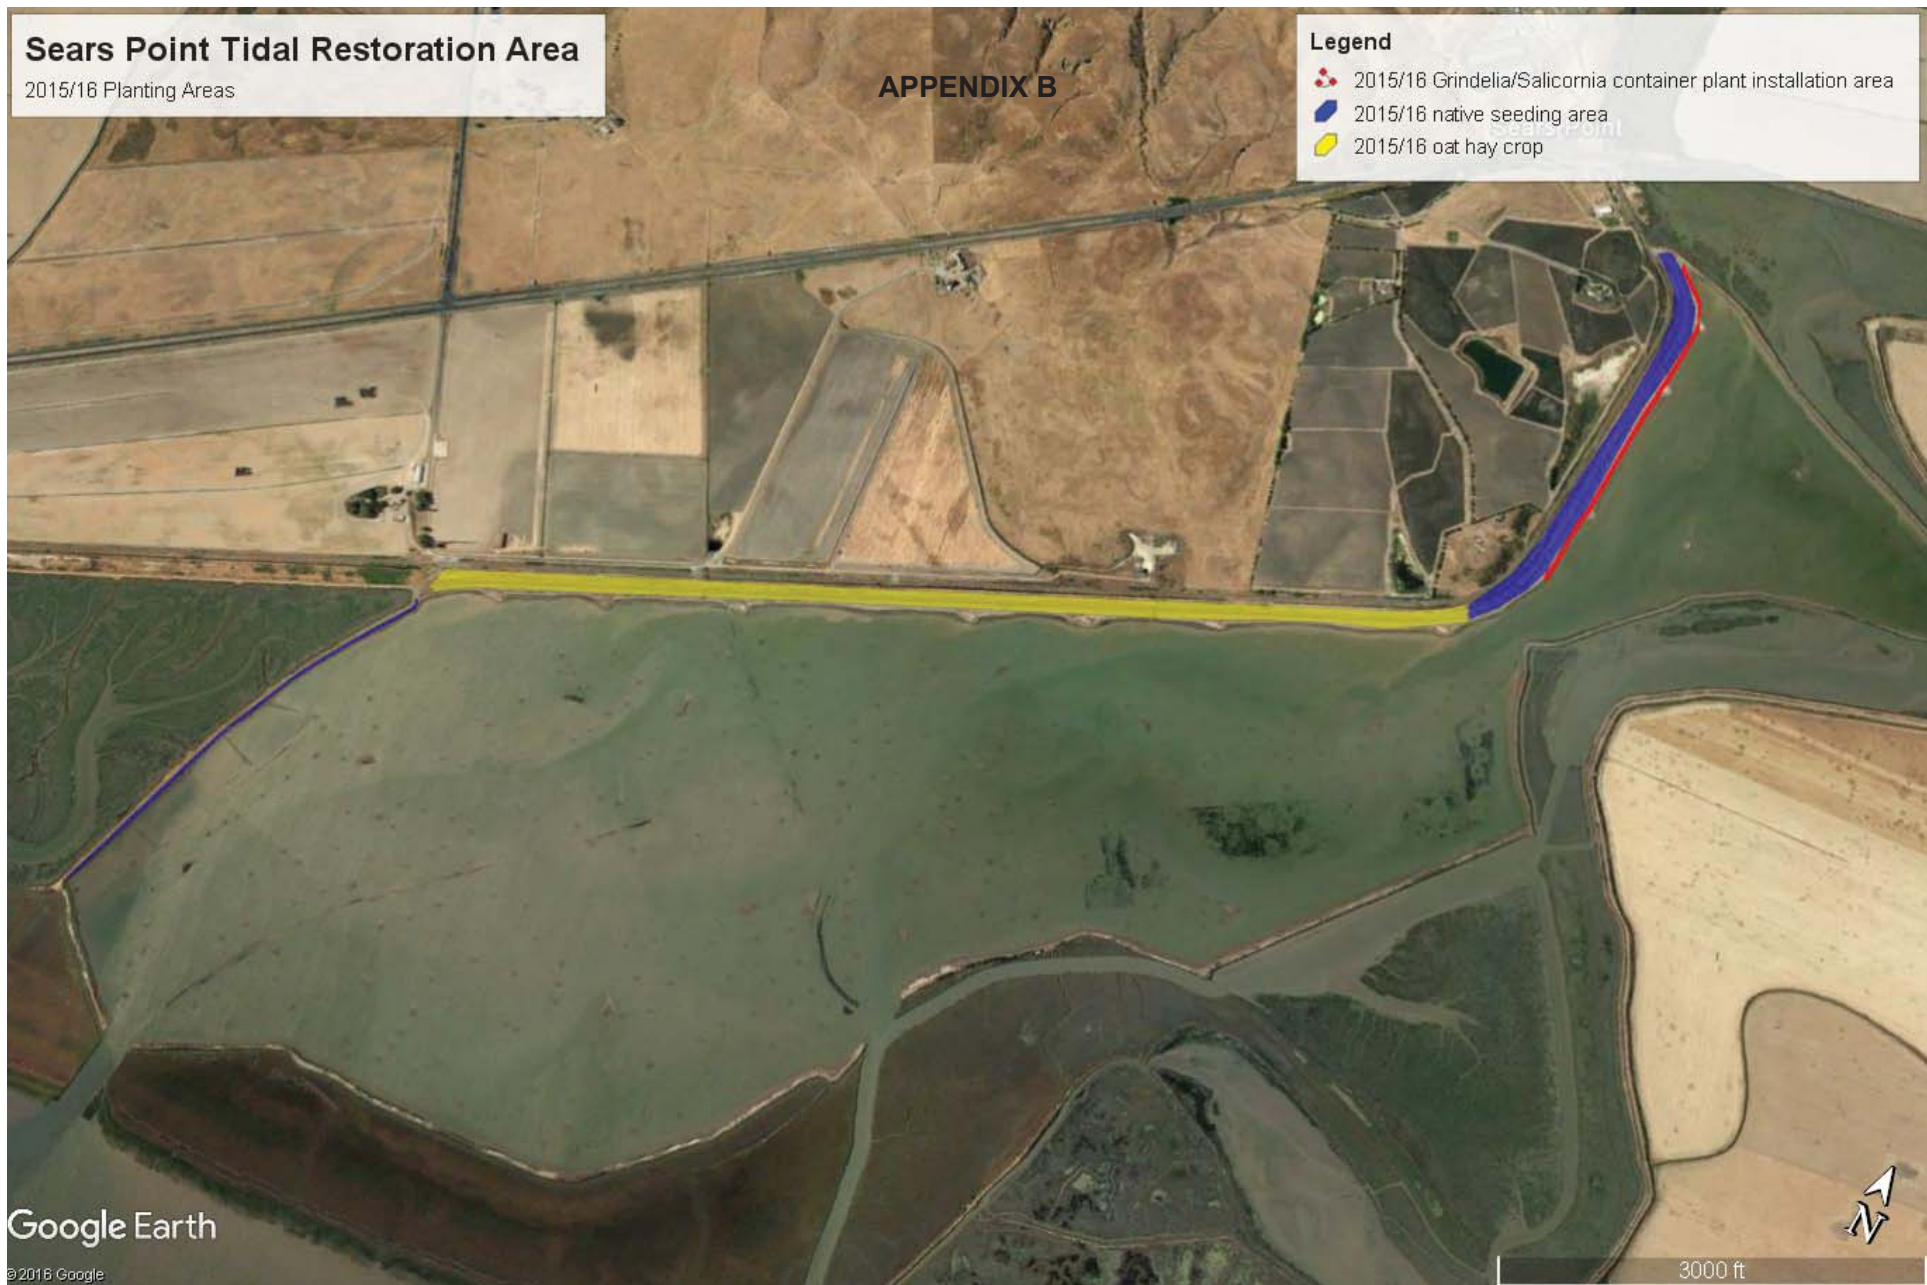
Figure 2. Overview of levee areas seeded with native species and oat hay crop in October 2015. Aerial photo date: August 2016.

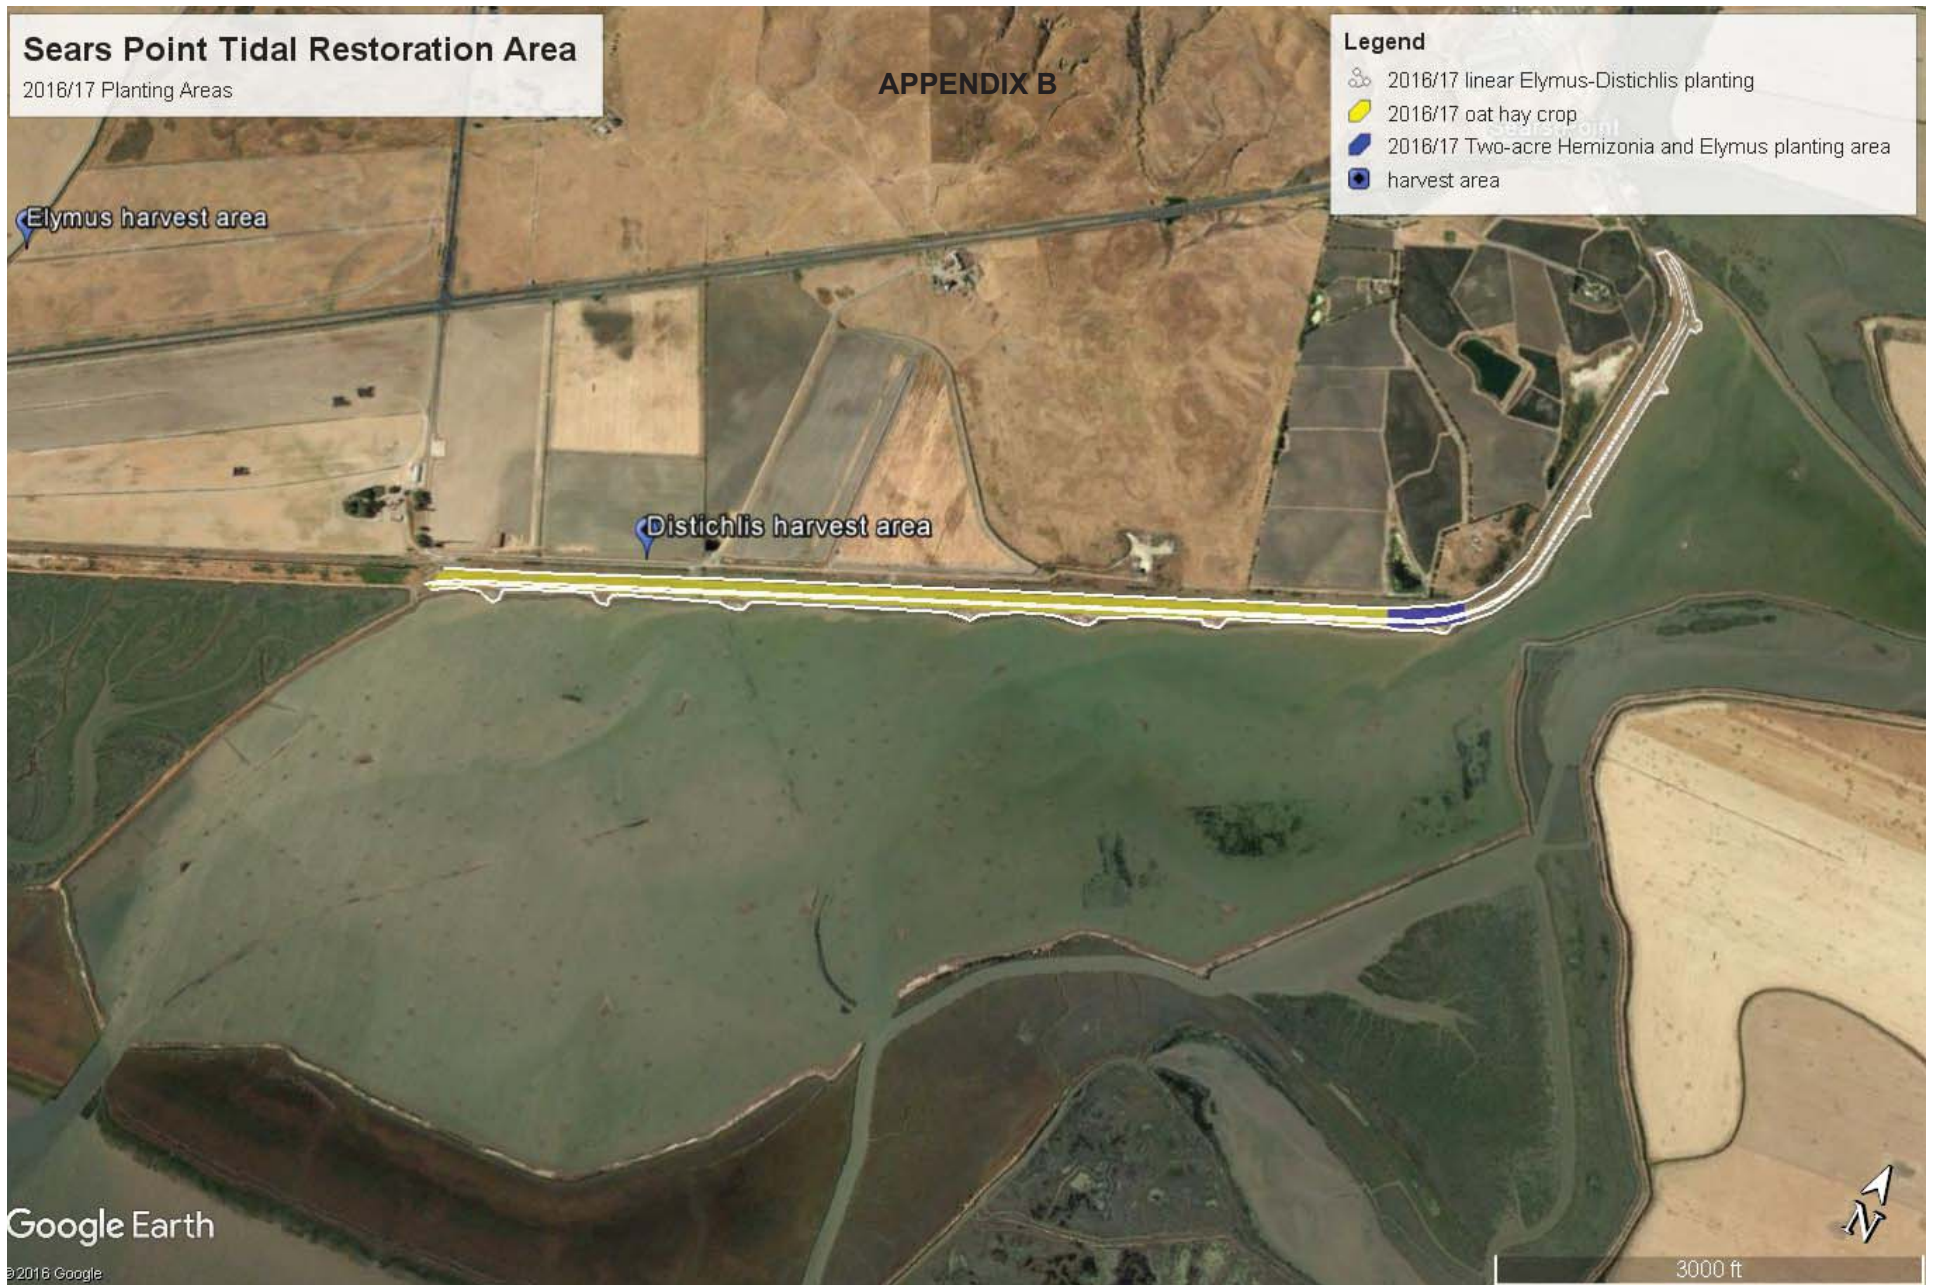
Figure 3. Overview of levee planting areas in 2016/17. Oat hay planted in October 2016. Hemizonia seeded in October 2016. Elymus rhizomes planted November 2015-April 2016. Aerial photo date: August 2016.

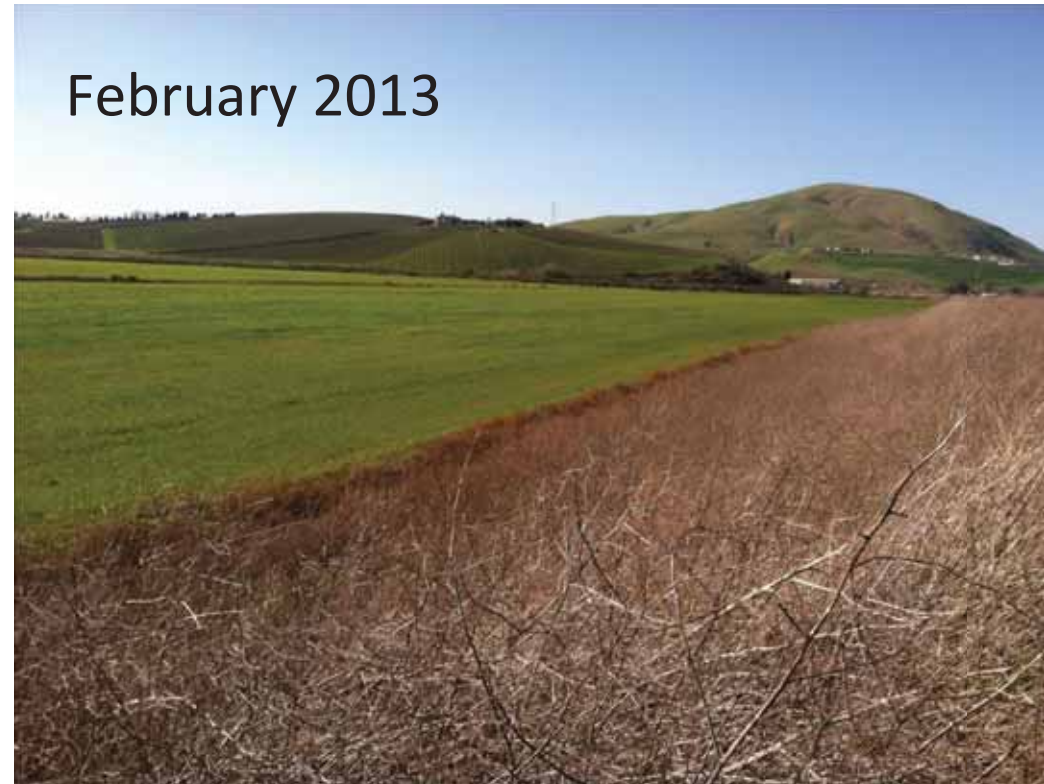
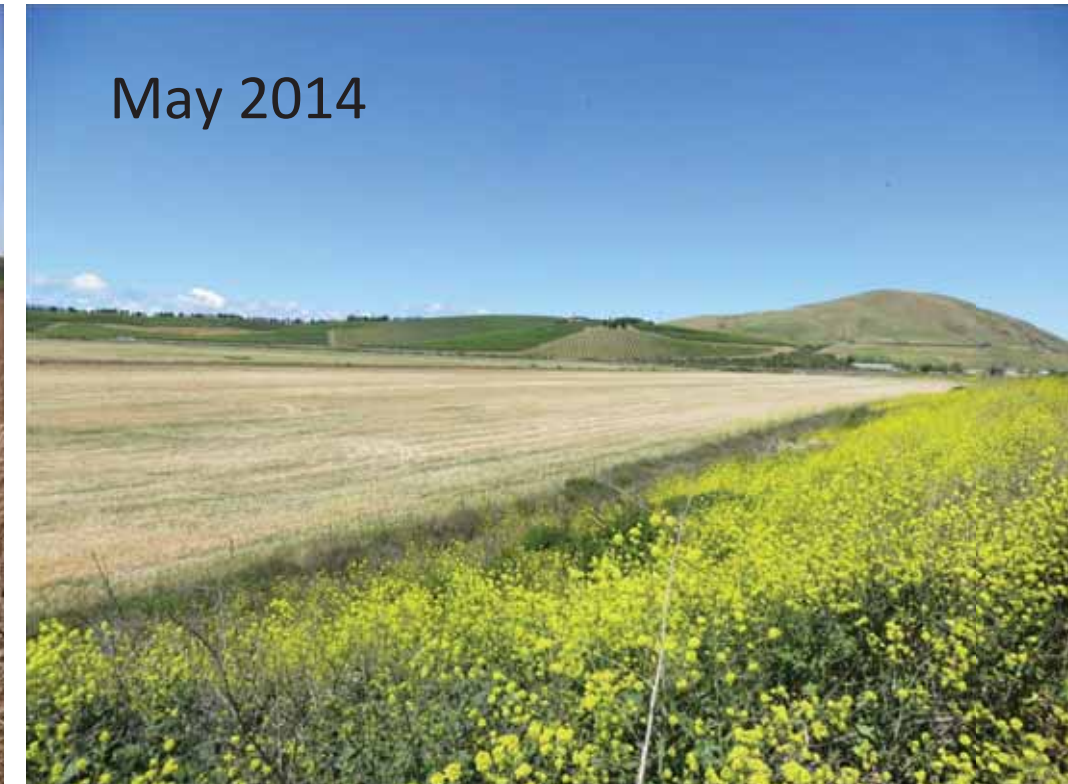
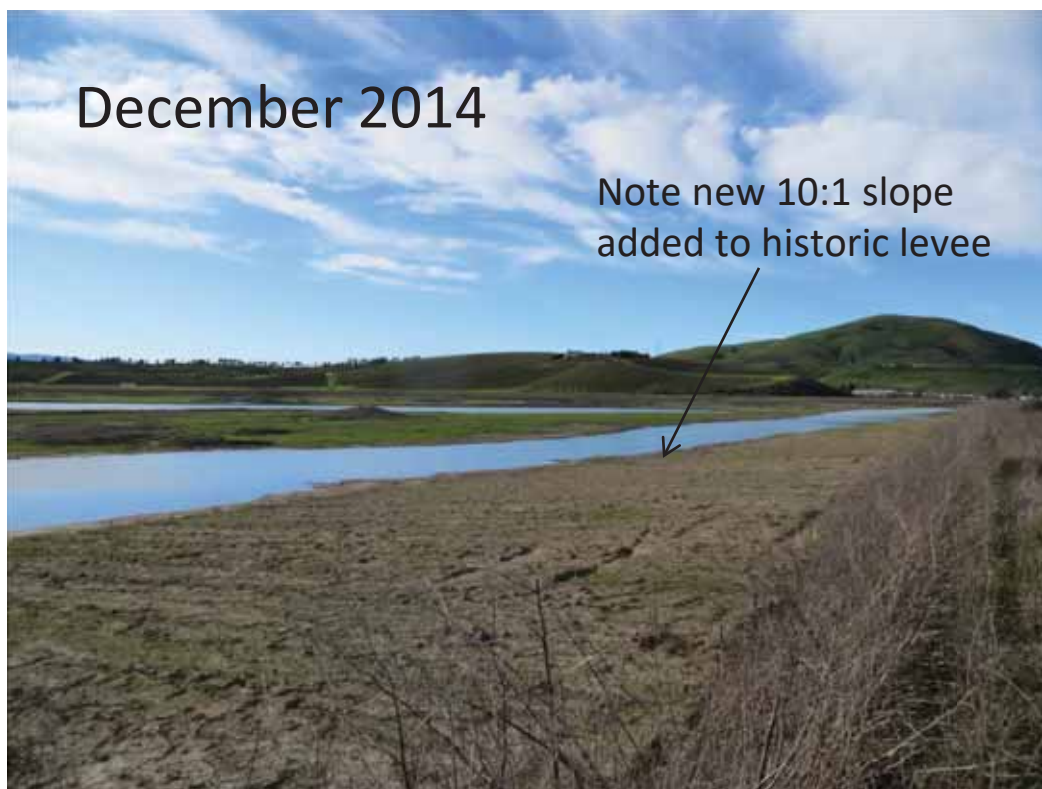
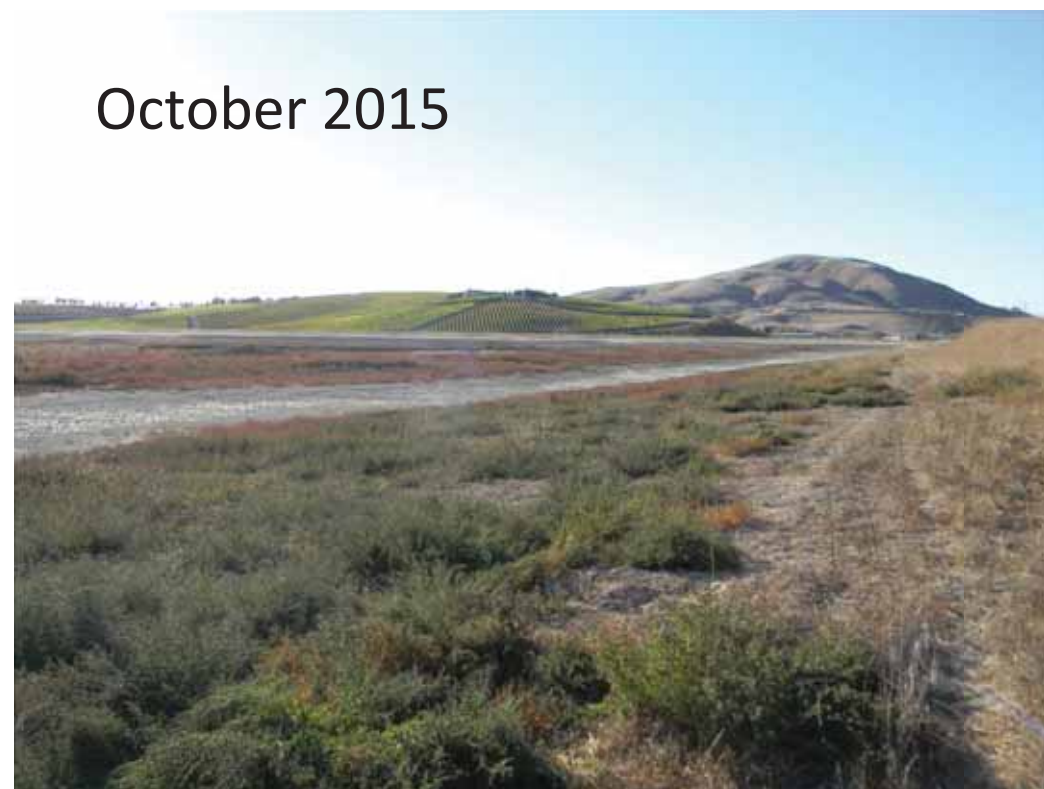
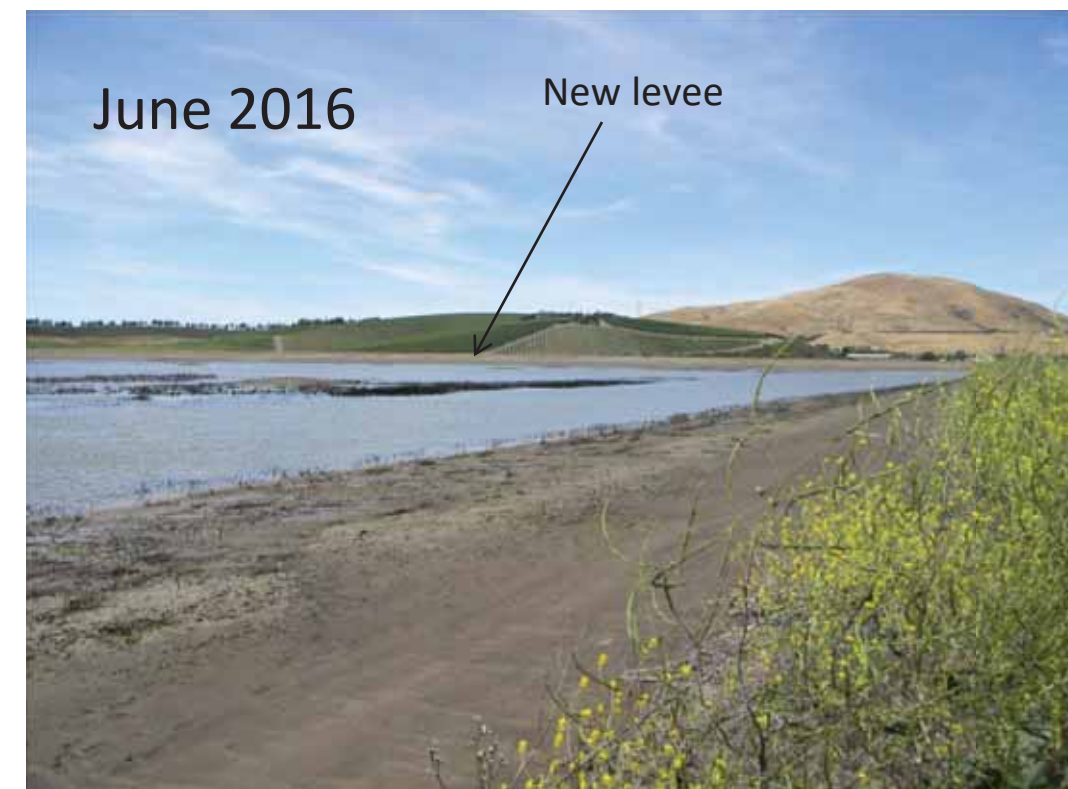
Photo Point 1, Photo 1.1
N 38.14709, W 122.43884
Bearing 279°

Photo Point Description: Crest of historic levee near northeast corner of property

Photo Description: View W overlooking ag field to Paradise Vineyard and Cougar Mountain showing where eastern end of new levee and marsh mounds will be constructed
