Sears Point Tidal Marsh Restoration Project

Monitoring and Management Status Report

October 2015 to June 2017

Sears Point Tidal Marsh Restoration Project
Monitoring and Management Status Report, Year 1
October 2015 to June 2017

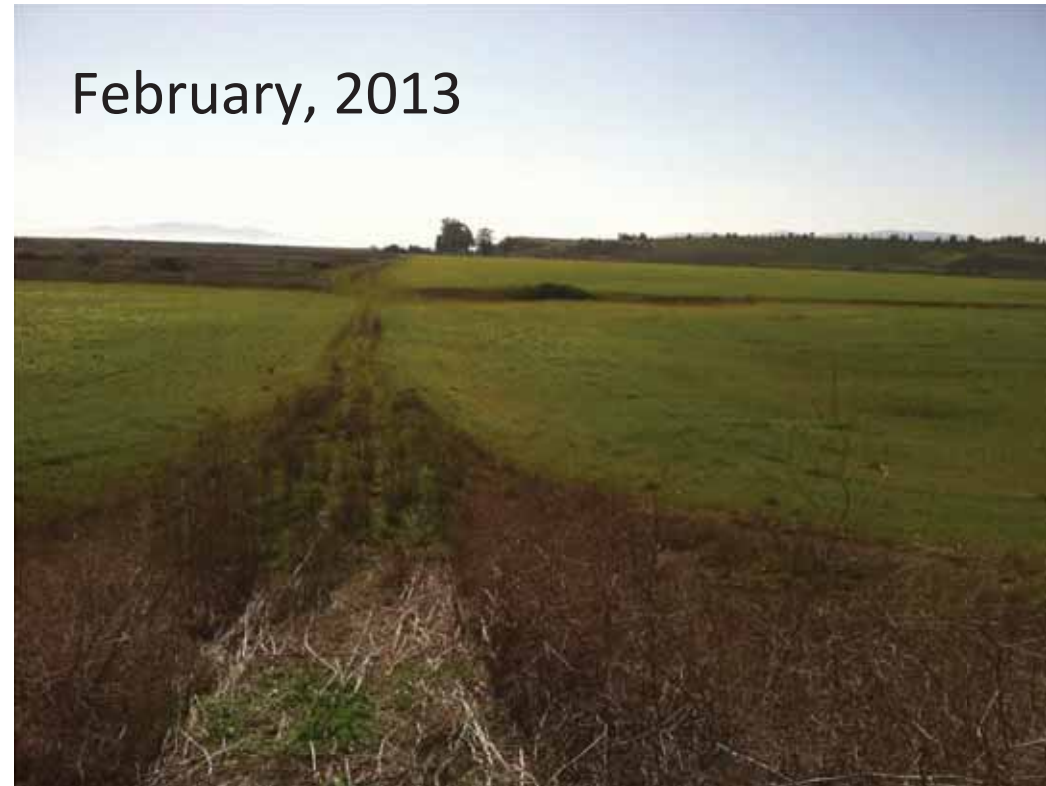
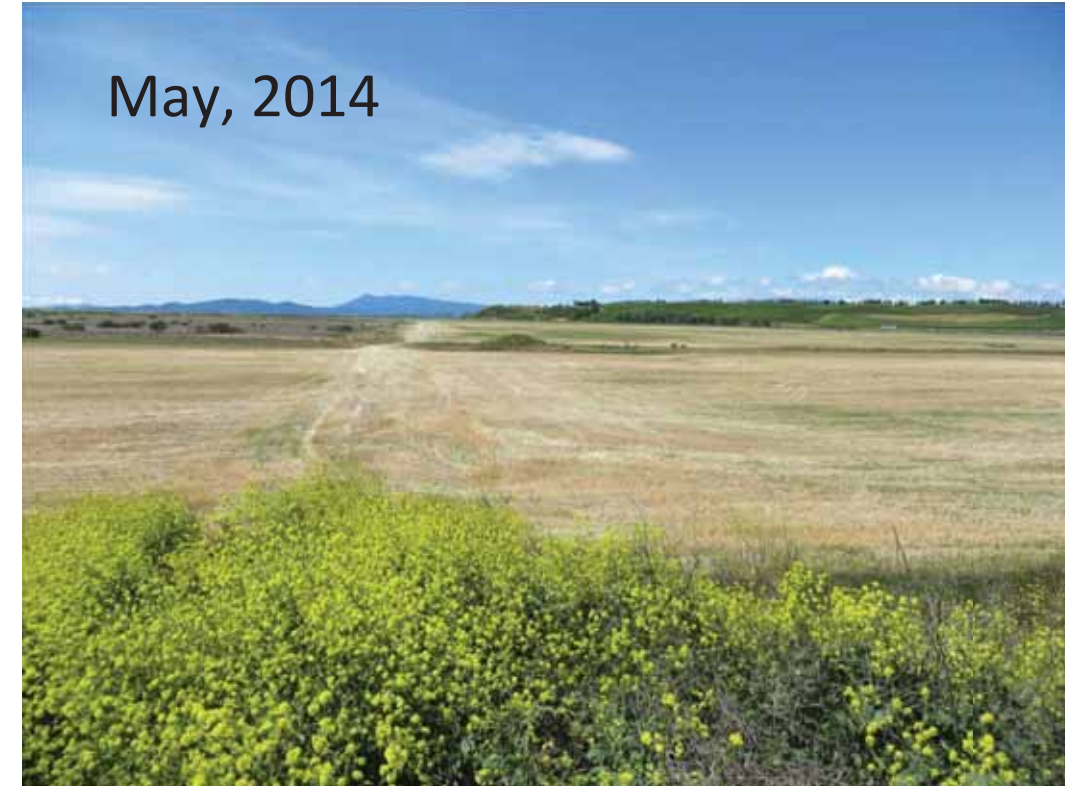
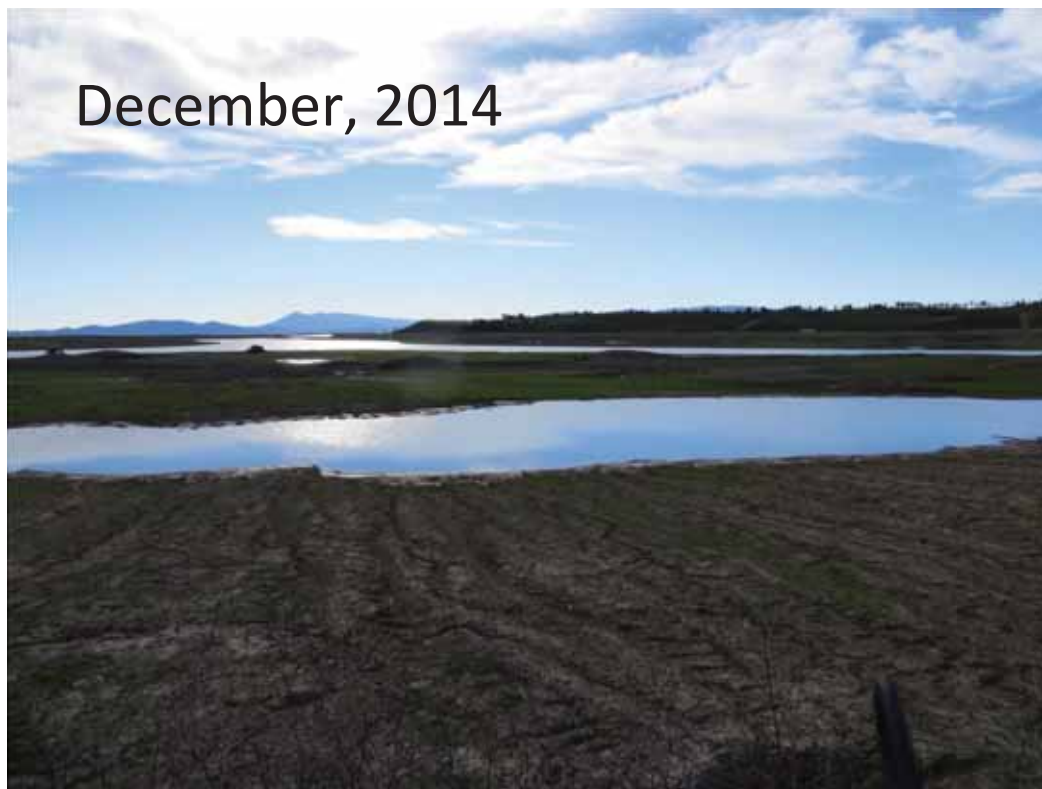
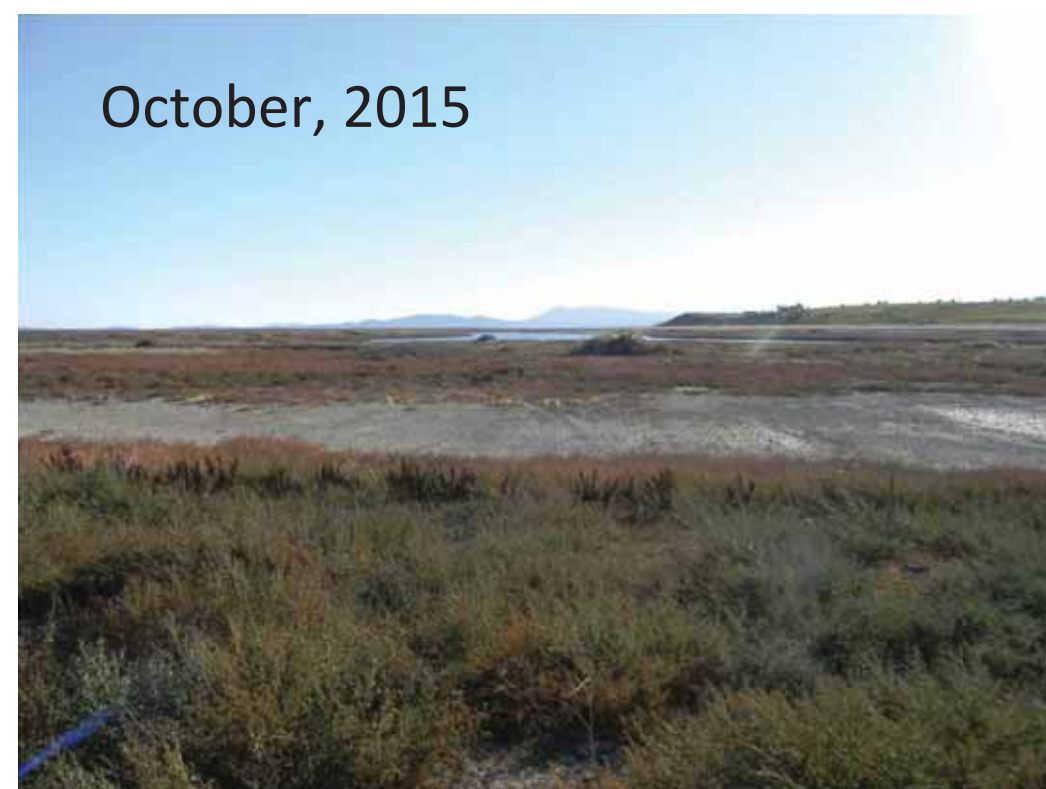
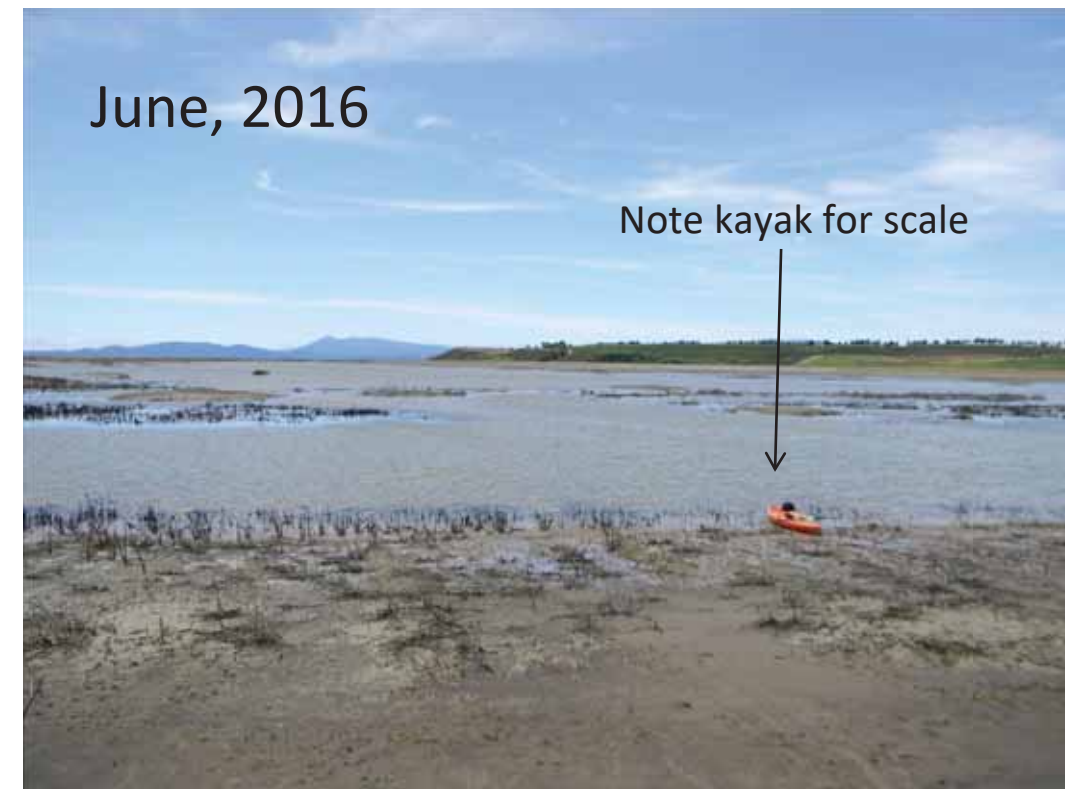
Photo Point 1, Photo 1.2
N 38.14709, W 122.43884
Bearing 222°

Photo Point Description: Crest of historic levee near northeast corner of property

Photo Description: View WSW across ag field toward hunt club and eucalyptus trees to show that both these features are removed and that marsh mounds and tidal channels have been constructed

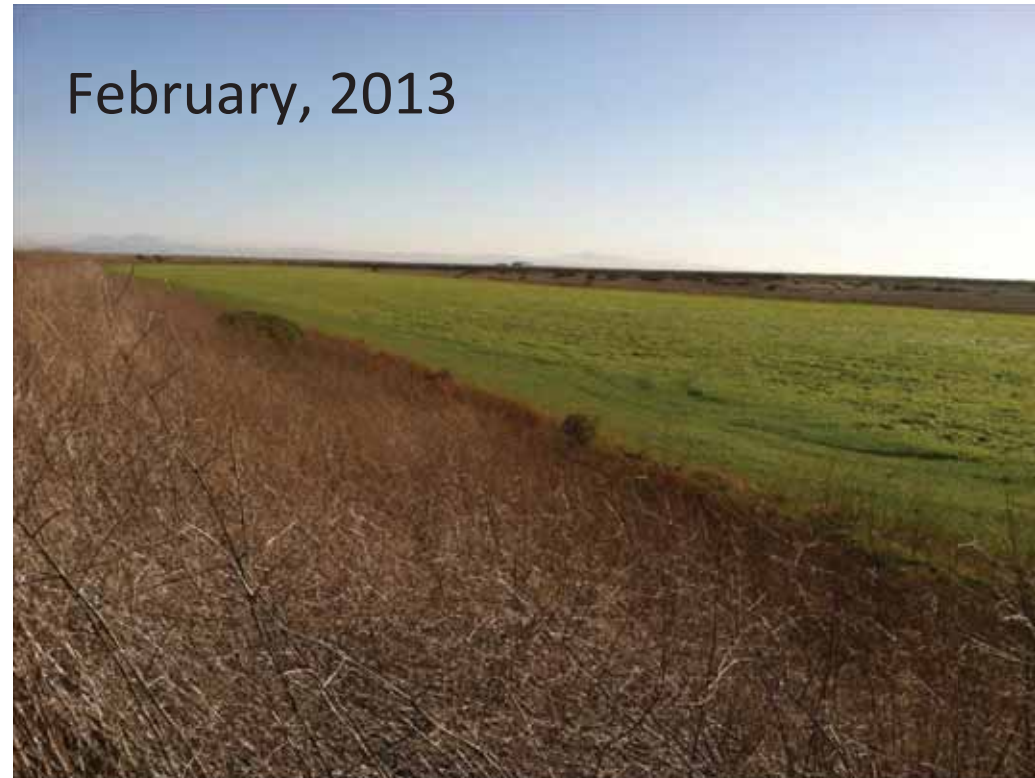
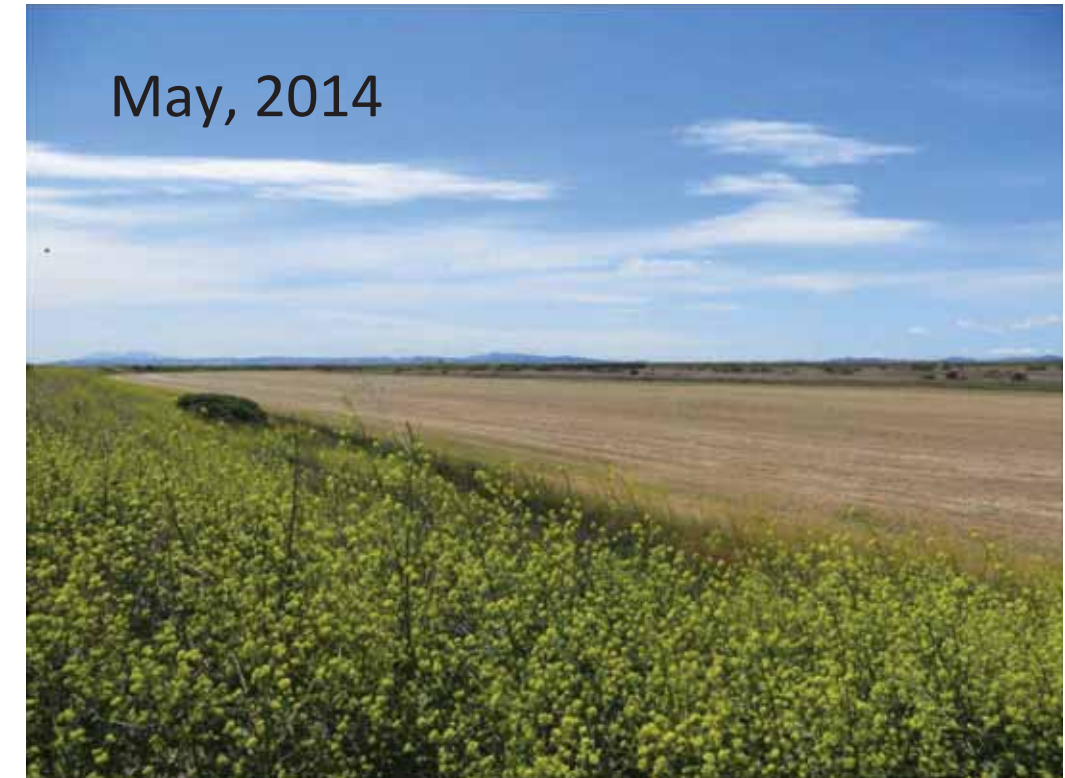
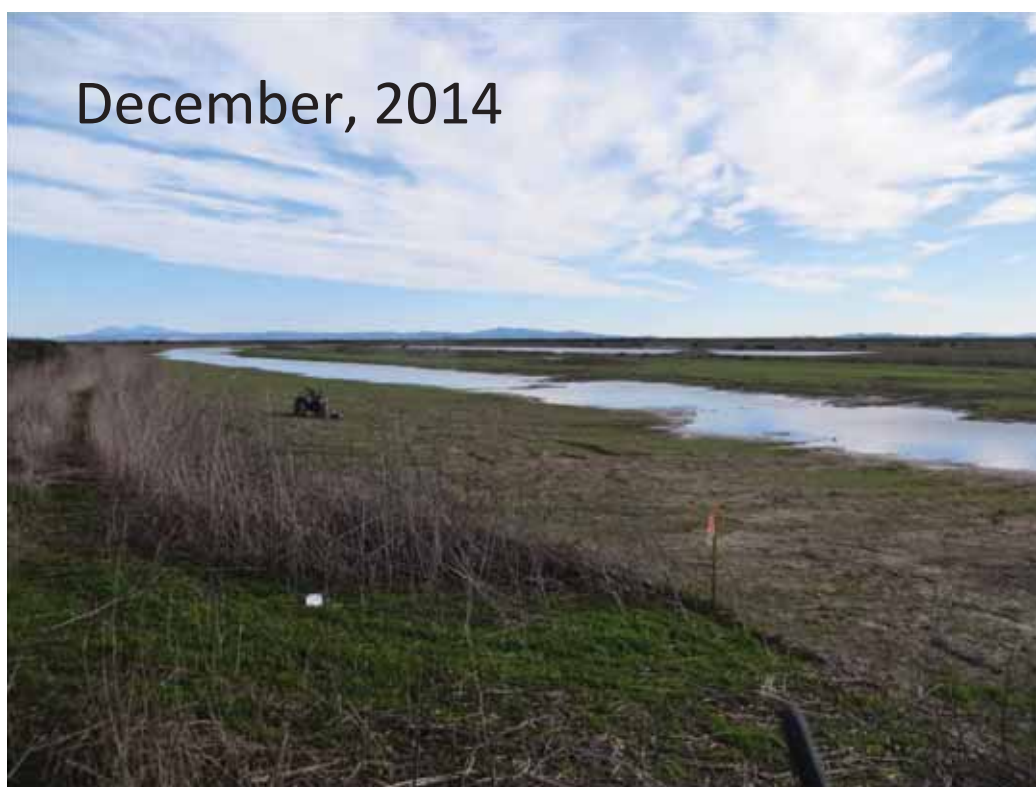
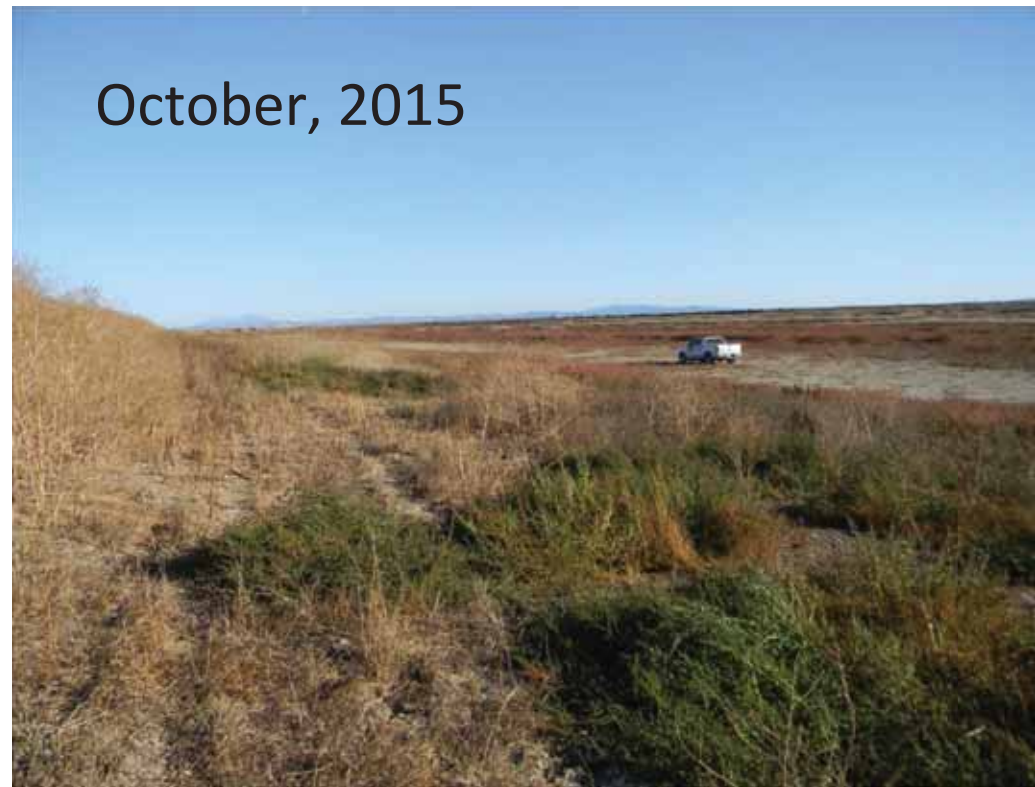
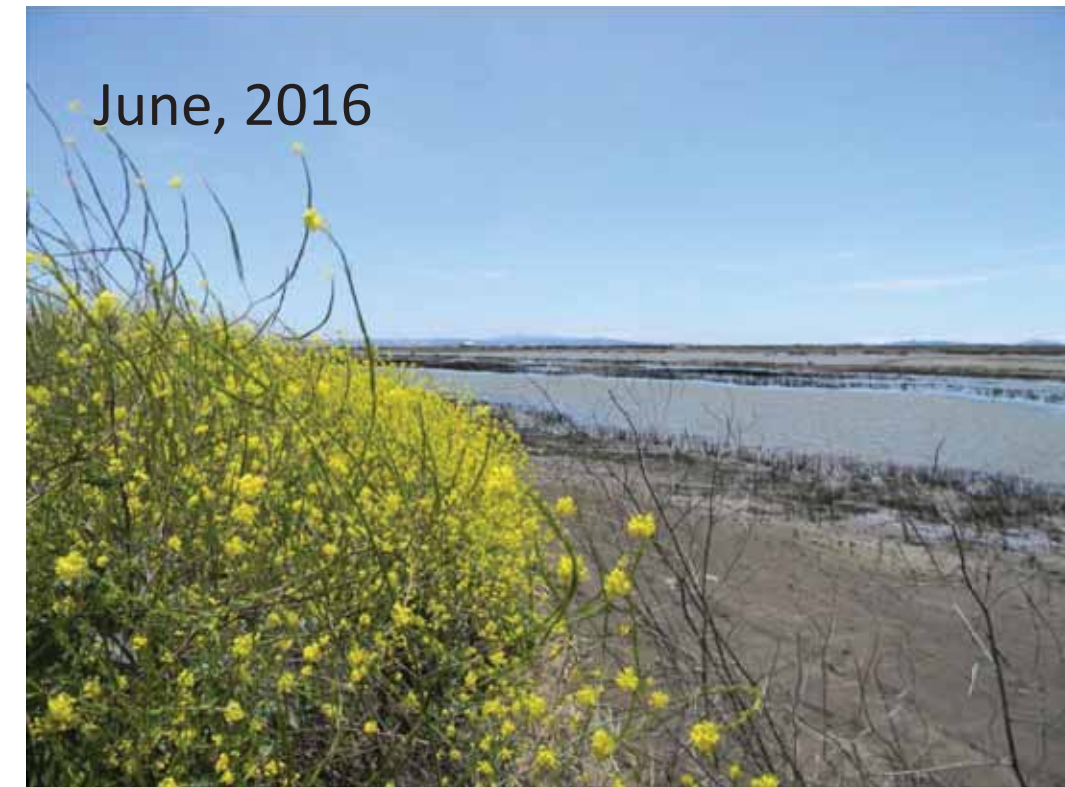
Photo Point 1, Photo 1.3
N 38.14709, W 122.43884
Bearing 140°

Photo Point Description: Crest of old levee near northeast corner of property

Photo Description: View ESE across ag field with Tubbs Island radio towers and Mt Diablo visible in background to show marsh mound and tidal channel construction

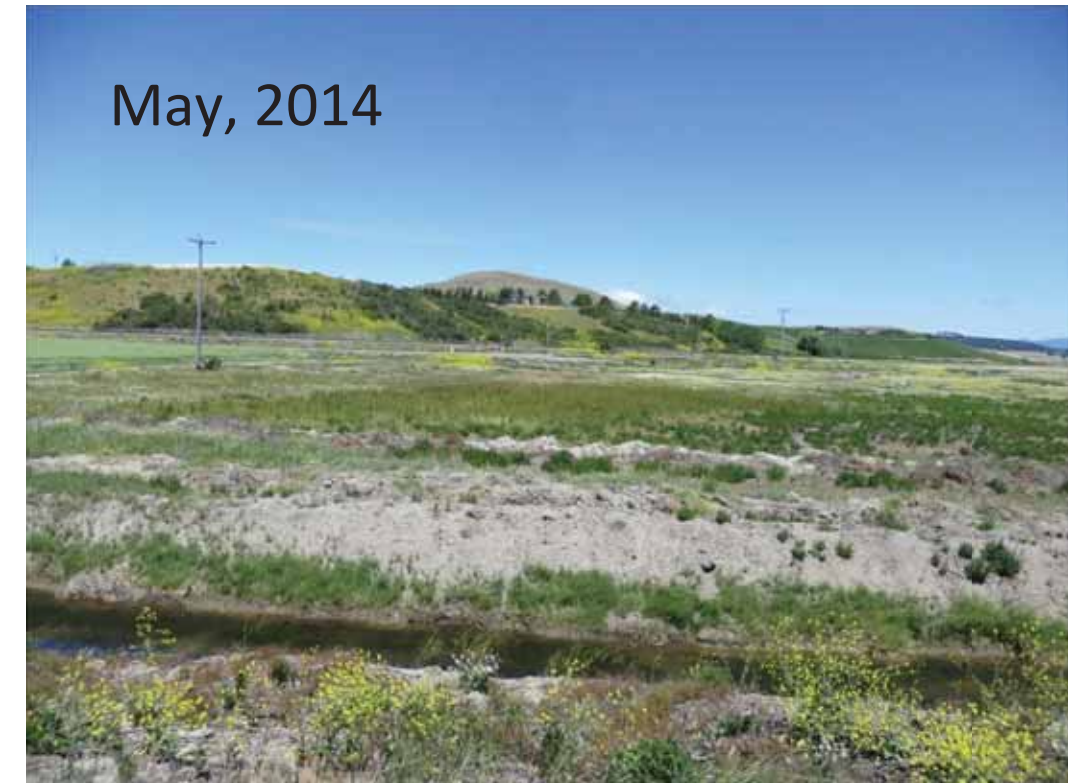
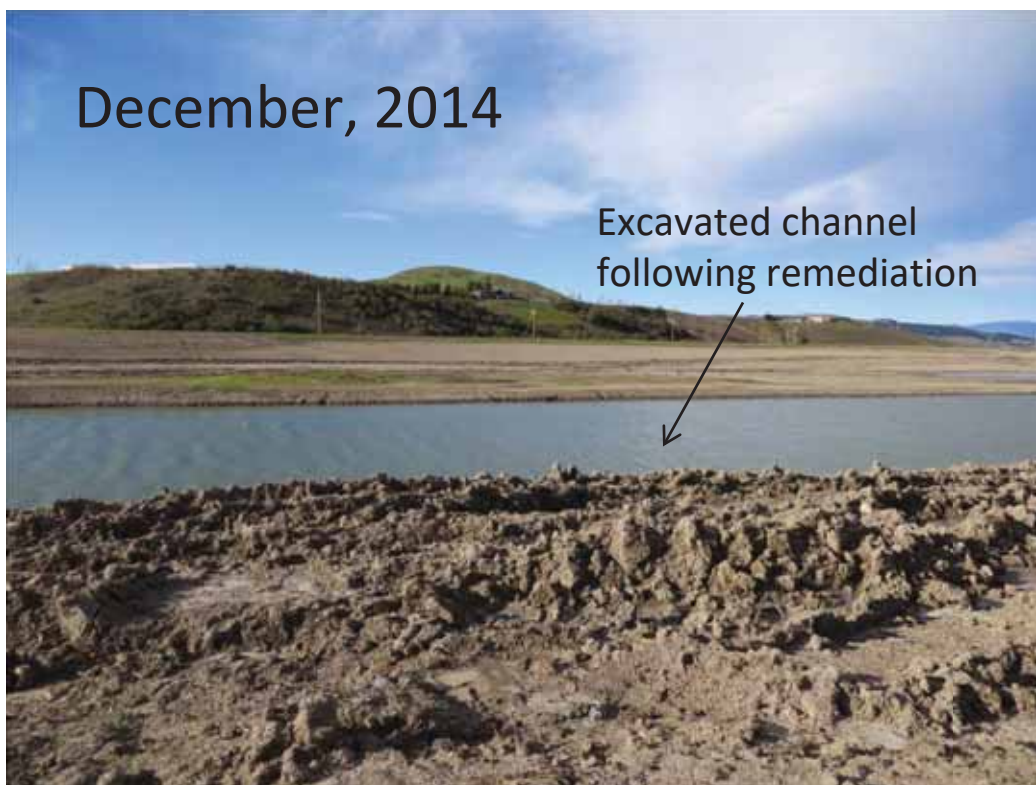
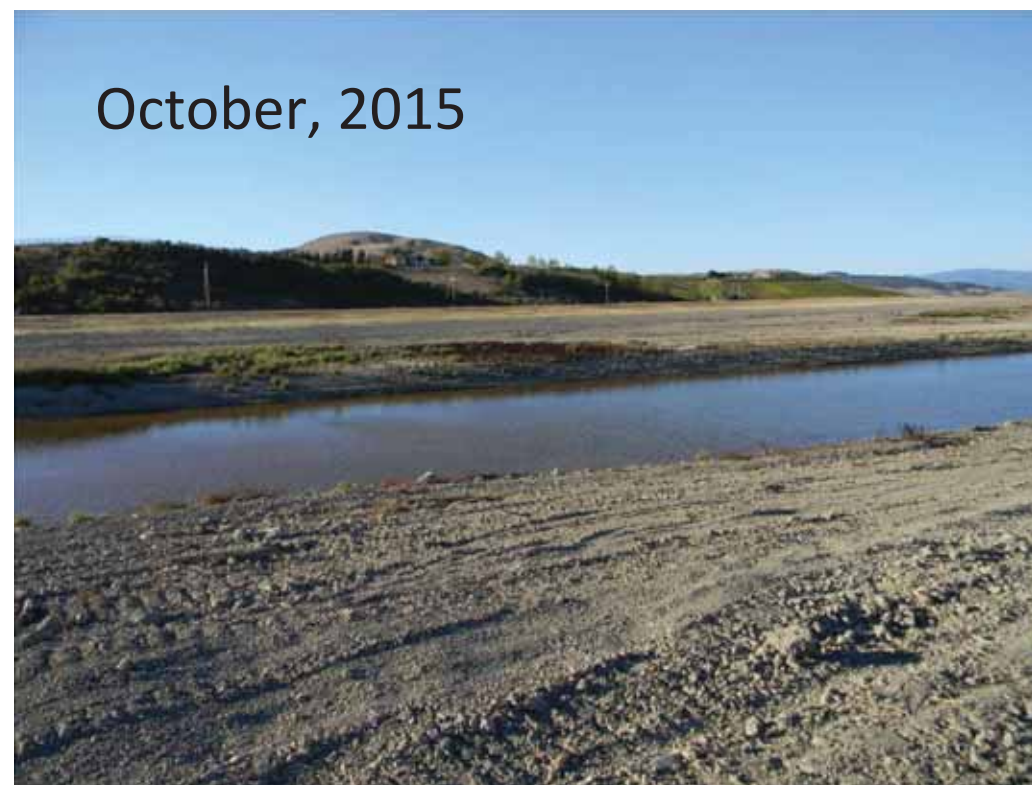
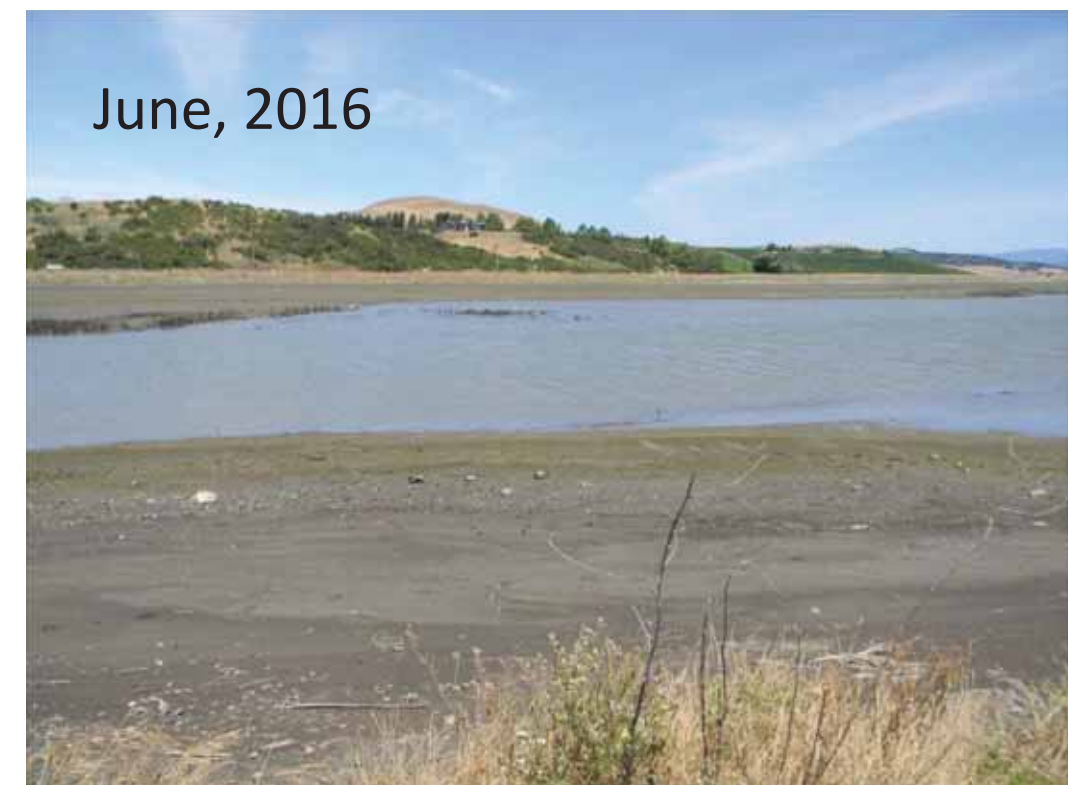
Photo Point 2, Photo 2.1
N 38.13850, W 122. 44356
Bearing 321°

Photo Point Description: Crest of historic levee at pinch point of property

Photo Description: View NW to show hunt club and eucalyptus trees to be removed and soil remediation area

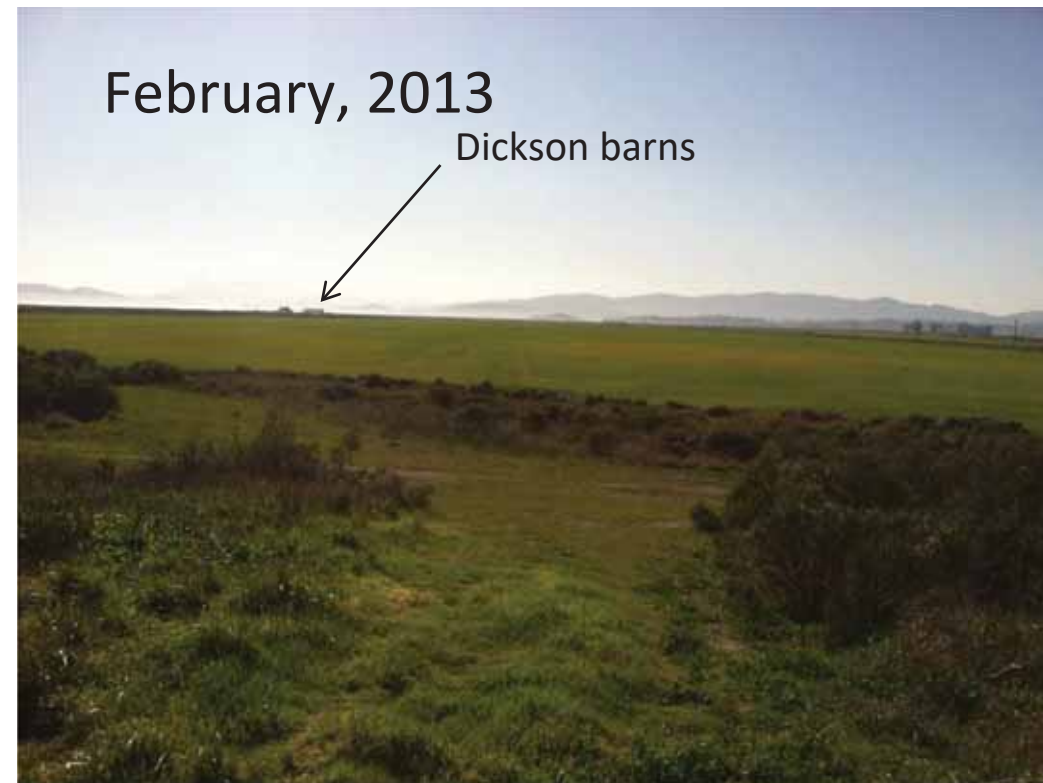
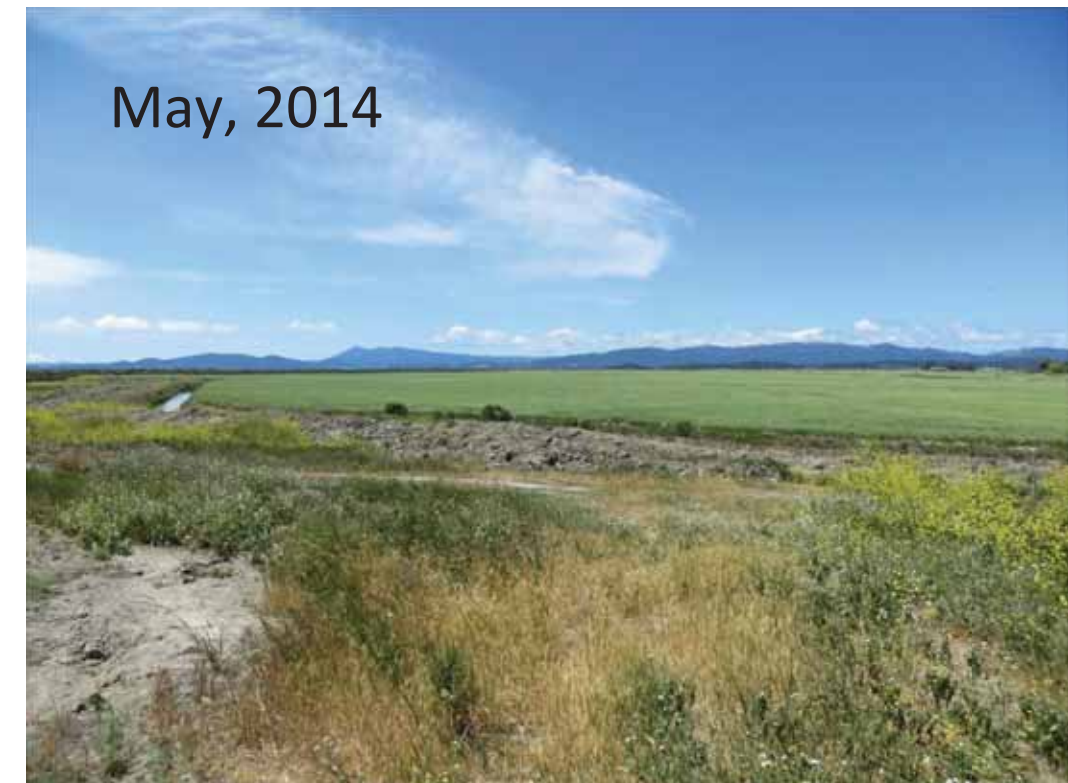
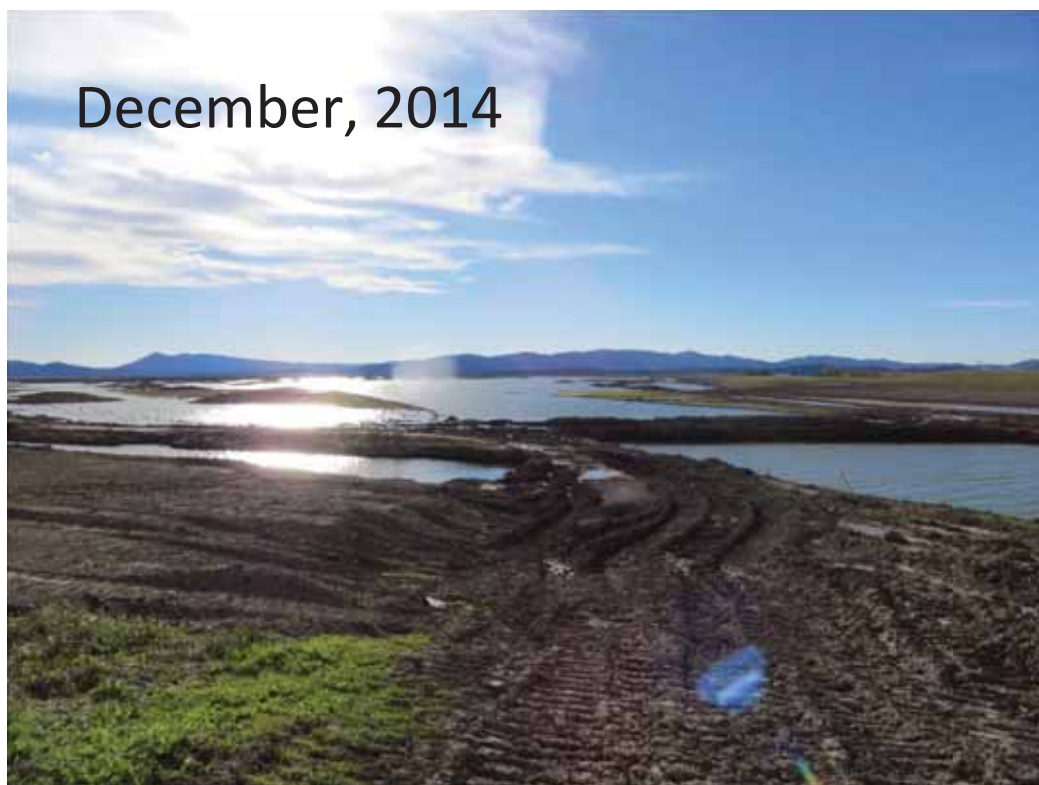
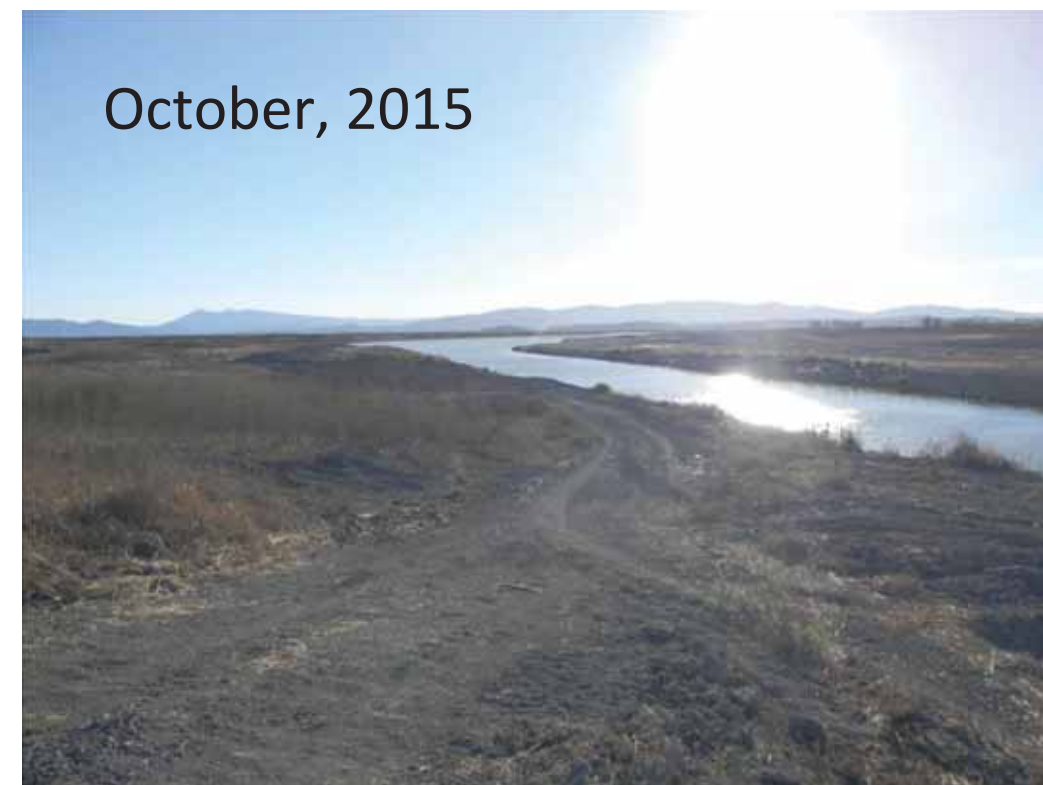
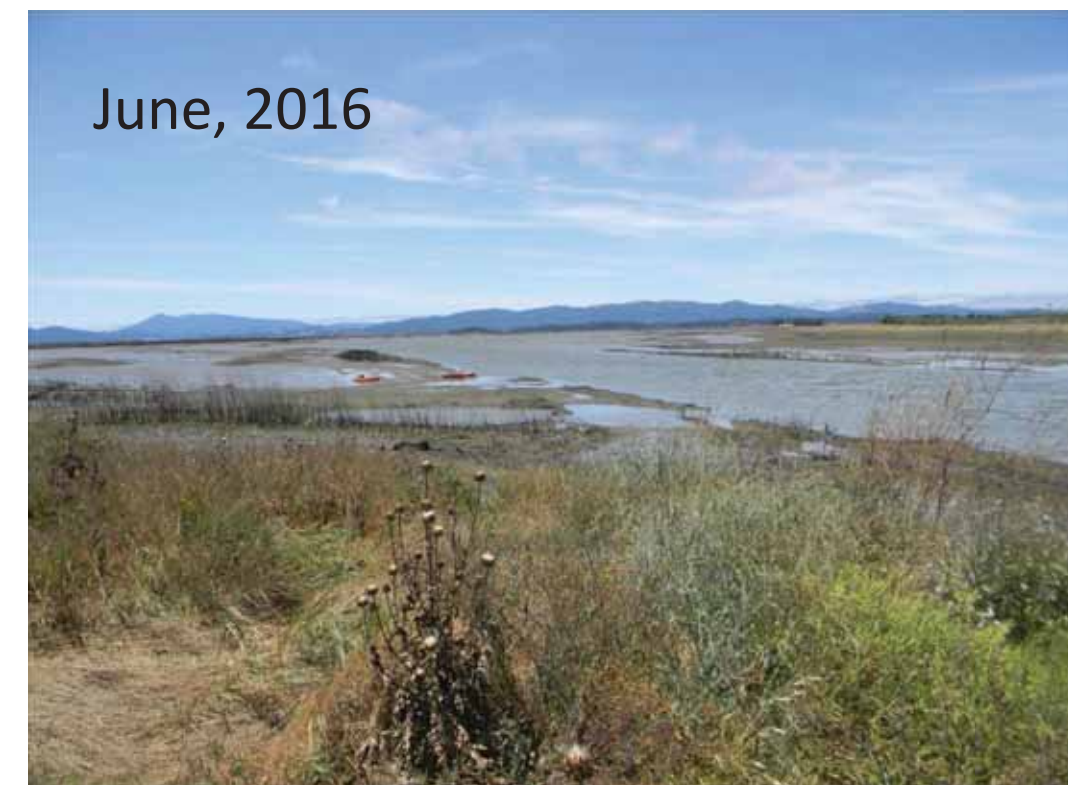
Photo Point 2, Photo 2.2
N 38.13850, W 122. 44356
Bearing 240°

Photo Point Description: Crest of old levee at pinch point of property

Photo Description: View W across ag fields toward Dickson barns and home site to show future tidal channels and marsh mounds and removal of structures

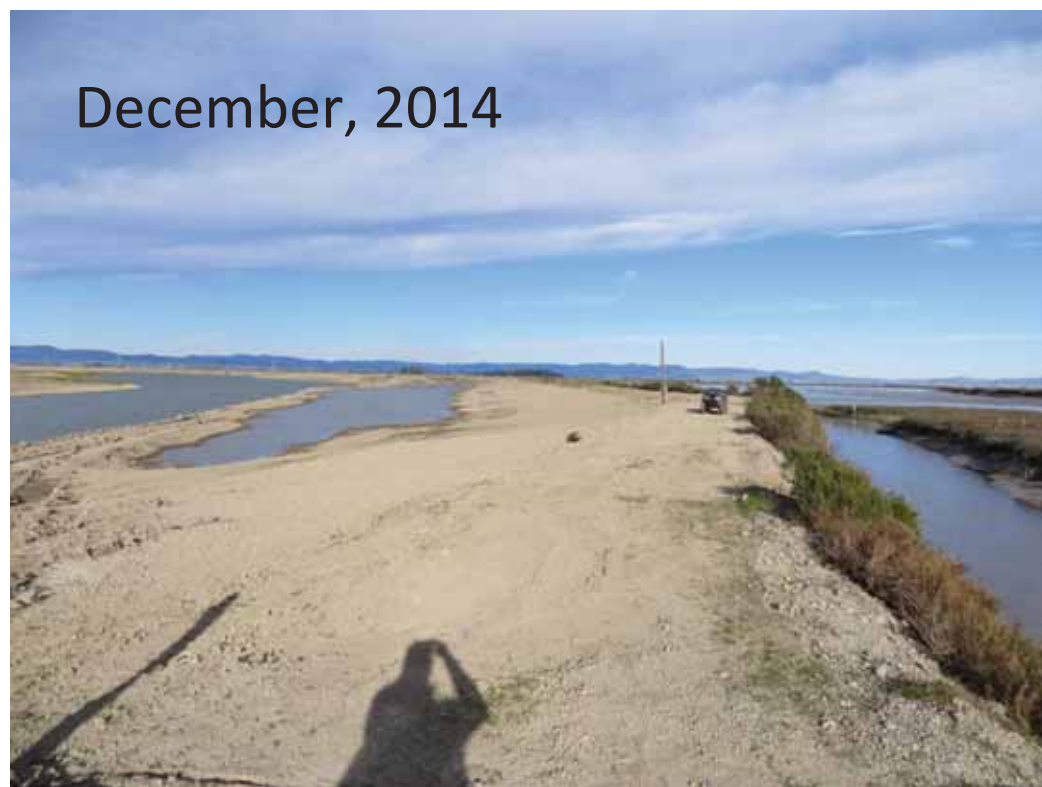
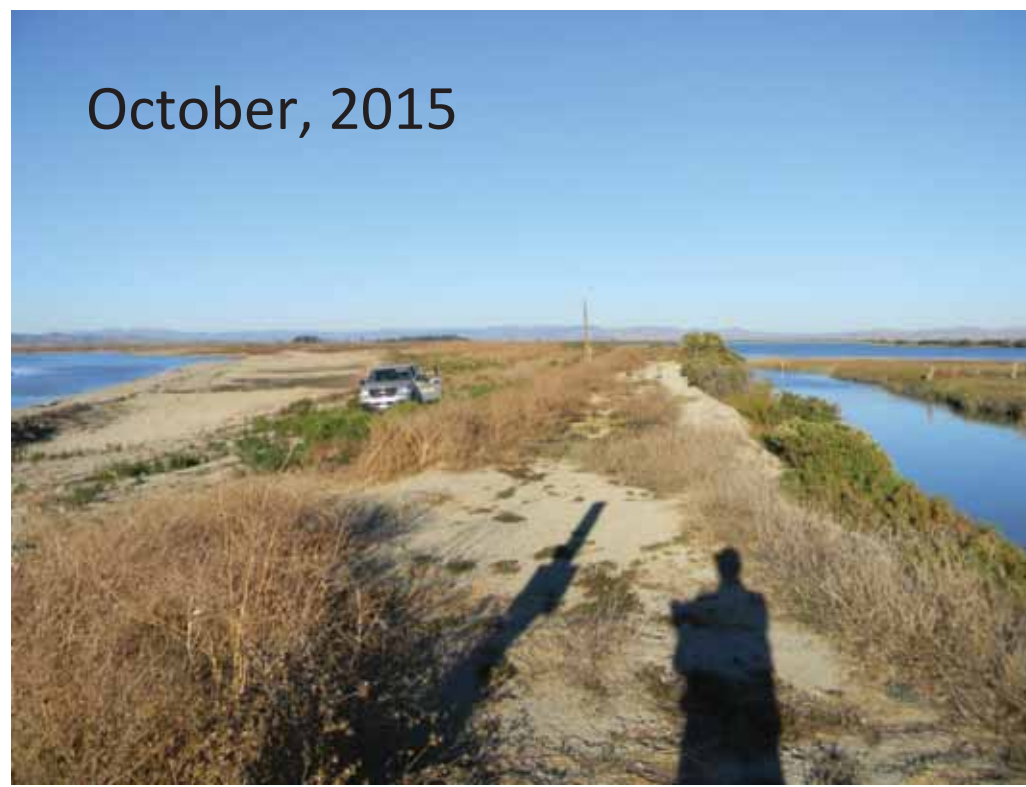
Photo Point 2, Photo 2.3
N 38.13850, W 122. 44356
Bearing 50°

Photo Point Description: Crest of old levee at pinch point of property

Photo Description: View E over graded levee with Tolay Creek on right of photo

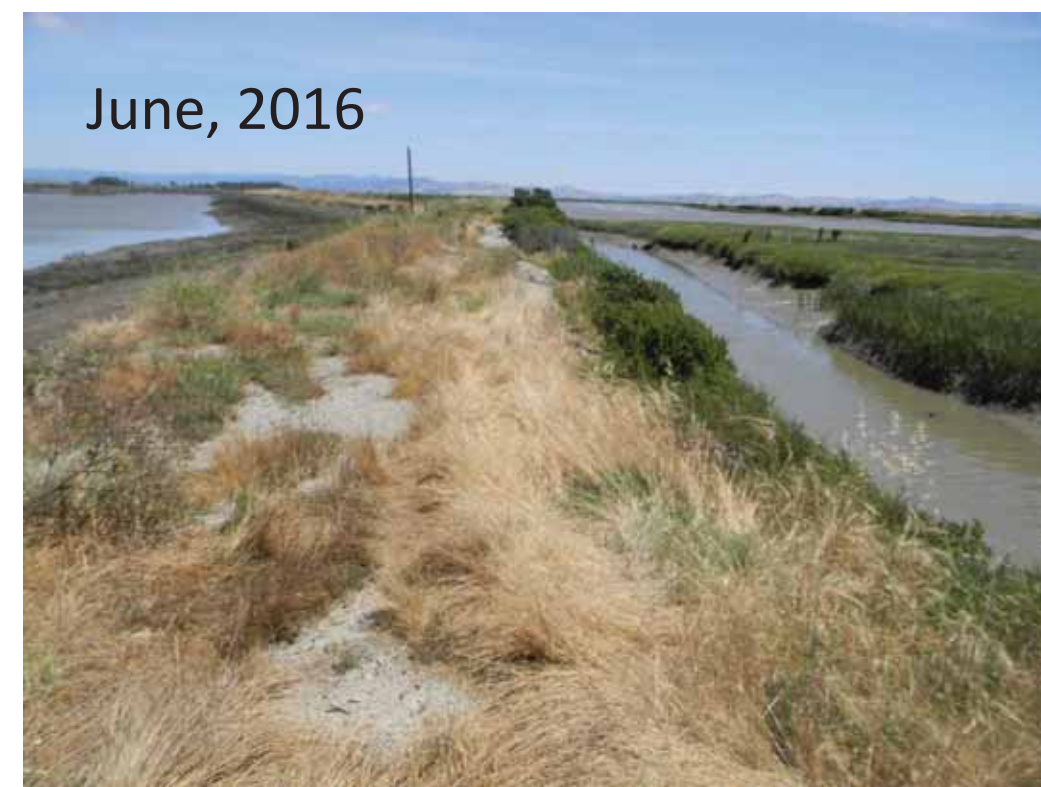
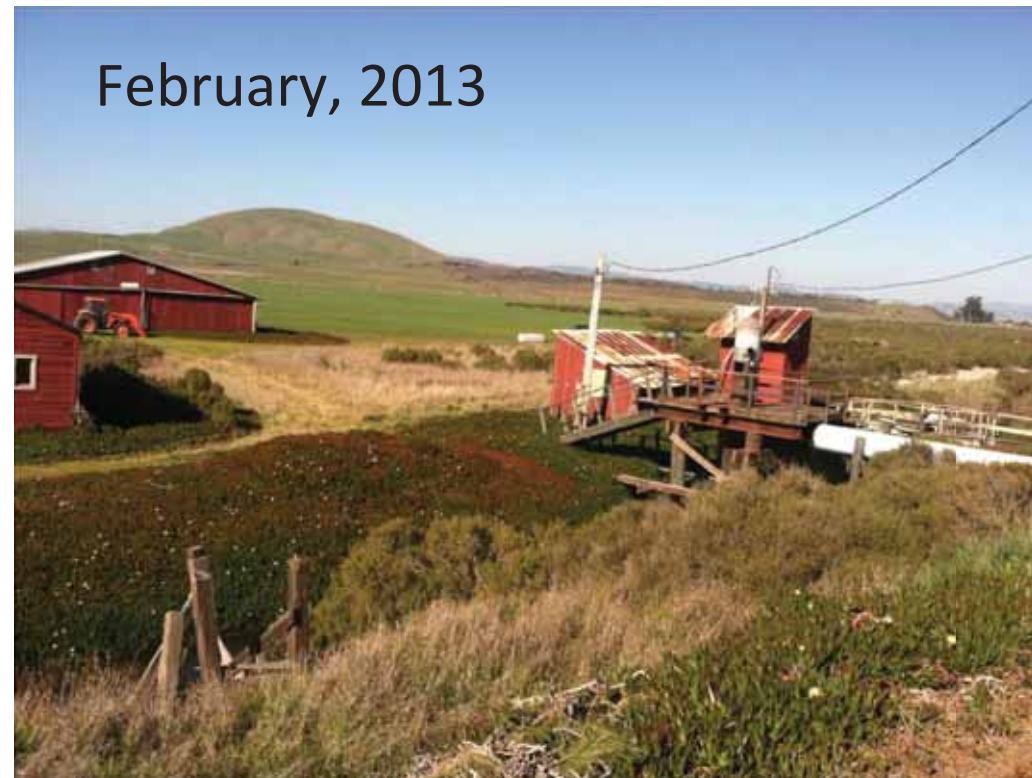
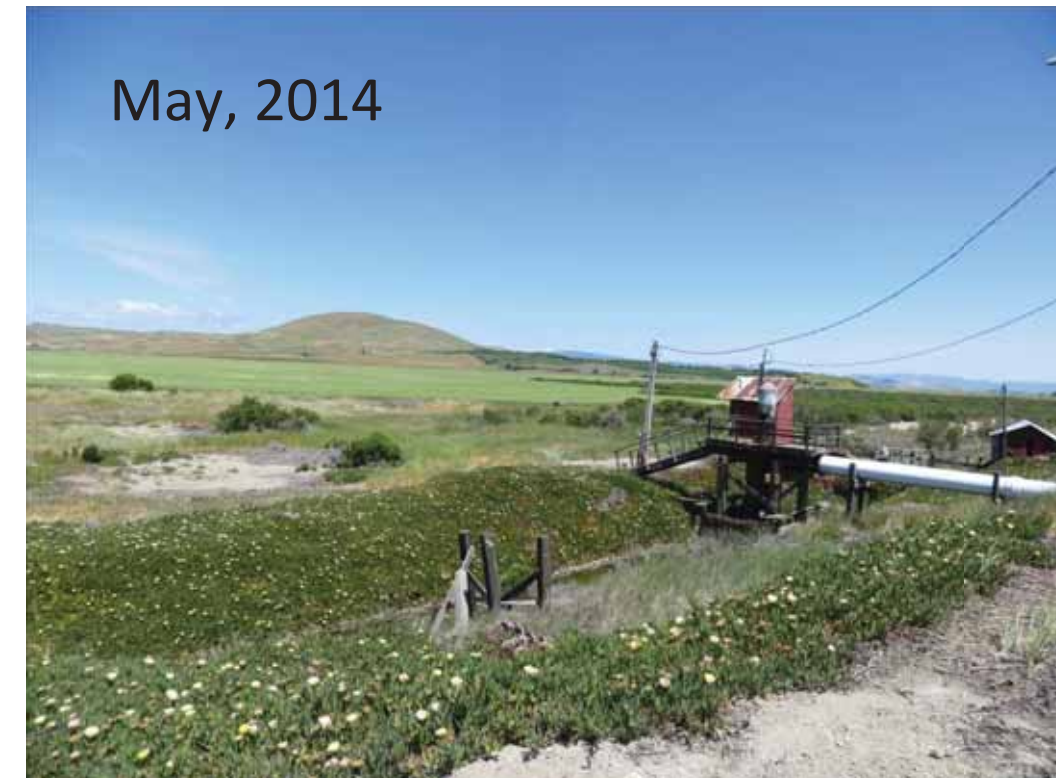
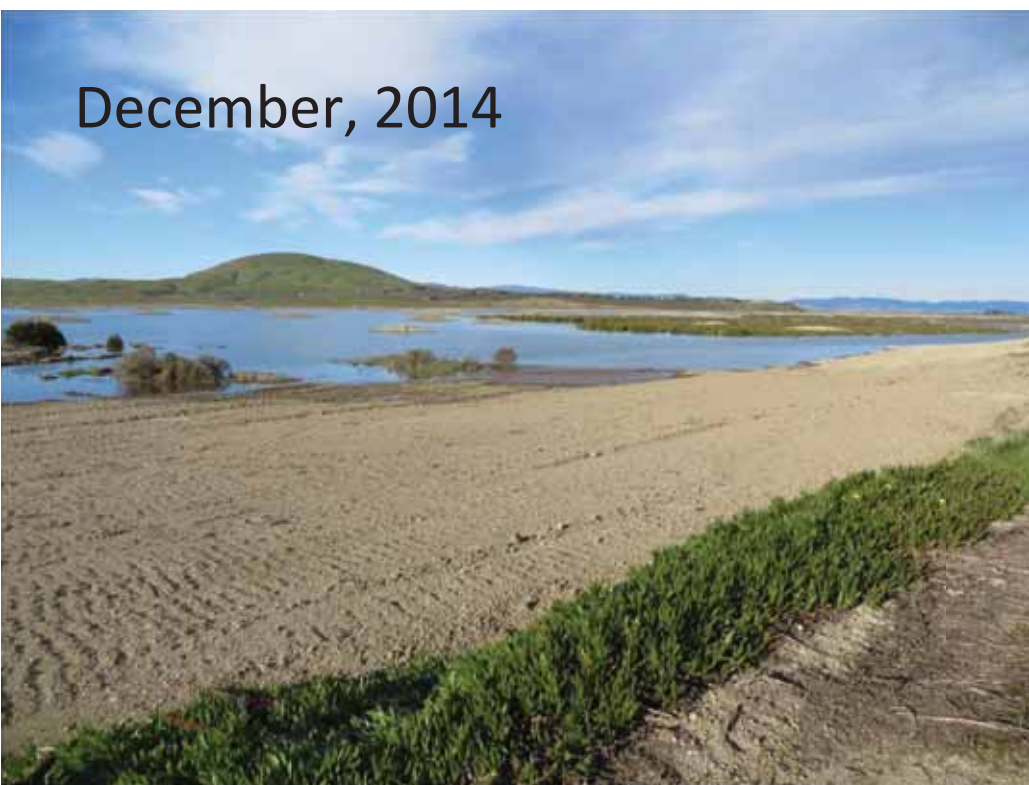
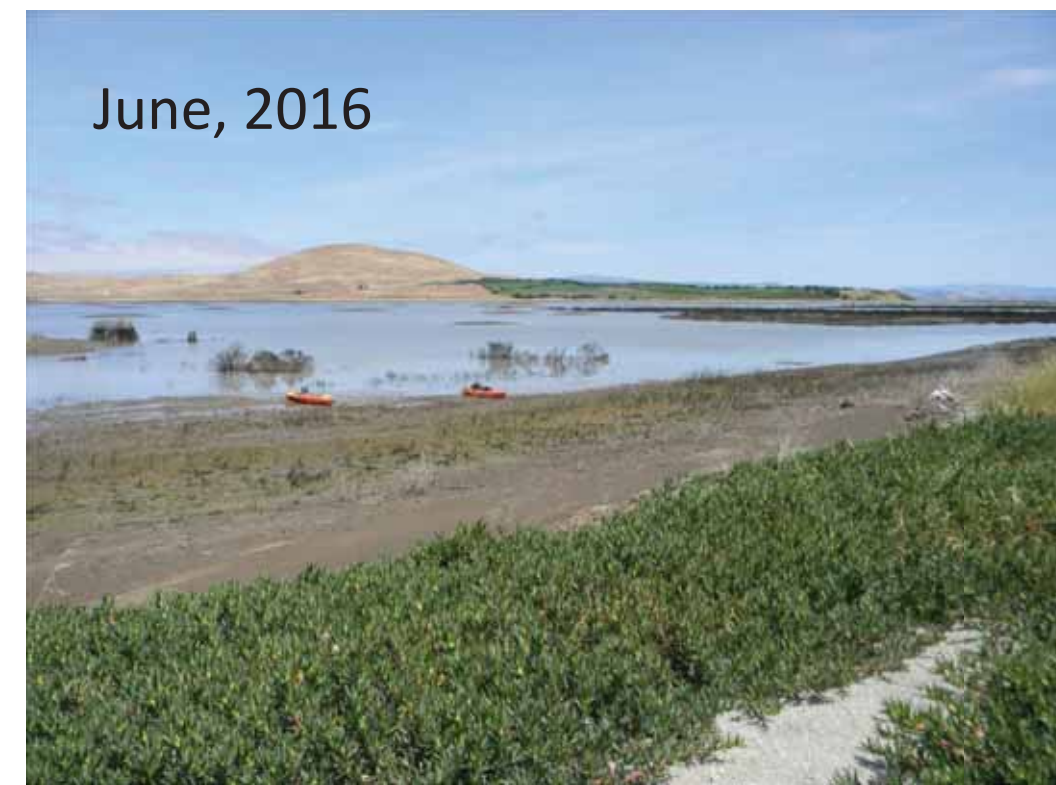
Photo Point 3, Photo 3.1
N 38.12732, W 122.45146
Bearing 359°

Photo Point Description: Crest of historic levee behind Dickson farm buildings

Photo Description: View N of pumps and buildings to be removed. Cougar Mountain in distance.
