Sears Point Tidal Marsh Restoration Project

Monitoring and Management Status Report

October 2015 to June 2017

Sears Point Tidal Marsh Restoration Project
Monitoring and Management Status Report, Year 1
October 2015 to June 2017

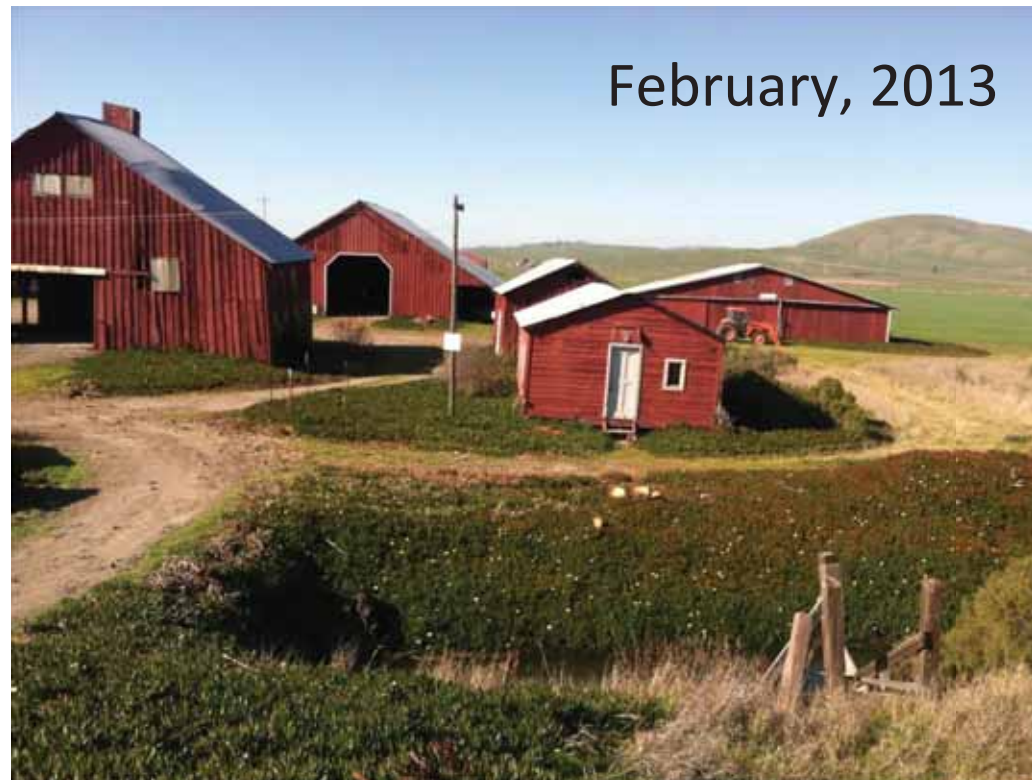
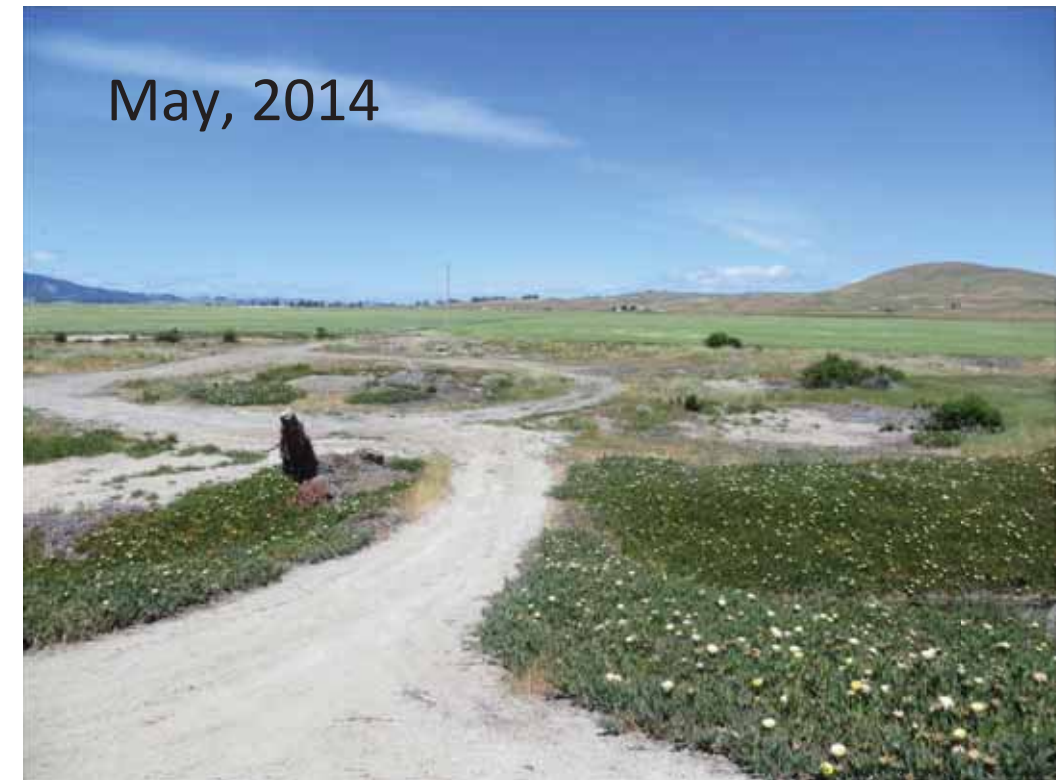
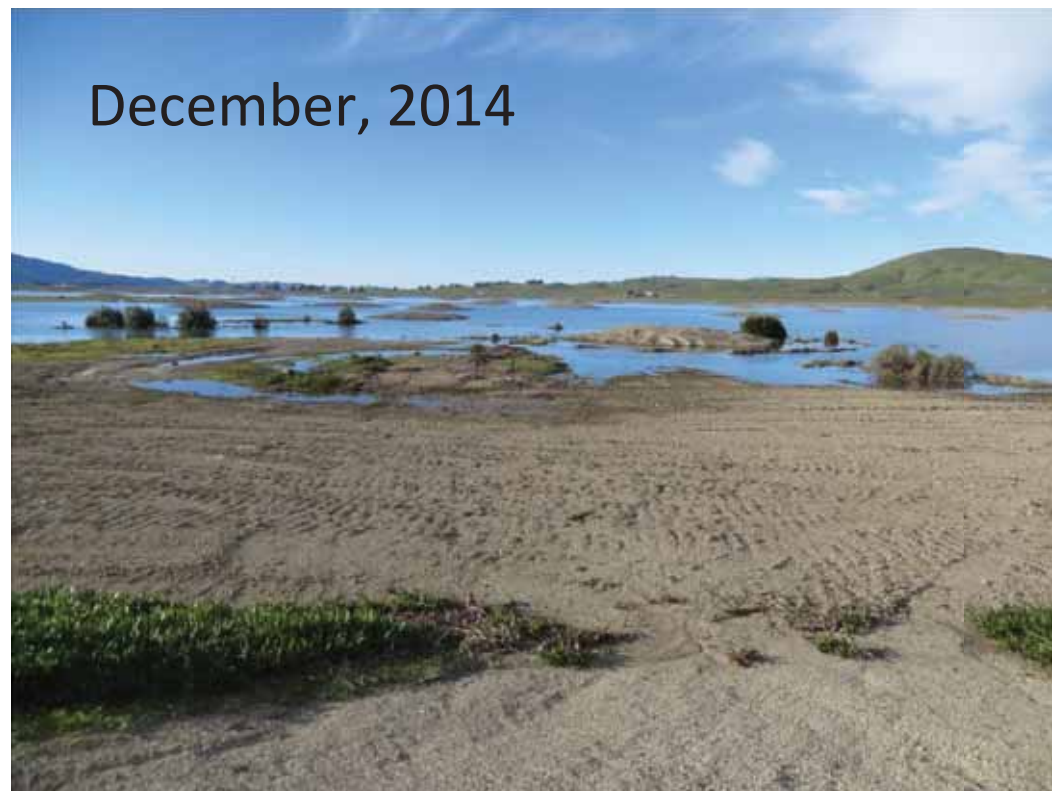
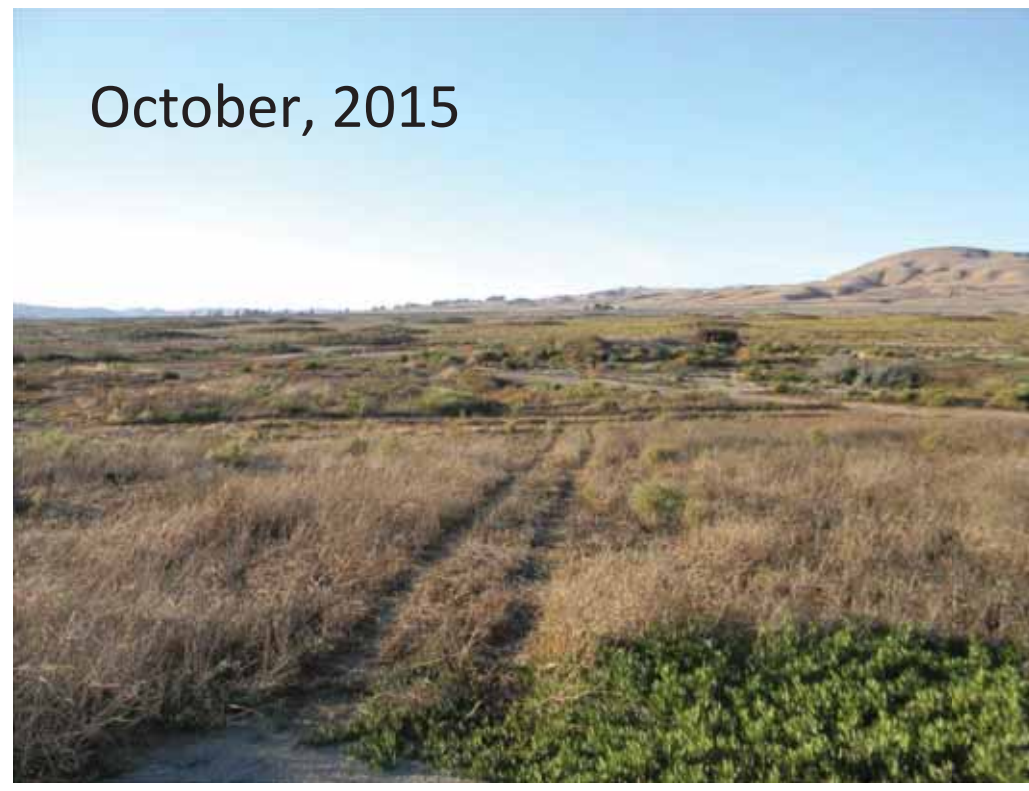
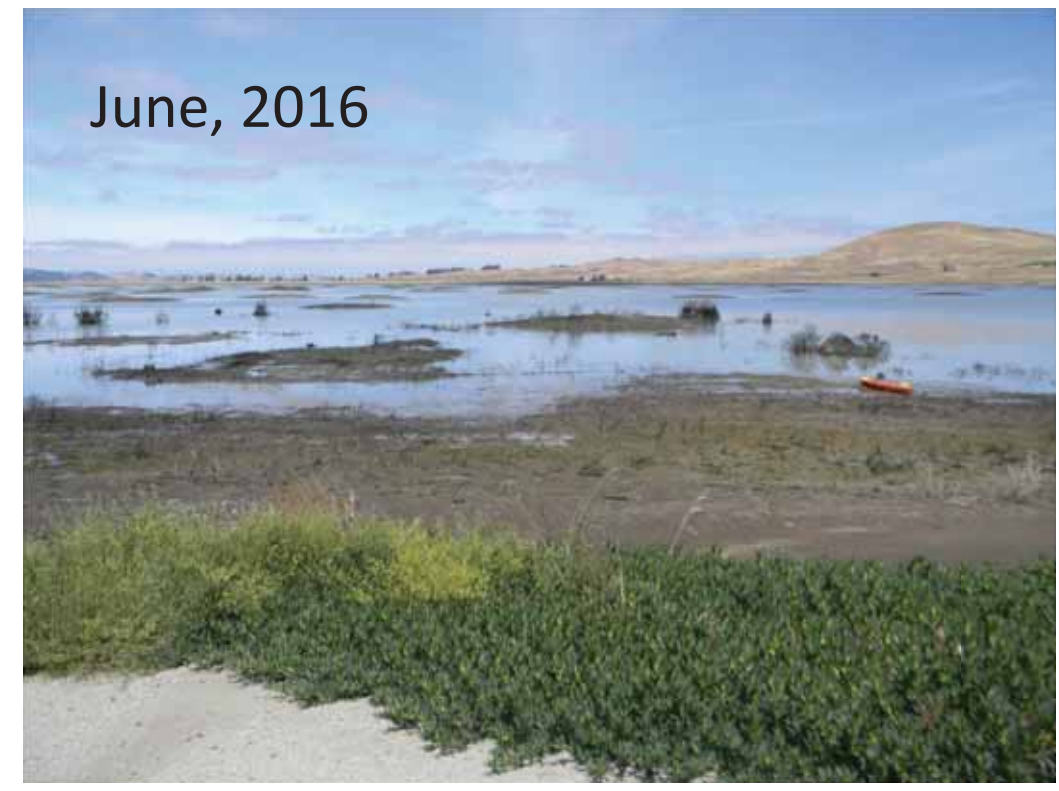
Photo Point 3, Photo 3.2
N 38.12732, W 122.45146
Bearing 316°

Photo Point Description: Crest of historic levee behind Dickson farm buildings

Photo Description: View NW of Dickson buildings to be removed.

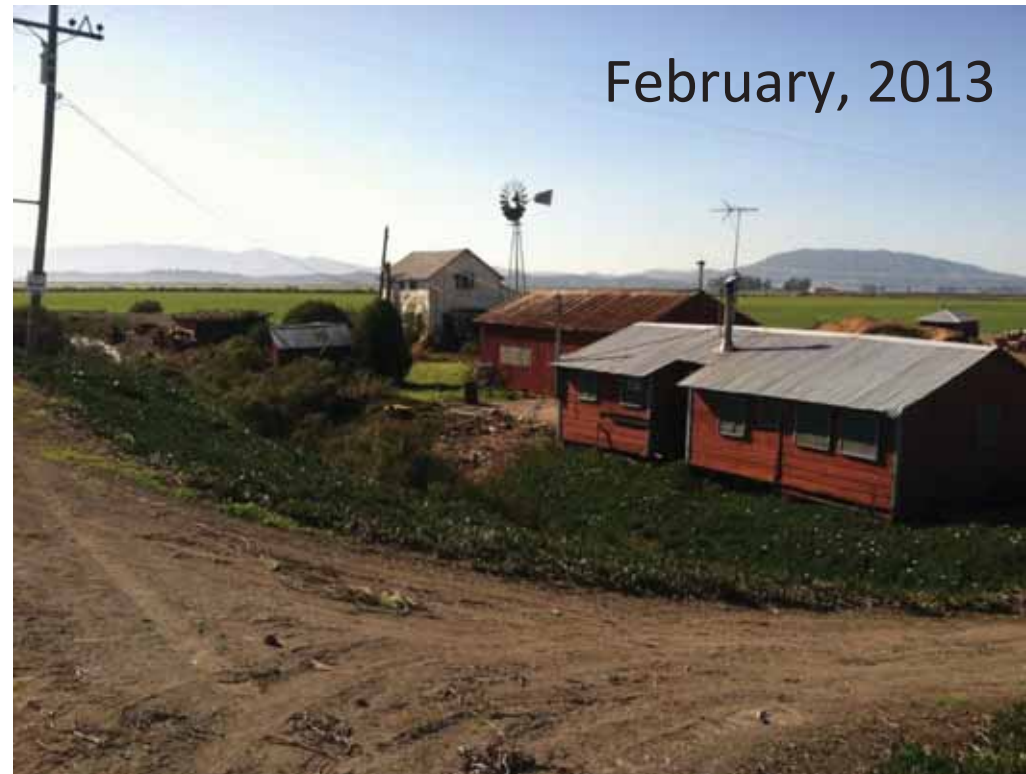
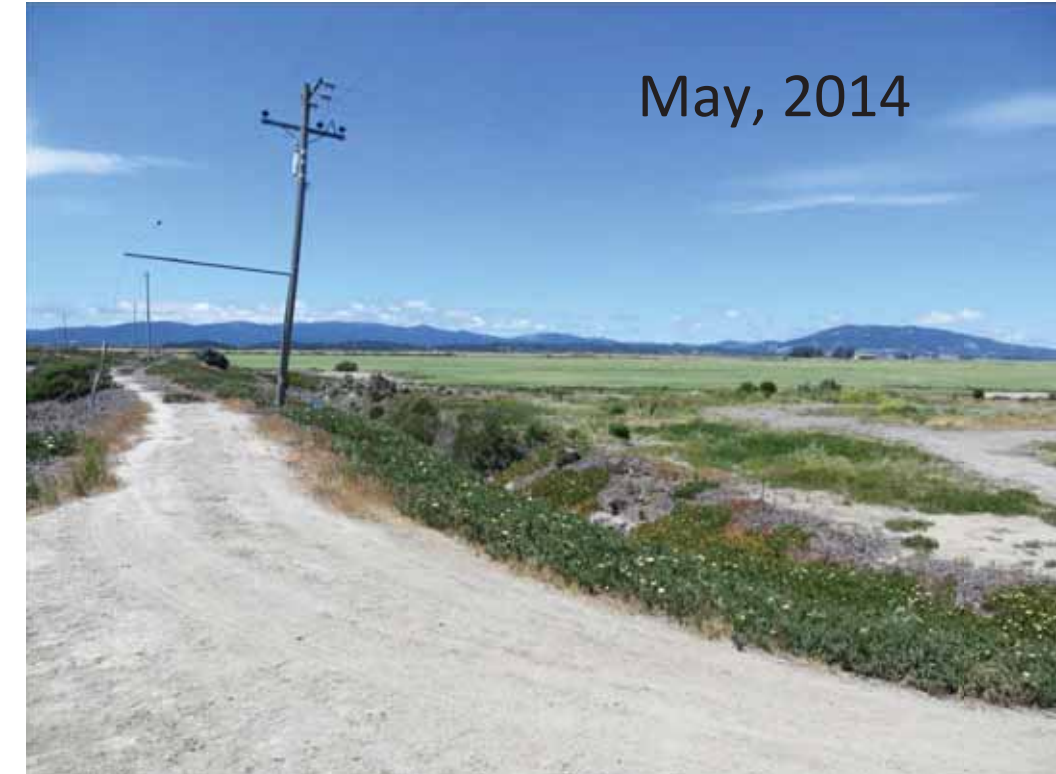
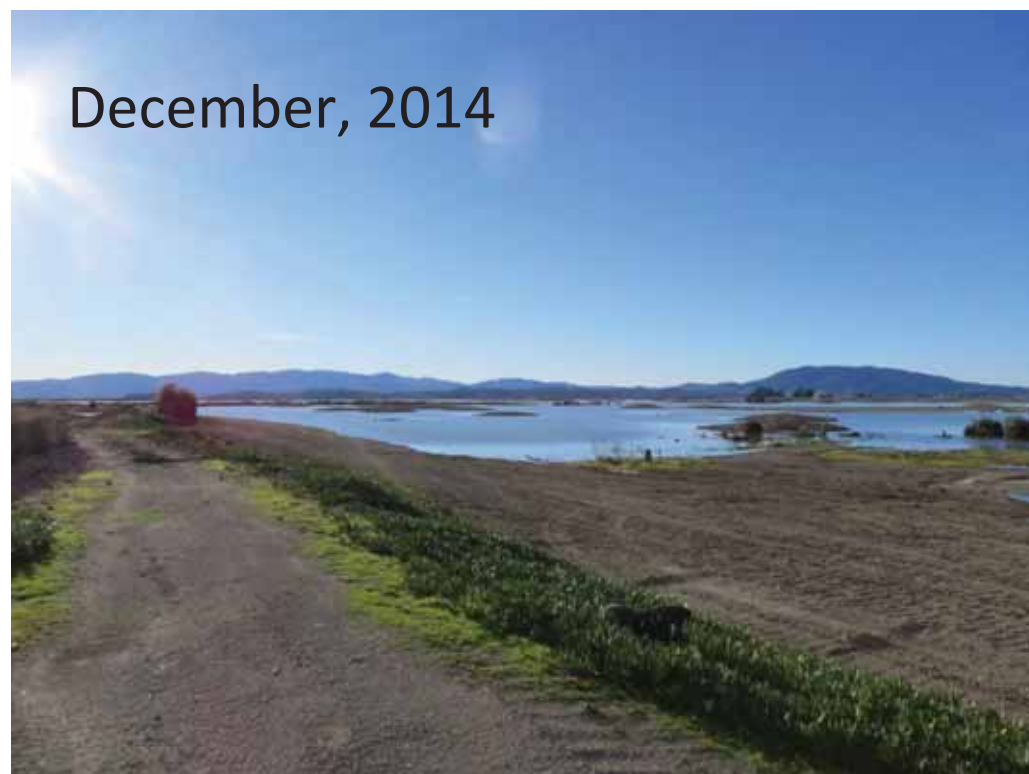
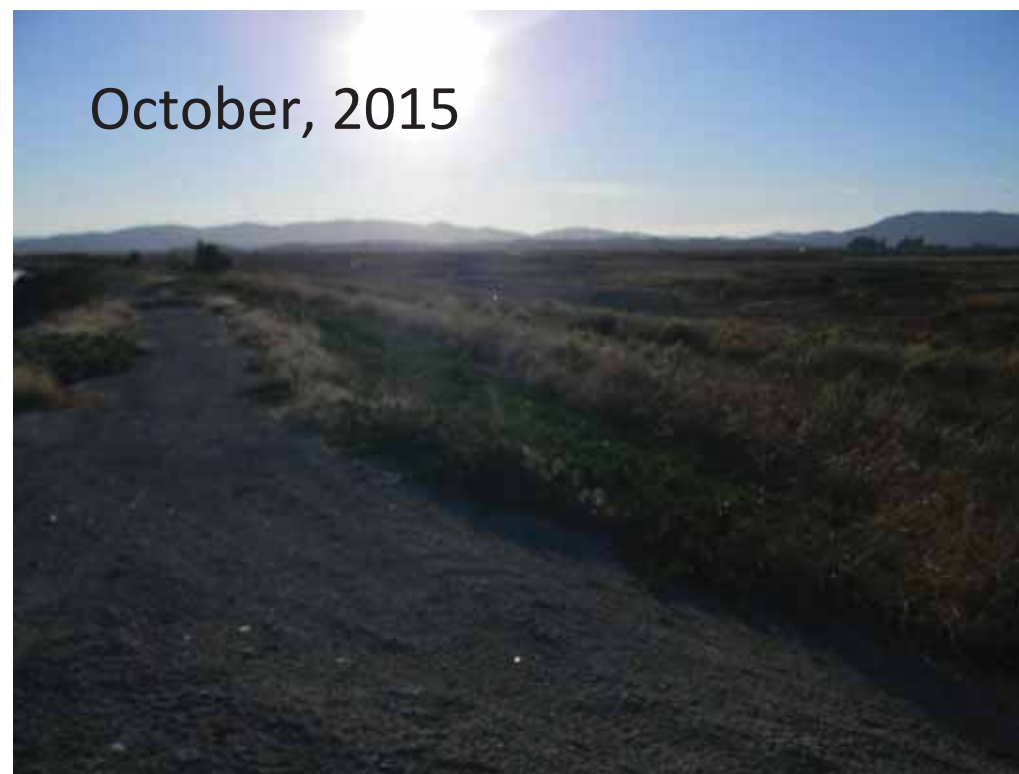
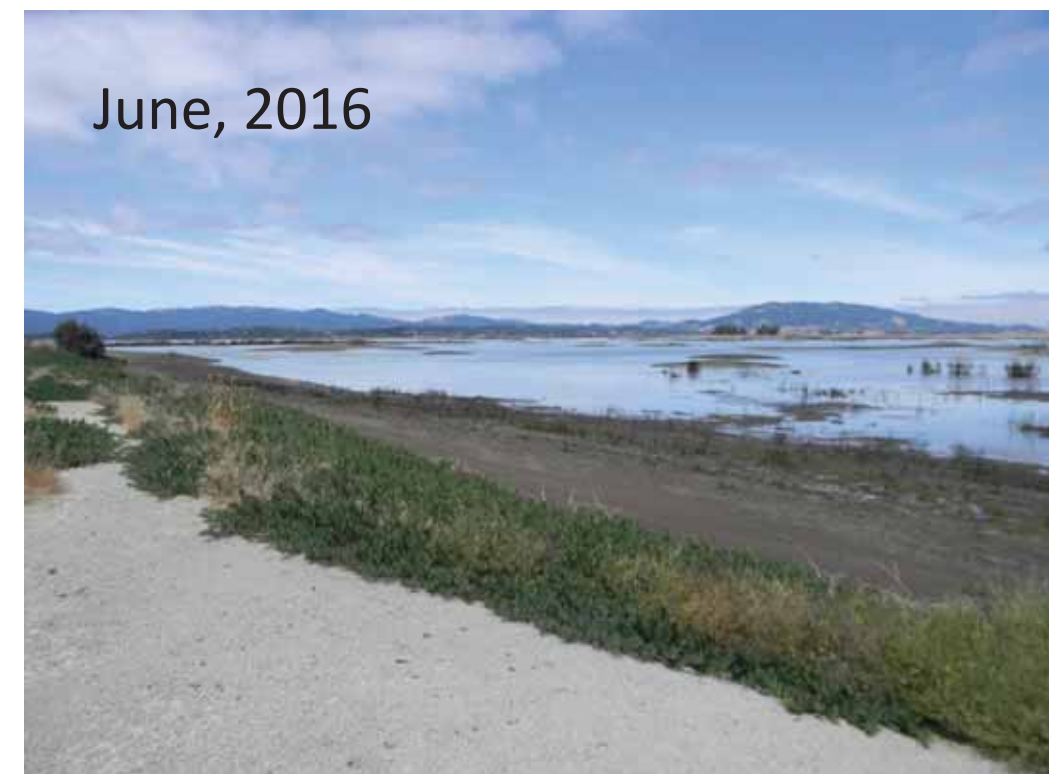
Photo Point 3, Photo 3.3
N 38.12732, W 122.45146
Bearing 263°

Photo Point Description: Crest of historic levee behind Dickson farm buildings

Photo Description: View W of Dickson buildings and power poles to be removed. Mt Burdell in background

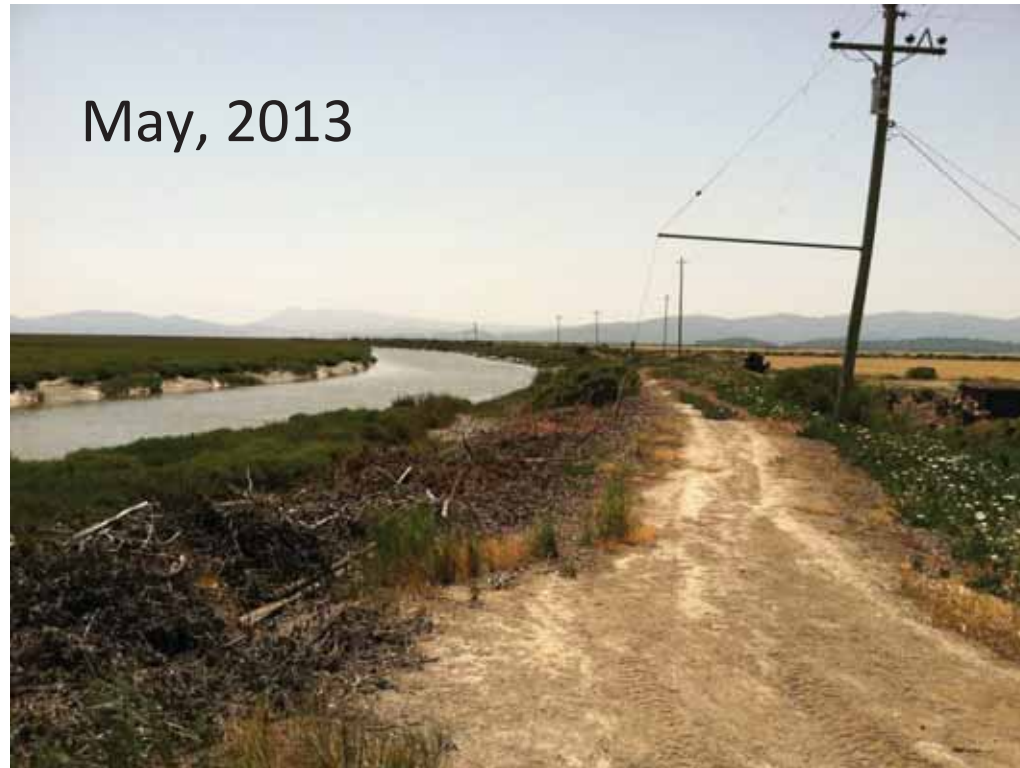
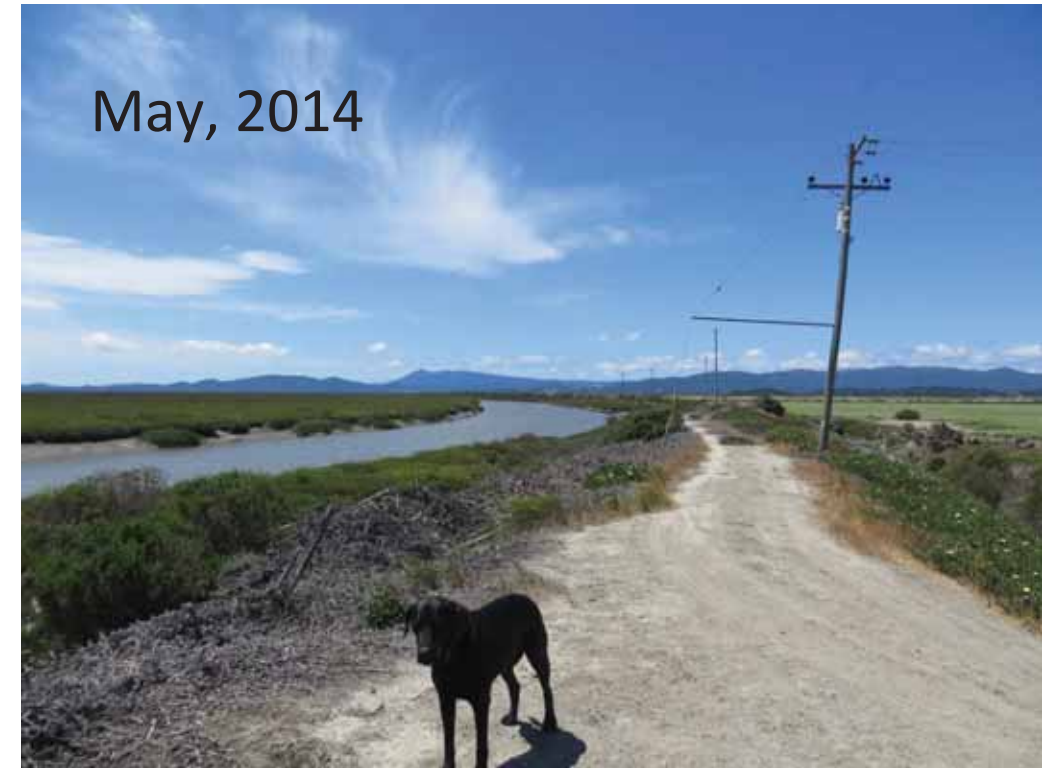
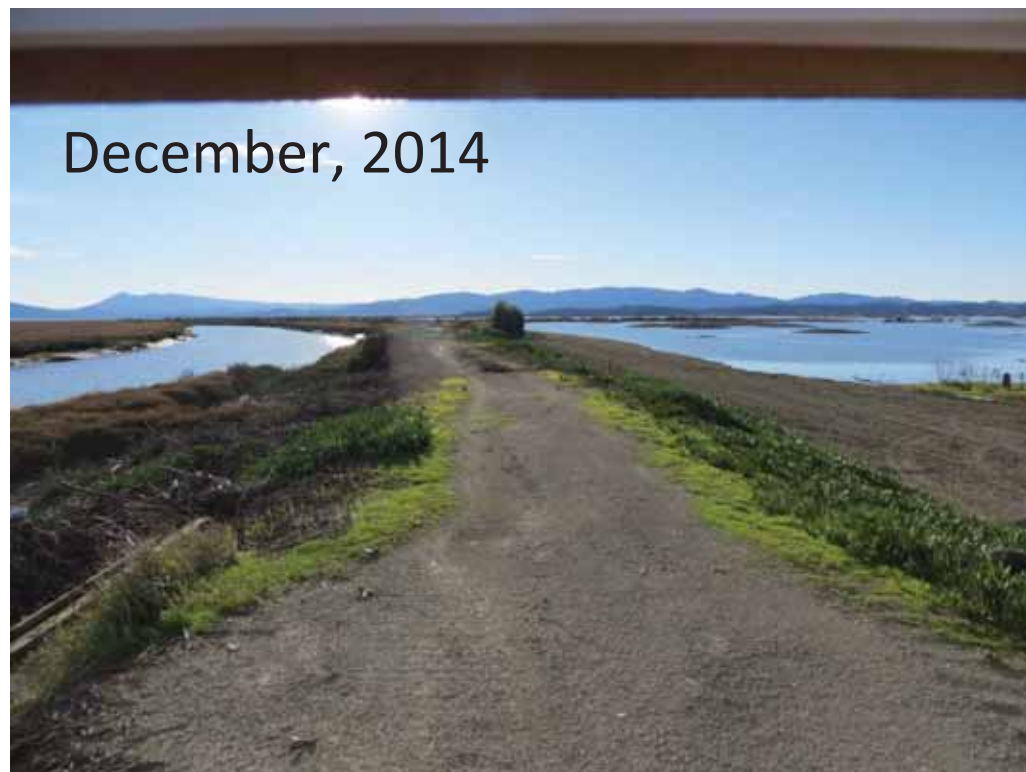
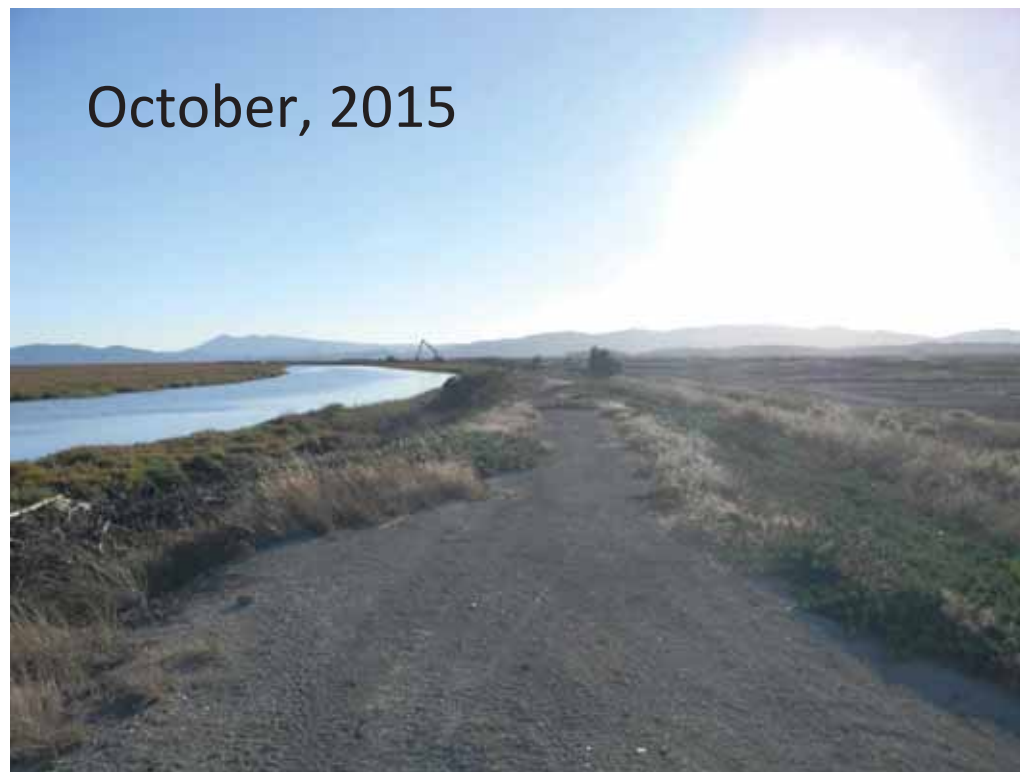
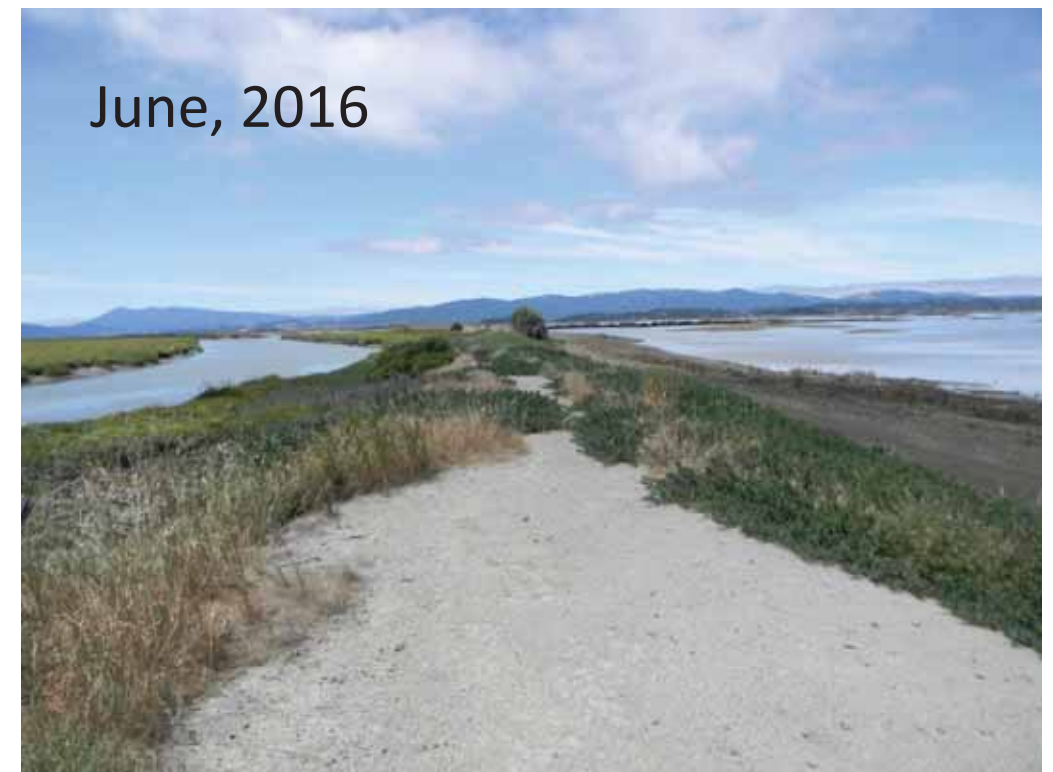
Photo Point 3, Photo 3.4
N 38.12732, W 122.45146
Bearing 230°

Photo Point Description: Crest of historic levee behind Dickson farm buildings

Photo Description: View along levee crest toward planned breach 2 with power poles scheduled for removal

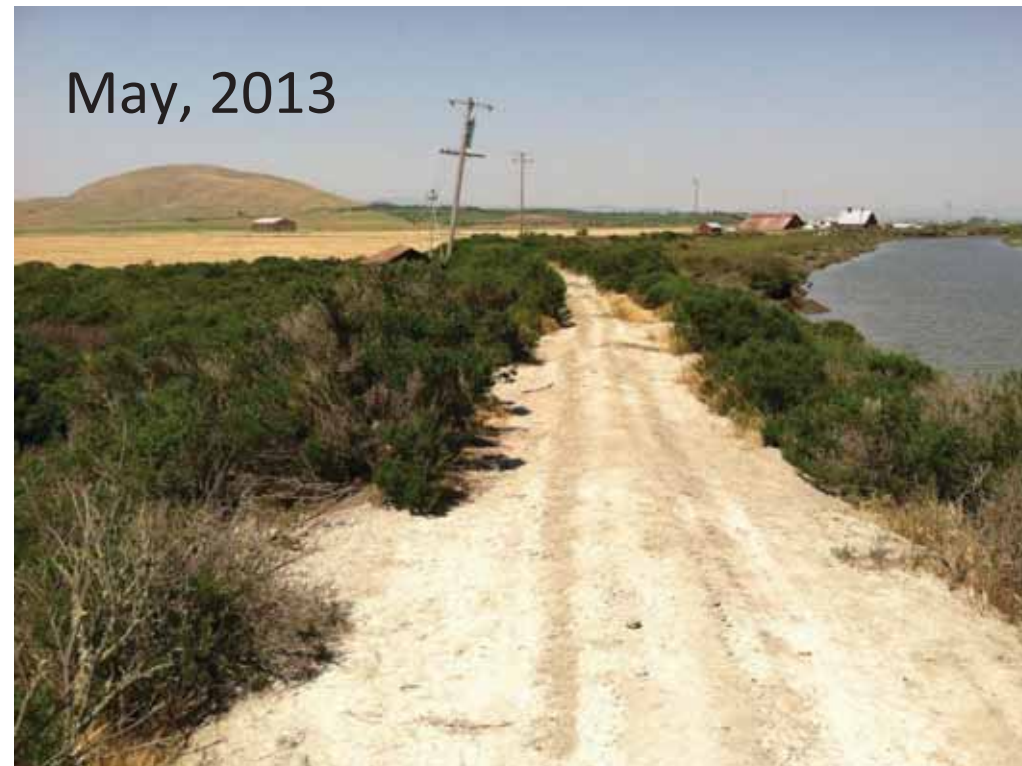
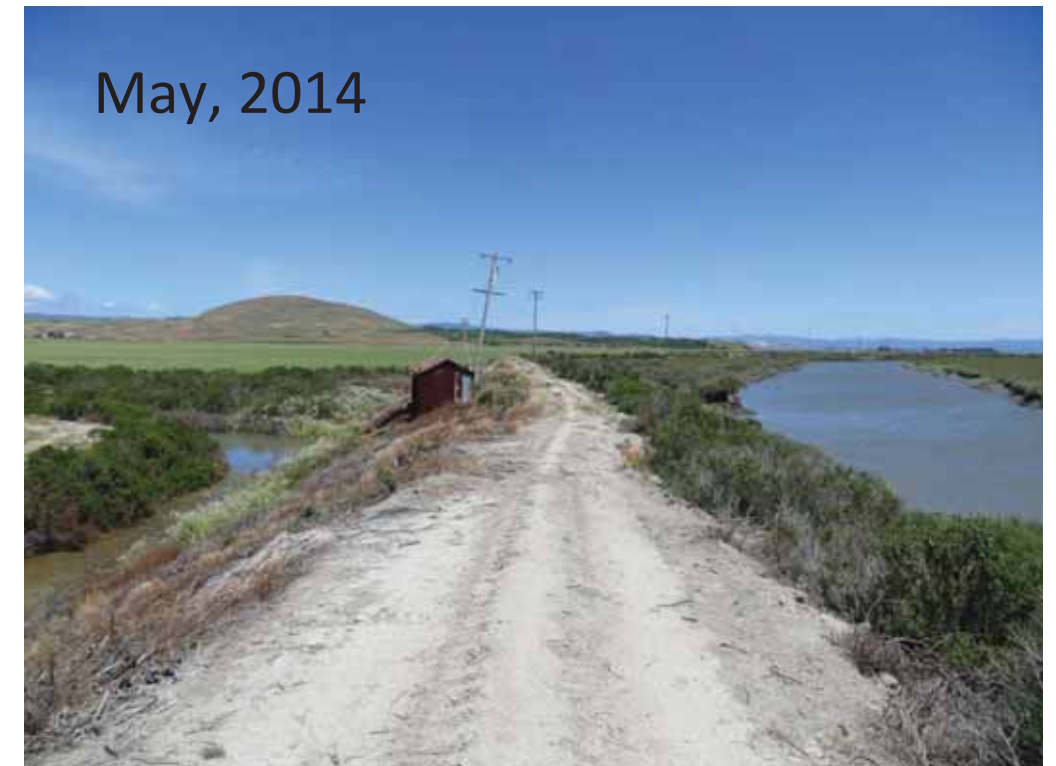
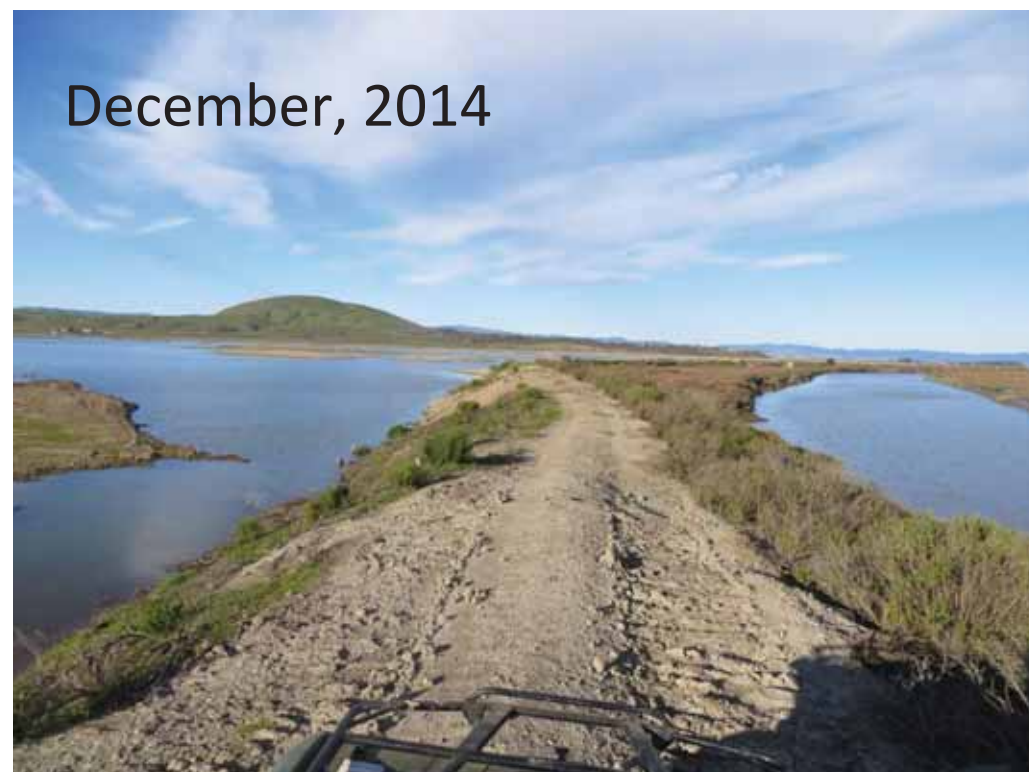
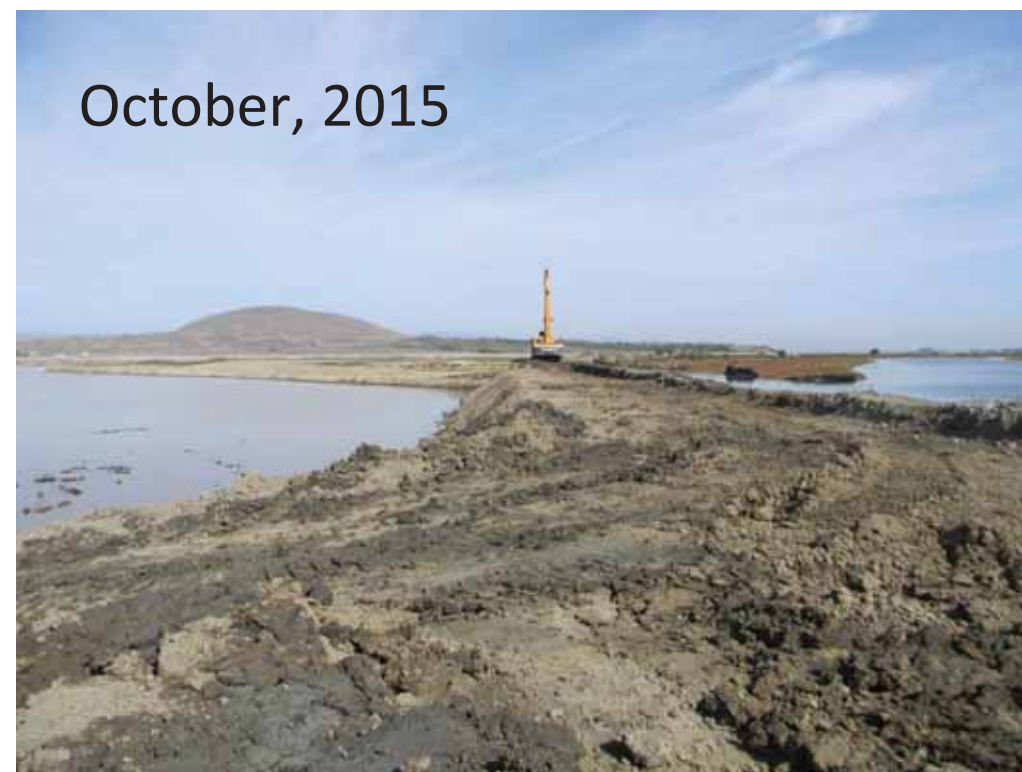
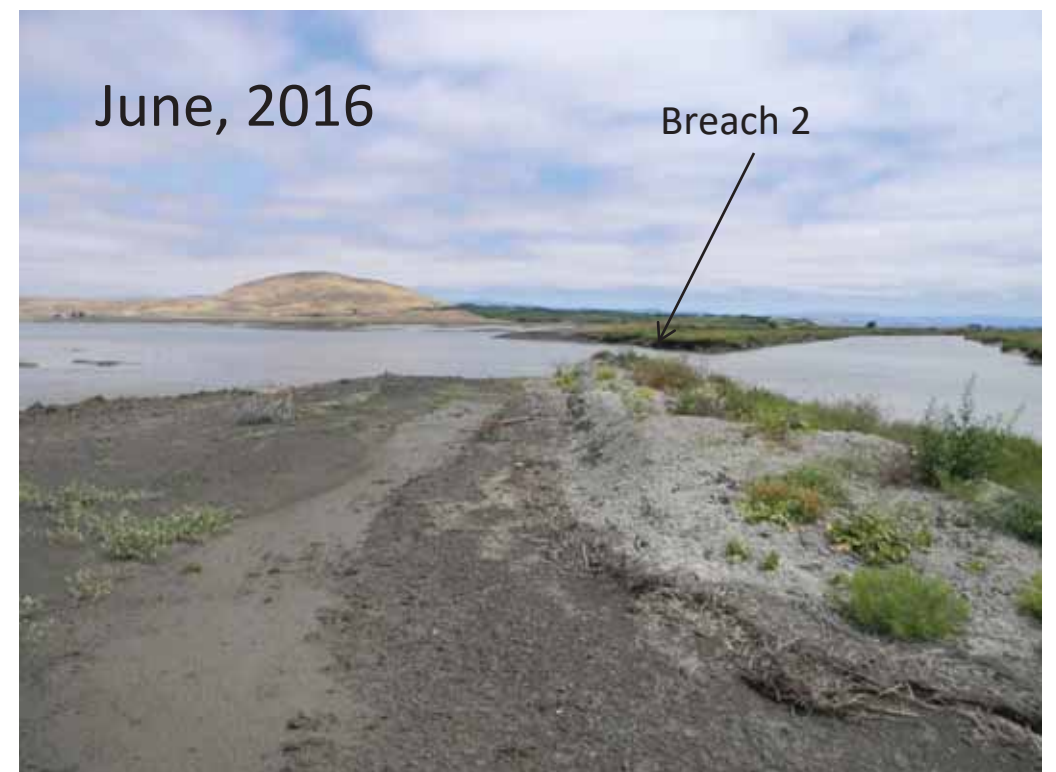
Photo Point 4, Photo 4.1

Photo Point Description: Crest of historic levee just west of planned breach two

Photo Description: Alternate view along levee crest toward planned breach 2 with poles to be removed

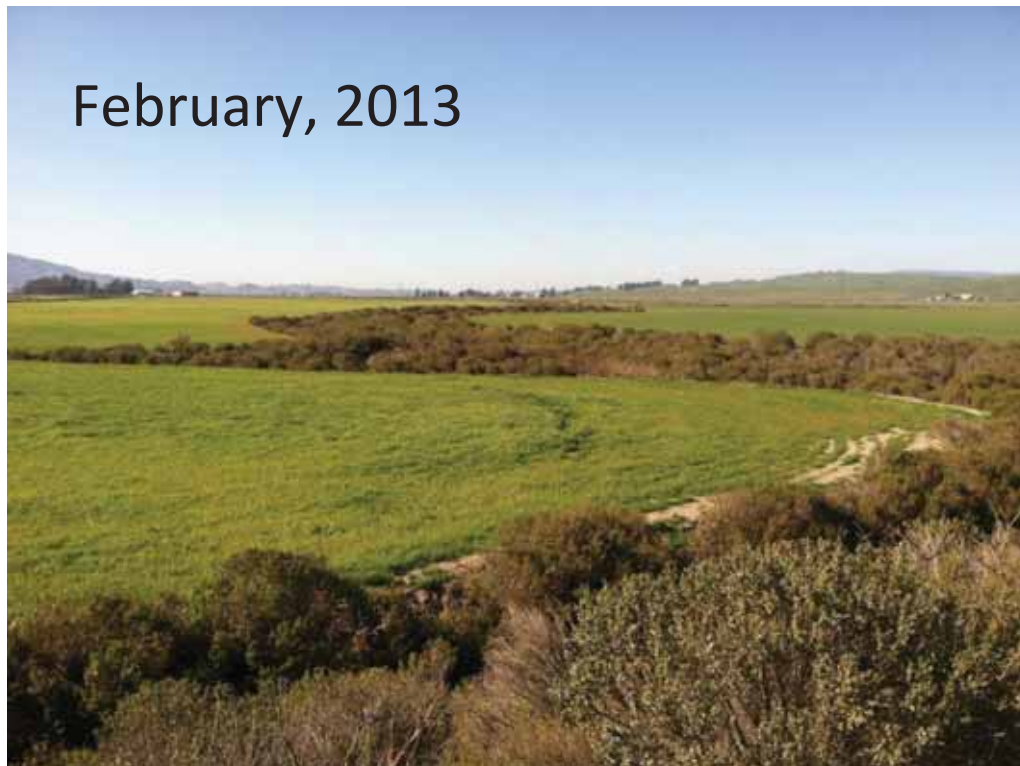
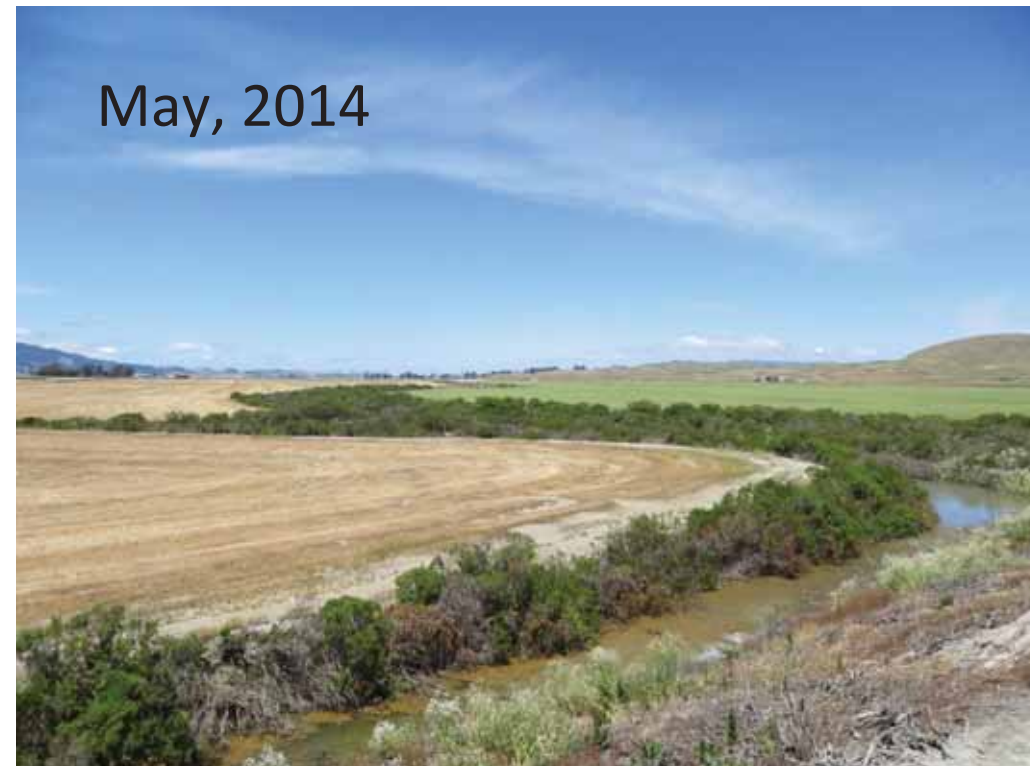
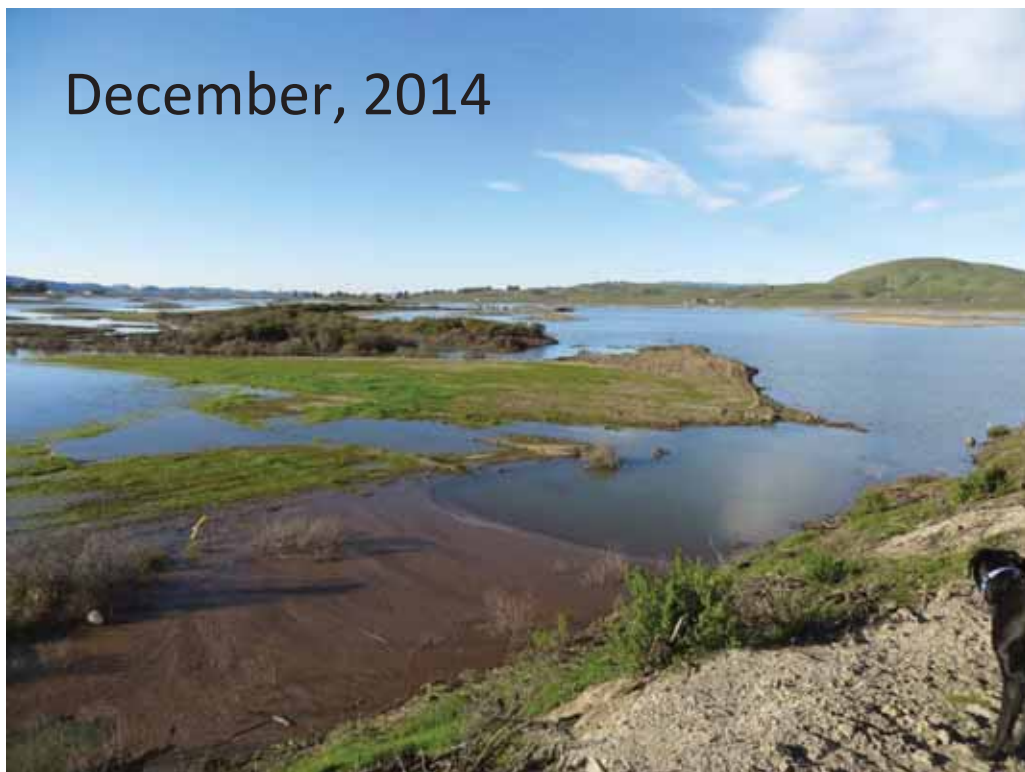
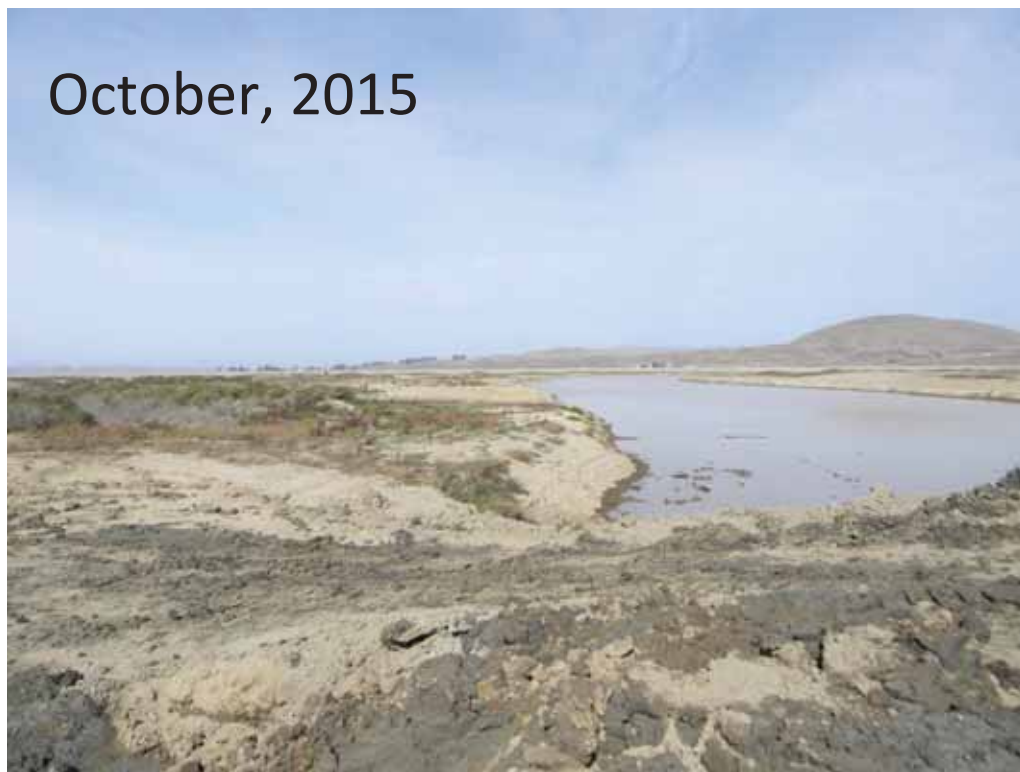
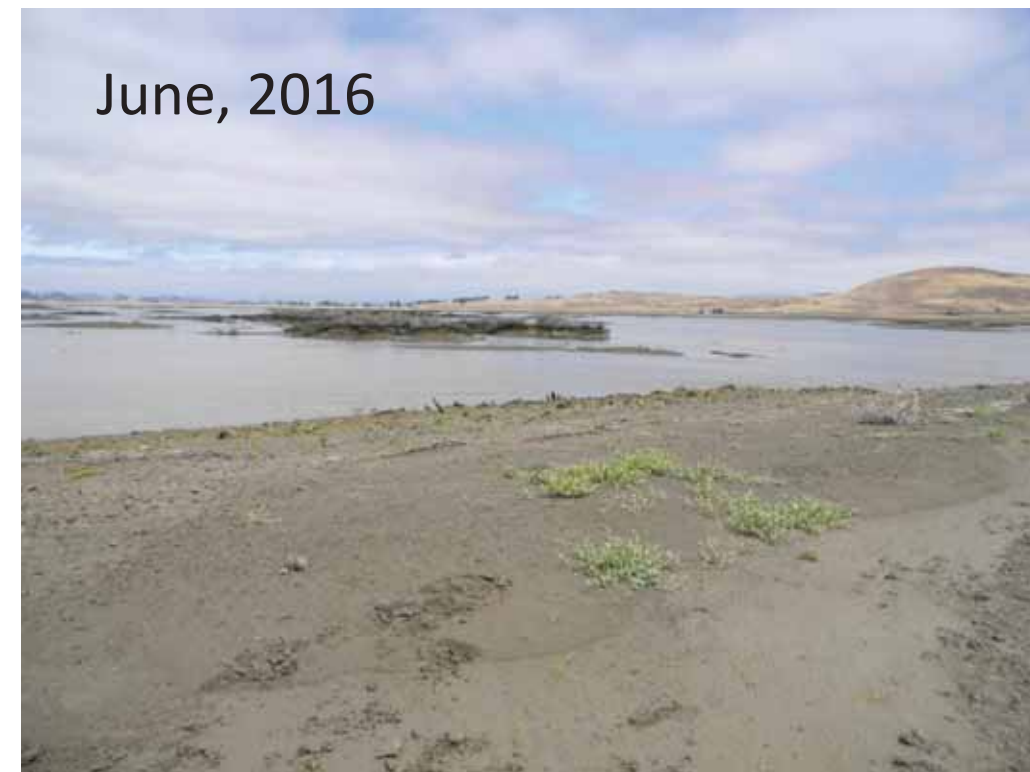
Photo Point 4, Photo 4.2

Photo Description: View NW over ag fields and existing drainage ditch where new tidal channels and marsh mounds will be constructed
