Sears Point Tidal Marsh Restoration Project

Monitoring and Management Status Report

October 2015 to June 2017

Sears Point Tidal Marsh Restoration Project
Monitoring and Management Status Report, Year 1
October 2015 to June 2017

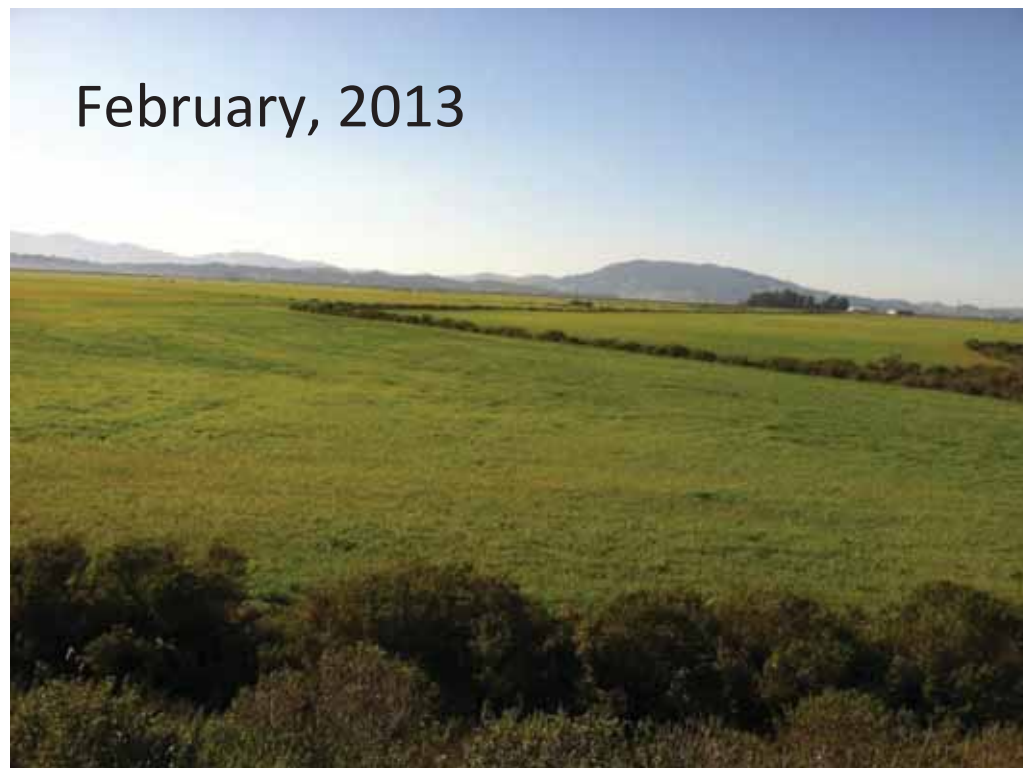
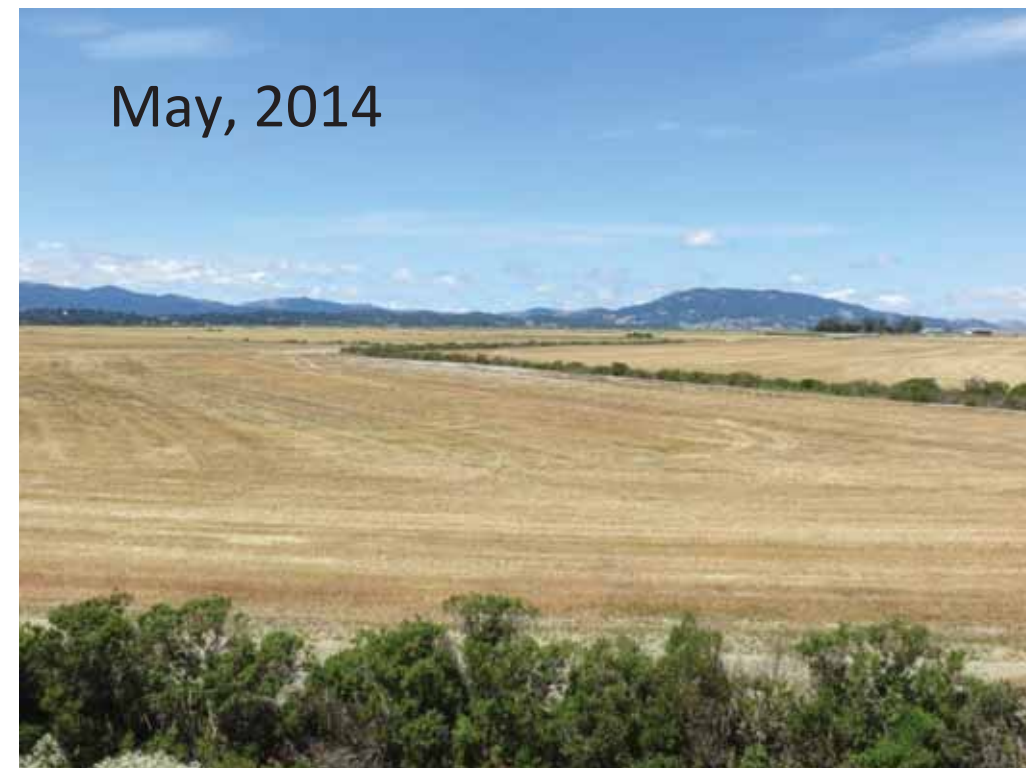
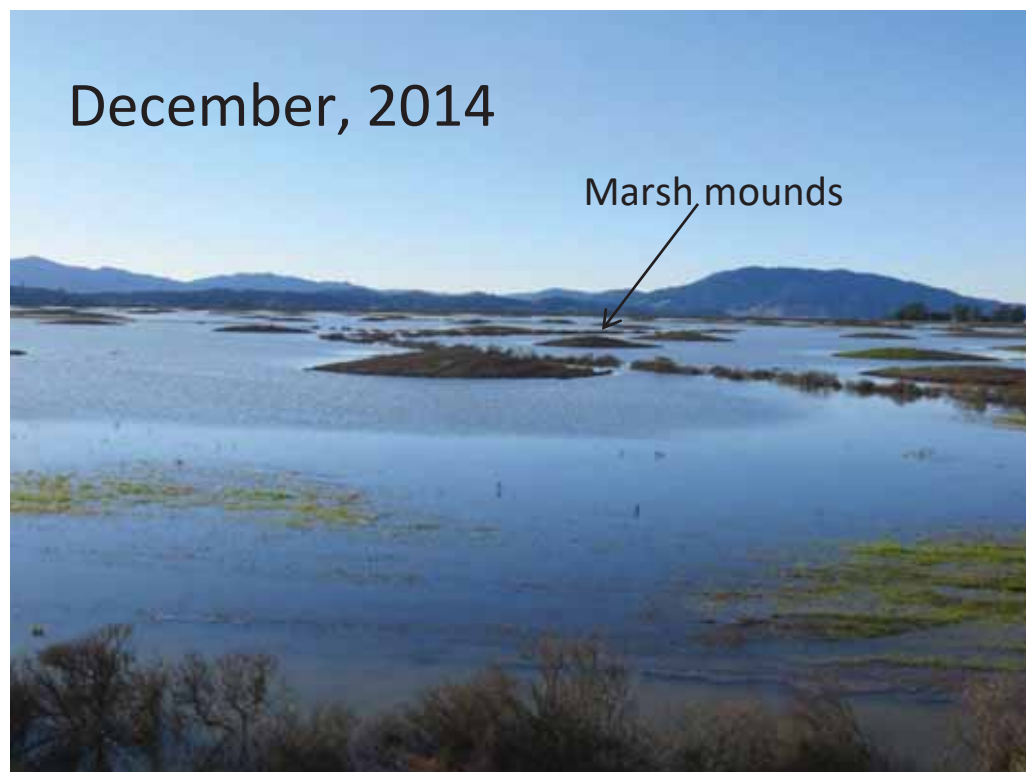
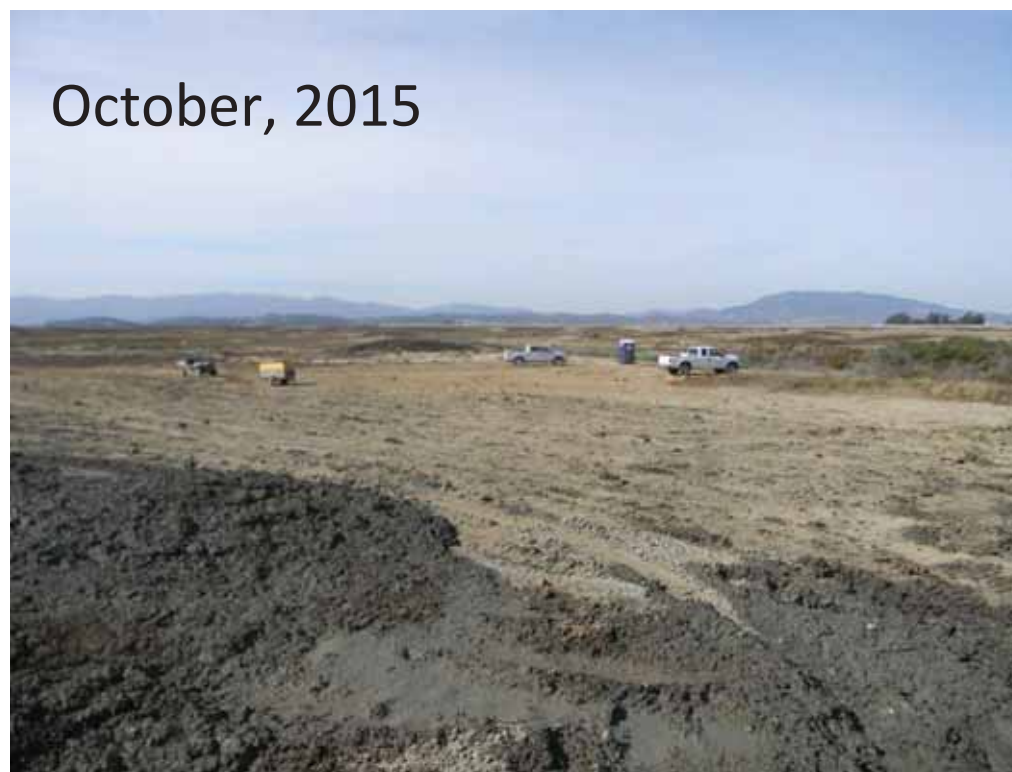
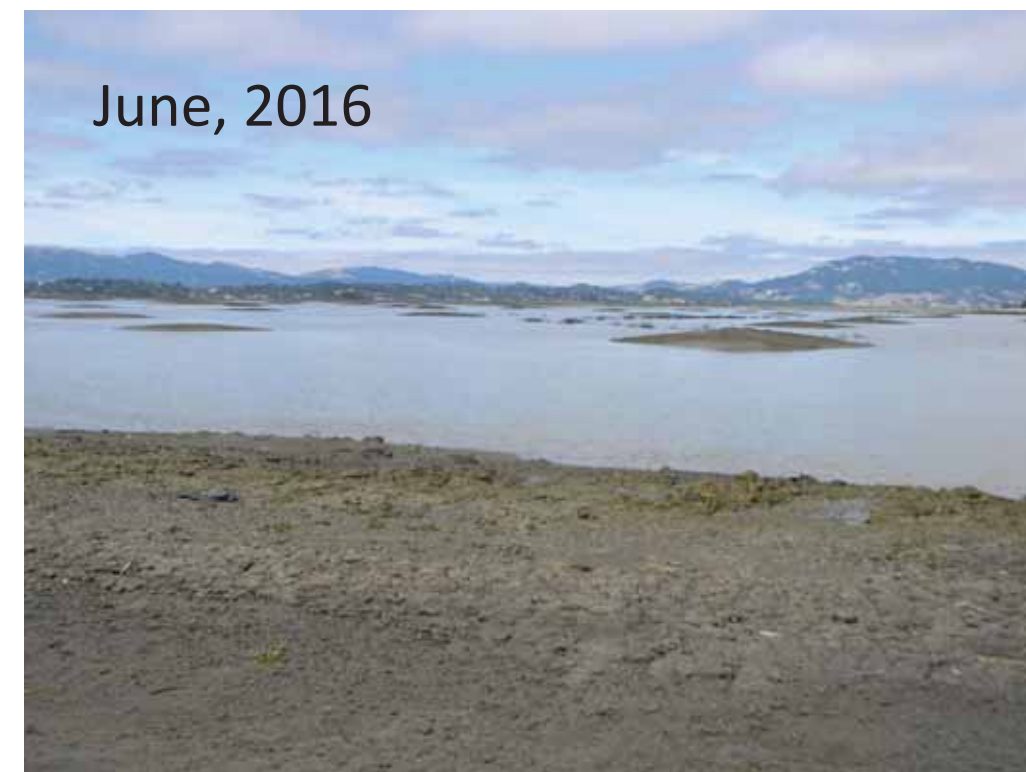
Photo Point 4, Photo 4.3

Photo Description: View W over ag fields where new tidal channels and marsh mounds will be constructed. Mt Burdell in distance.

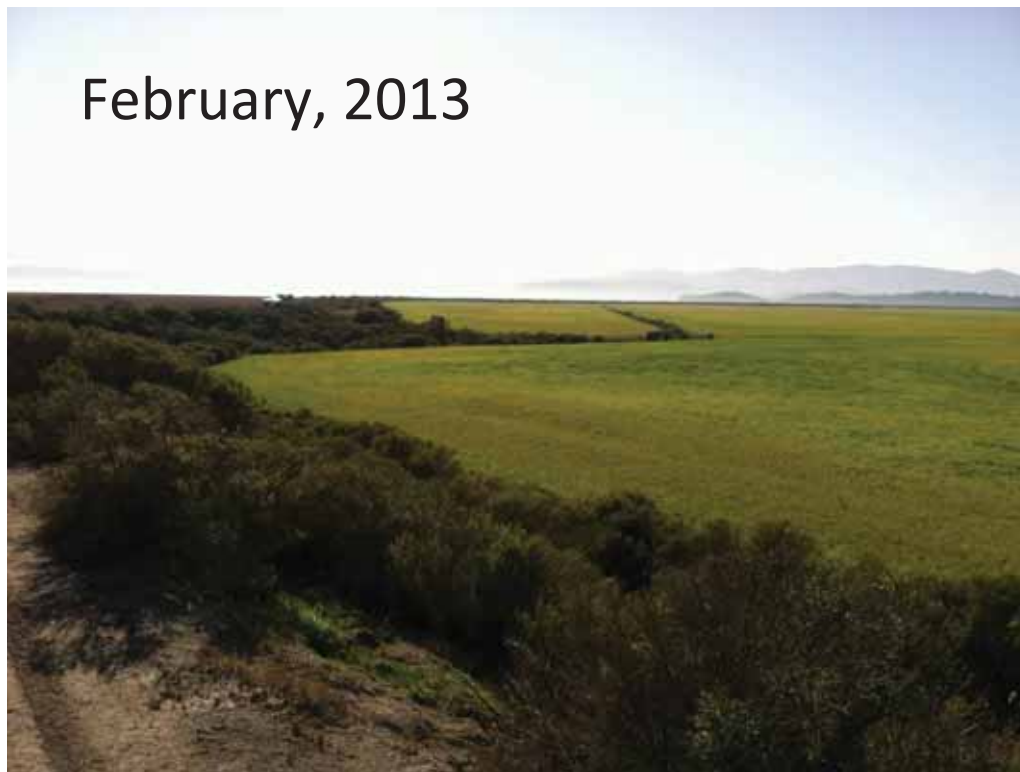
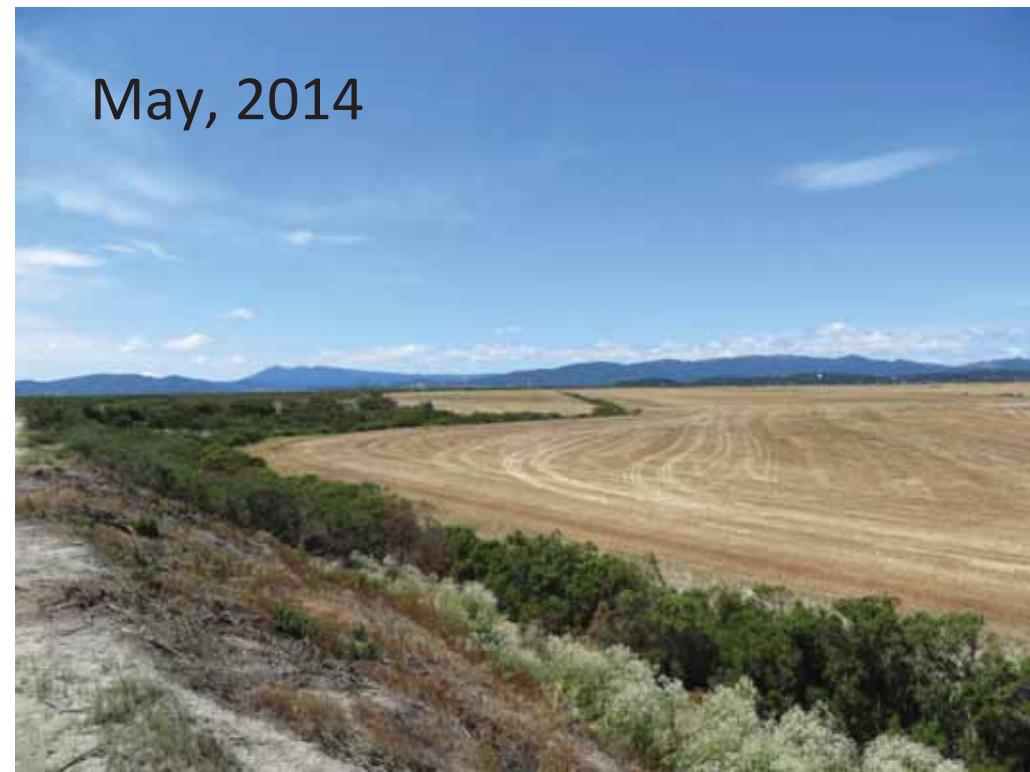
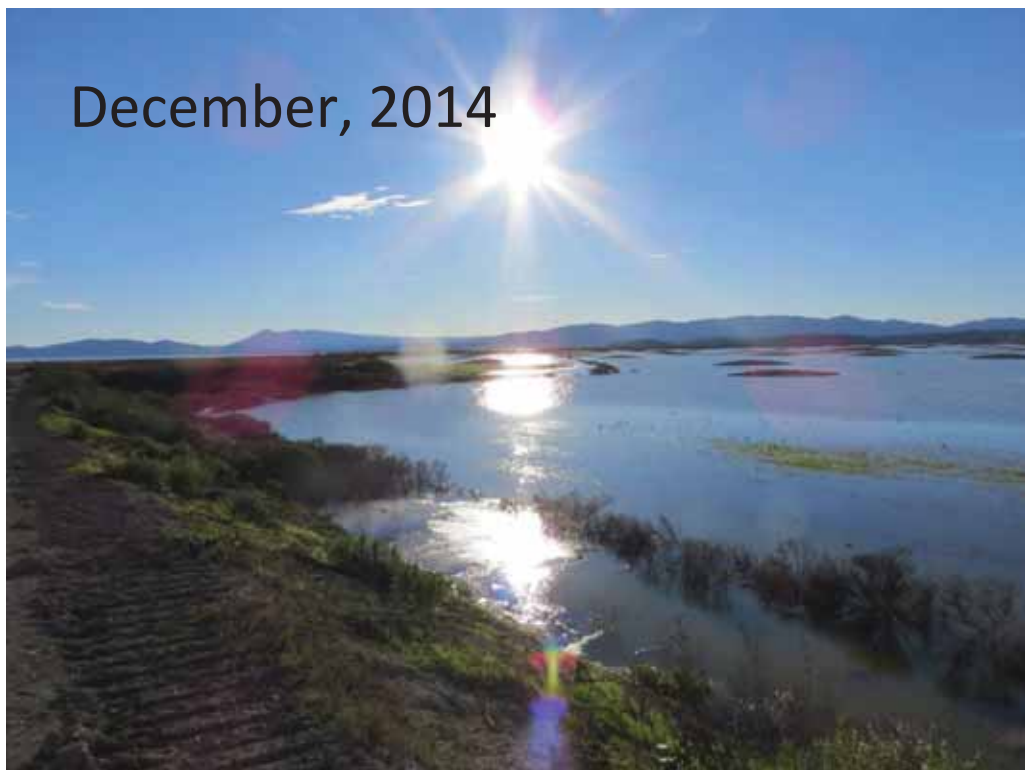
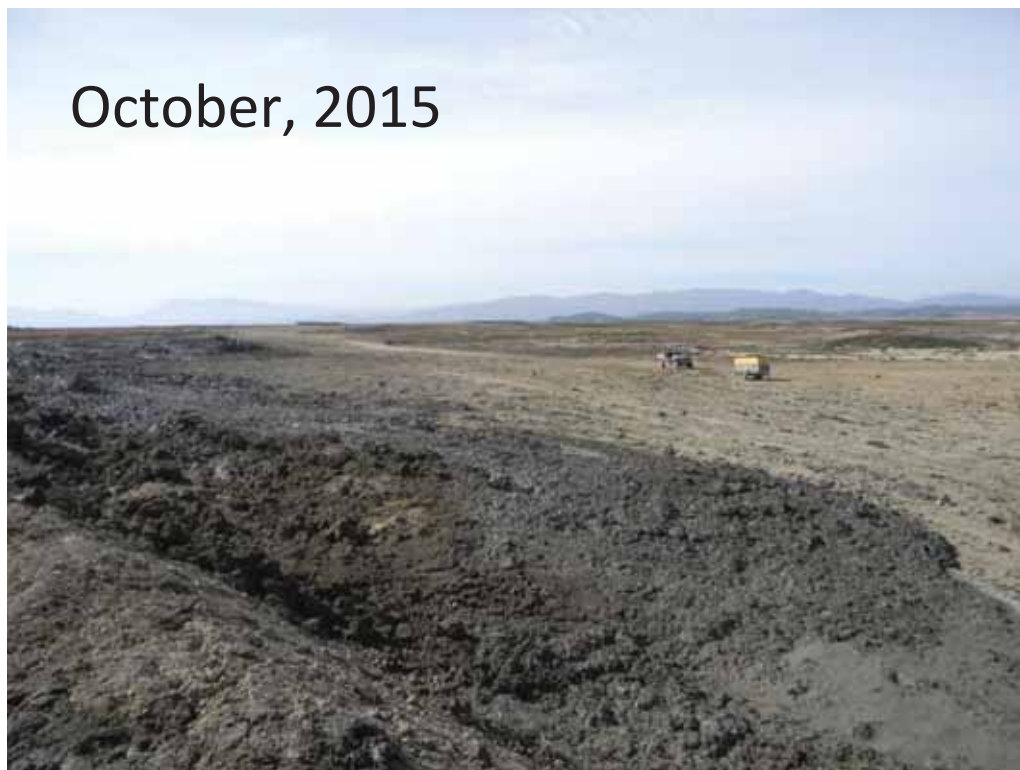
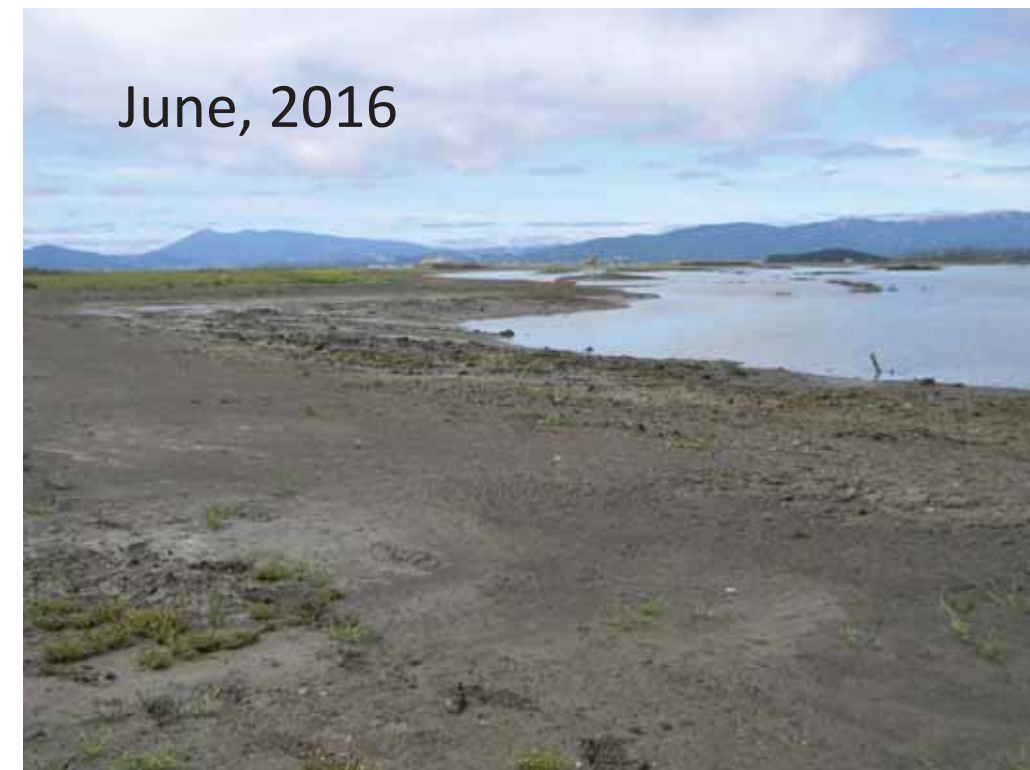
Photo Point 4, Photo 4.4

Photo Description: View SW over fields toward Sonoma Baylands where new tidal channels and marsh mounds will be constructed

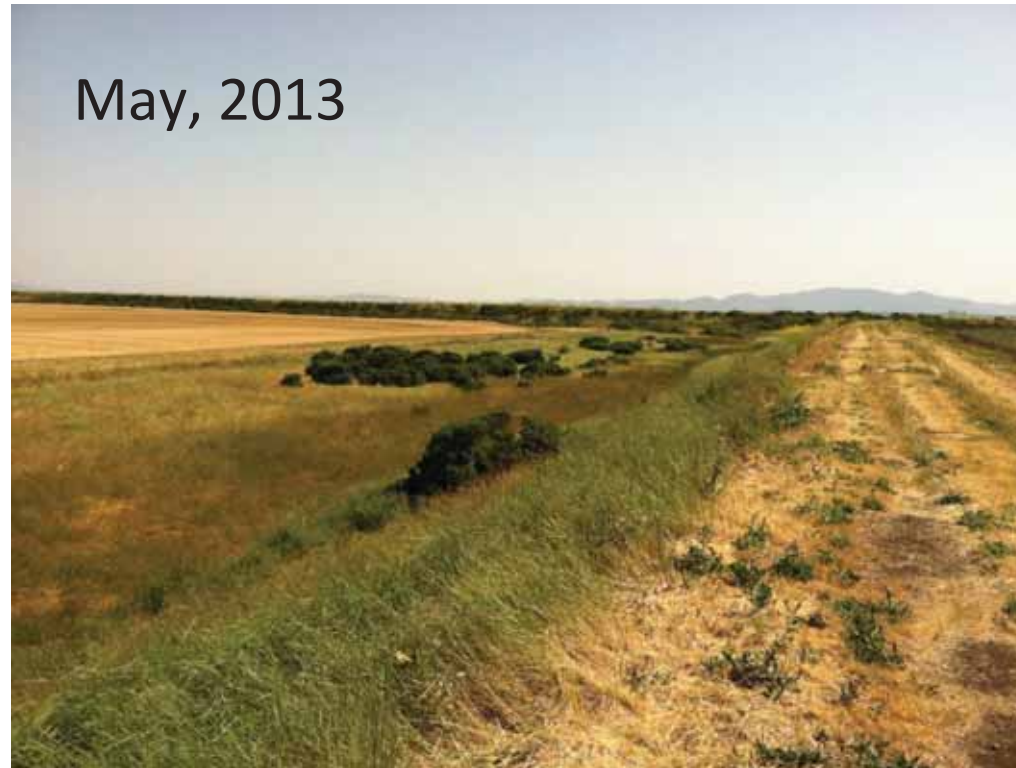
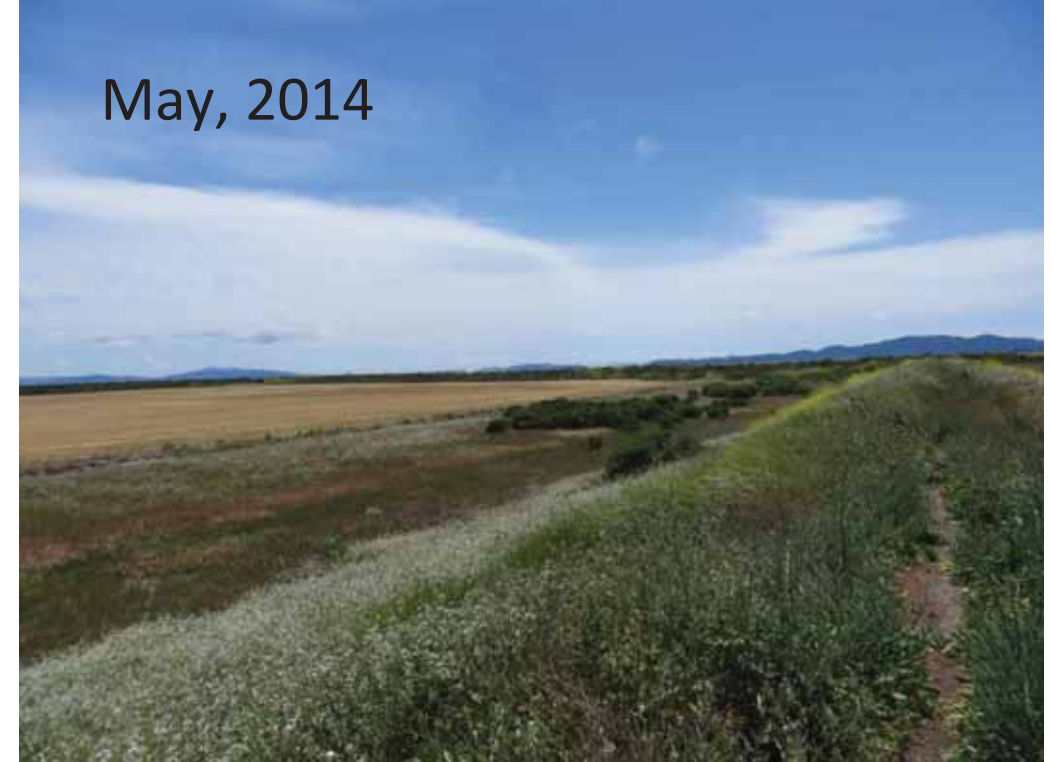
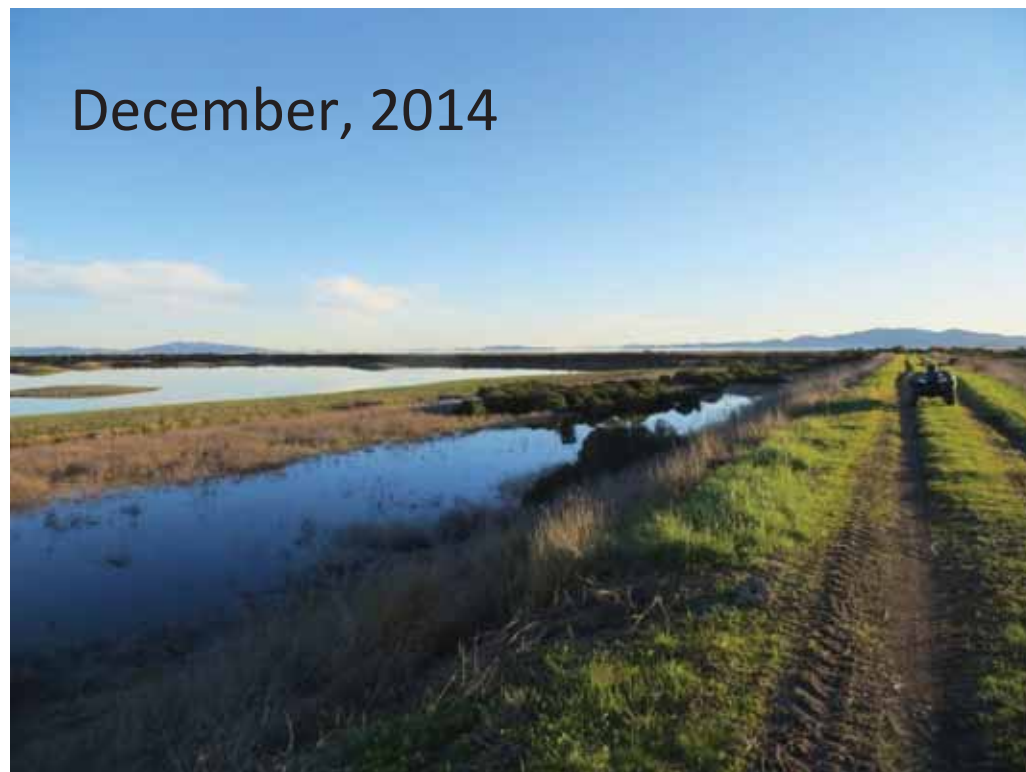
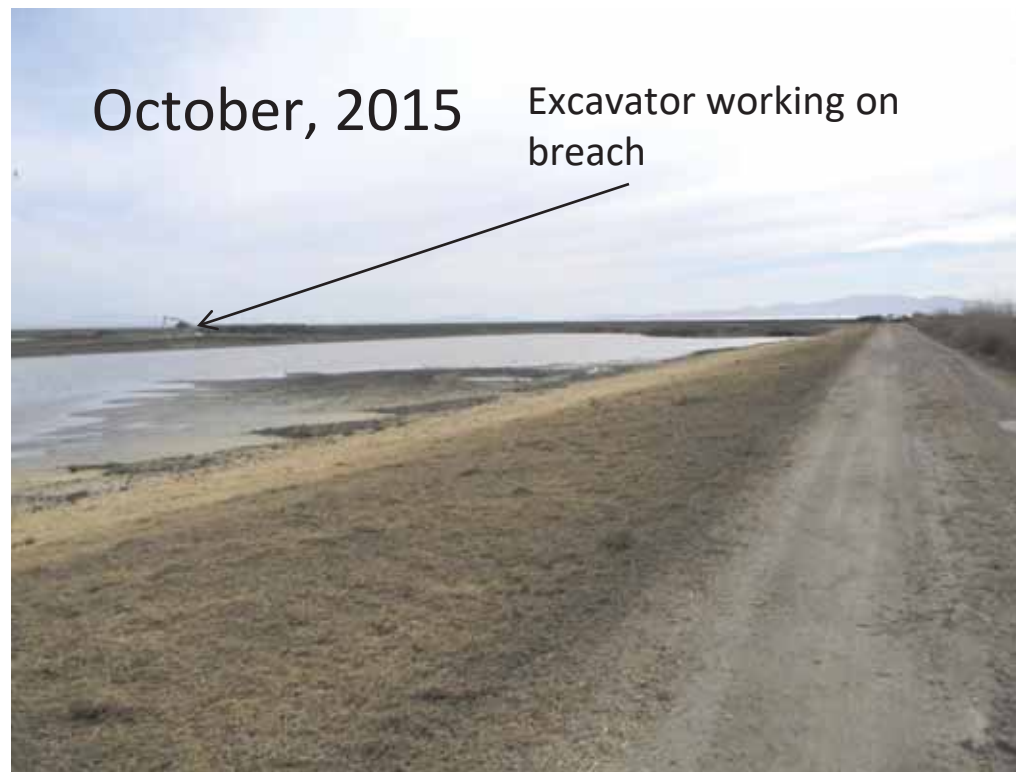
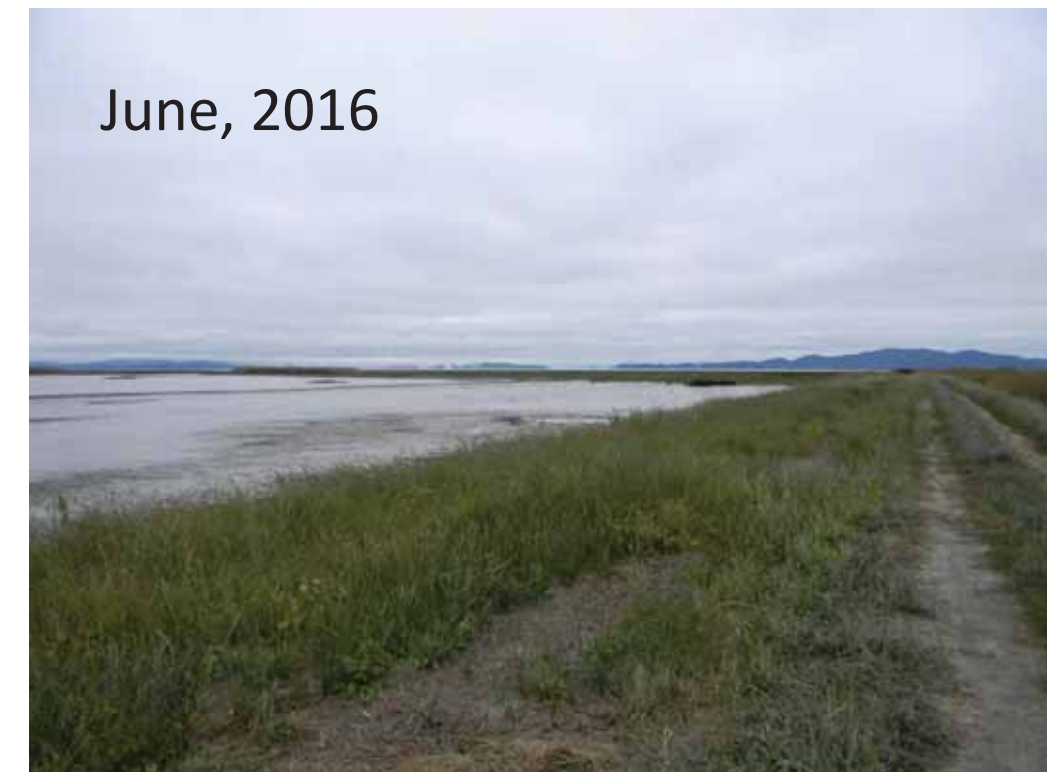
Photo Description: View S of future
Breach 1

Excavator working on
breach

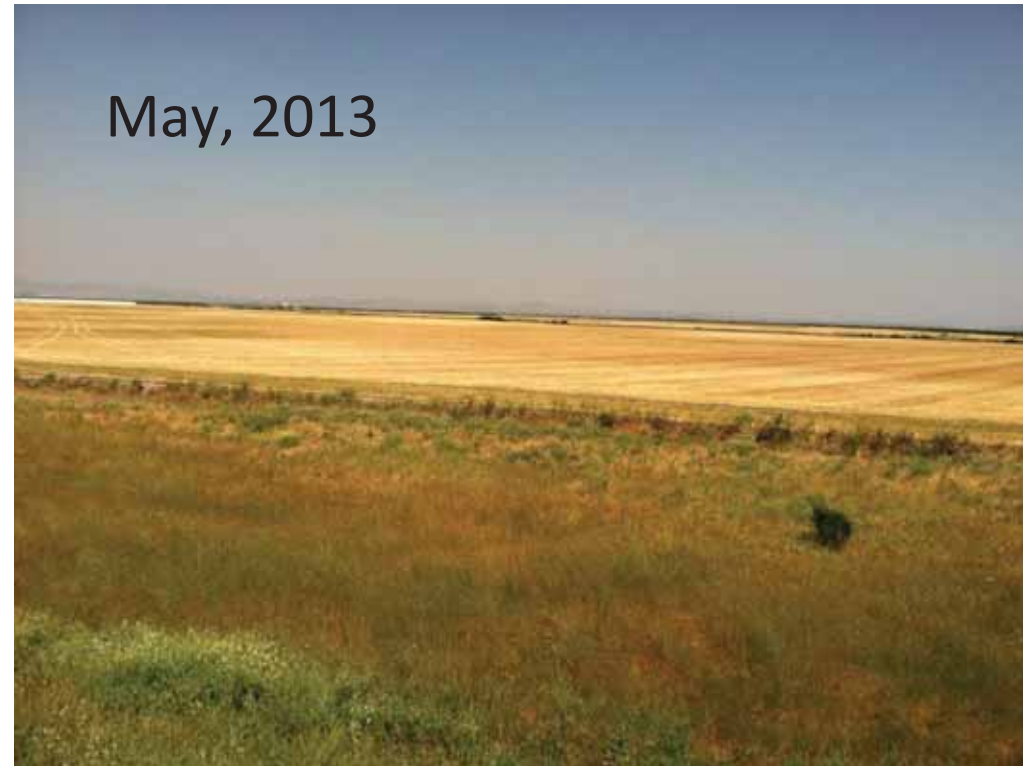
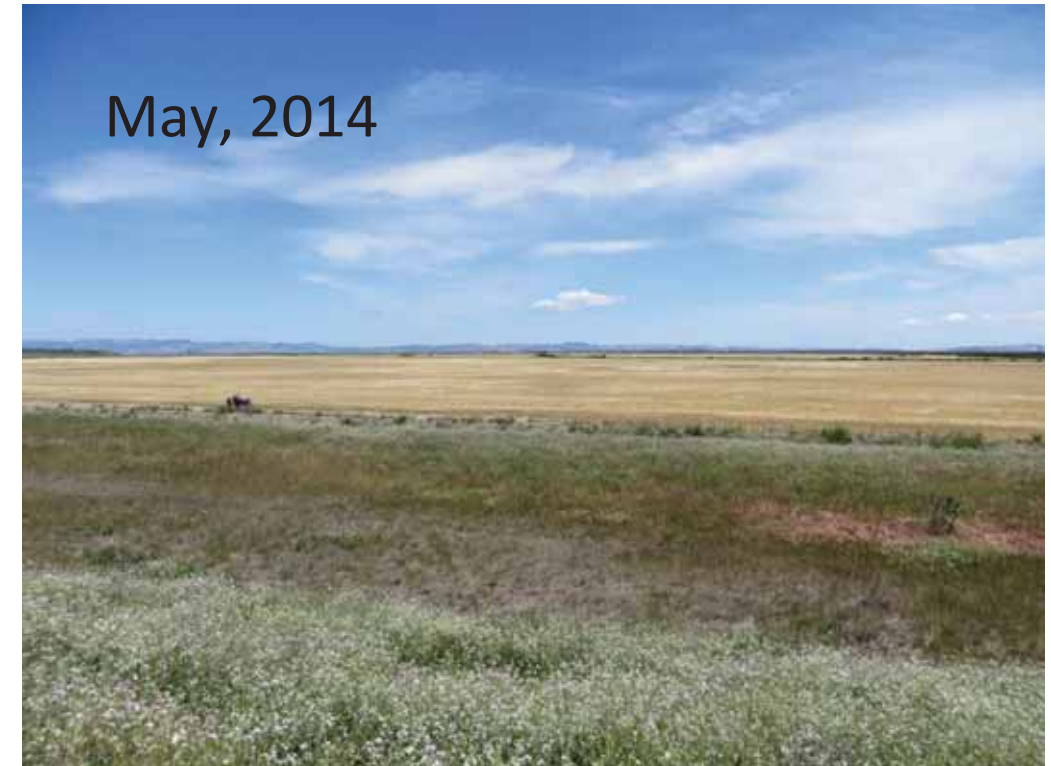
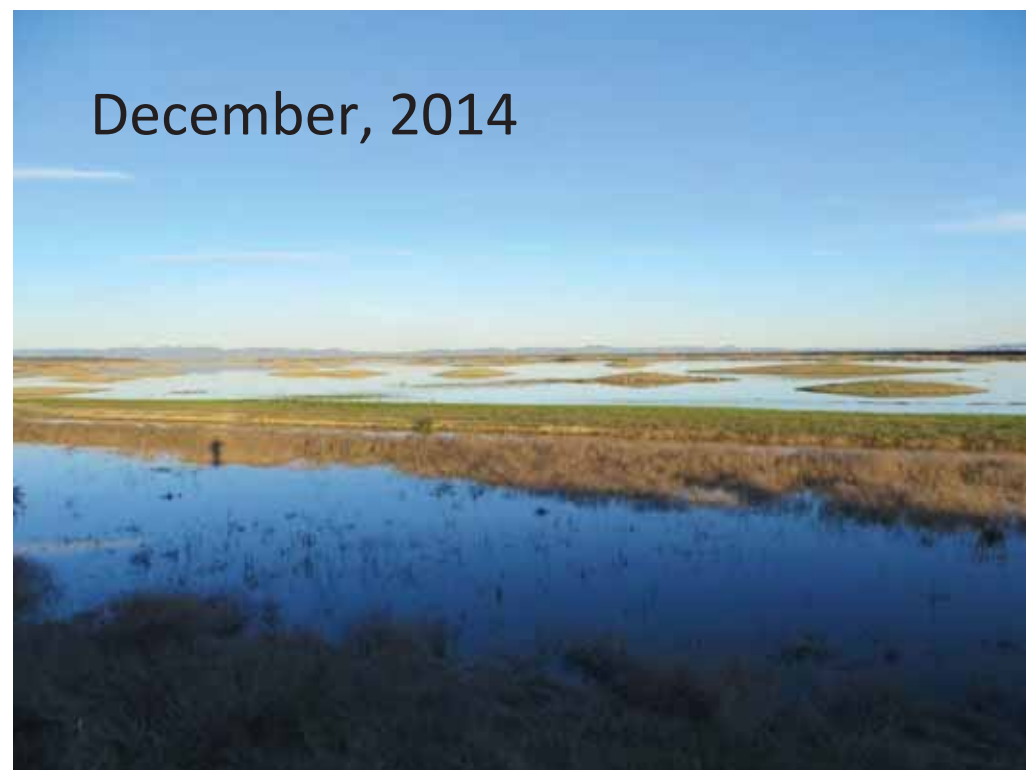
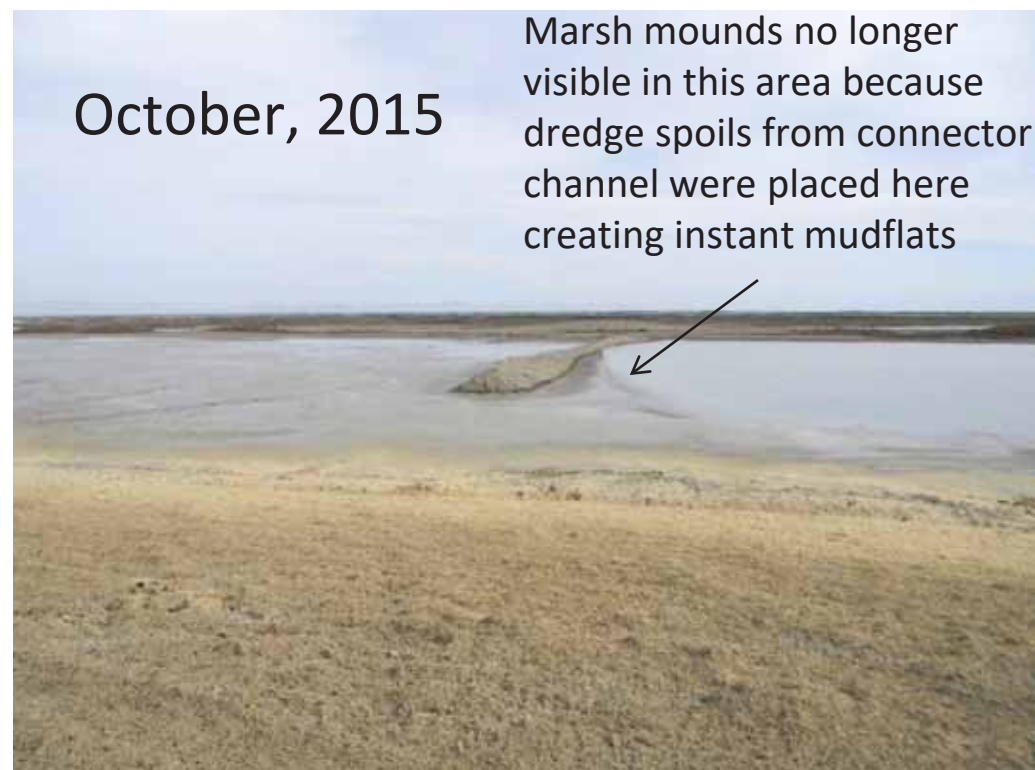
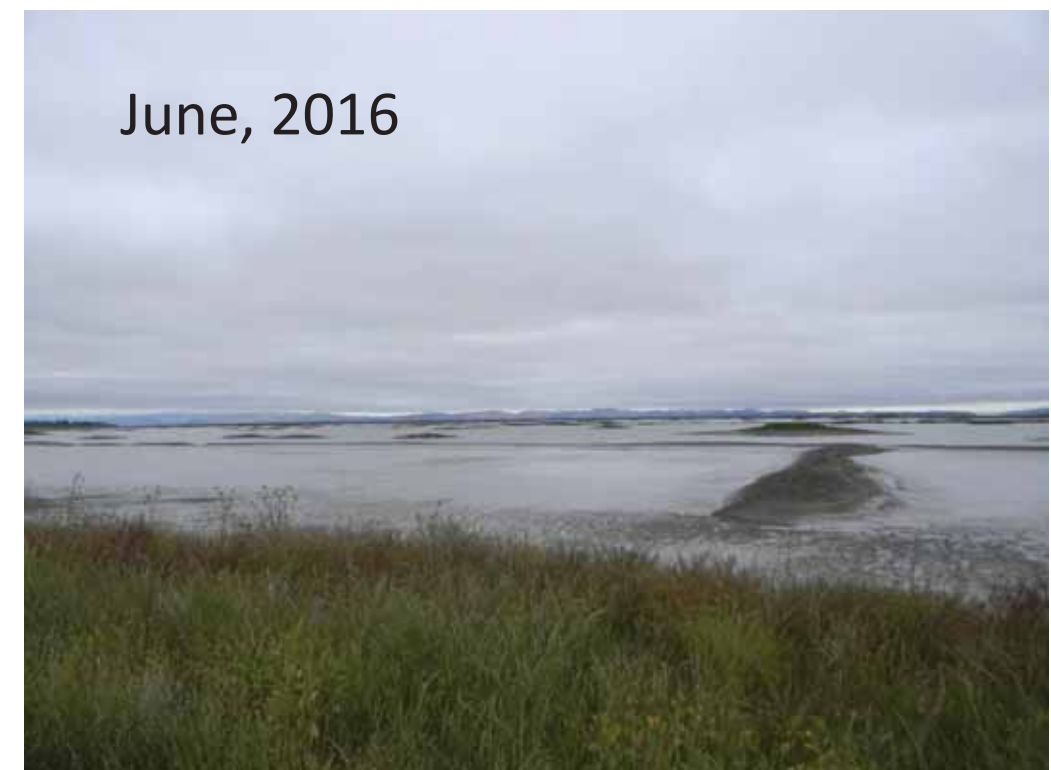
Photo Point 5, Photo 5.2
N 38.12049, W 122.47446
Bearing 77°

Photo Point Description: south end of levee dividing Sears Point from Sonoma Baylands

Photo Description: View NE over ag fields where new tidal channels and marsh mounds will be constructed

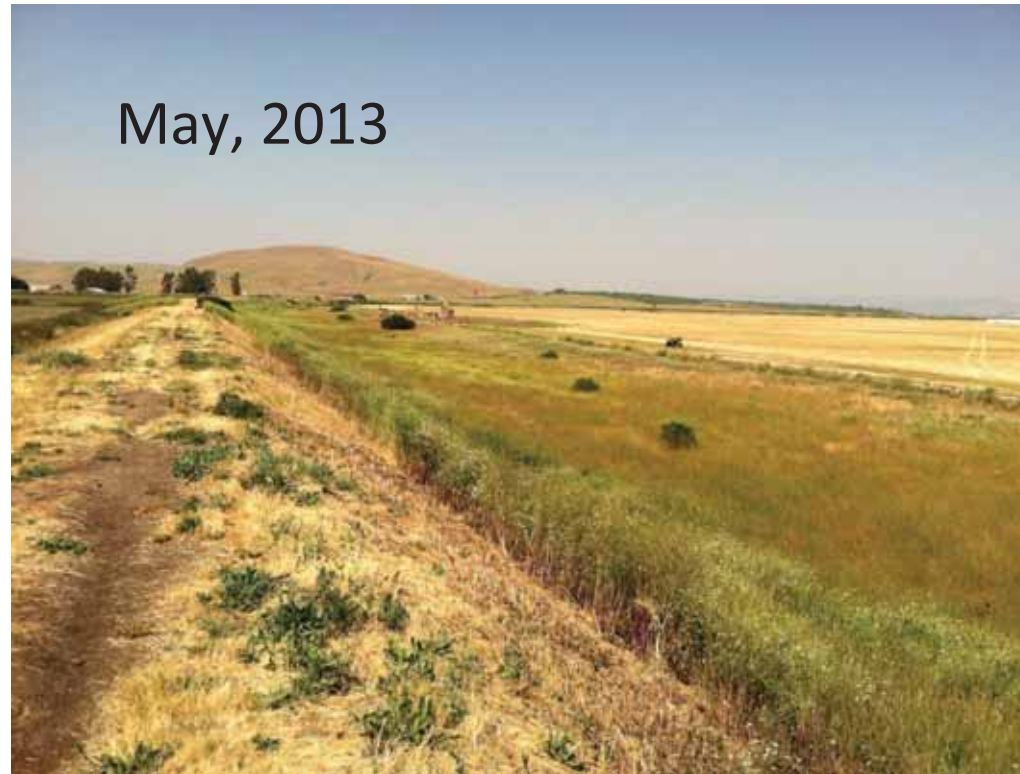
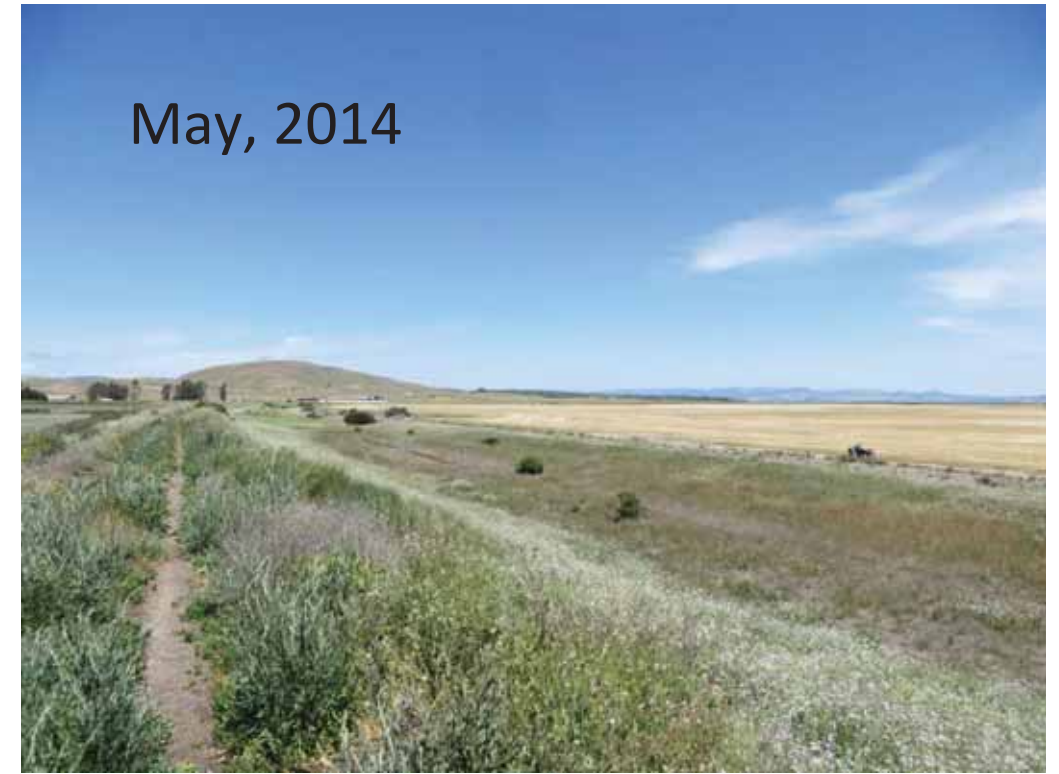
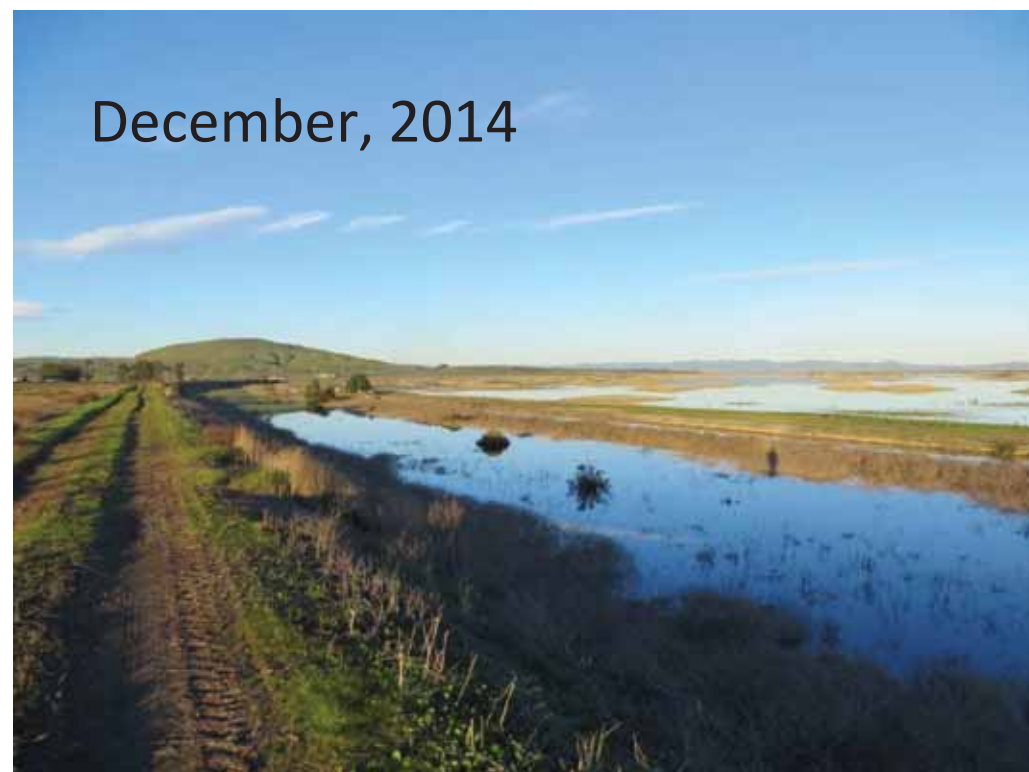
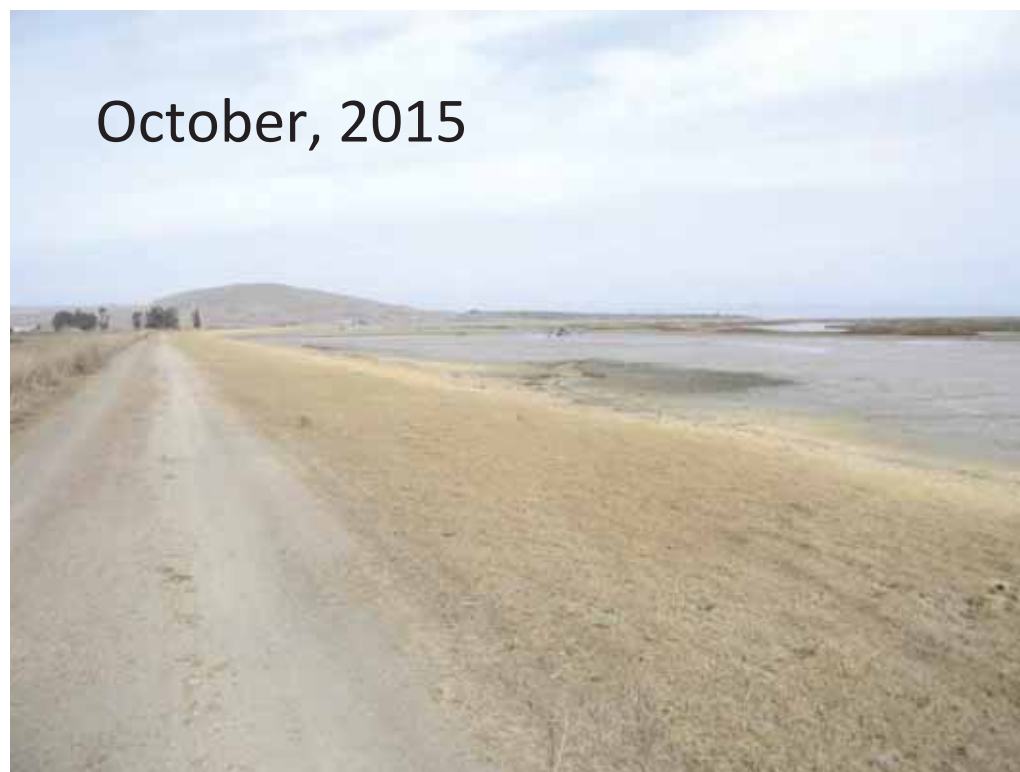
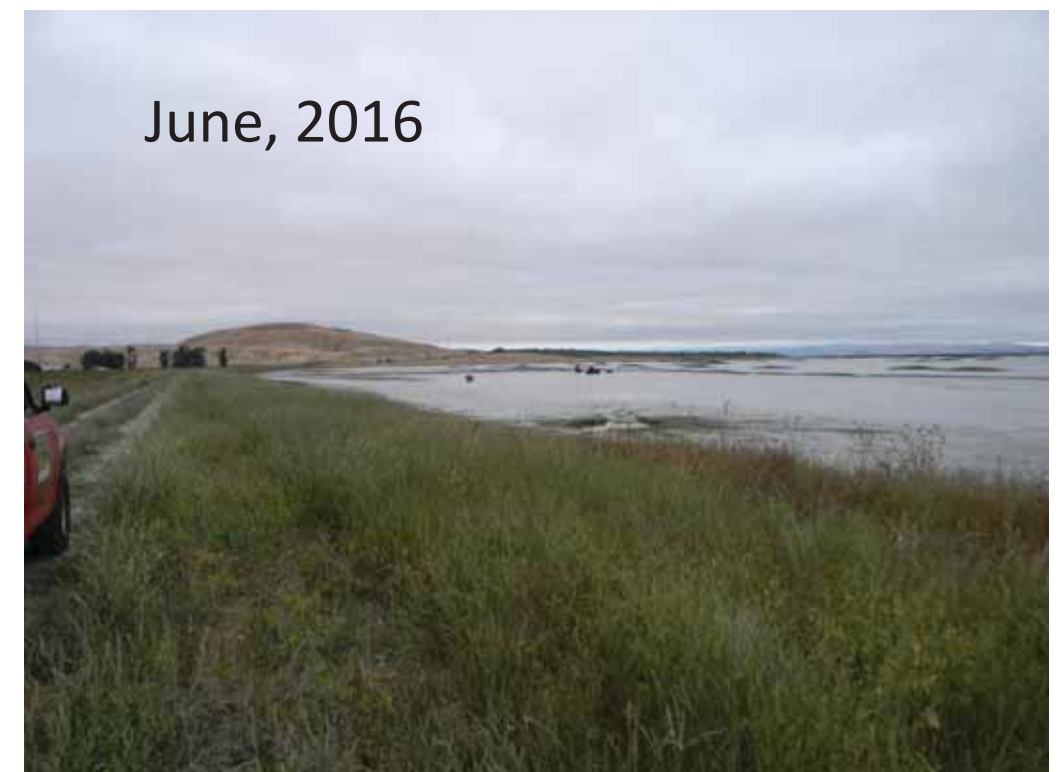
Photo Point 5, Photo 5.3
N 38.12049, W 122.47446
Bearing 31°

Photo Point Description: south end of levee dividing Sears Point from Sonoma Baylands

Photo Description: View NE along levee and fields where new tidal channels and marsh mounds will be constructed
