Sears Point Tidal Marsh Restoration Project

Monitoring and Management Status Report

October 2015 to June 2017

Sears Point Tidal Marsh Restoration Project
Monitoring and Management Status Report, Year 1
October 2015 to June 2017

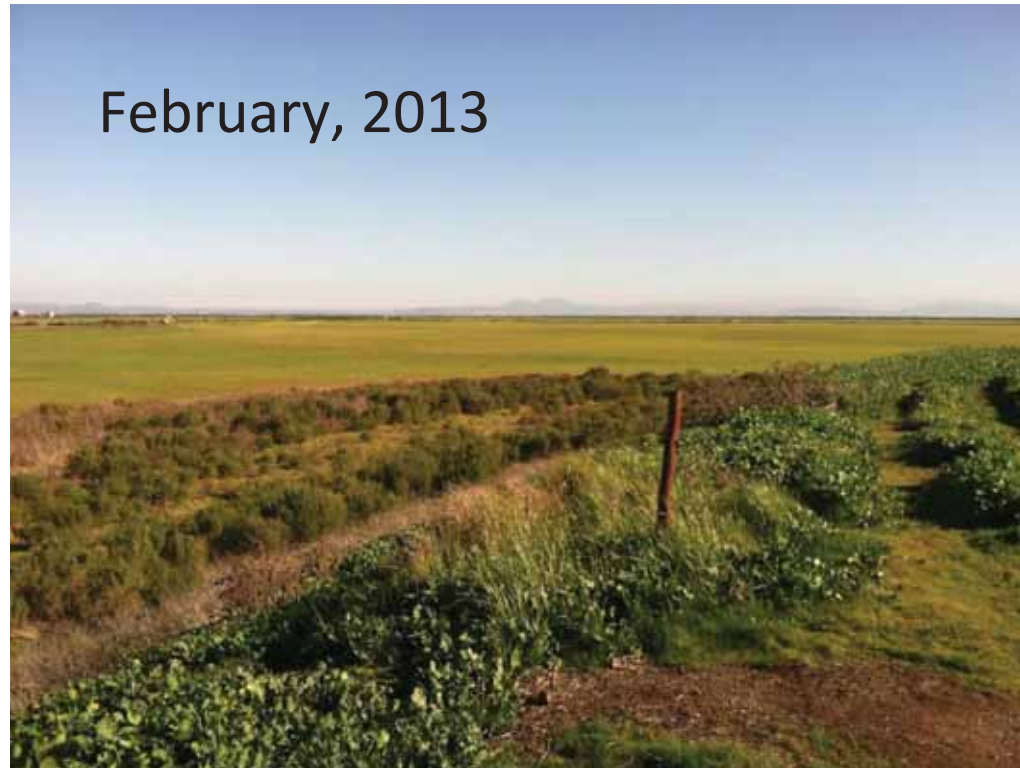
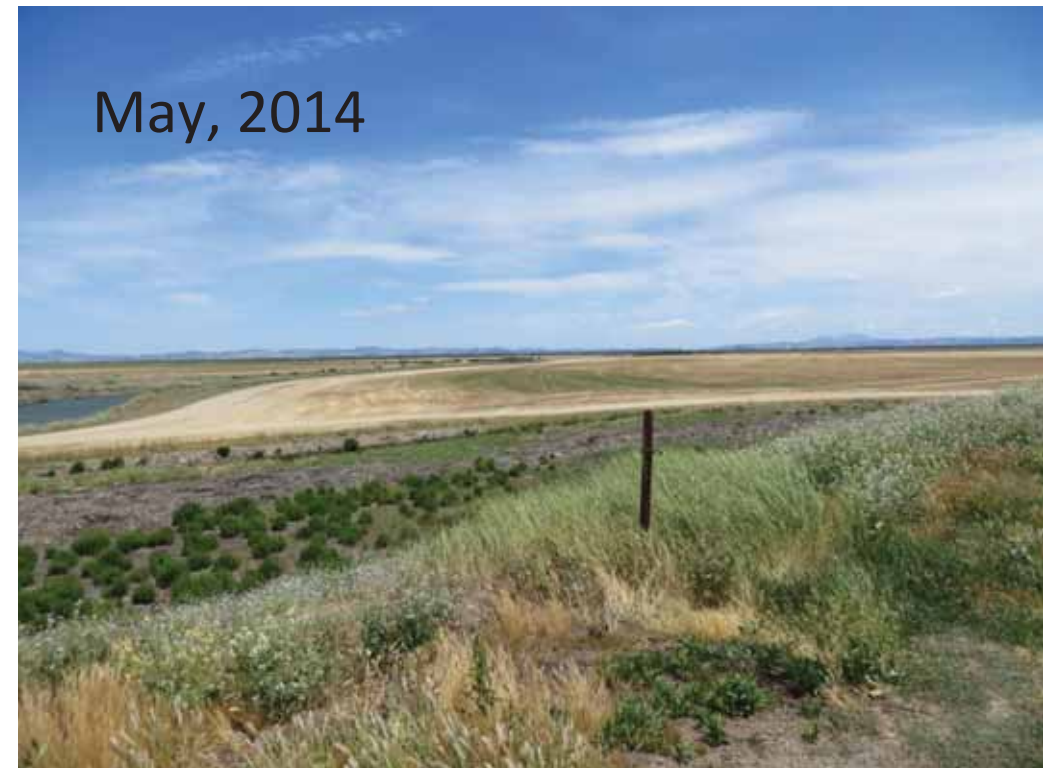
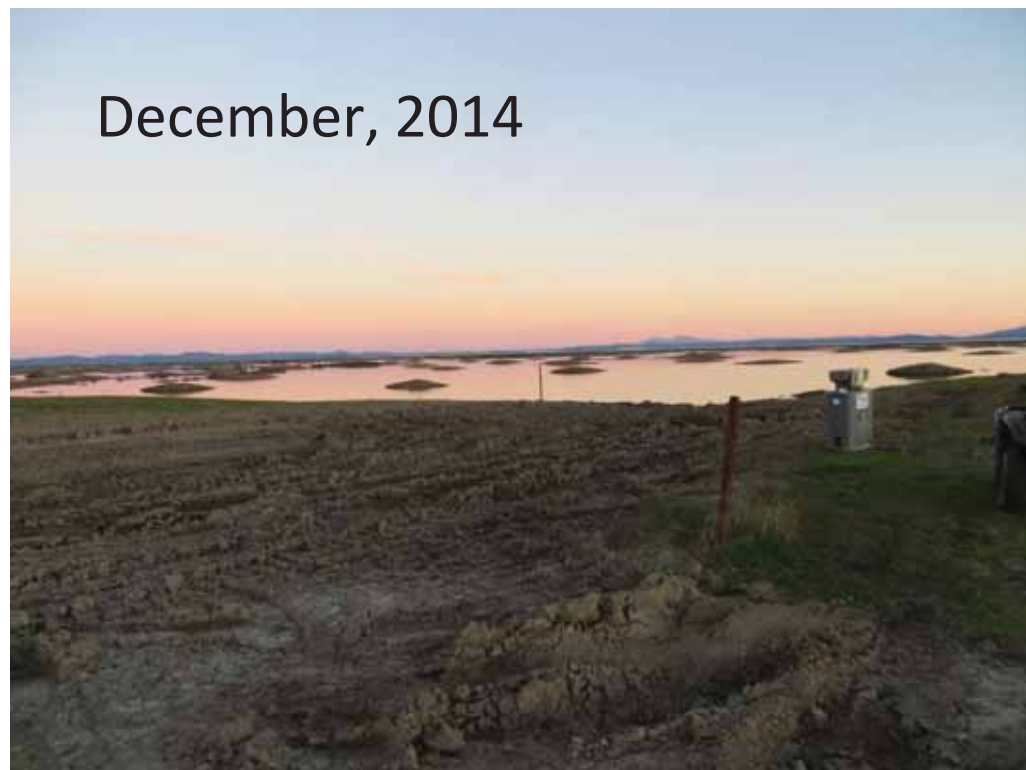
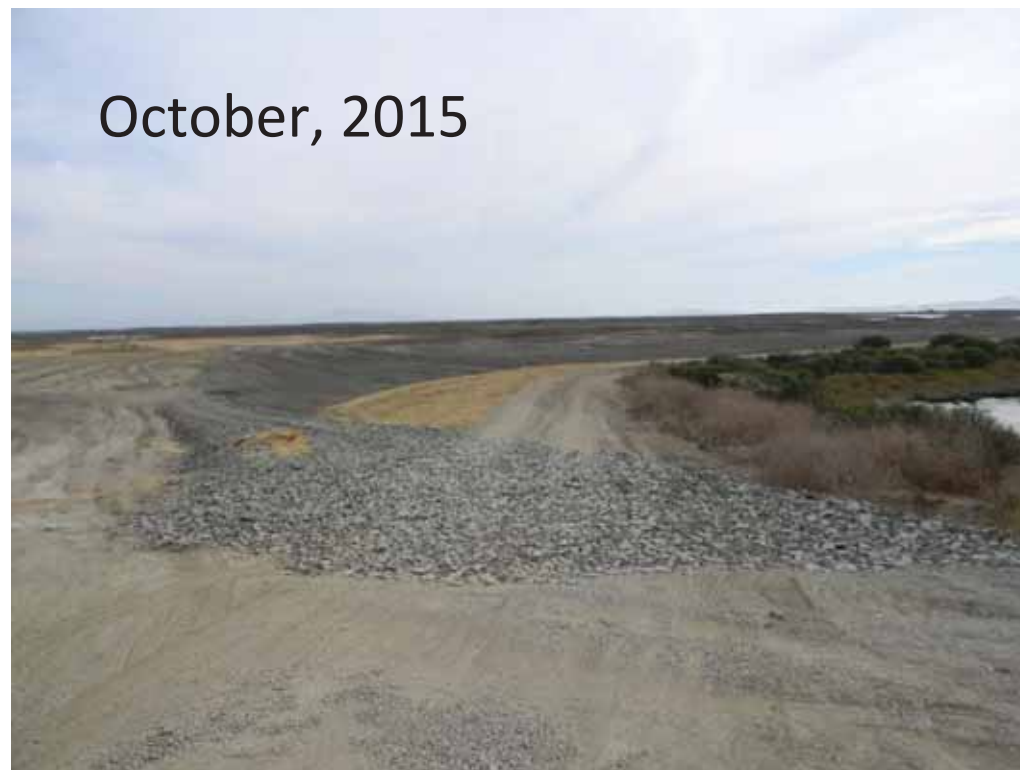
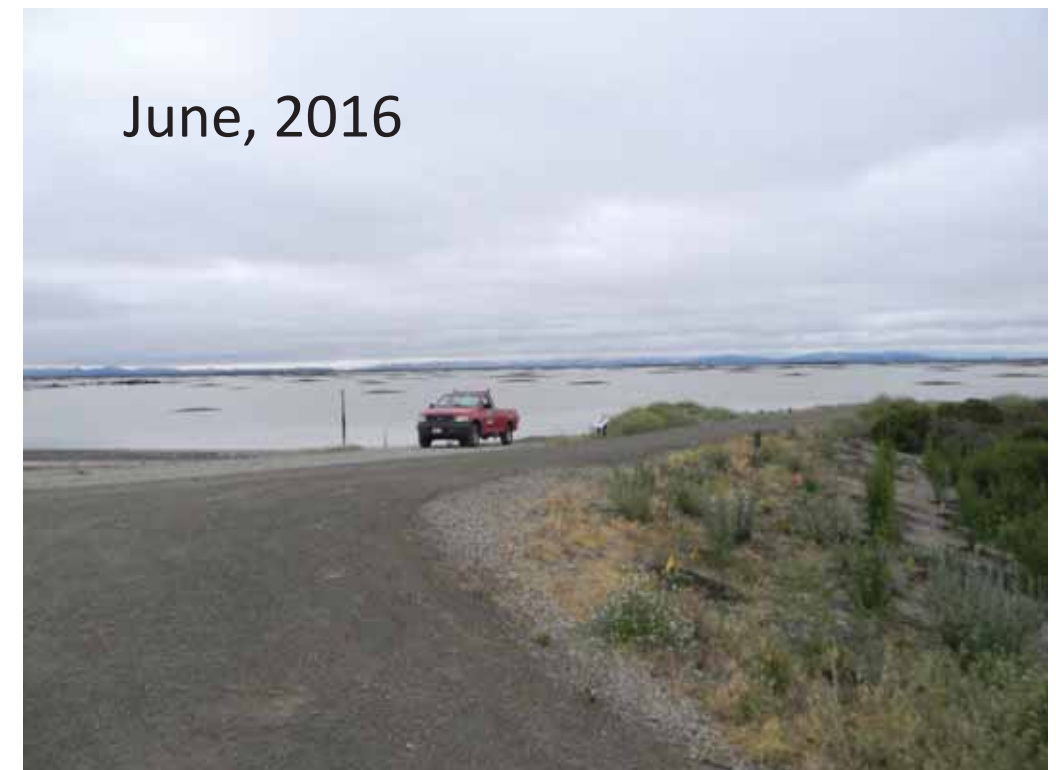
Photo Point 6, Photo 6.2
N 38.12773, W 122.47174
Bearing 120°

Photo Point Description: Sonoma Baylands levee where it will join Sears Point levee

Photo Description: View SE over ag fields where new tidal channels and marsh mounds will be constructed. Mt Diablo in distance

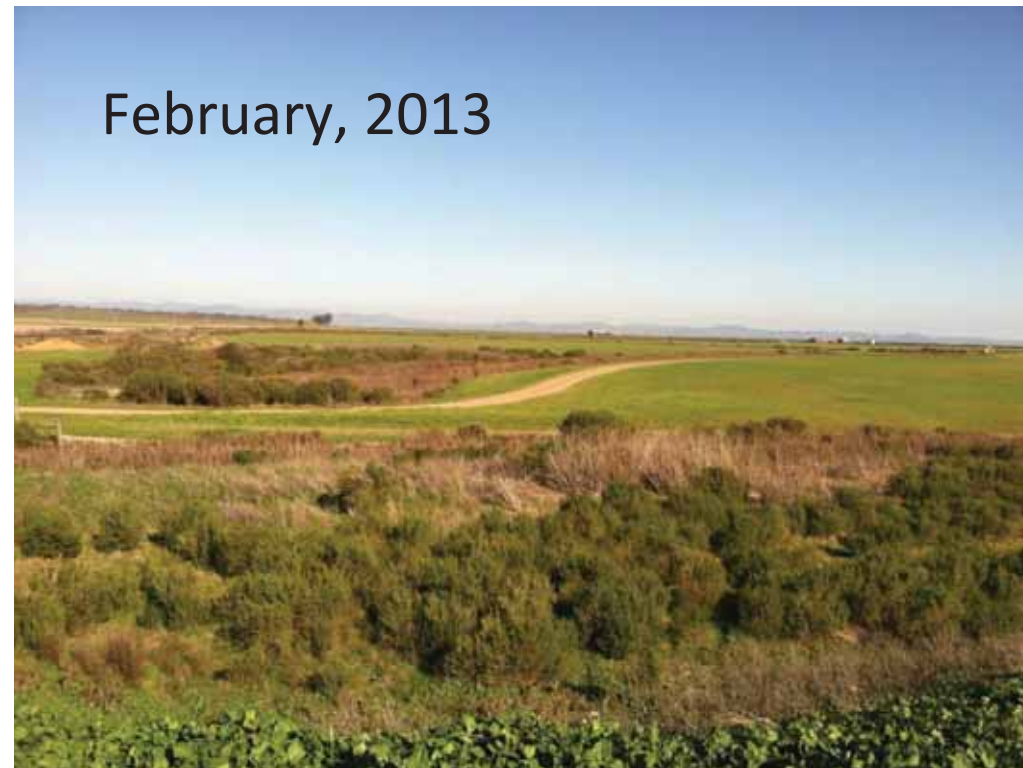
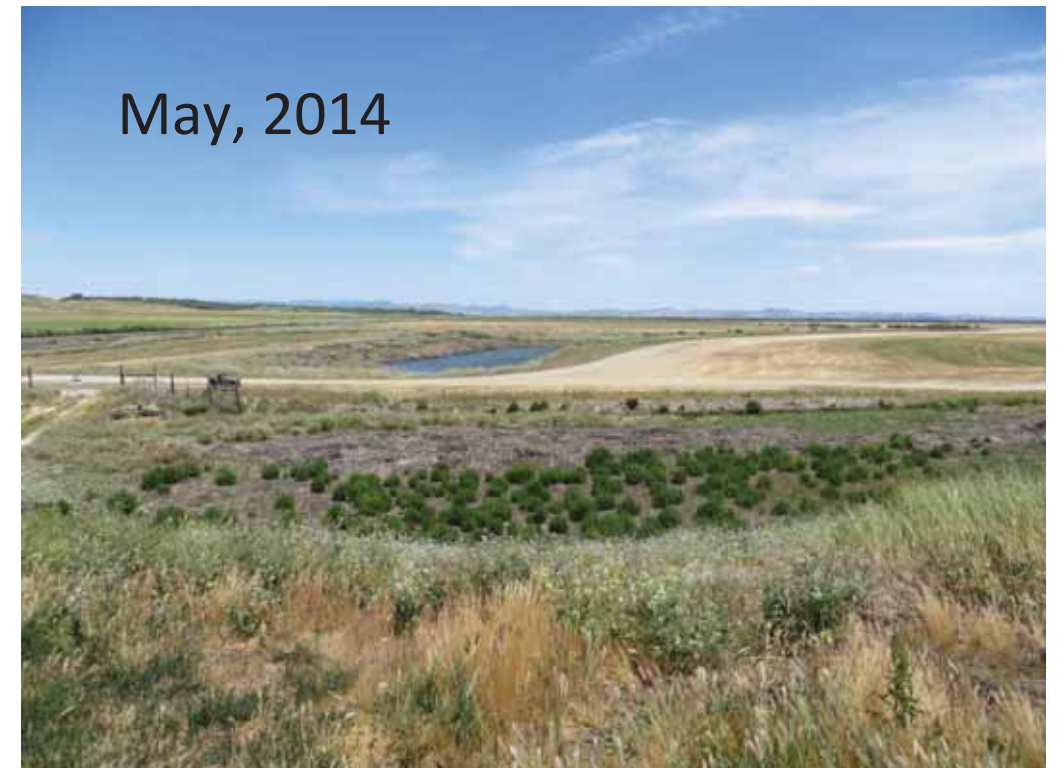
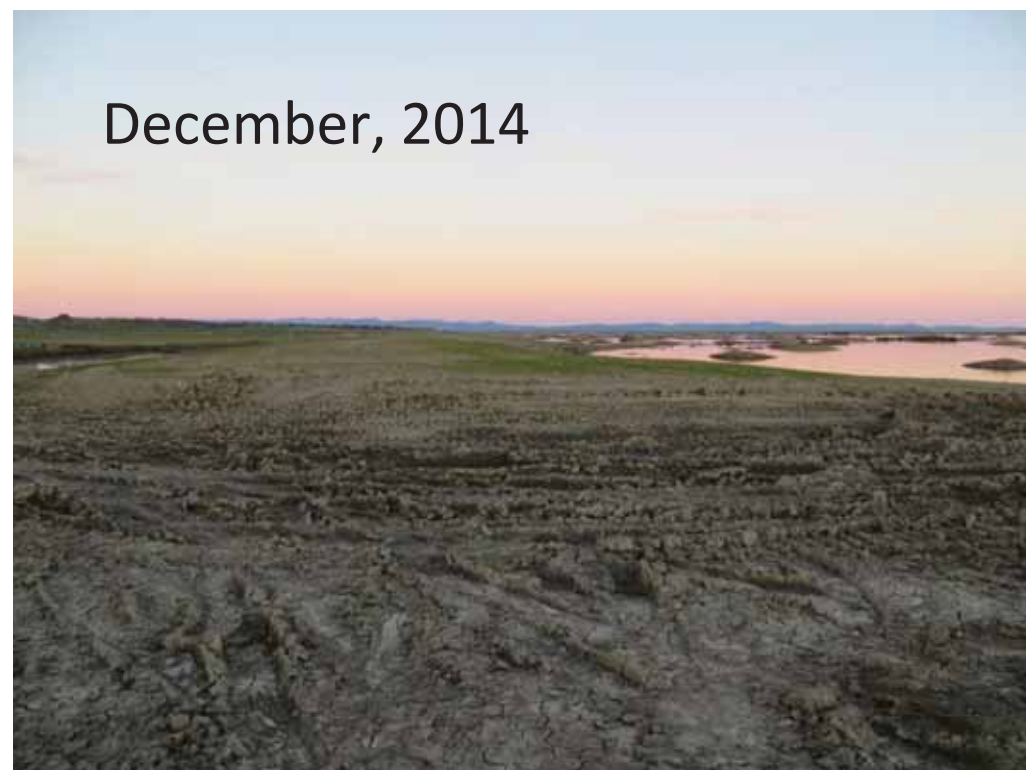
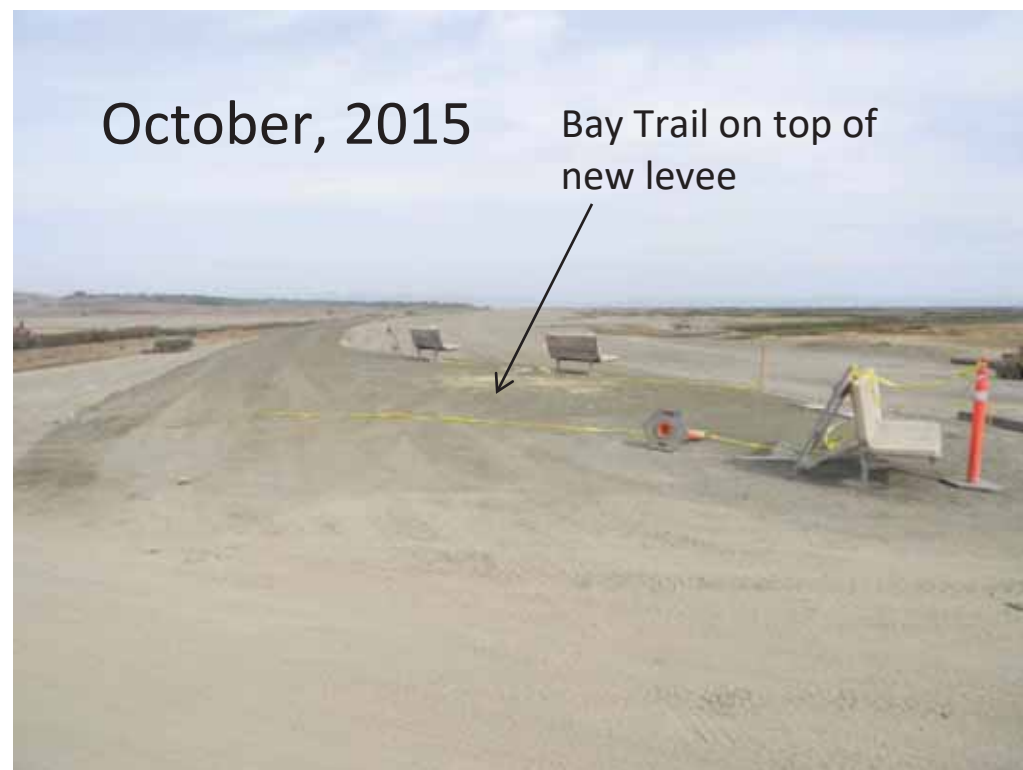
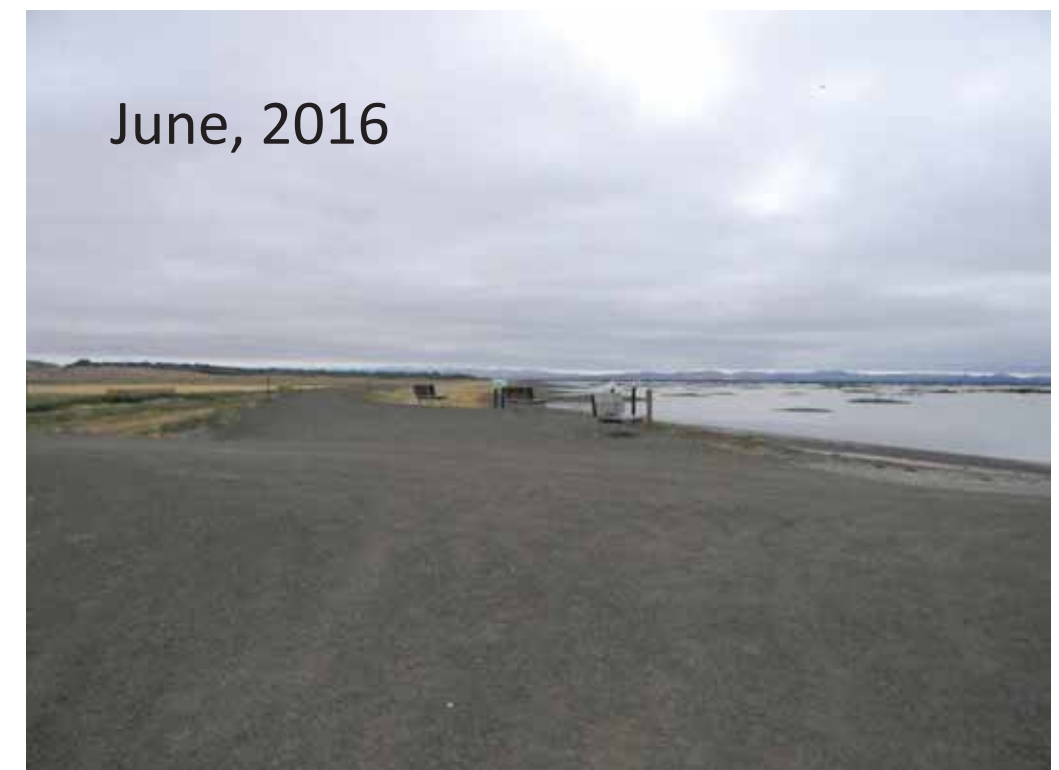
Photo Point 6, Photo 6.3
N 38.12773, W 122.47174
Bearing 62°

Photo Point Description: Sonoma Baylands levee where it will join Sears Point levee

Photo Description: View ENE where new levee and Bay Trail will be built

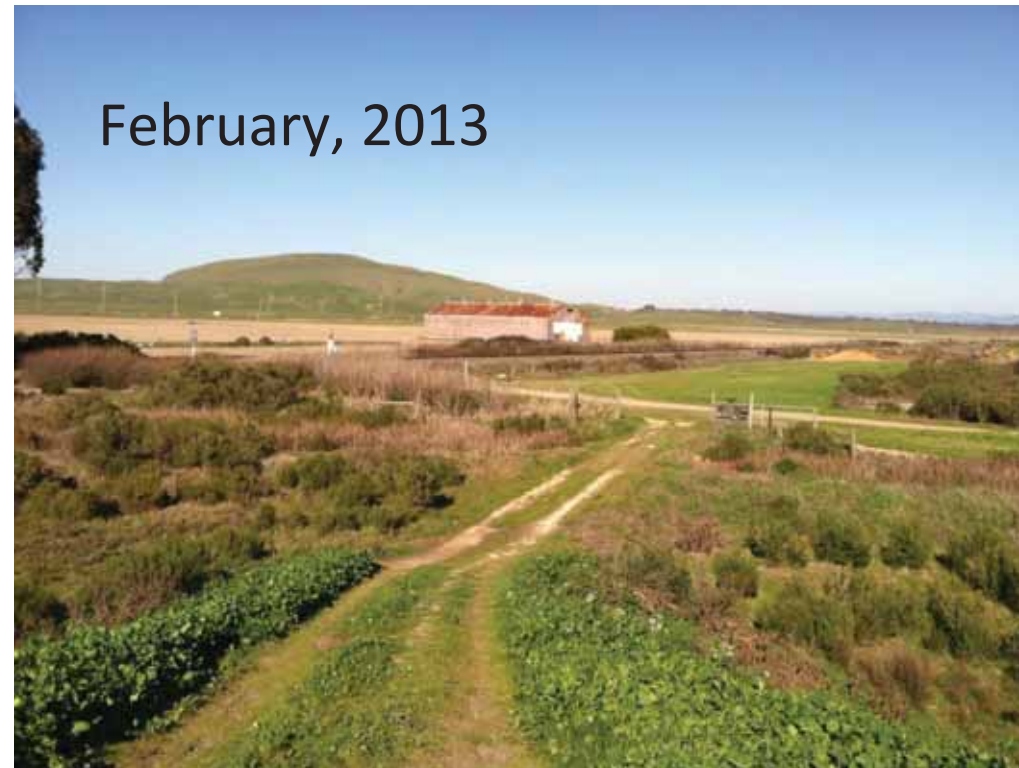
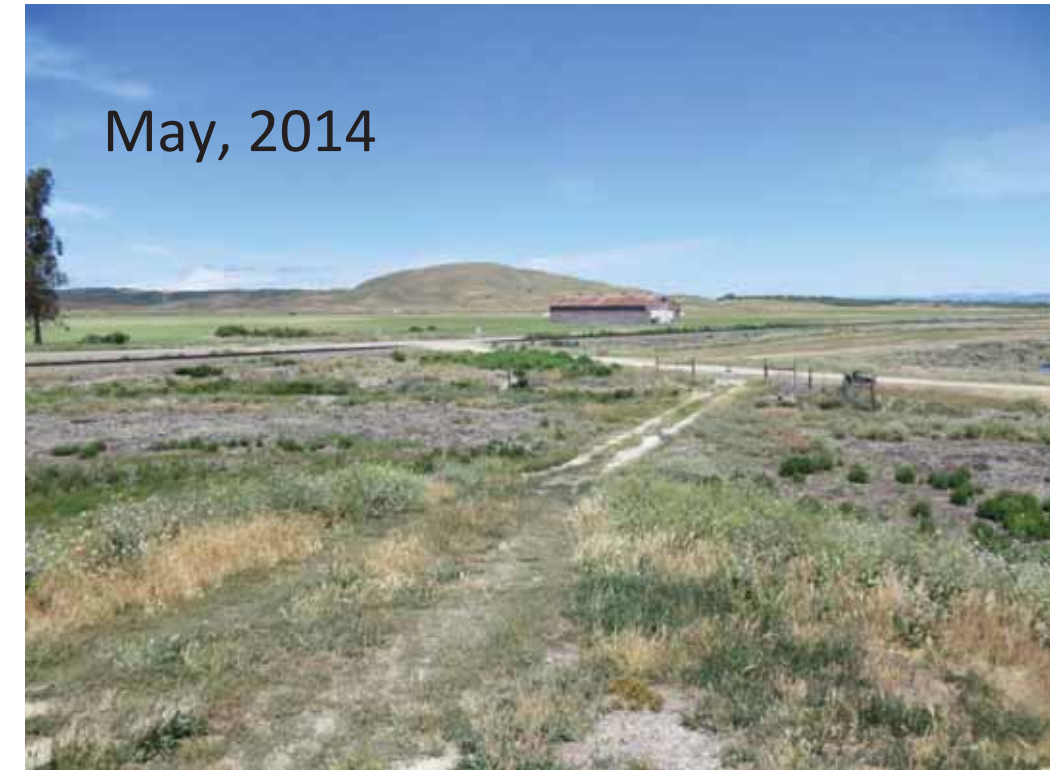
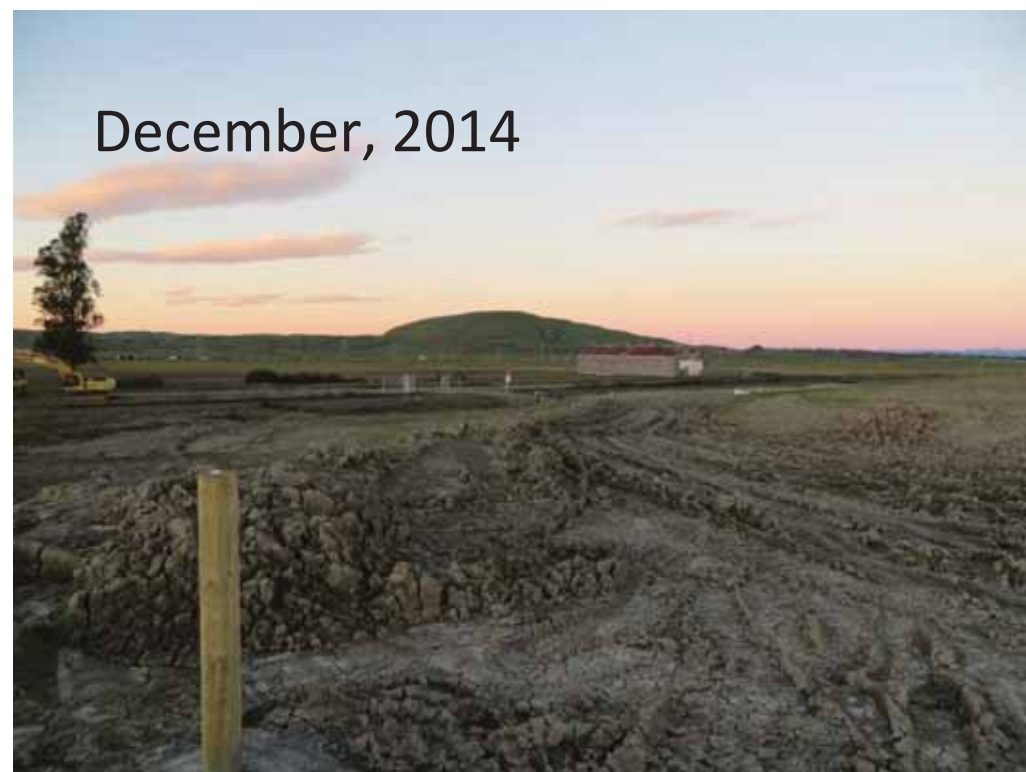
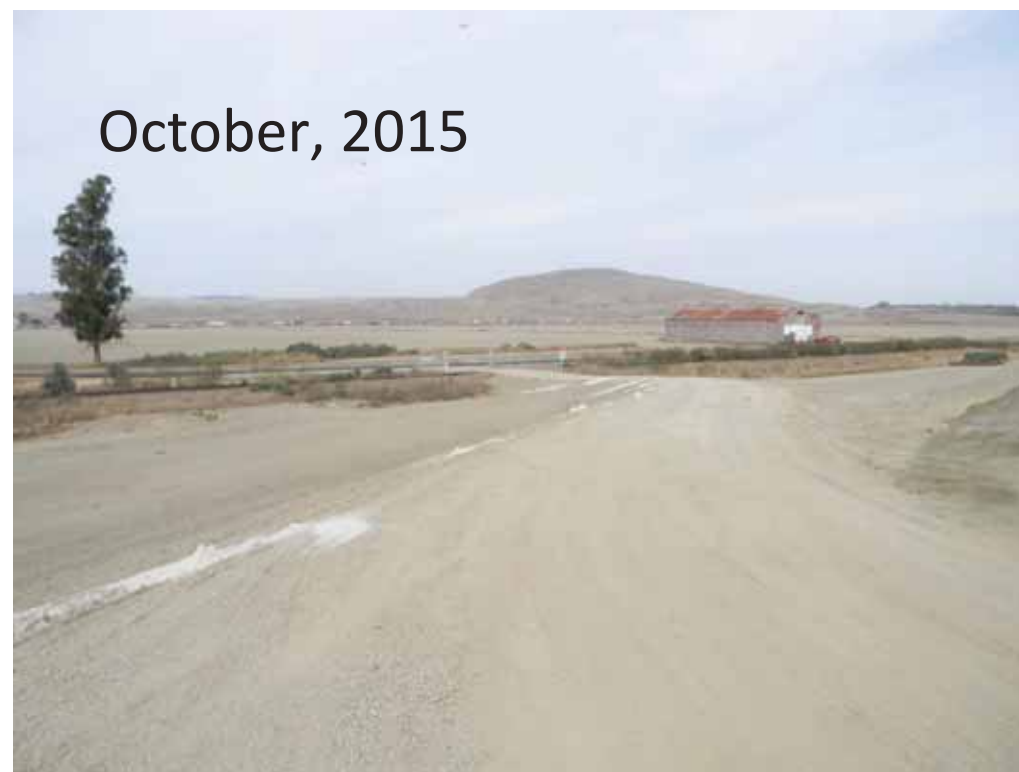
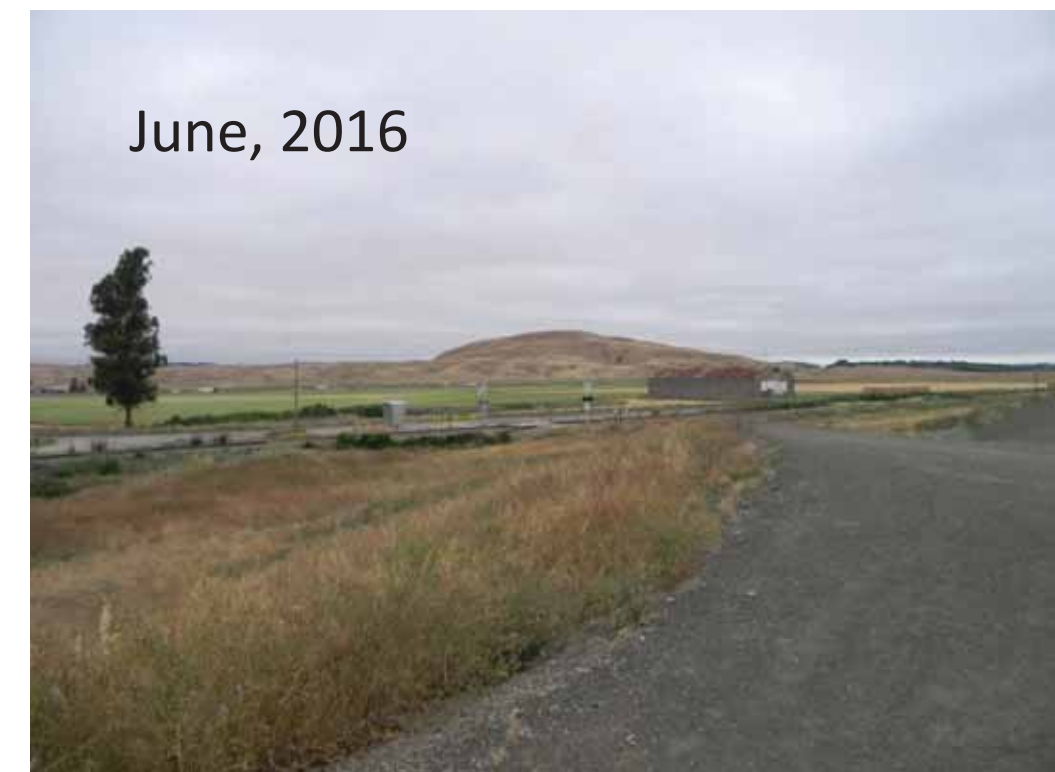
Photo Point 6, Photo 6.4
N 38.12773, W 122.47174
Bearing 31°

Photo Point Description: Sonoma Baylands levee where it will join Sears Point levee

Photo Description: View NE toward Cougar Mountain across fields north of RR with barn where new levee will be built

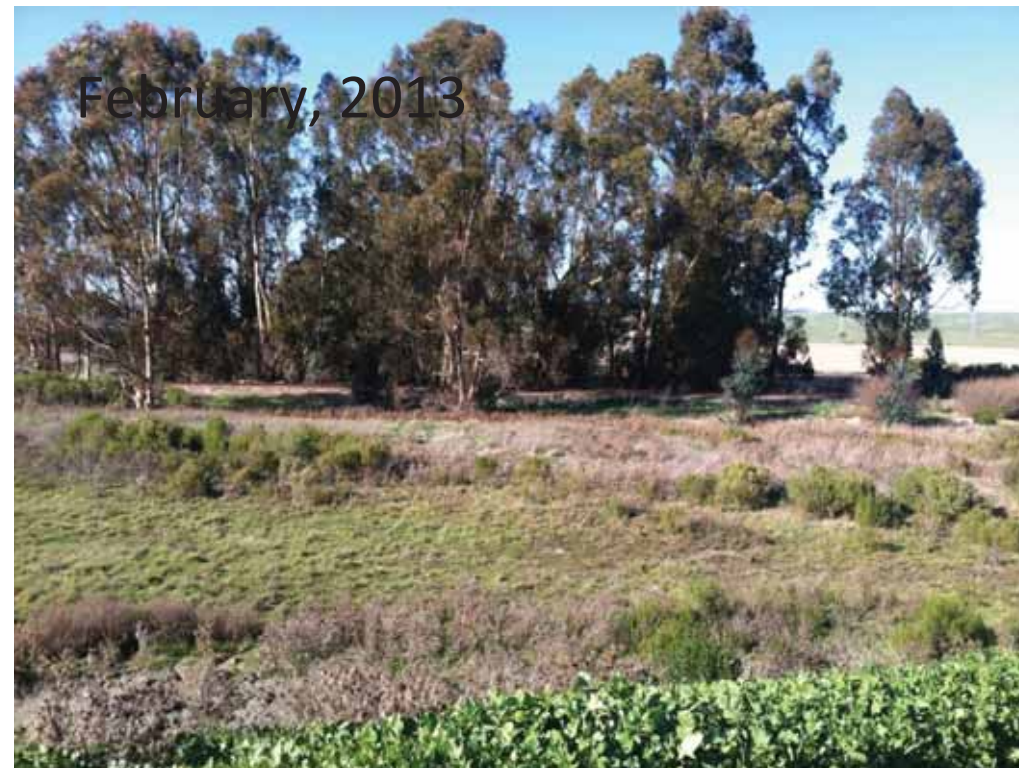
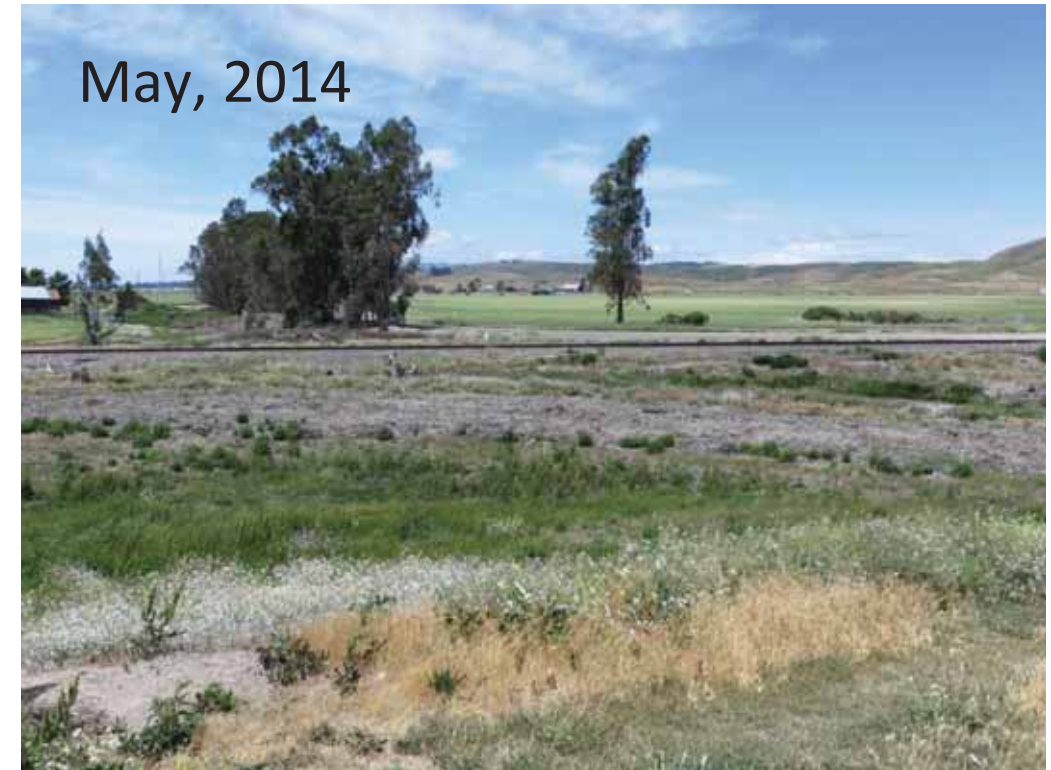
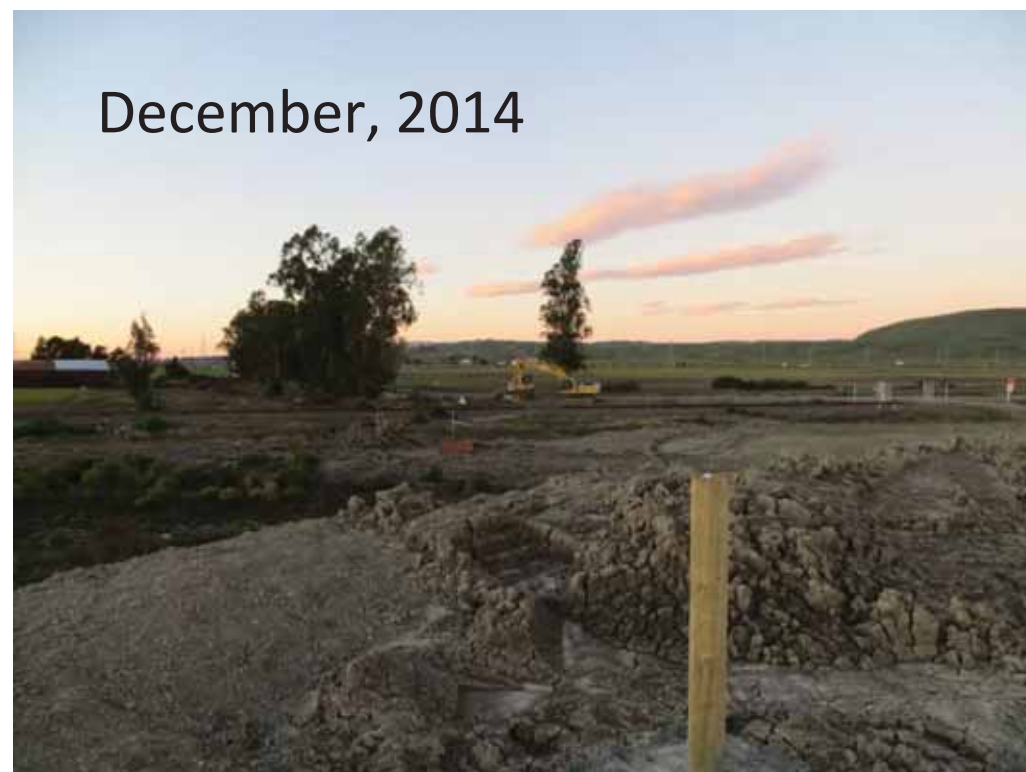
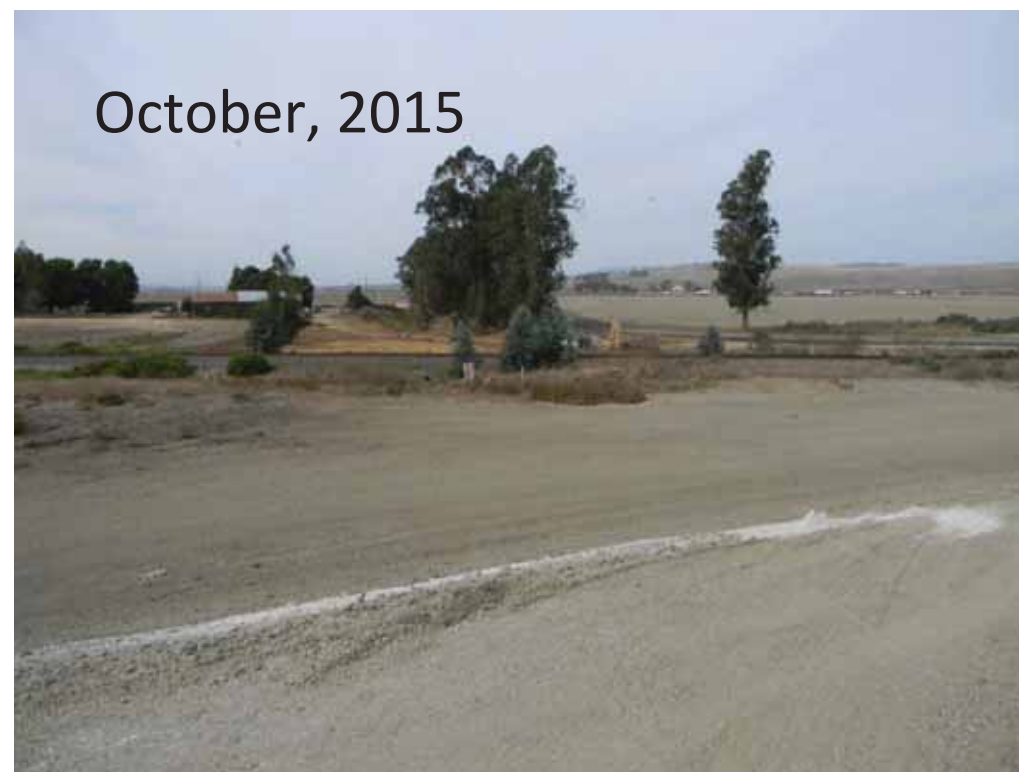
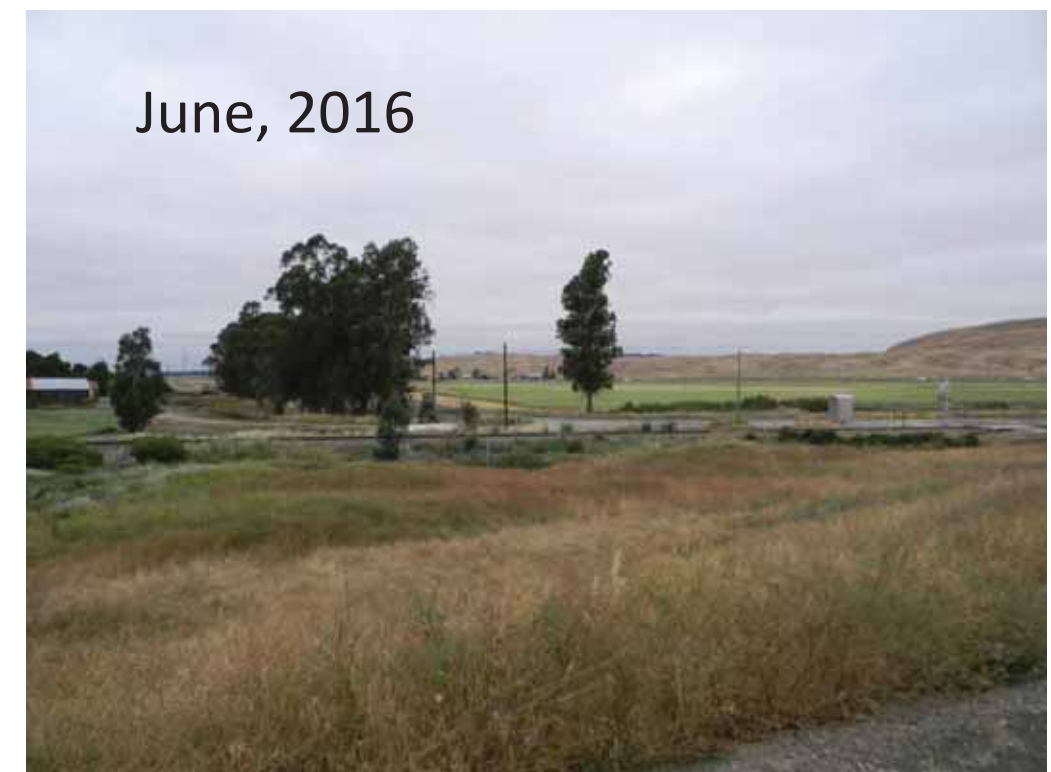
Photo Point 6, Photo 6.5
N 38.12773, W 122.47174
Bearing 329°

Photo Point Description: Sonoma Baylands levee where it will join Sears Point levee

Photo Description: View NW across RR track toward eucalyptus that will be removed

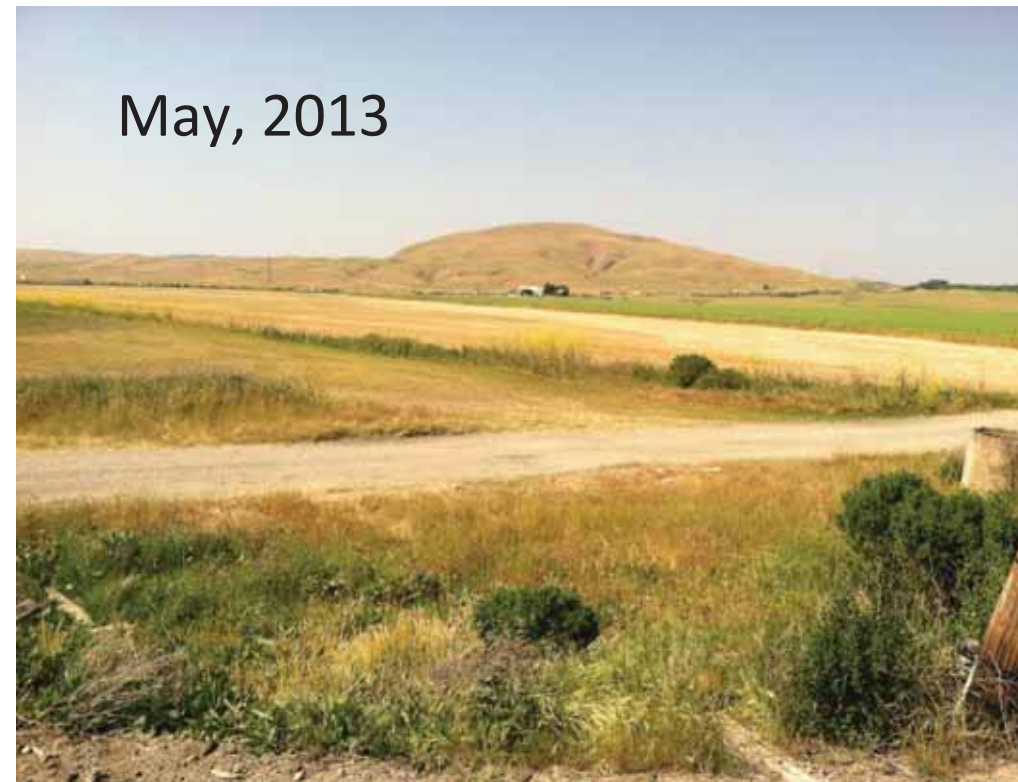
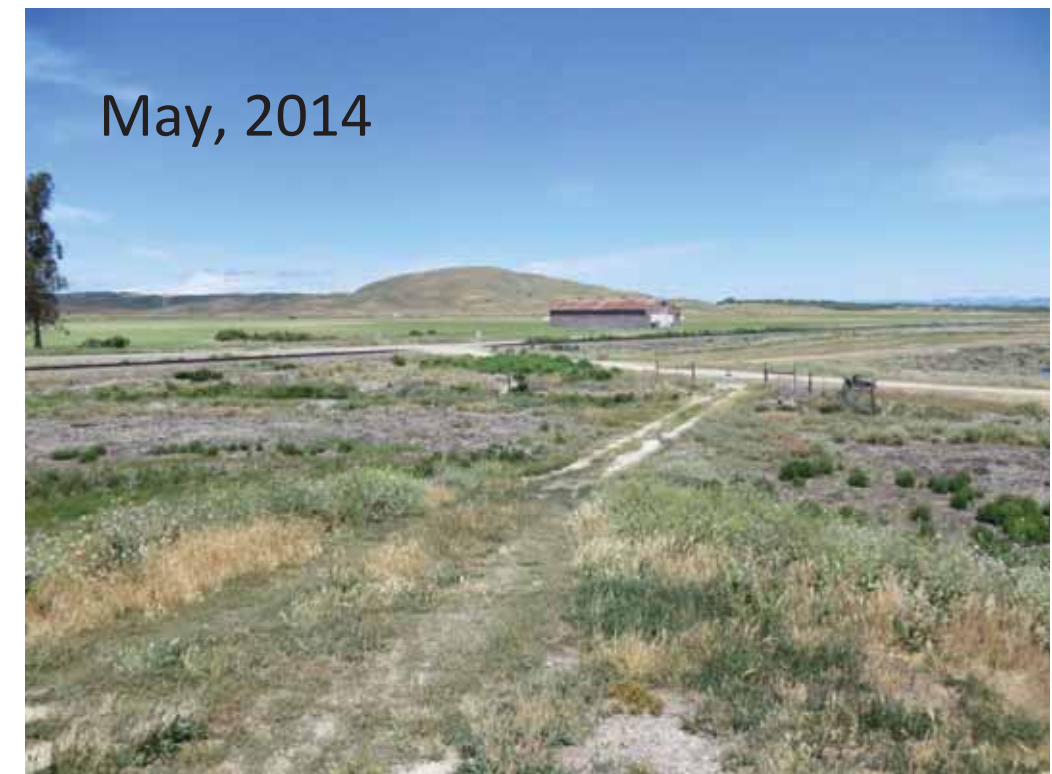
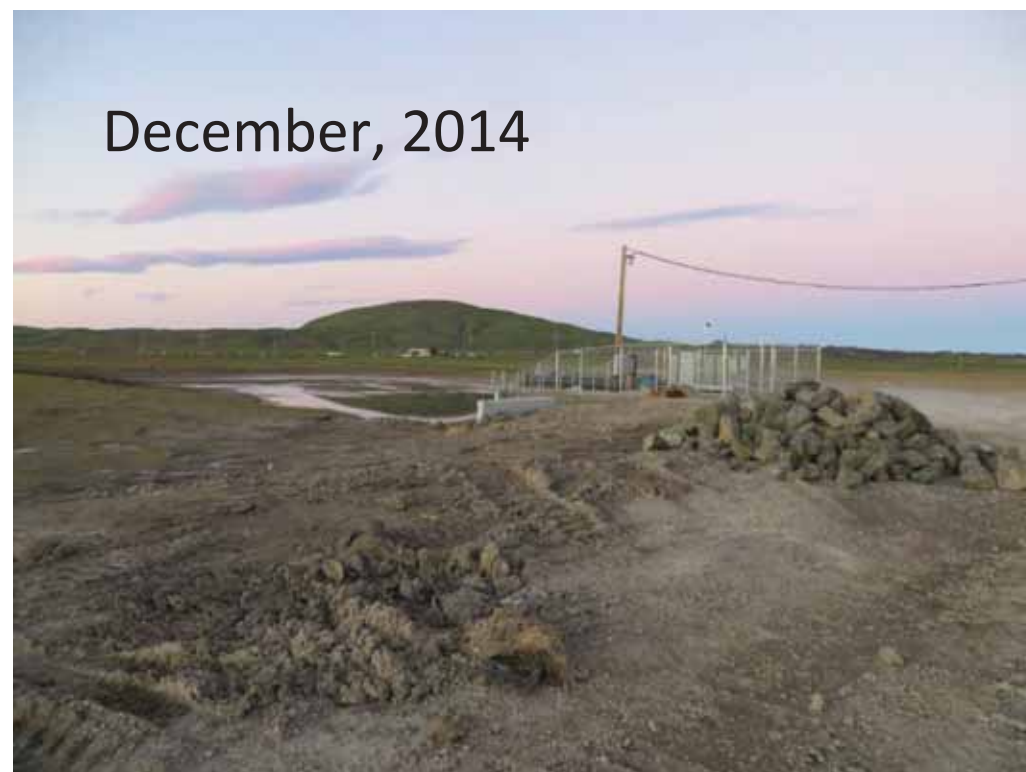
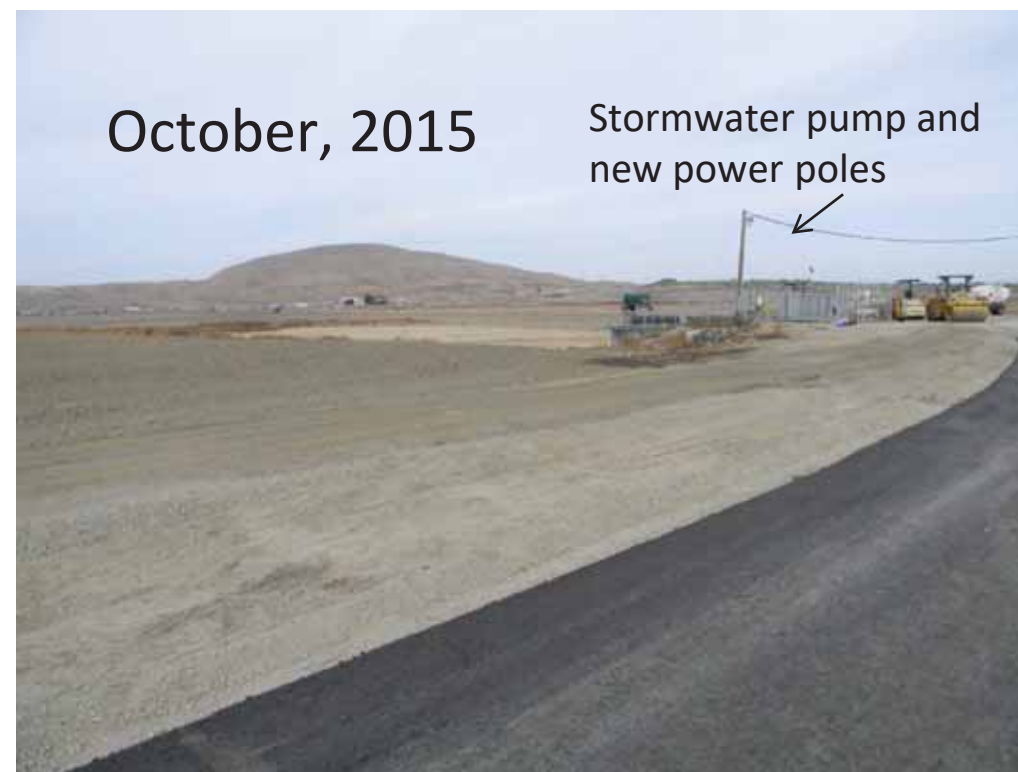
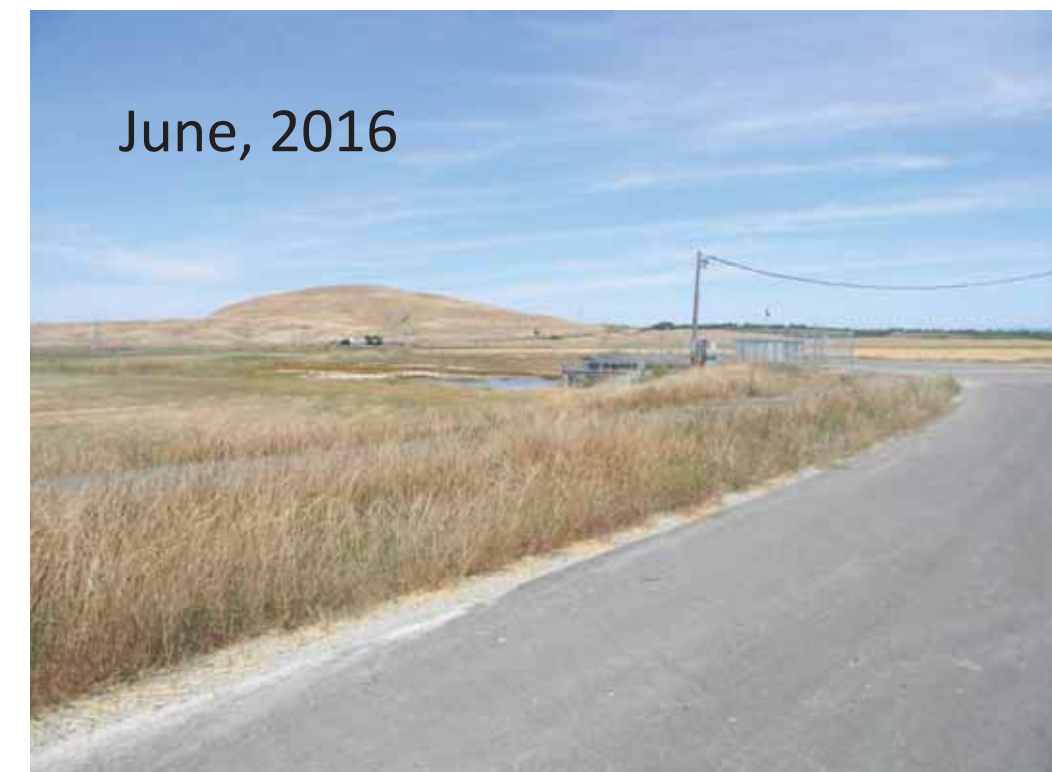
Photo Point Description: North of railroad crossing on Reclamation Road

Photo Description: View N toward Cougar Mountain. New road and stormwater pump will be in foreground
