Sears Point Tidal Marsh Restoration Project

Monitoring and Management Status Report

October 2015 to June 2017

Sears Point Tidal Marsh Restoration Project
Monitoring and Management Status Report, Year 1
October 2015 to June 2017

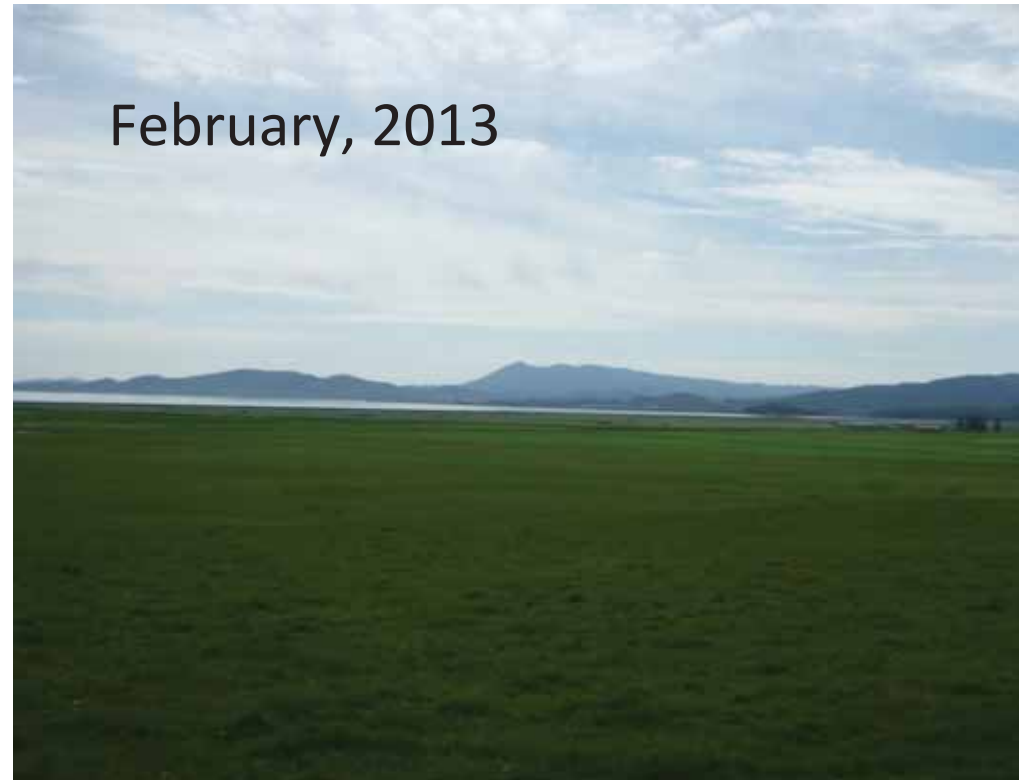
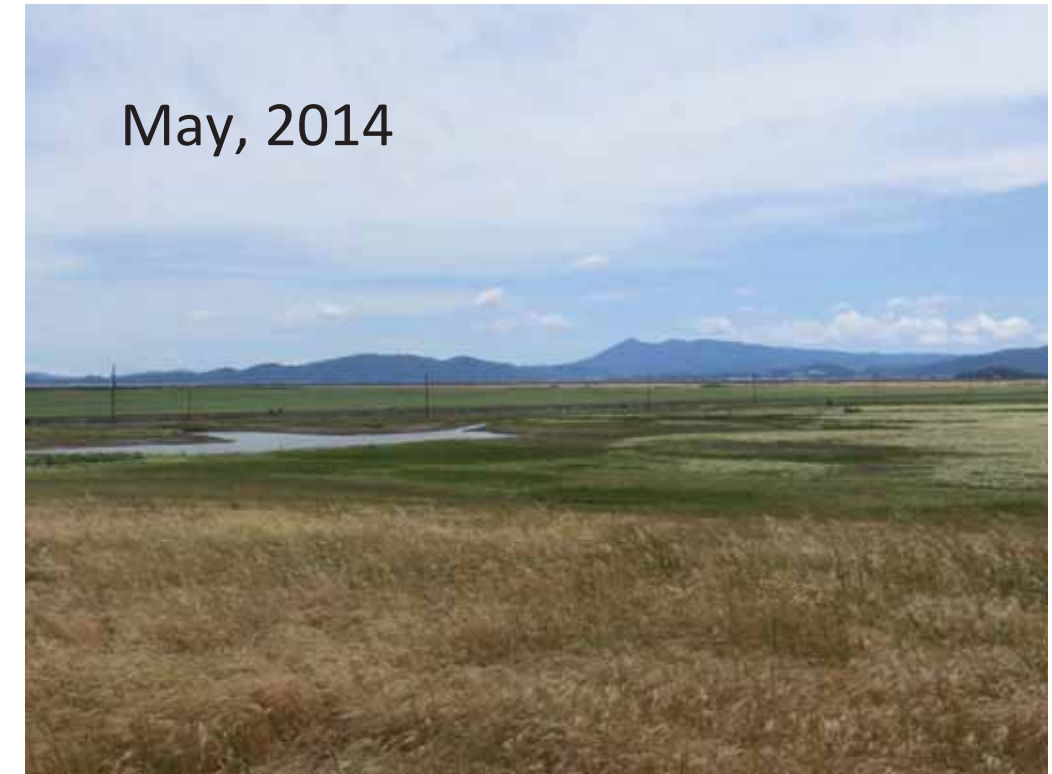
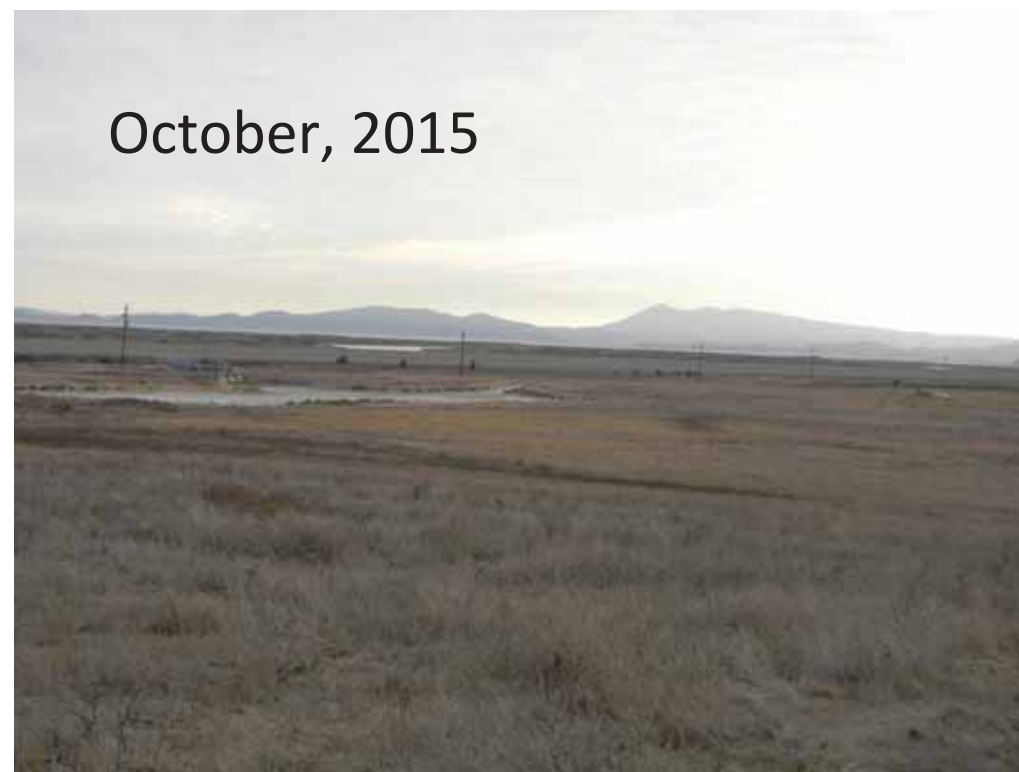
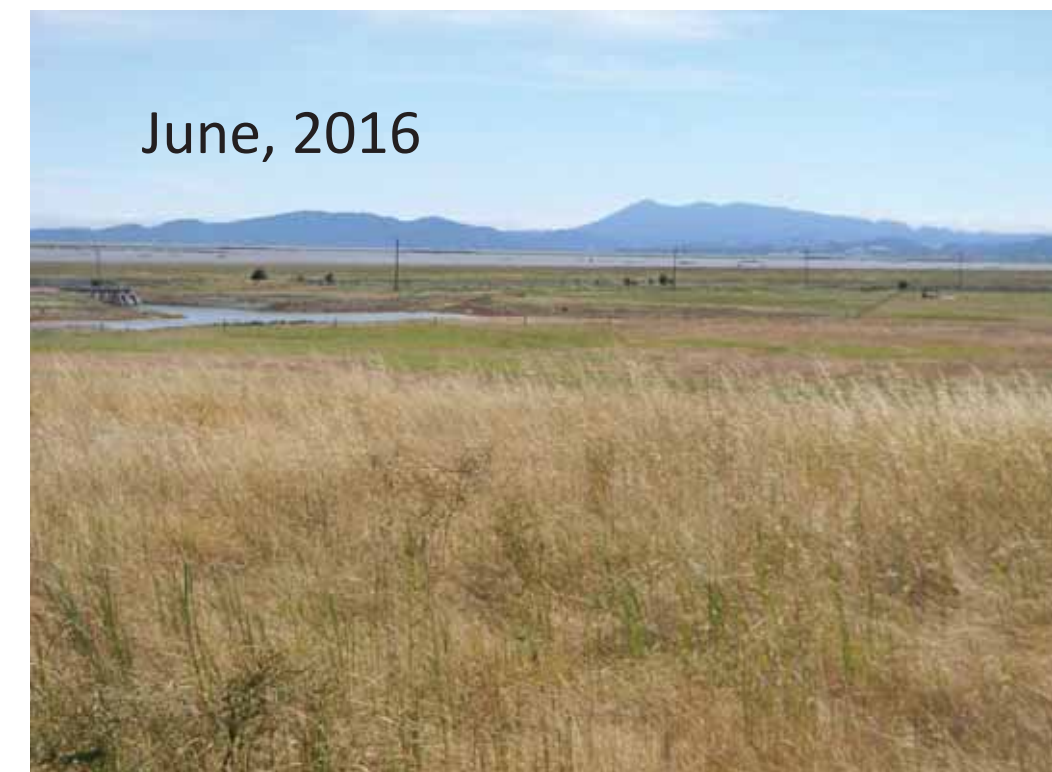
Photo Point 8, Photo 8.1
N 38.13892, W 122.45336
Bearing 206°

Photo Description: View toward Mt. Tam and San Pablo Bay with future tidal restoration area in mid-ground. Note detention pond for stormwater pump built in foreground

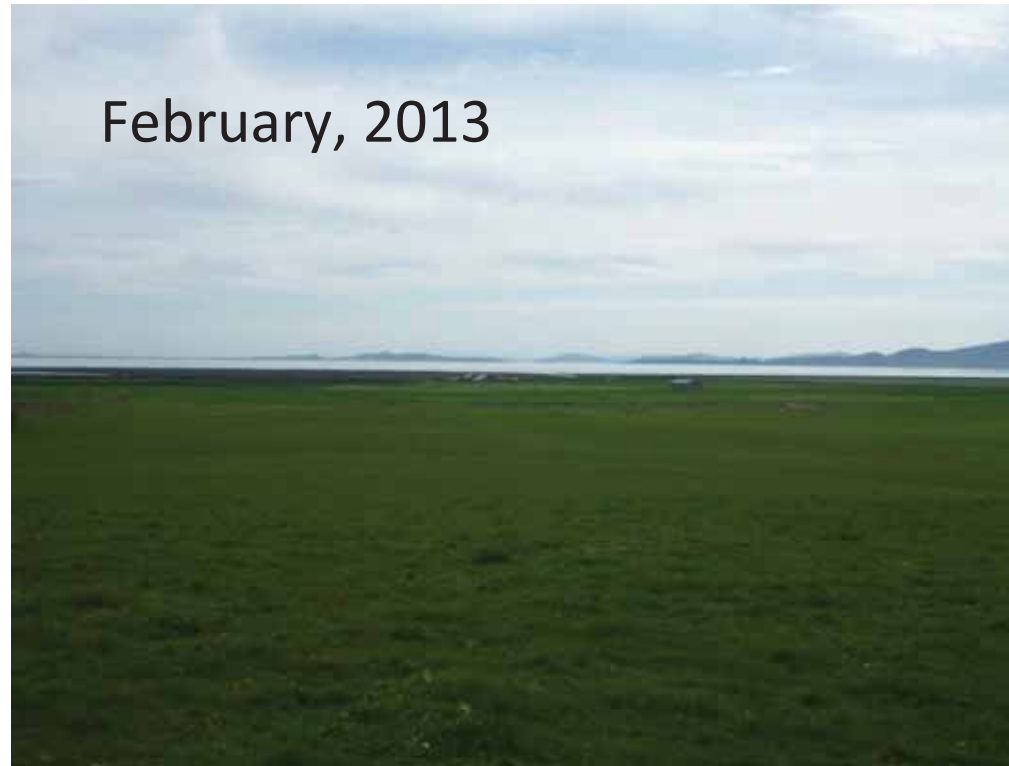
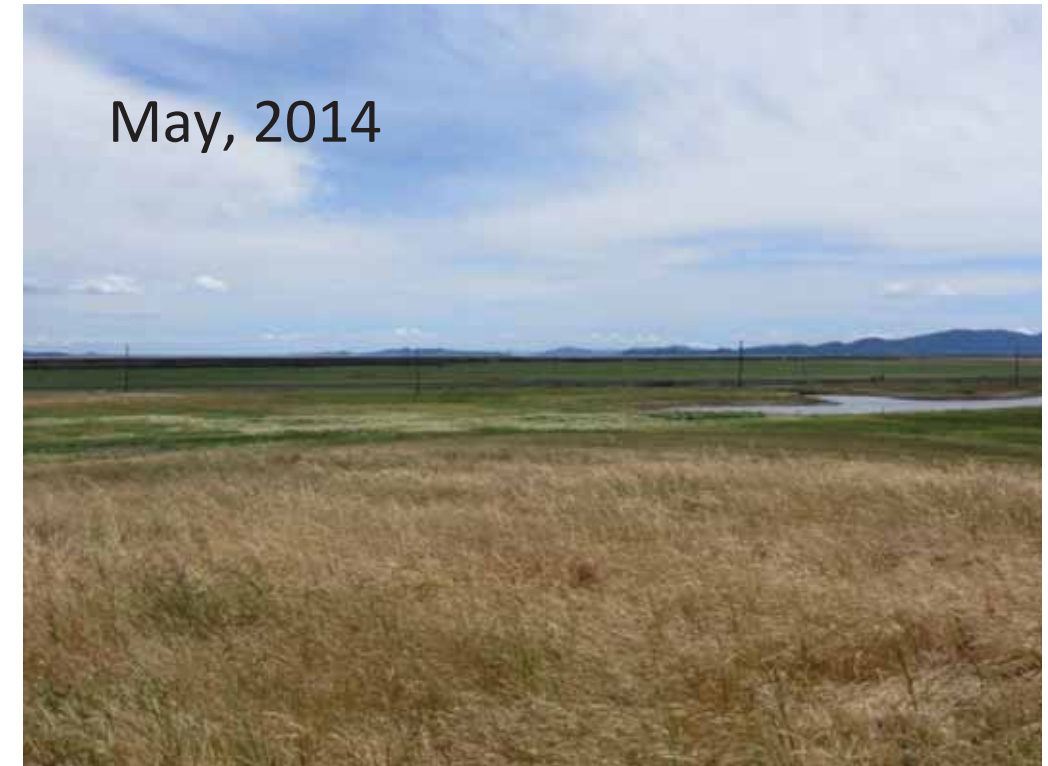
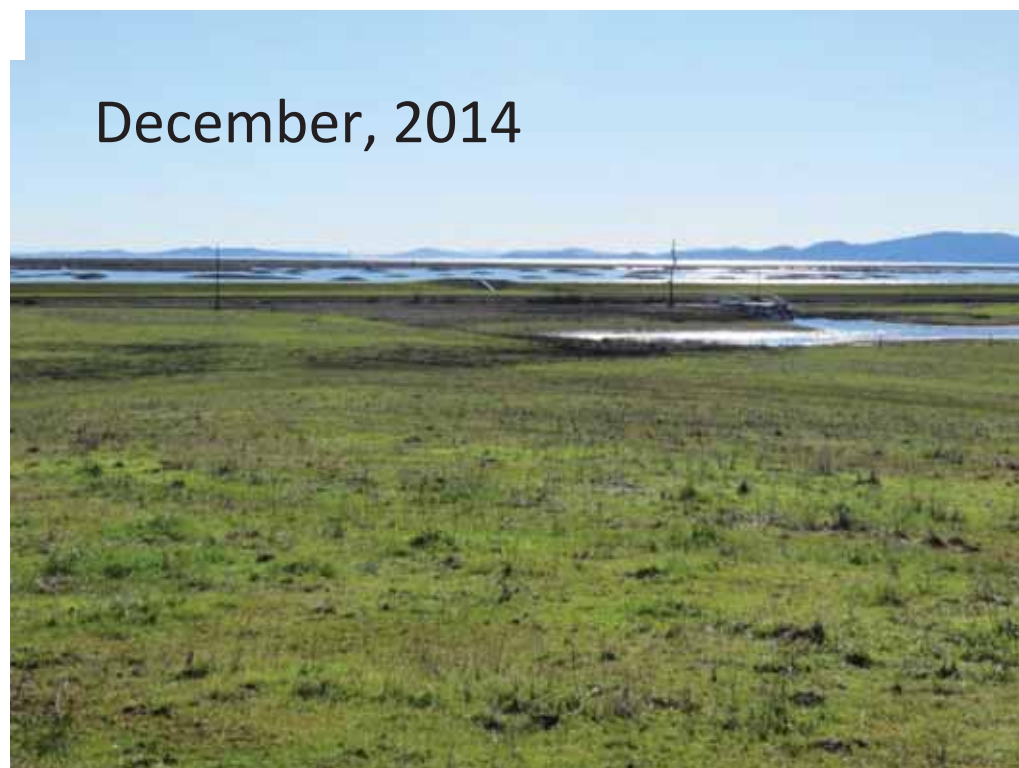
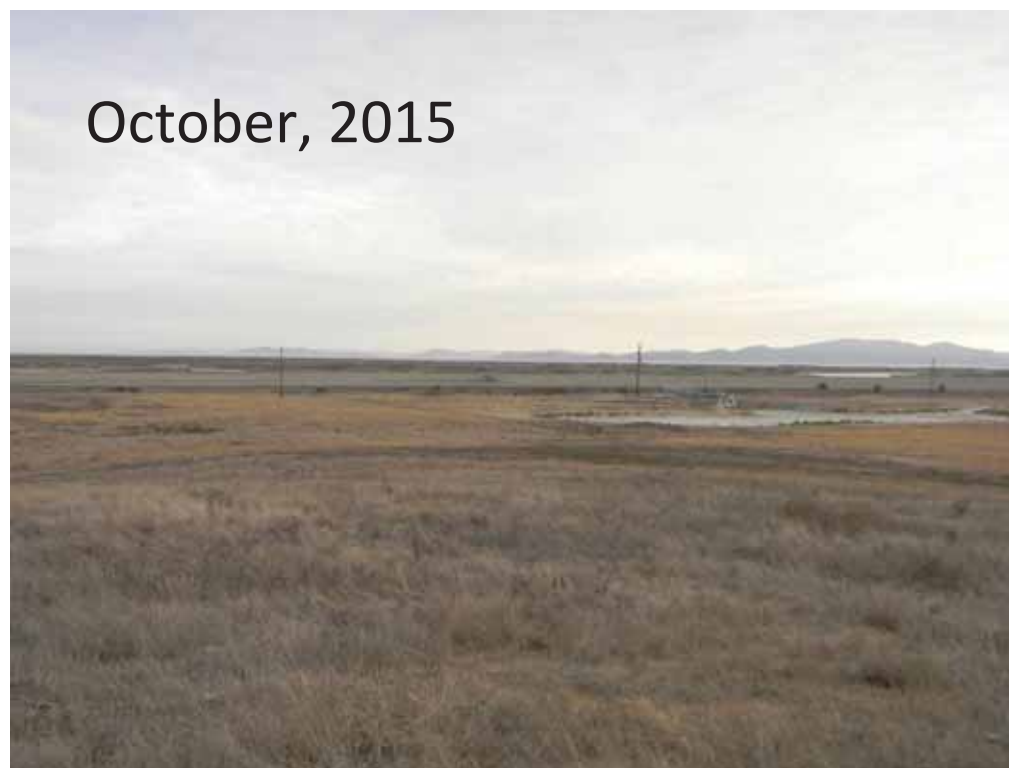
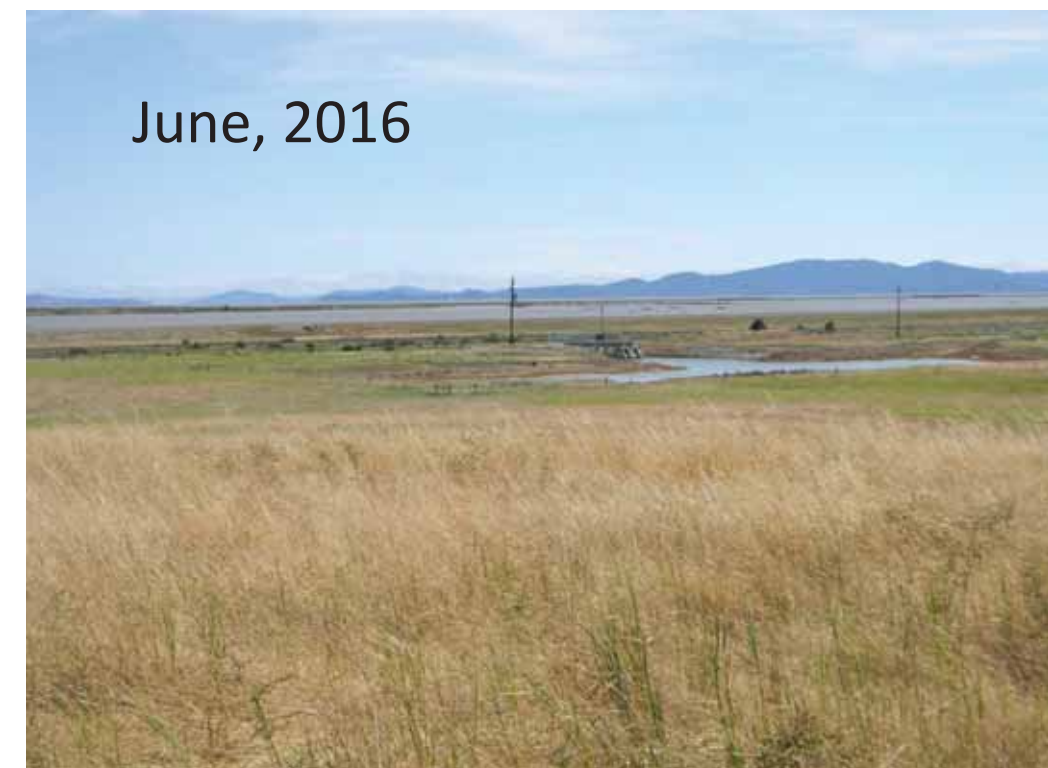
Photo Point 8, Photo 8.2
N 38.13892, W 122.45336
Bearing 175°

Photo Description: View toward San Francisco and San Pablo Bay with Dickson Ranch buildings and future tidal area in mid-ground. Note detention pond for stormwater pump built in foreground

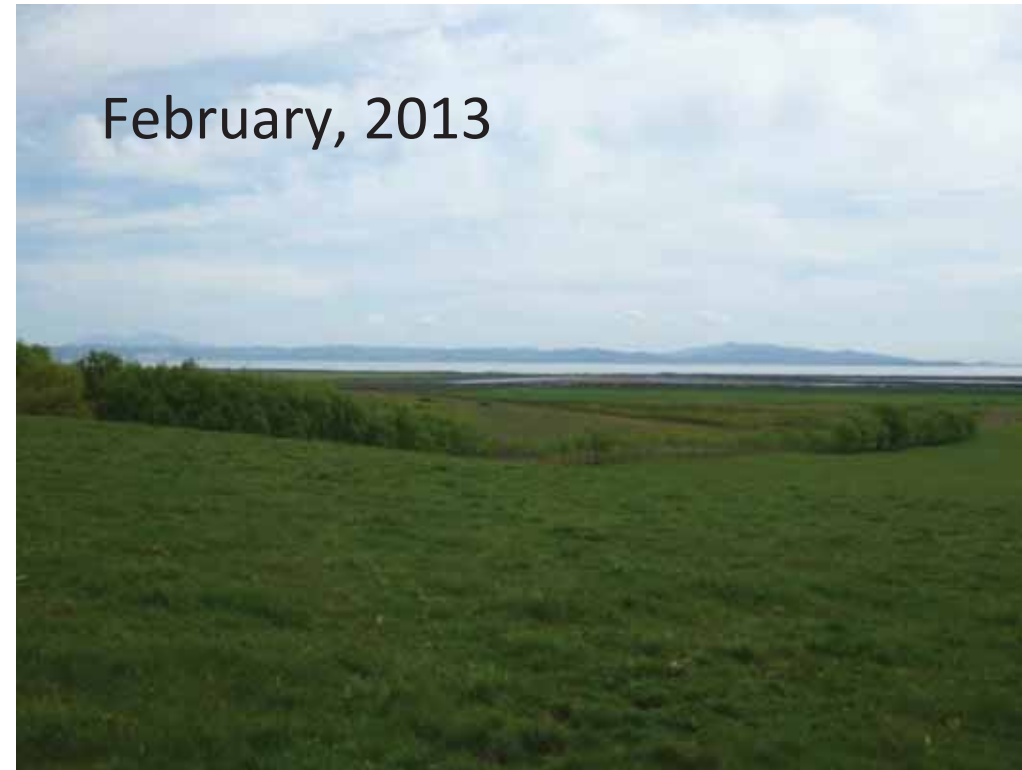
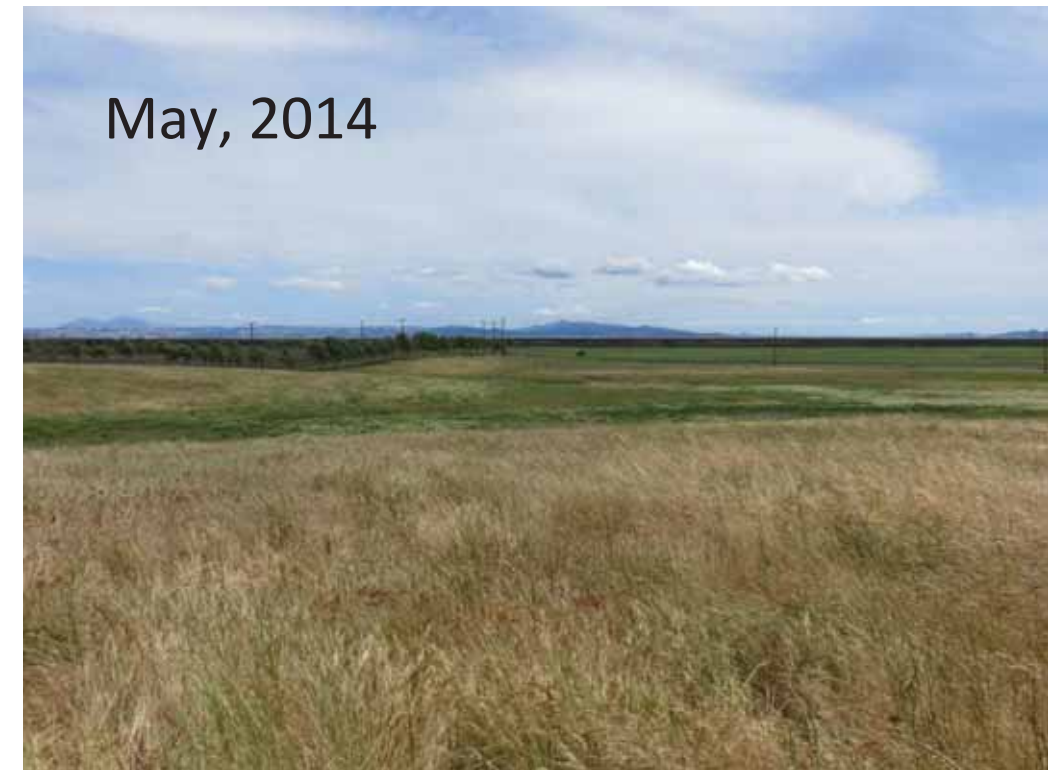
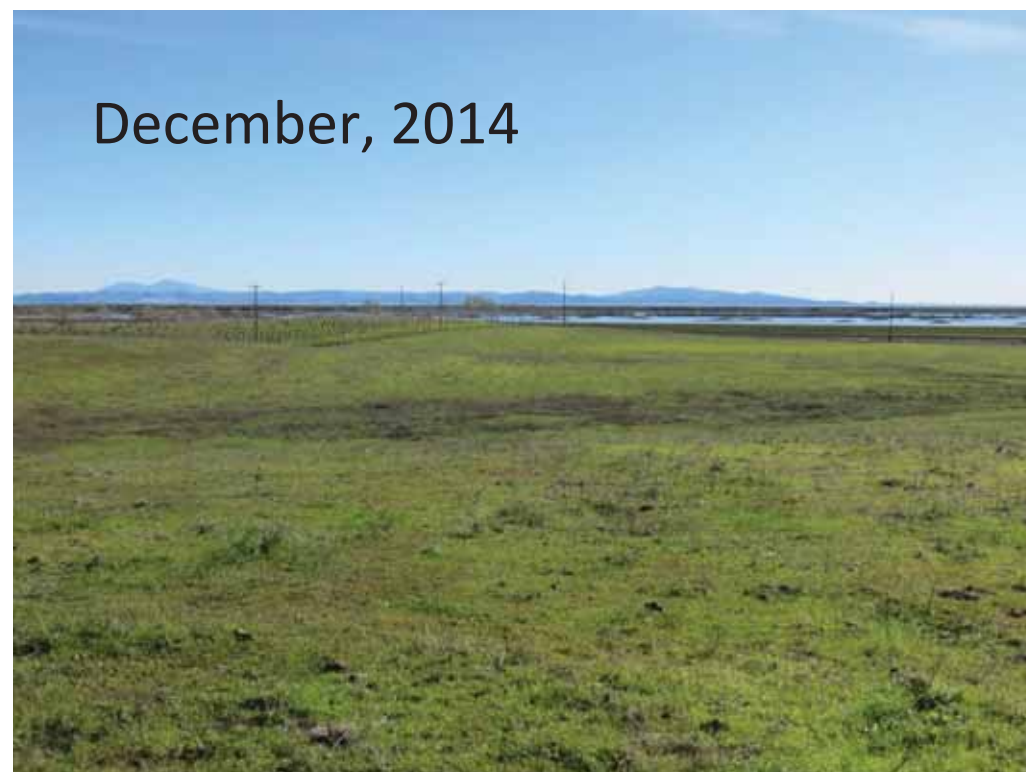
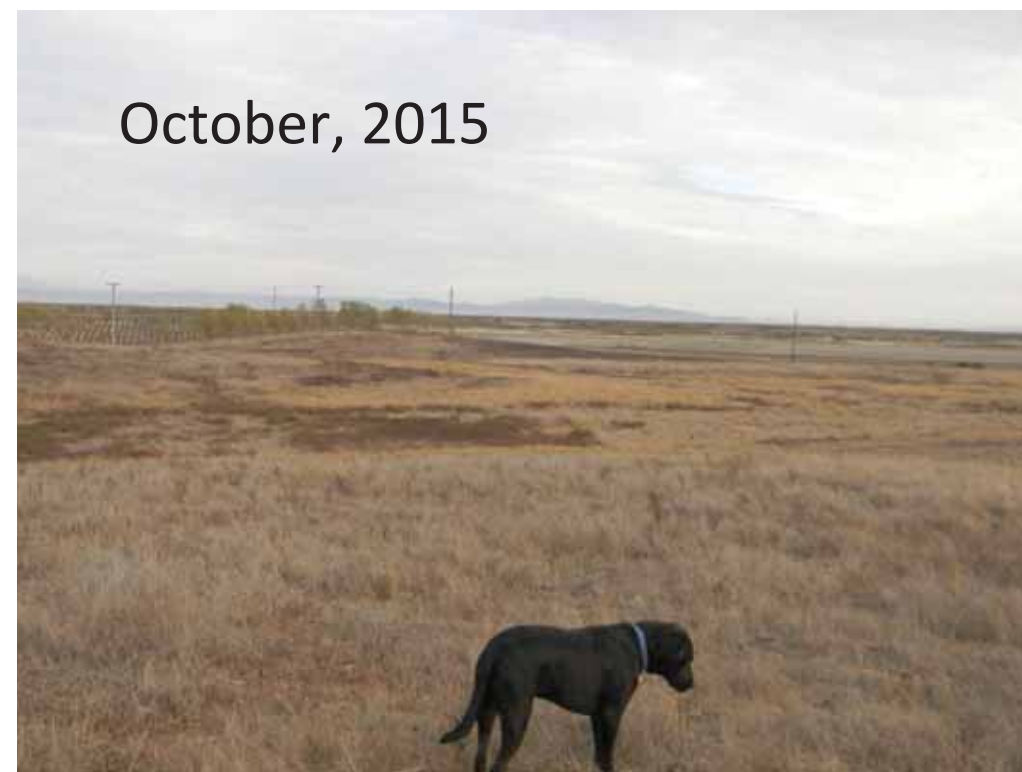
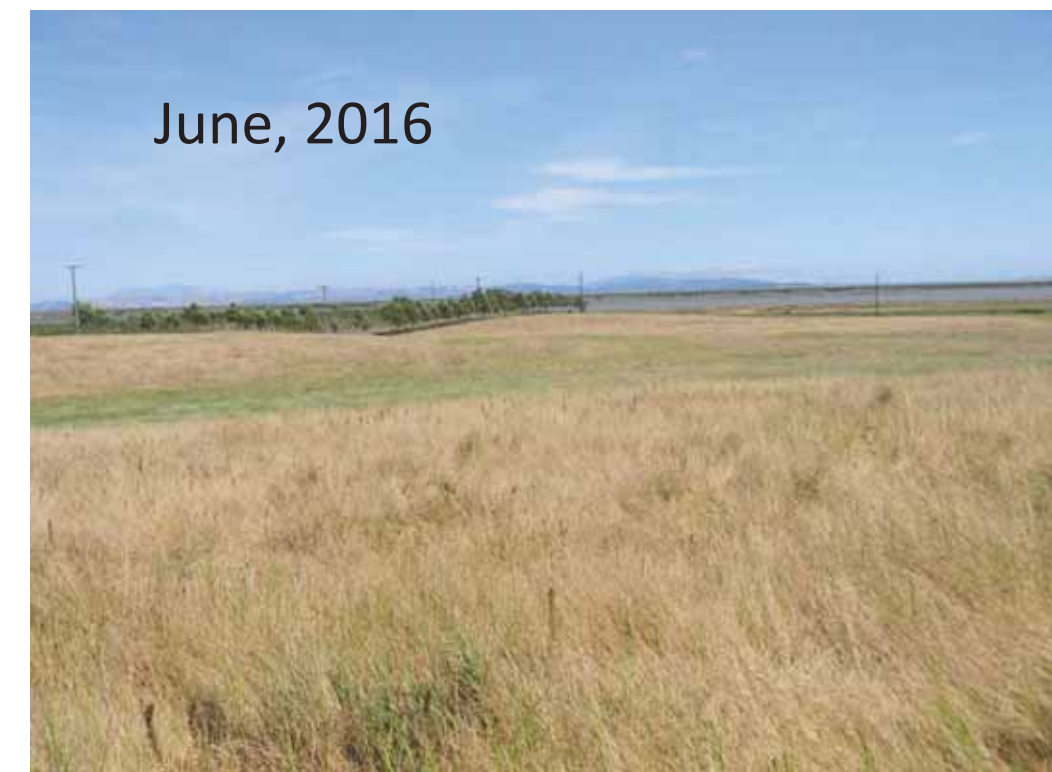
Photo Point 8, Photo 8.3
N 38.13892, W 122.45336
Bearing 140°

Photo Description: View toward Mt. Diablo and San Pablo Bay with vineyard in foreground and future tidal area in mid-ground

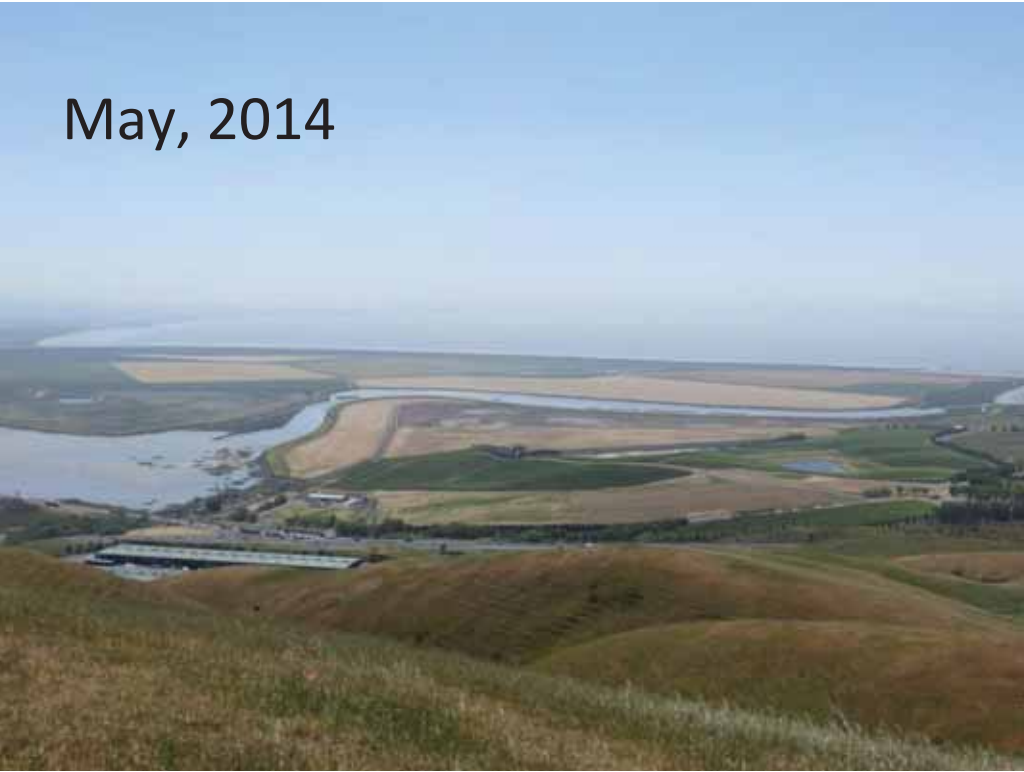
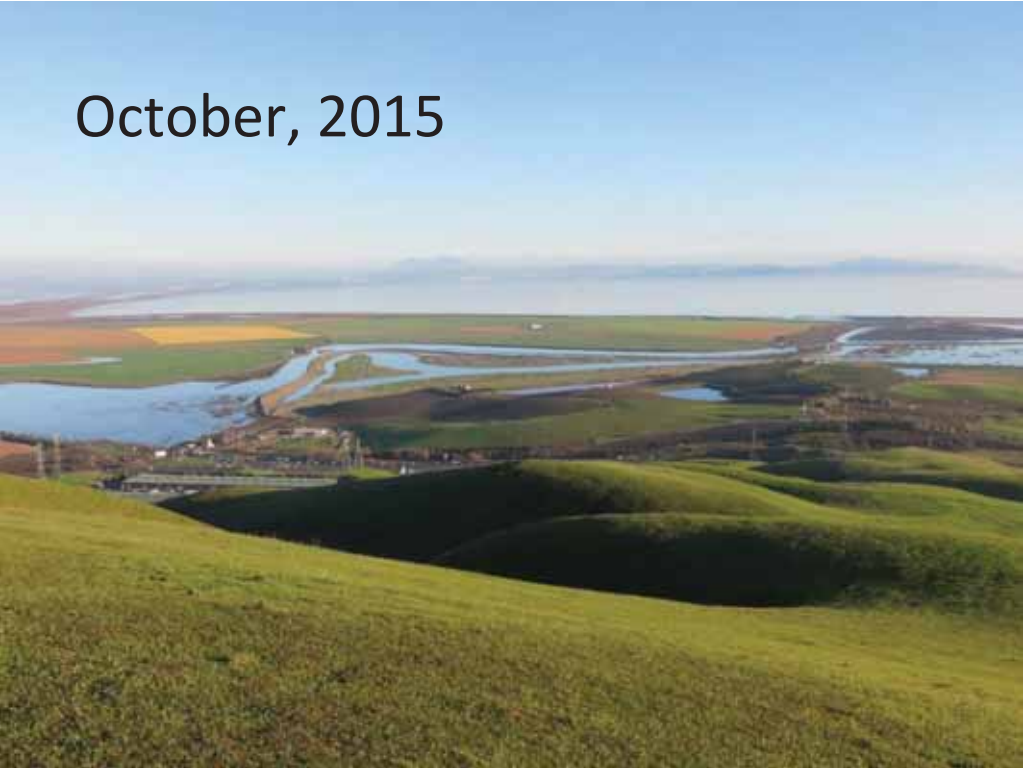
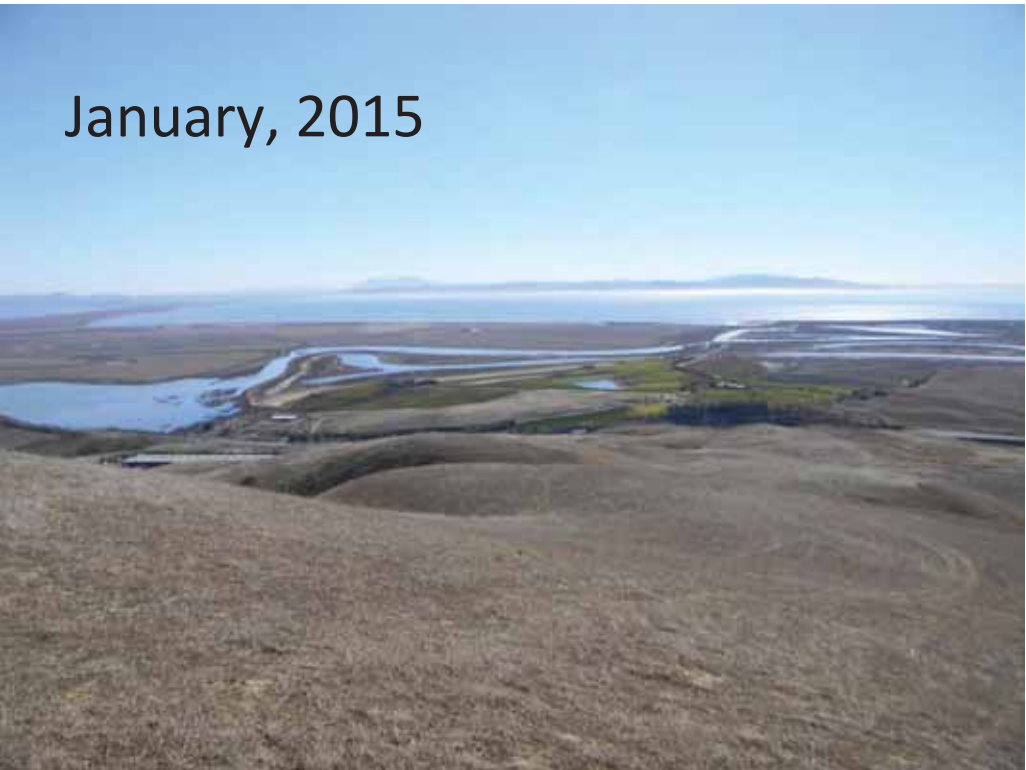
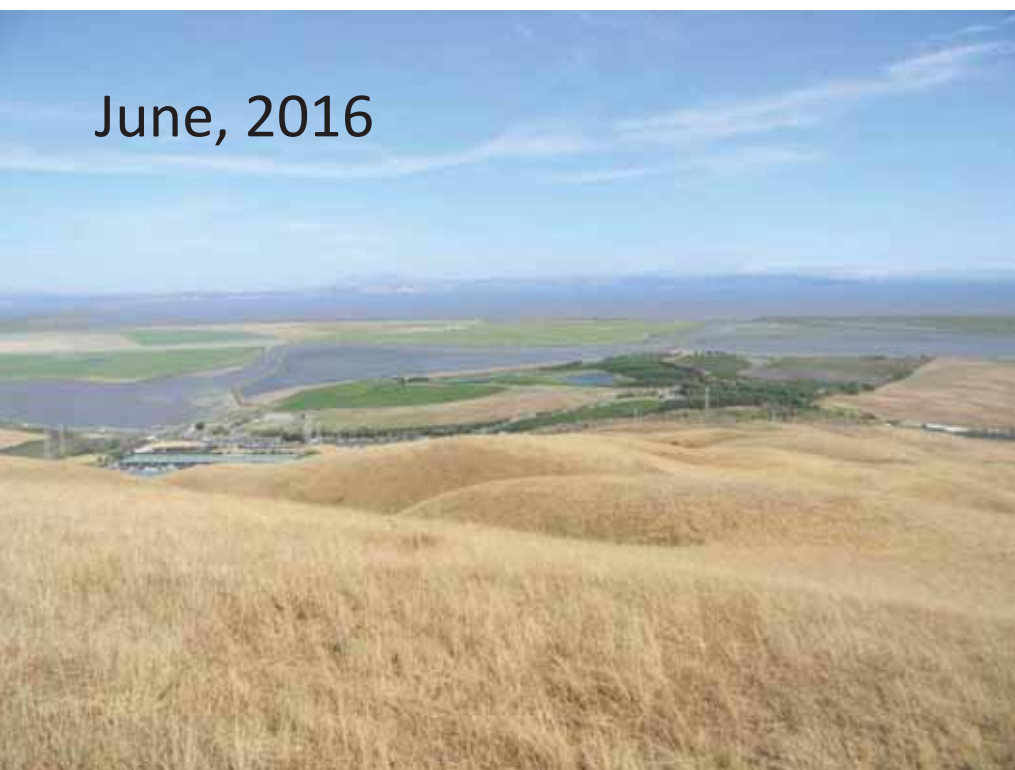
Photo Point 10, Photo 10.1

Photo Description: View ESE toward the head of Tolay Creek (tidal portion) and the eastern portion of the tidal restoration area.

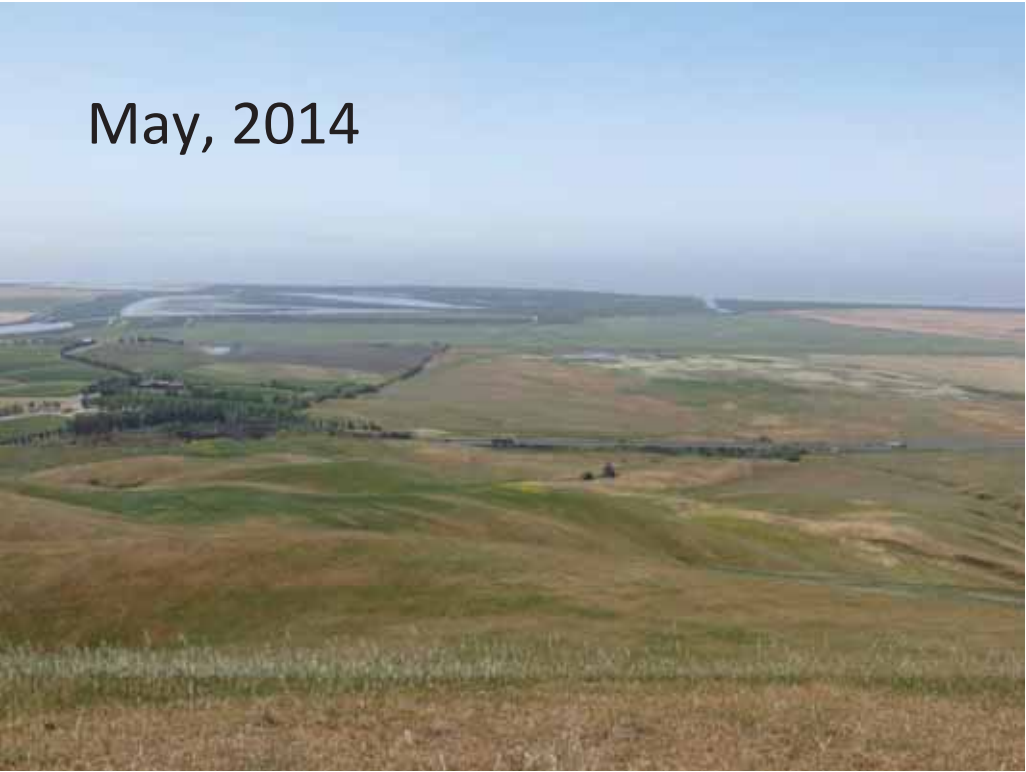
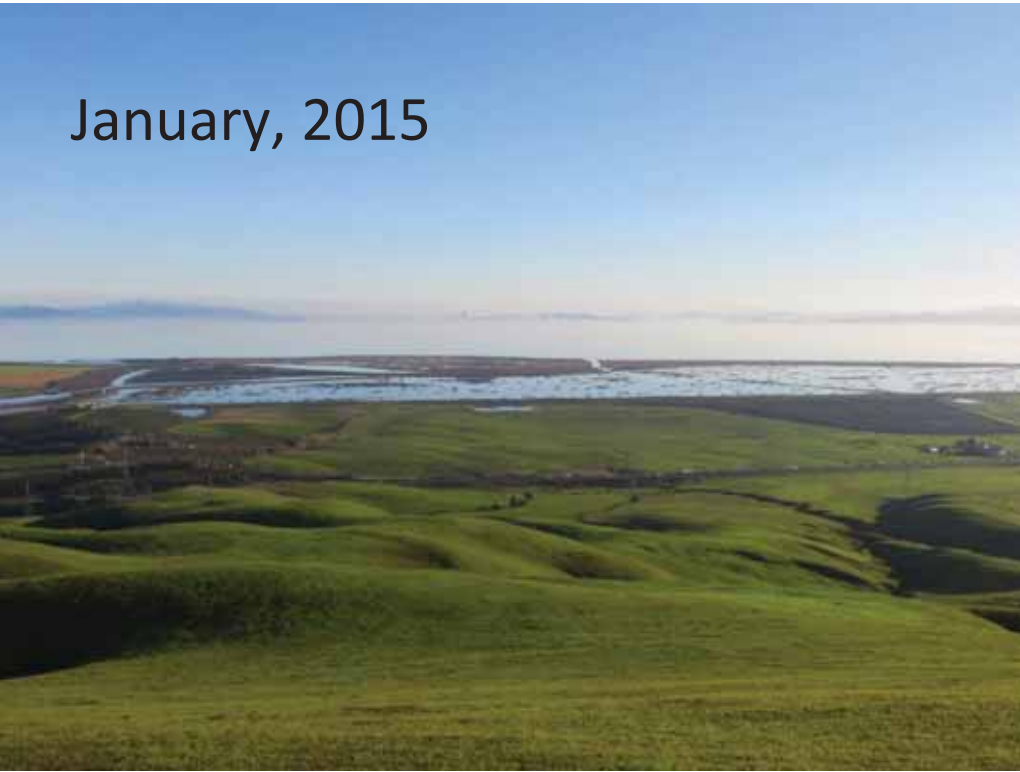
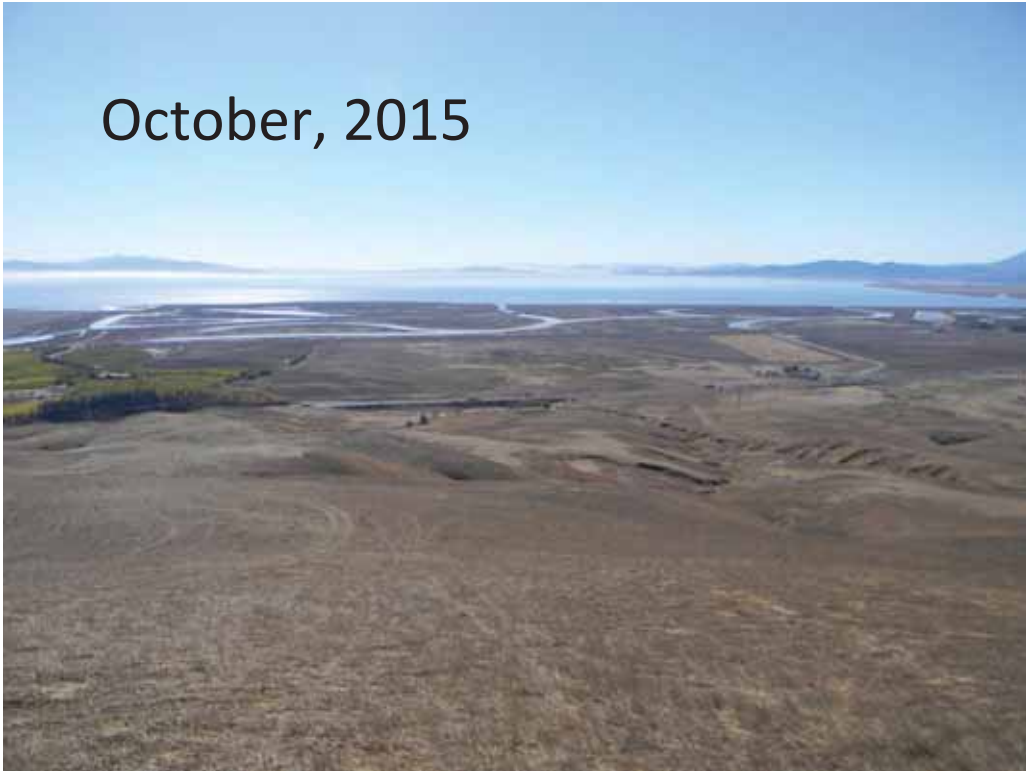
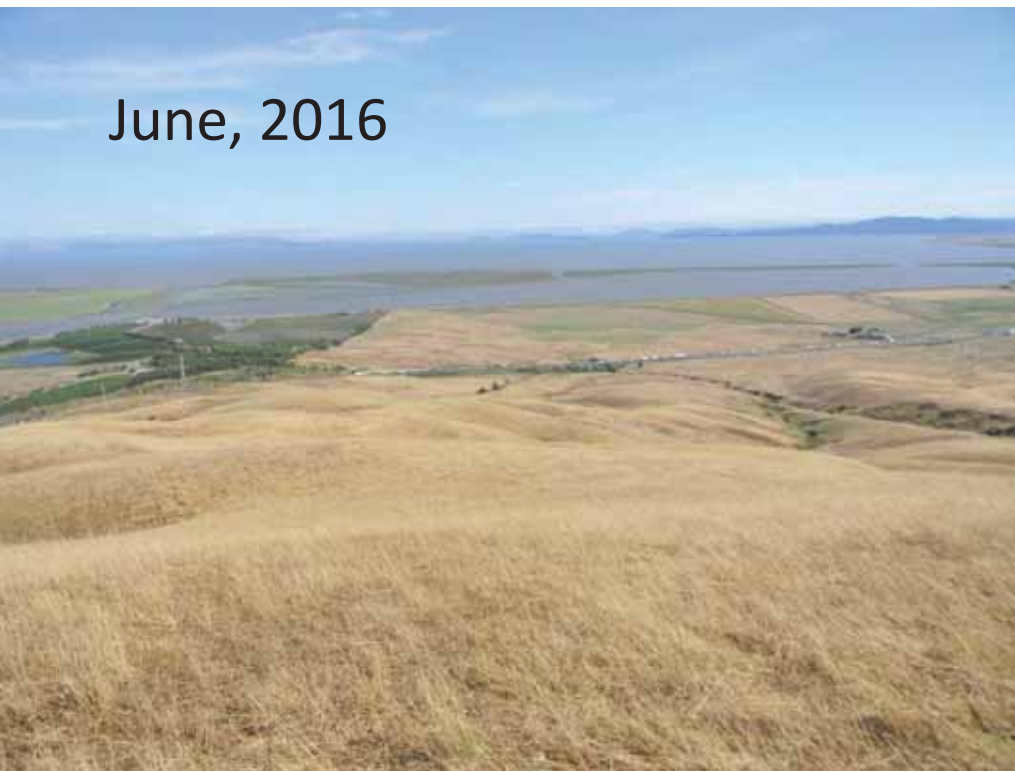
Photo Point 10, Photo 10.2

Photo Description: View SE of middle portion of tidal restoration area with riparian enhancement area and stormwater pond 2 visible in mid-ground of photo

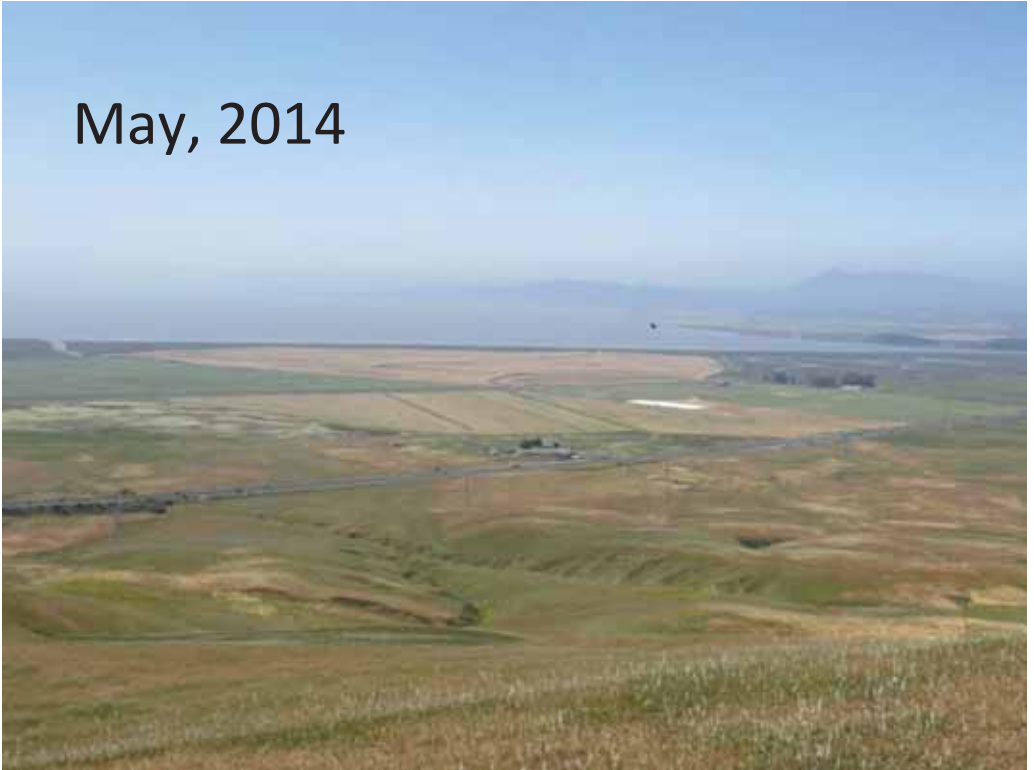
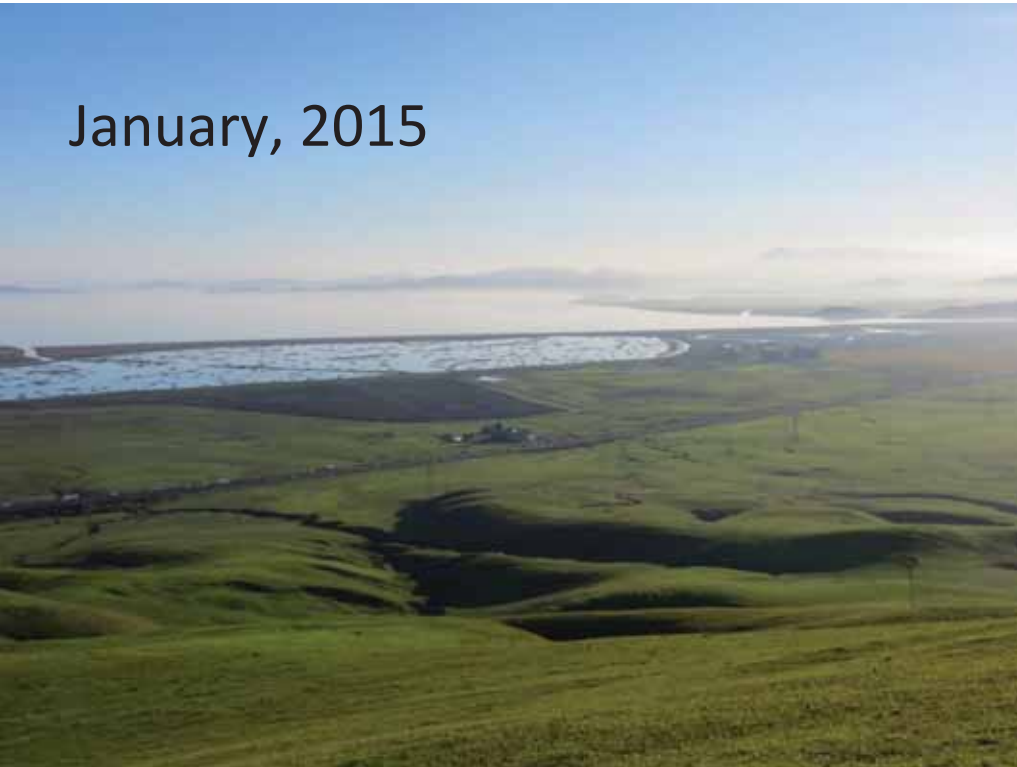
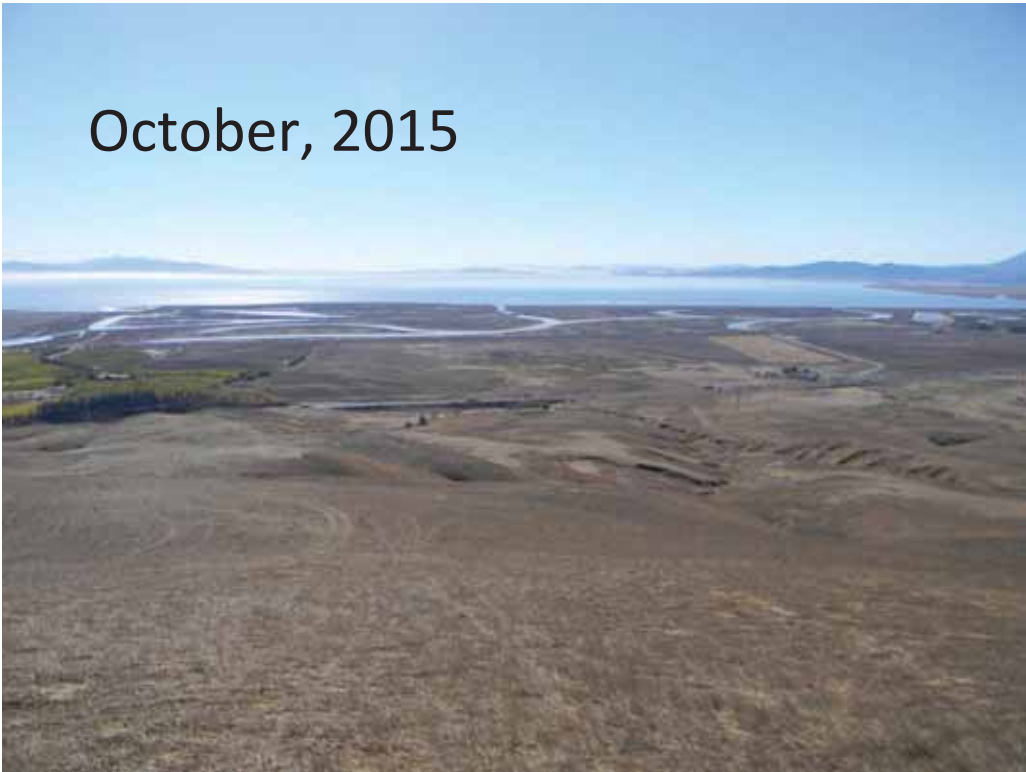
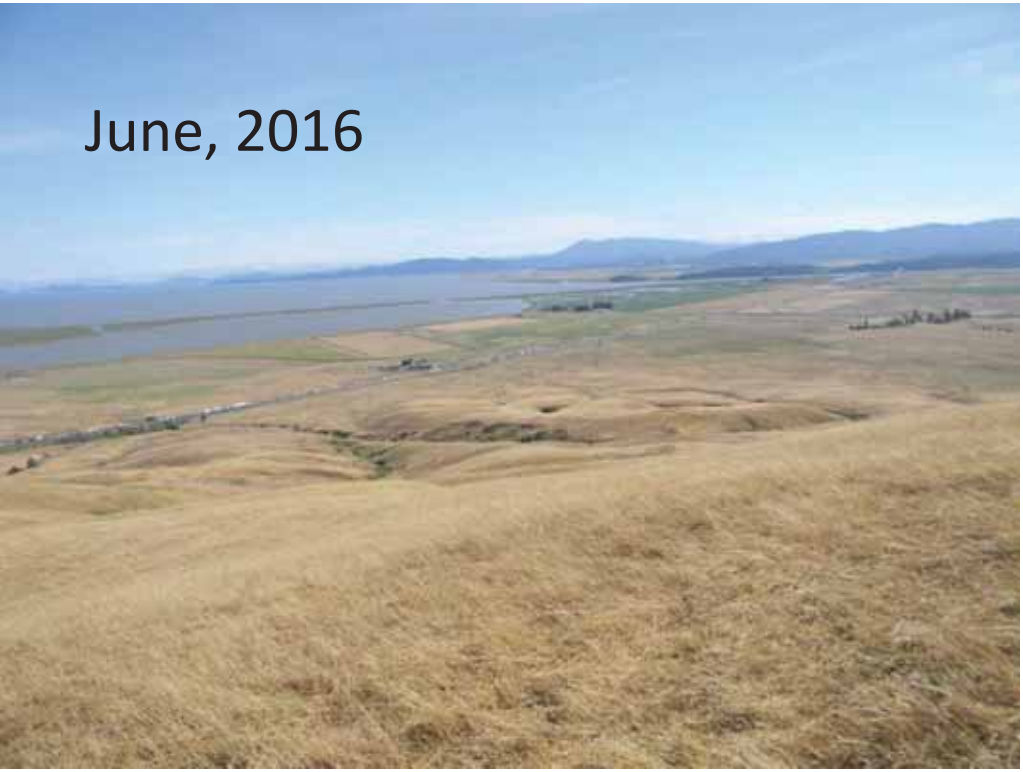
Photo Point 10, Photo 10.3

Photo Description: View SW over Refuge headquarters, stormwater pond 1 and western portion of tidal restoration area. Mt Tam in background.
