Sears Point Tidal Marsh Restoration Project

Monitoring and Management Status Report

October 2015 to June 2017

Sears Point Tidal Marsh Restoration Project
Monitoring and Management Status Report, Year 1
October 2015 to June 2017

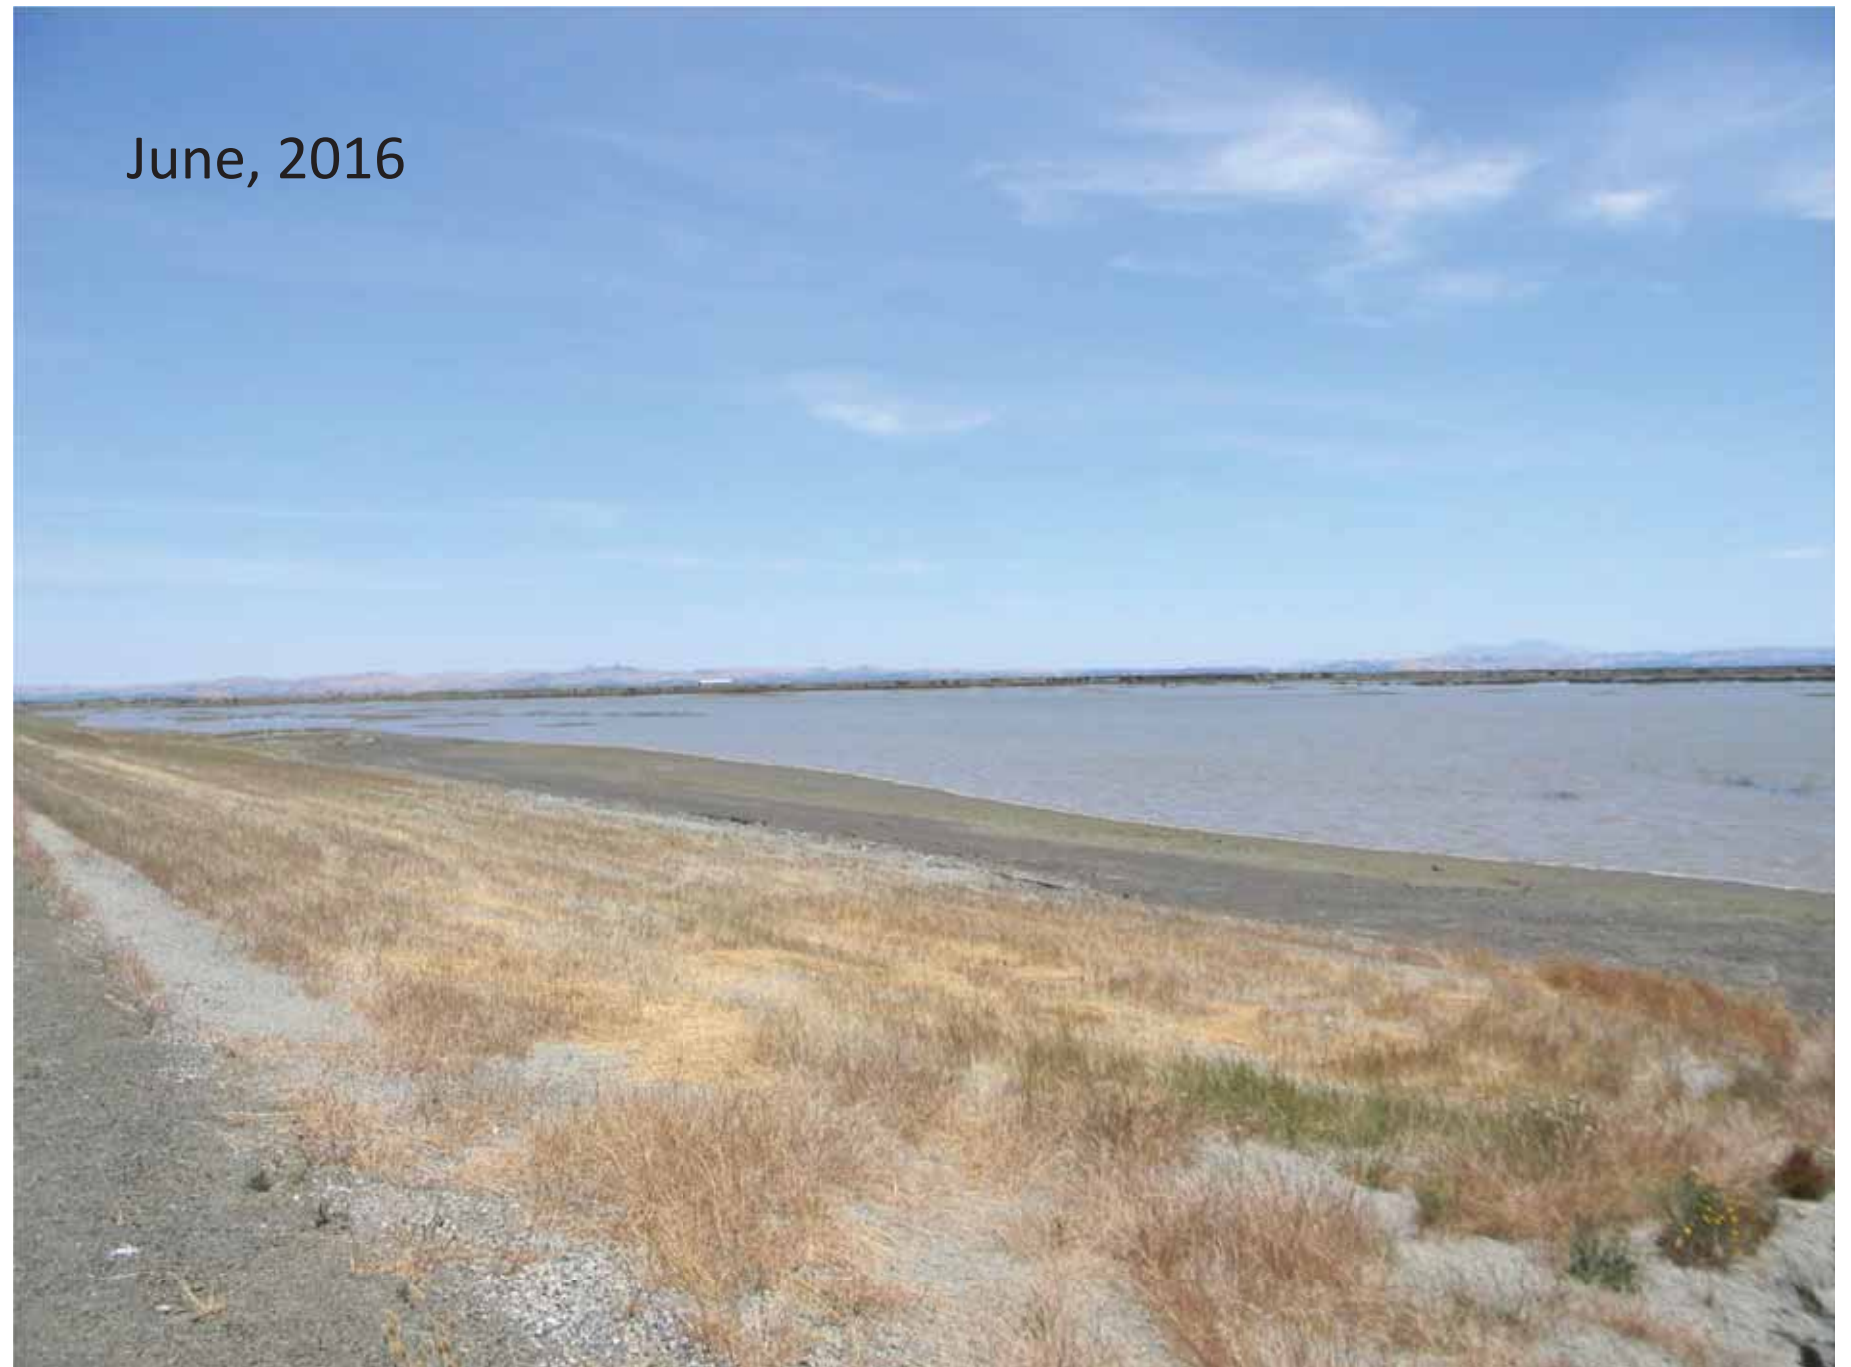
Photo Description: View E of habitat levee slope and restoration area. Low tide during original photo shows exposed mudflat

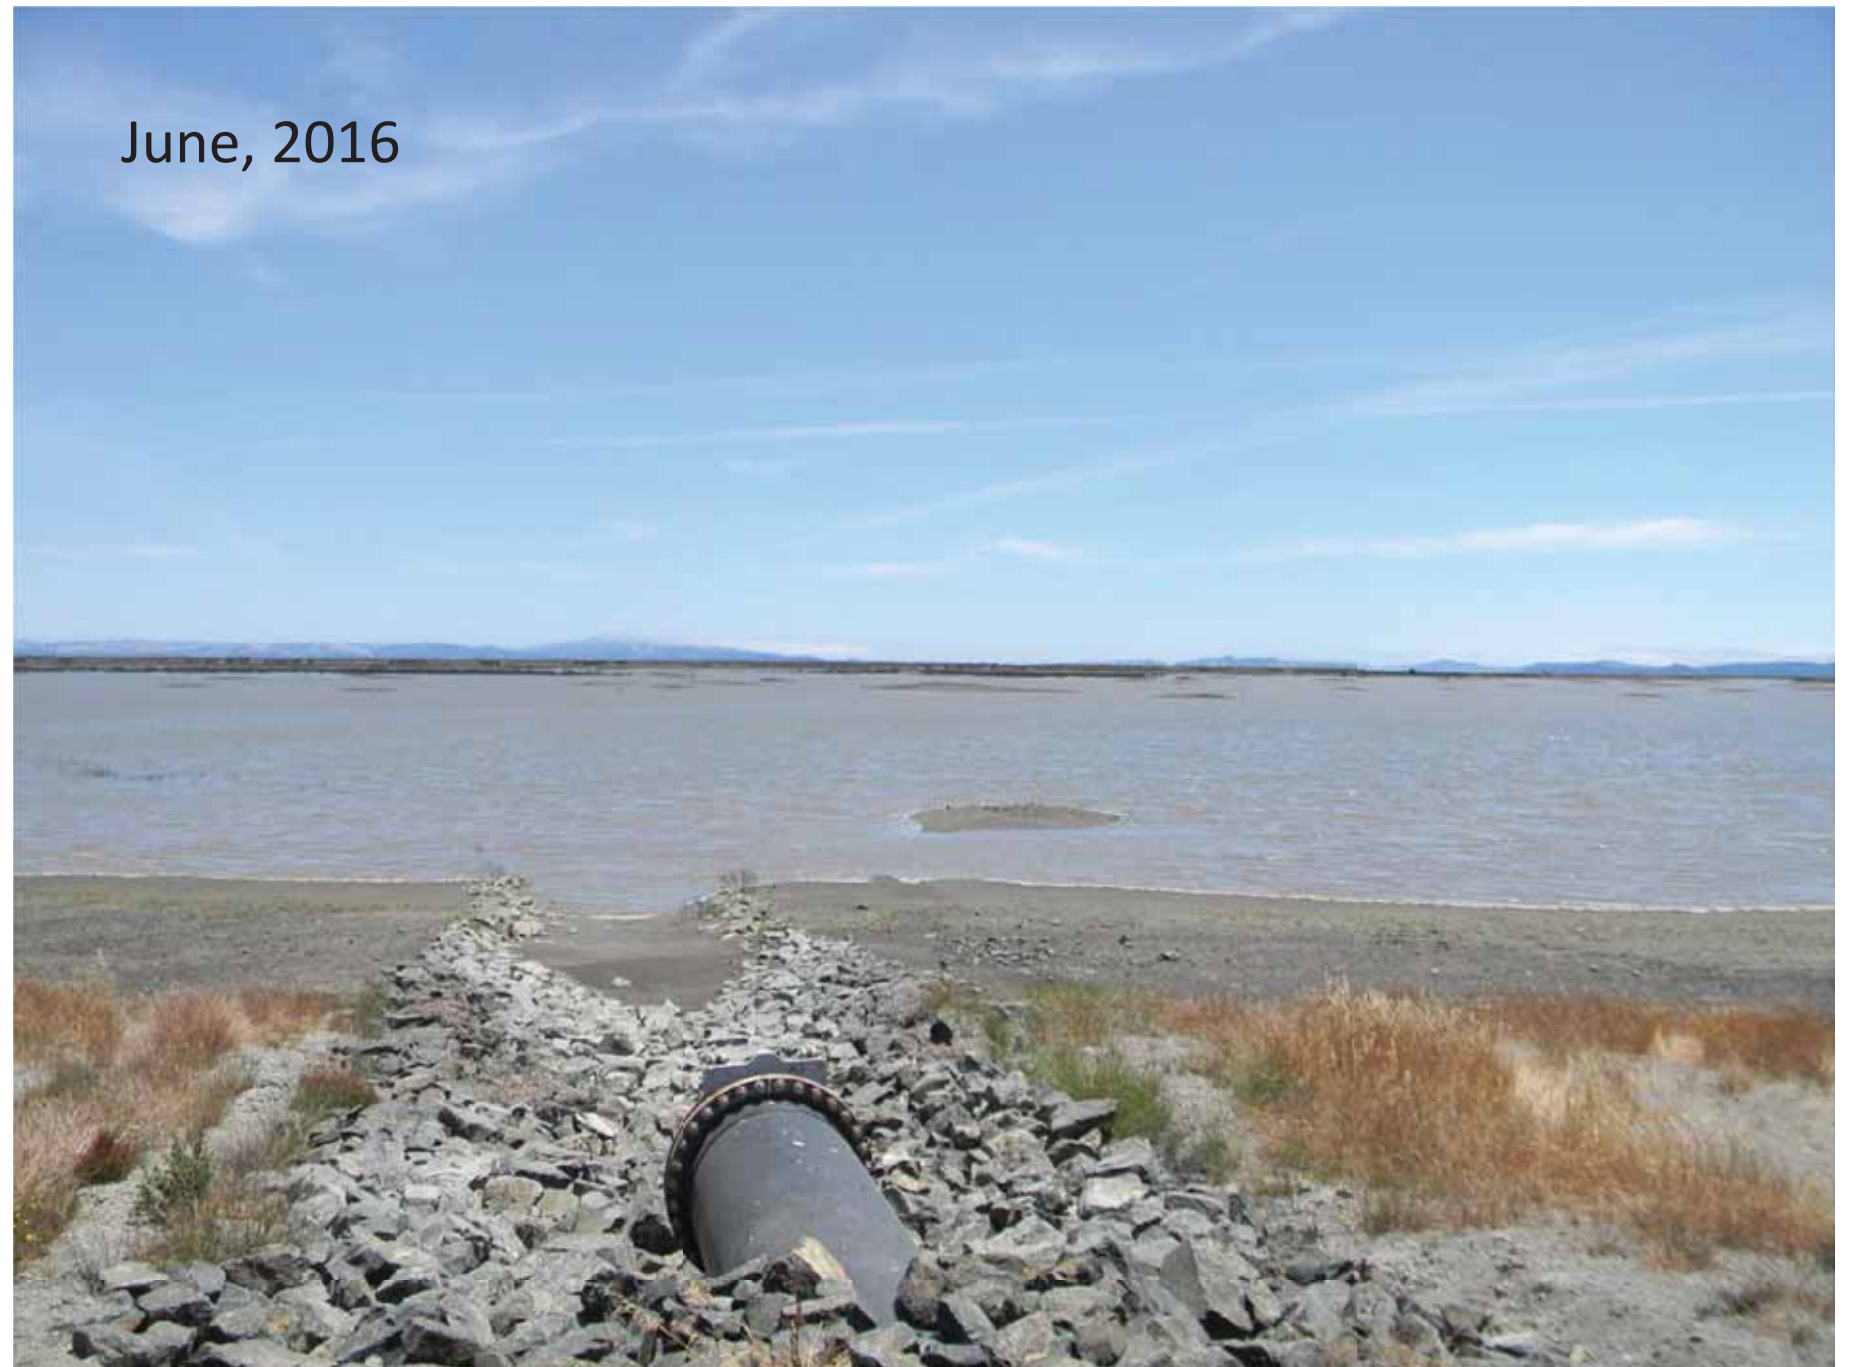
Photo Point 13, Photo 13.2

Photo Description: View ESE over pump 2 outlet and restoration area. Low tide during original photo shows exposed mudflat

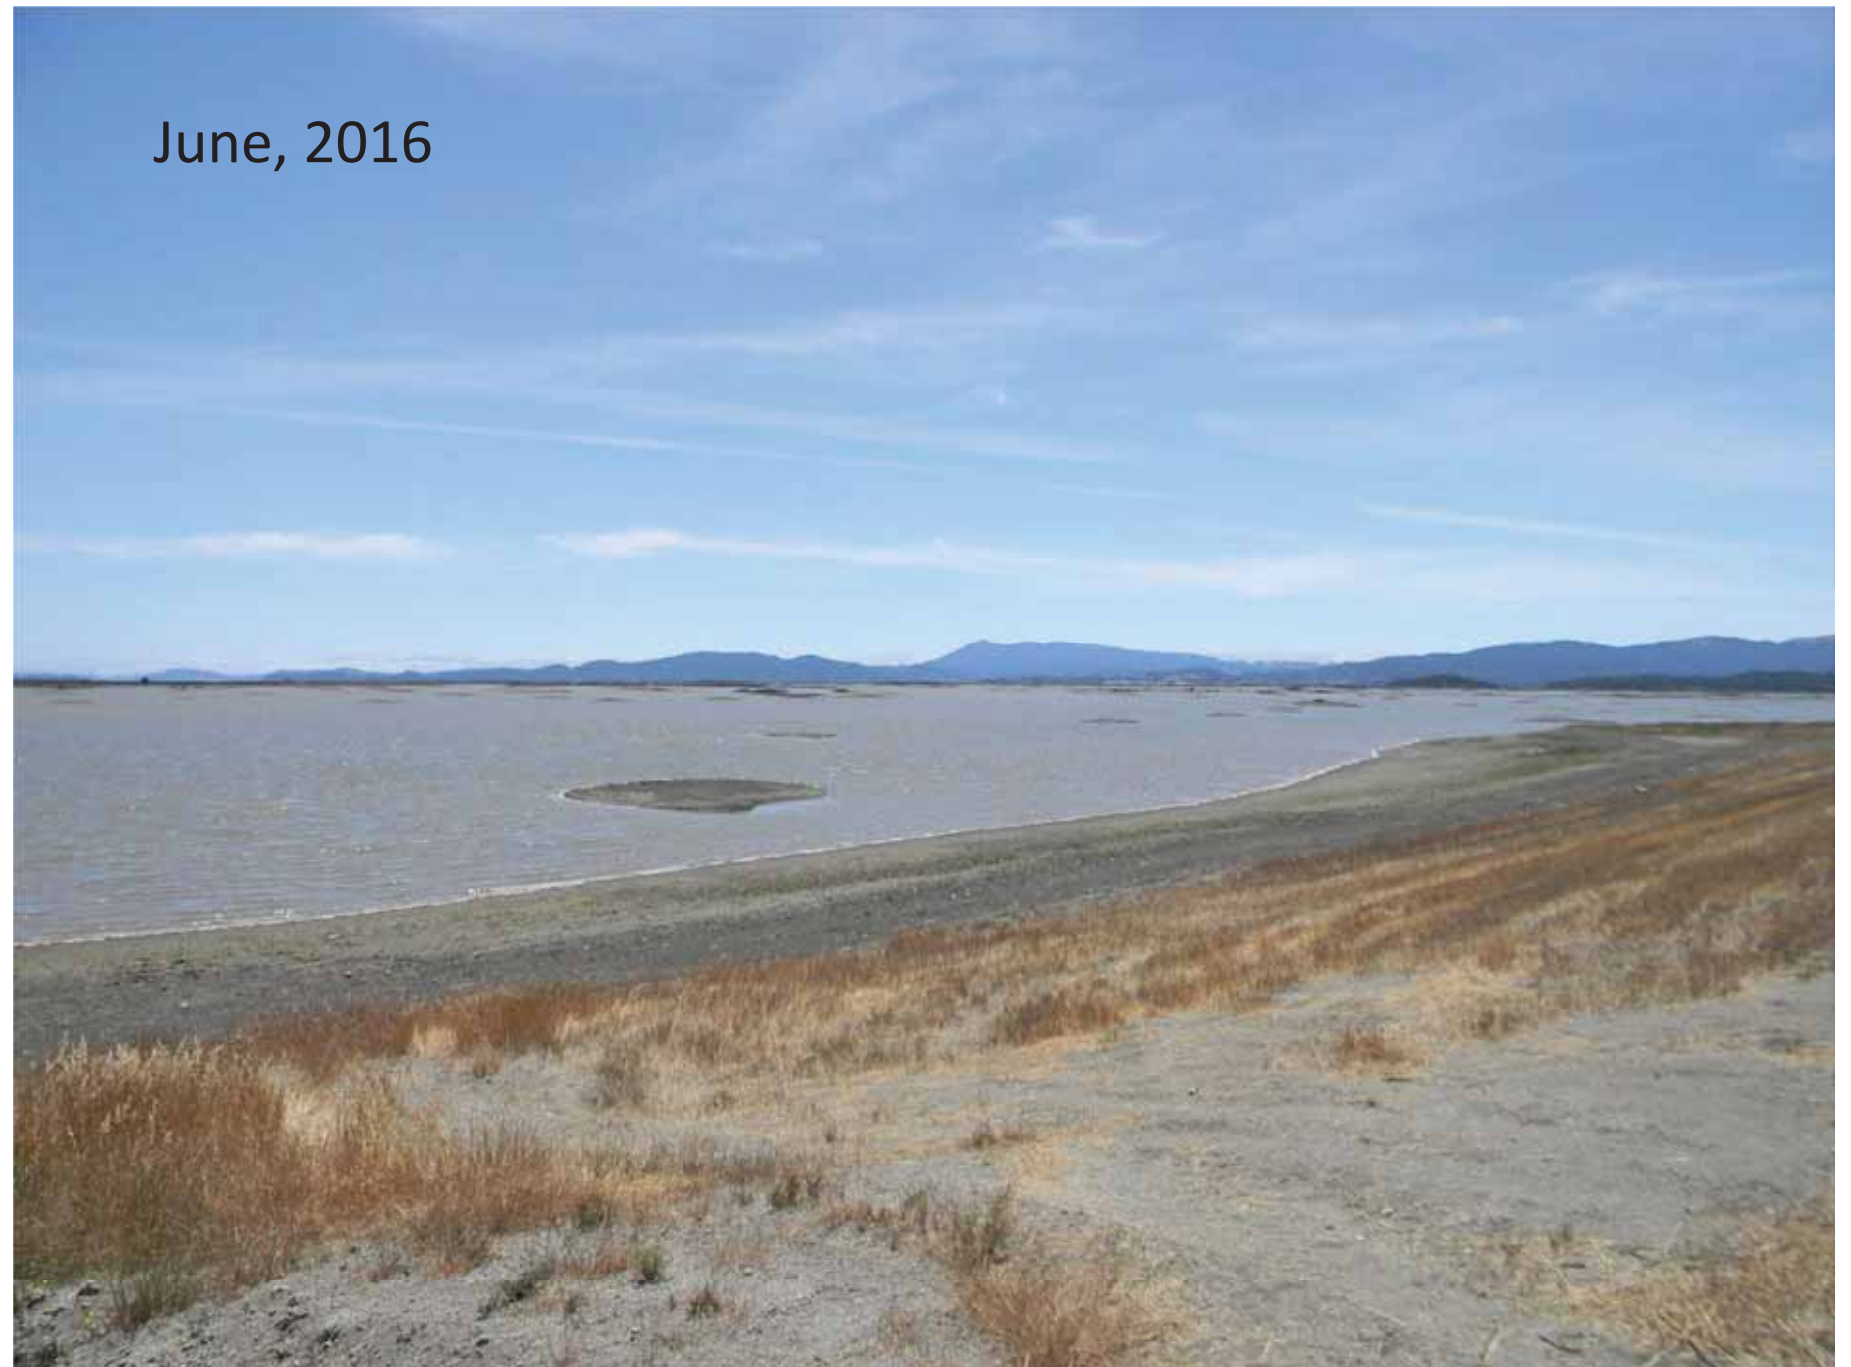
Photo Point 13, Photo 13.3

Photo Description: View SW over habitat levee and restoration area. Low tide during original photo shows exposed mudflat

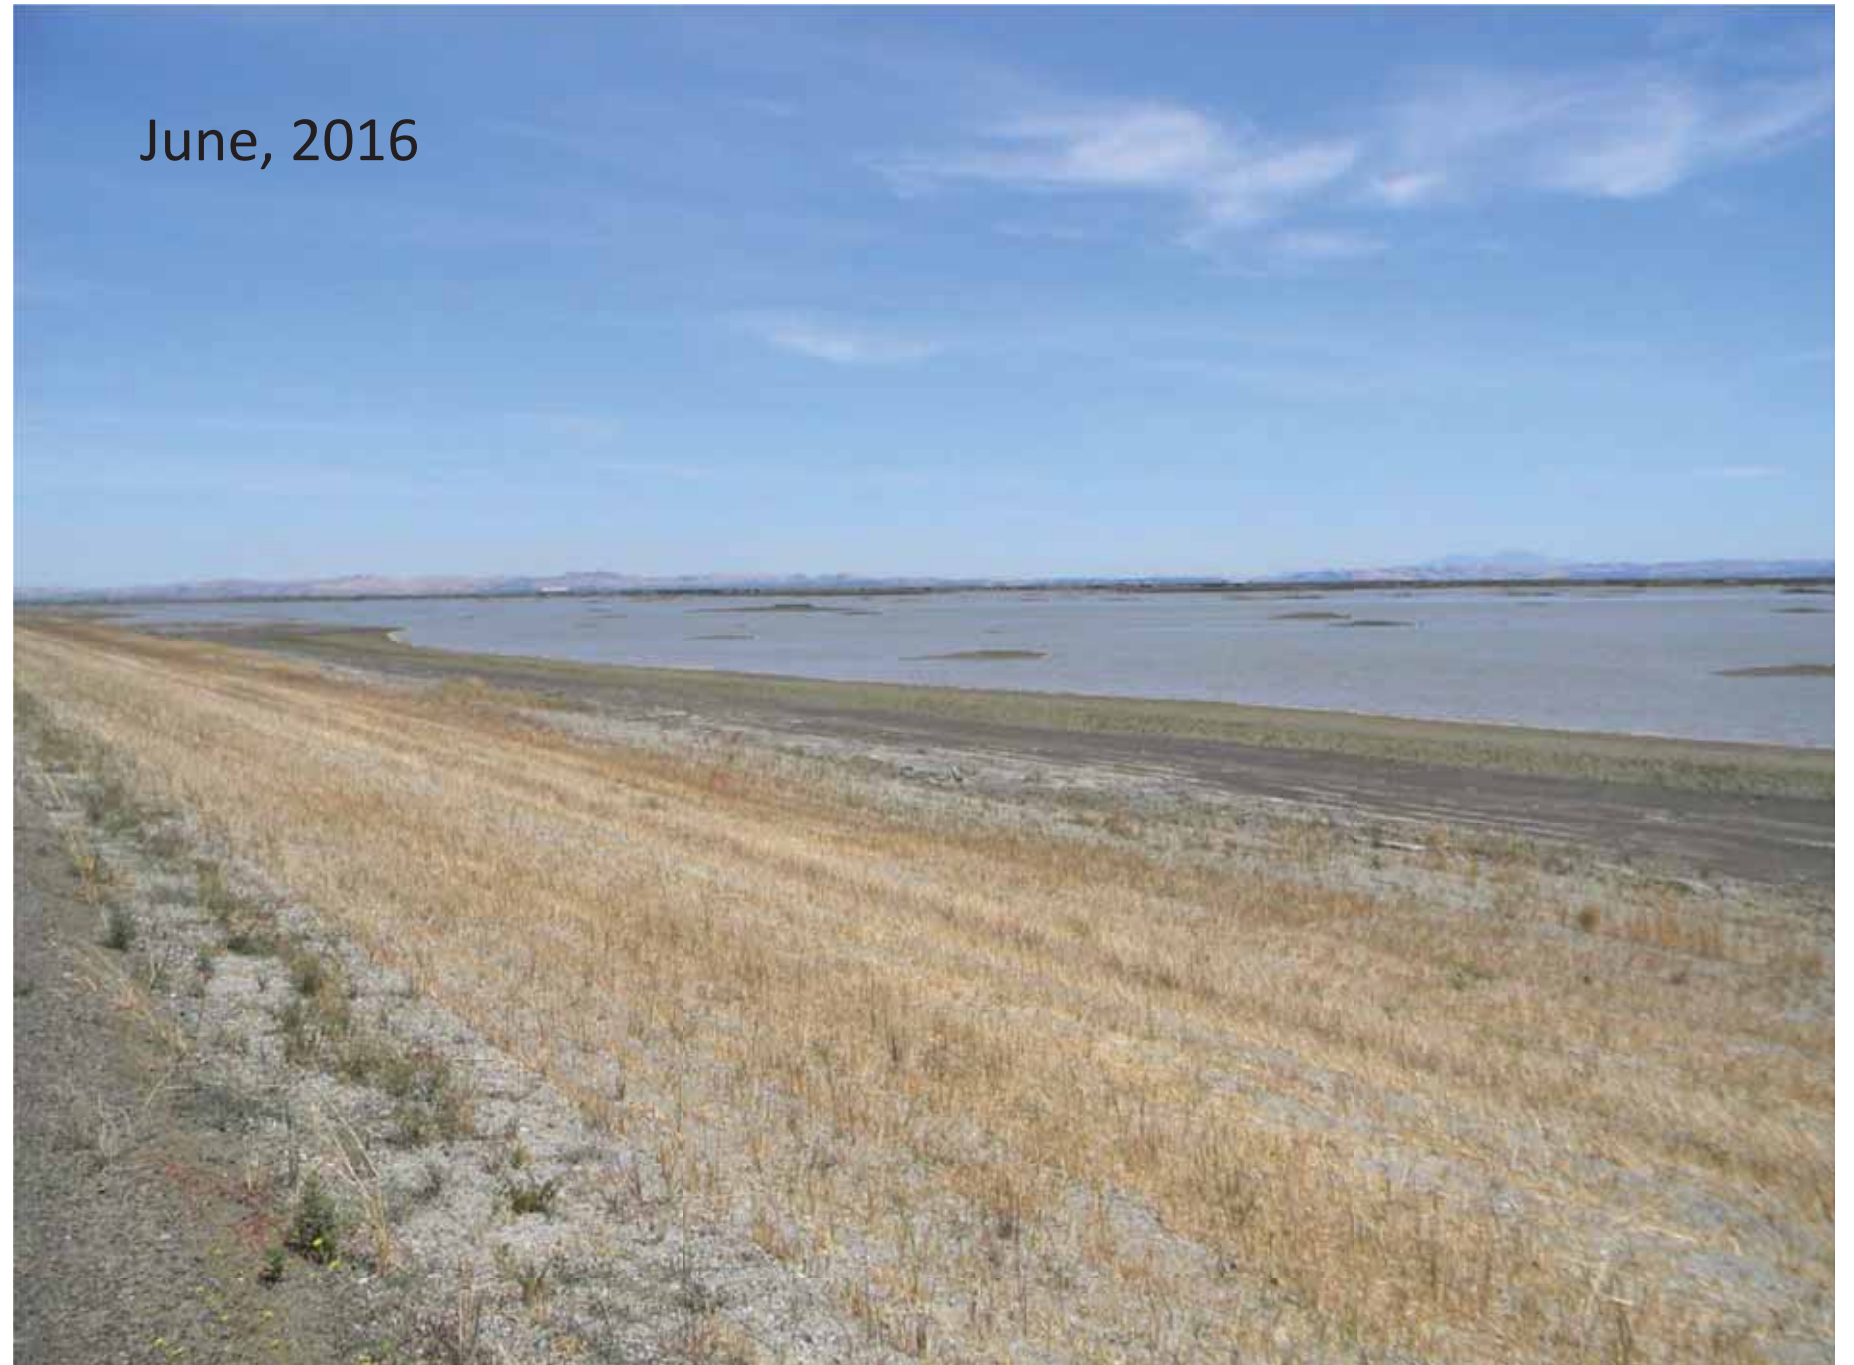
Photo Point 14, Photo 14.1

Photo Description: View E over levee habitat slope and restoration area. Low tide during original photo shows exposed mudflat area

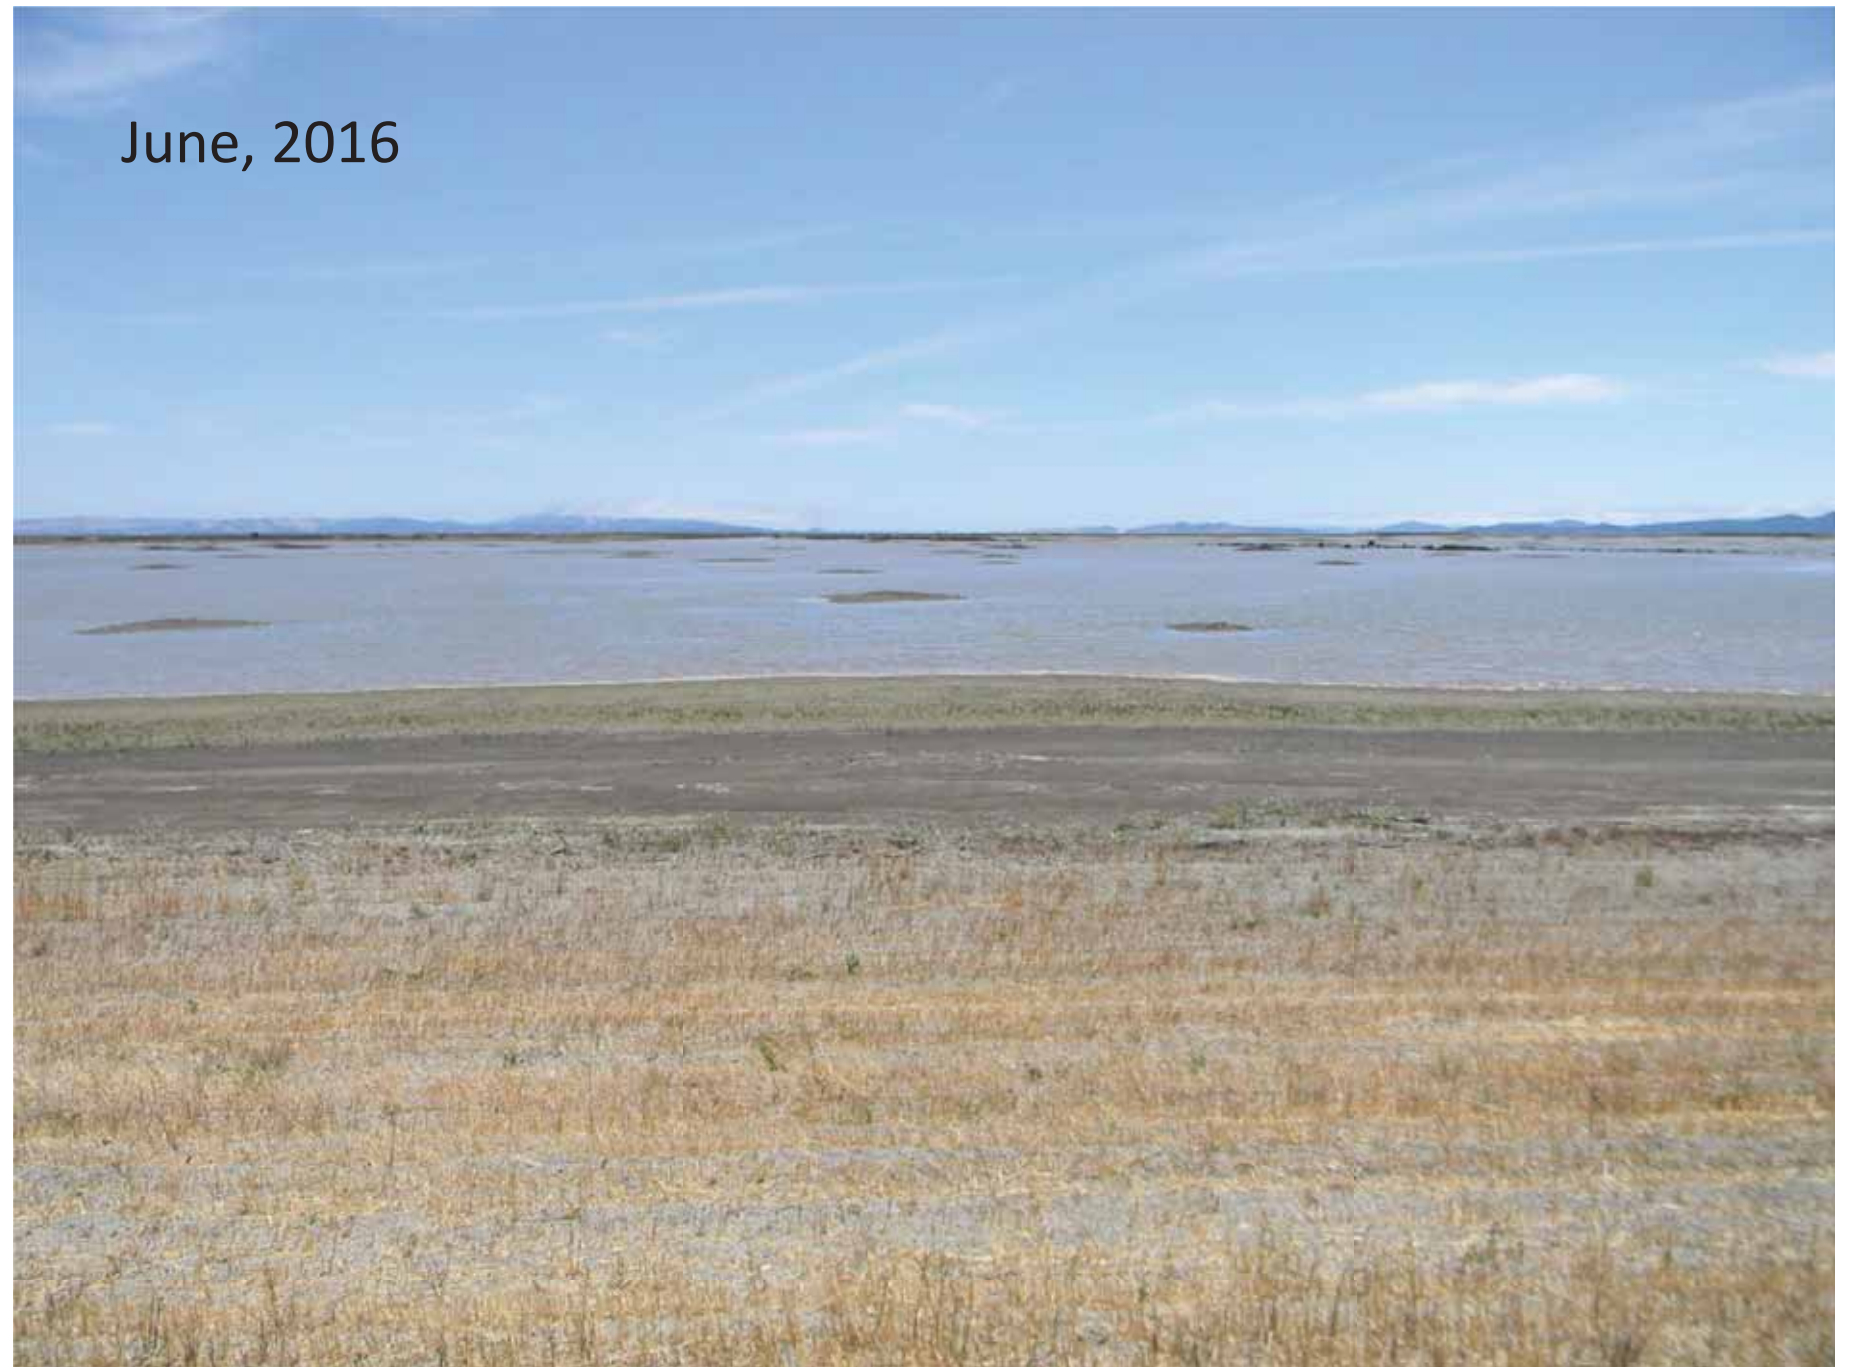
Photo Point 14, Photo 14.2

Photo Description: View SE over levee habitat slope and restoration area. Low tide during original photo shows exposed mudflat area

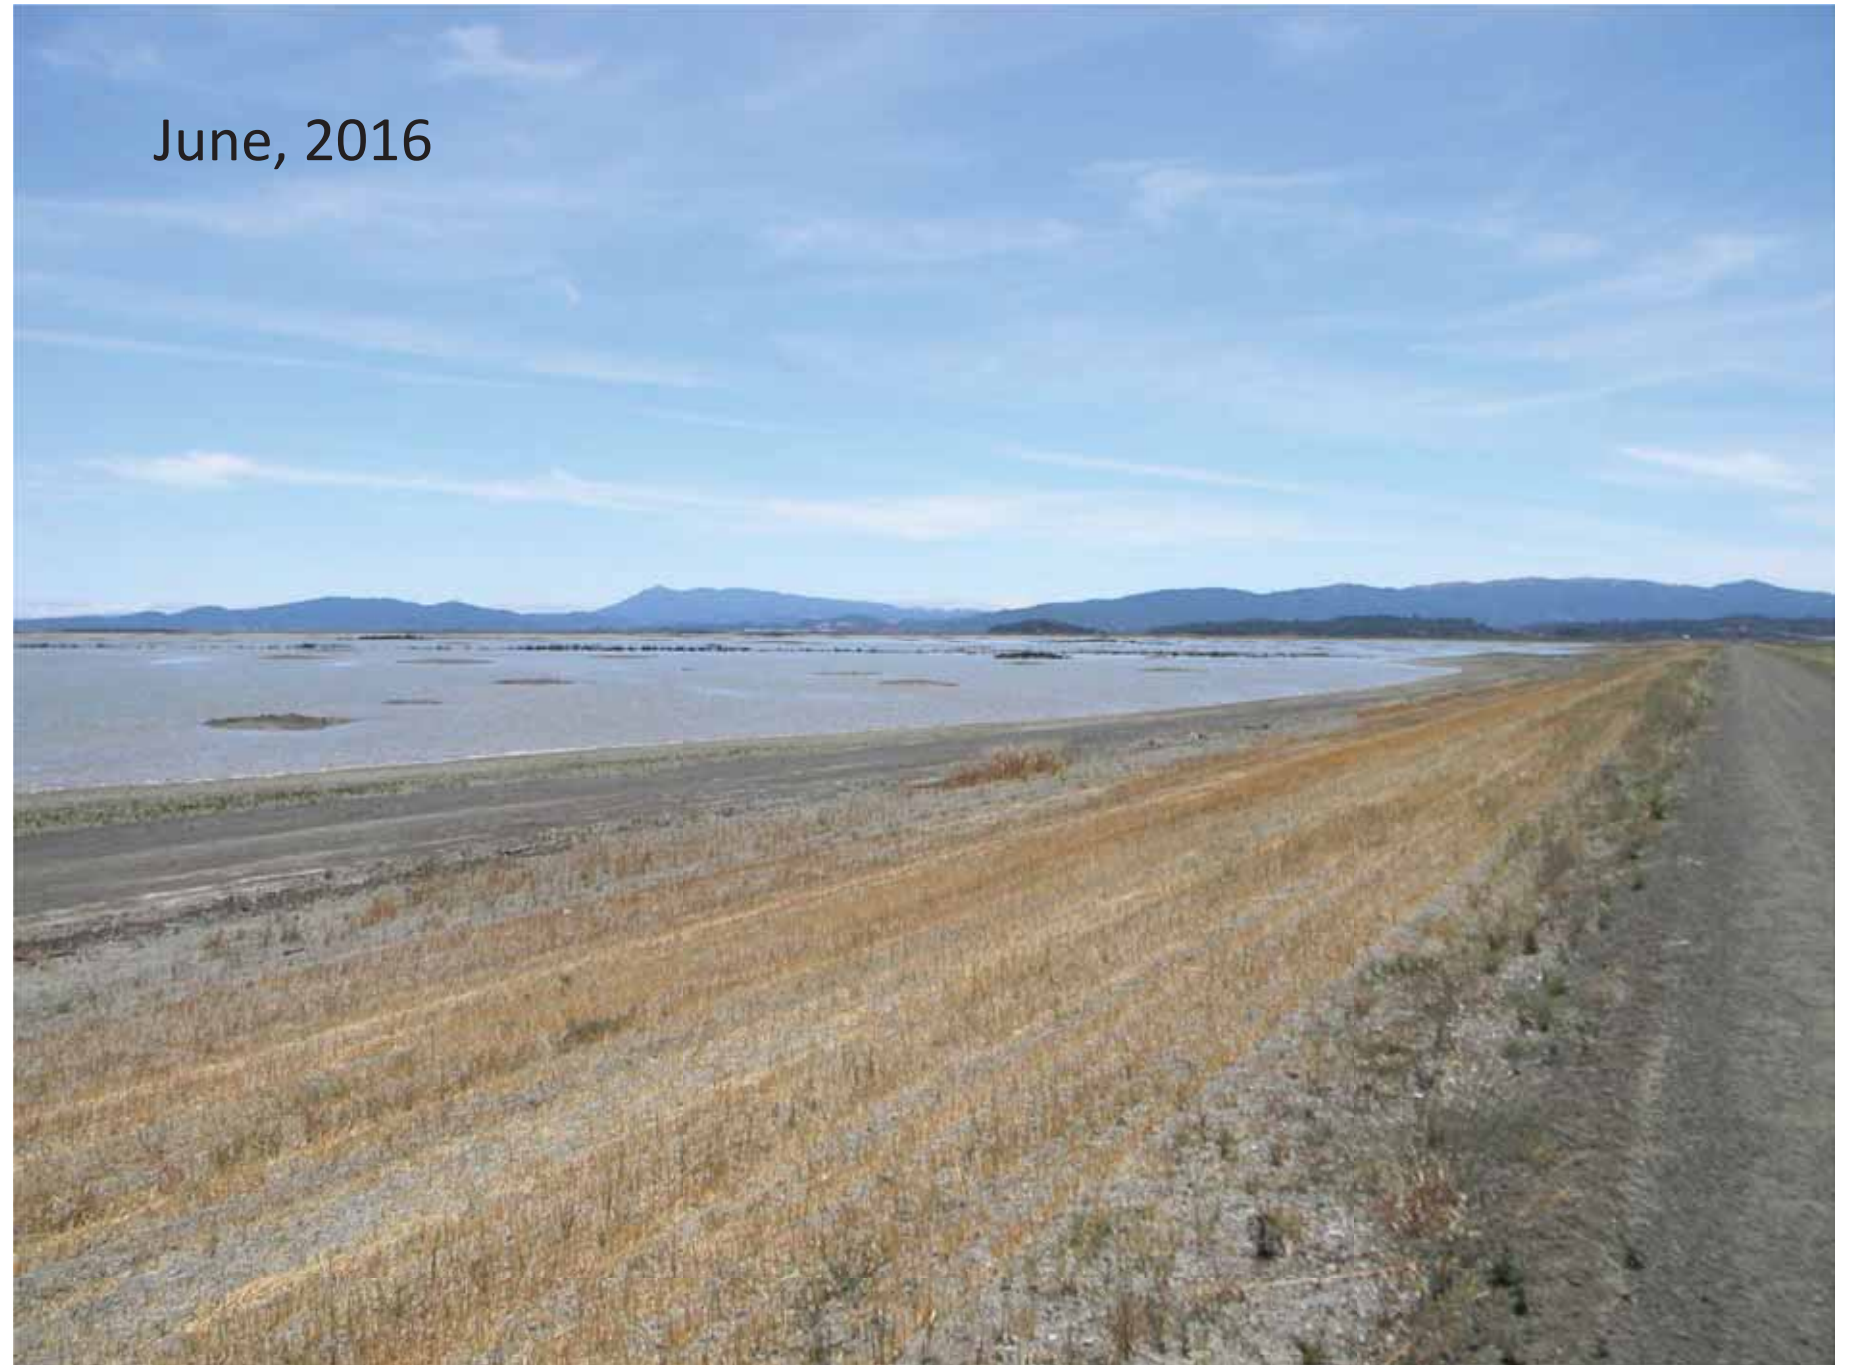
Photo Point 14, Photo 14.3

Photo Description: View SW over levee habitat slope and restoration area. Low tide during original photo shows exposed mudflat area

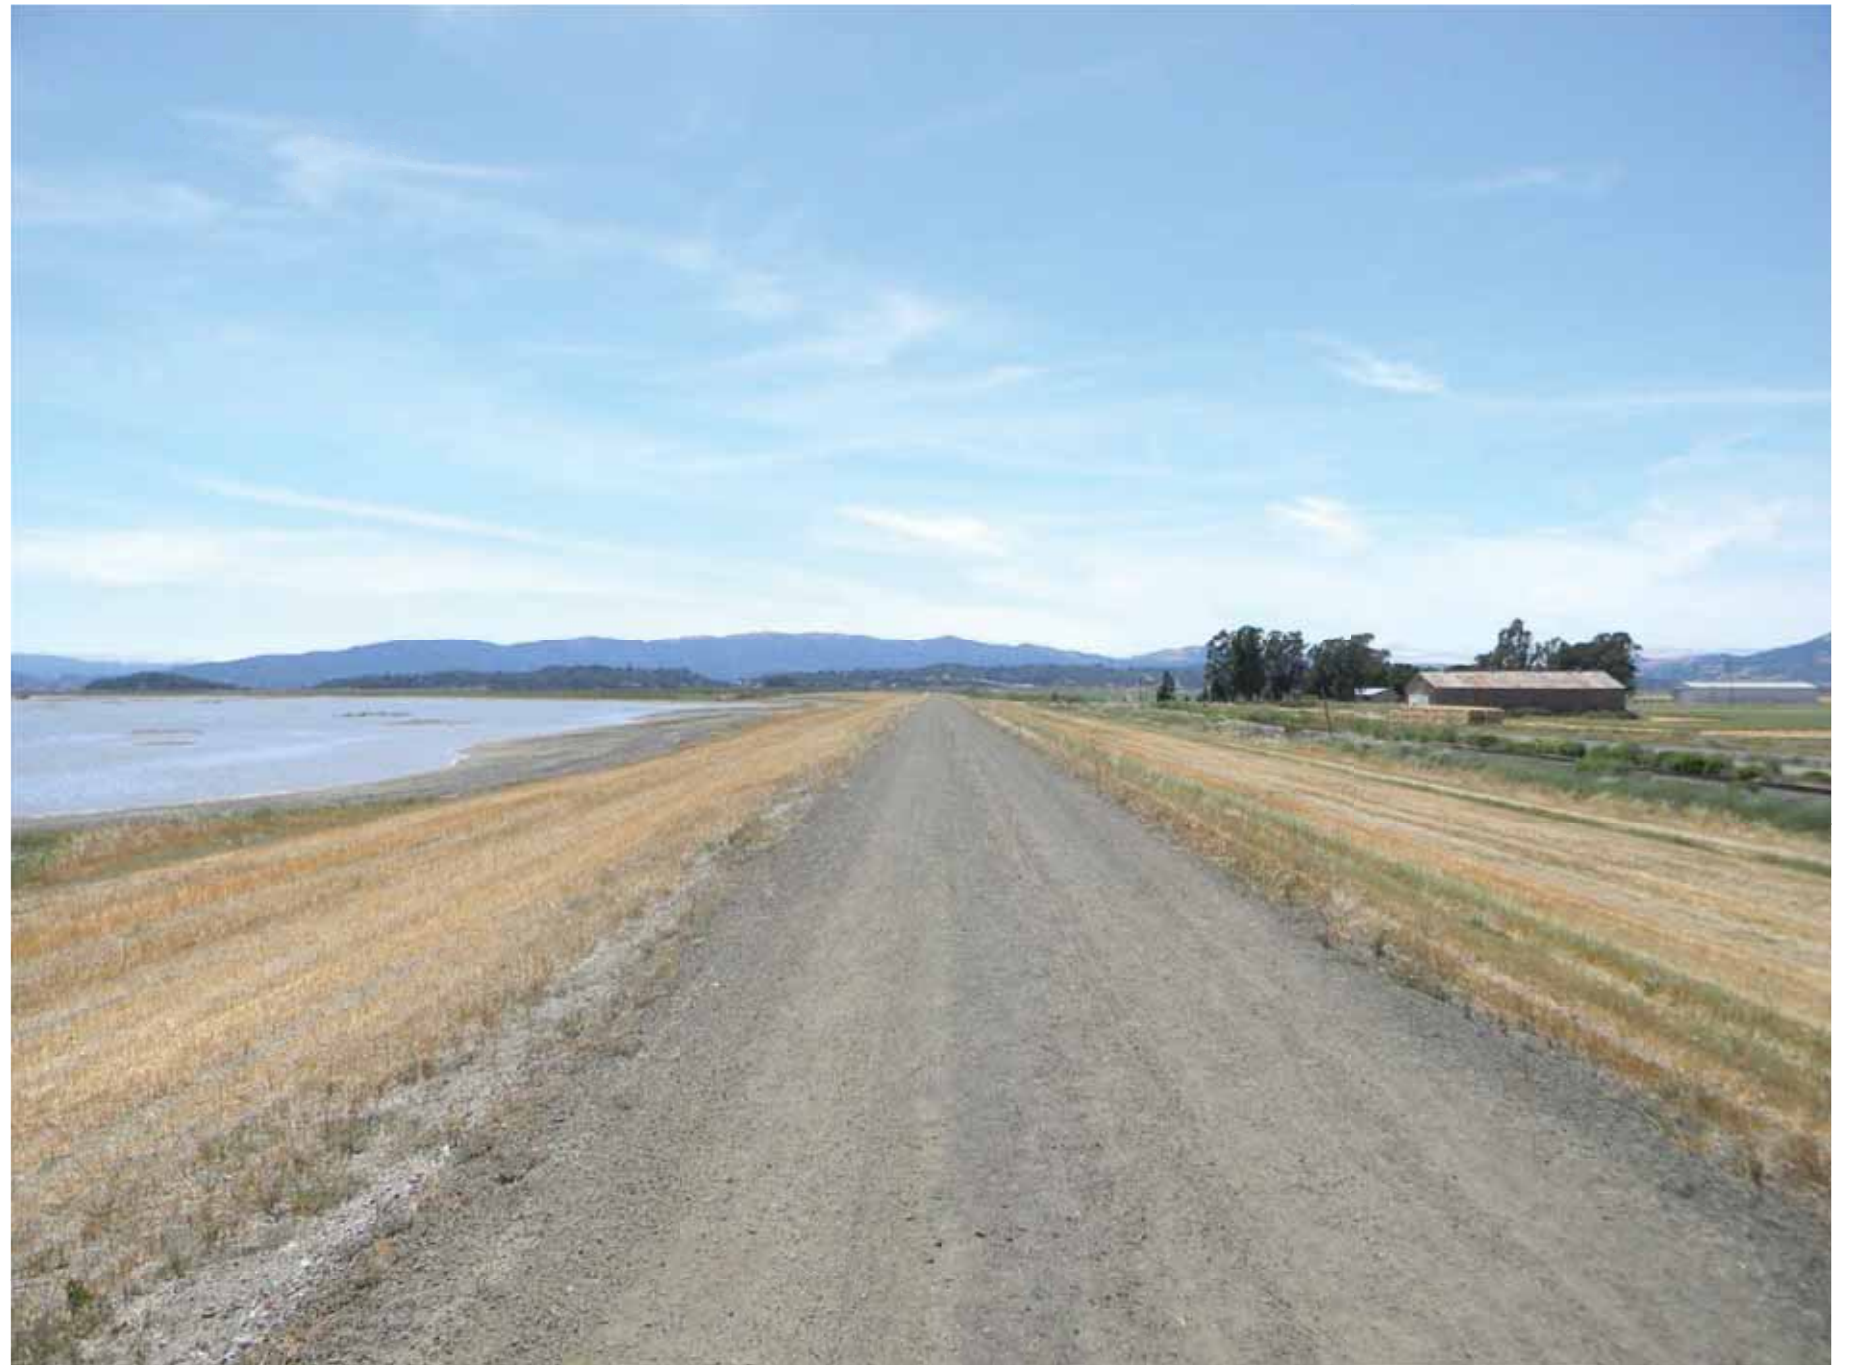
Photo Point 15, Photo 15.2

Photo Description: View W over levee habitat slope and restoration area. Levee top in photo center. Vegetation on either side of levee is stubble following hay harvest.

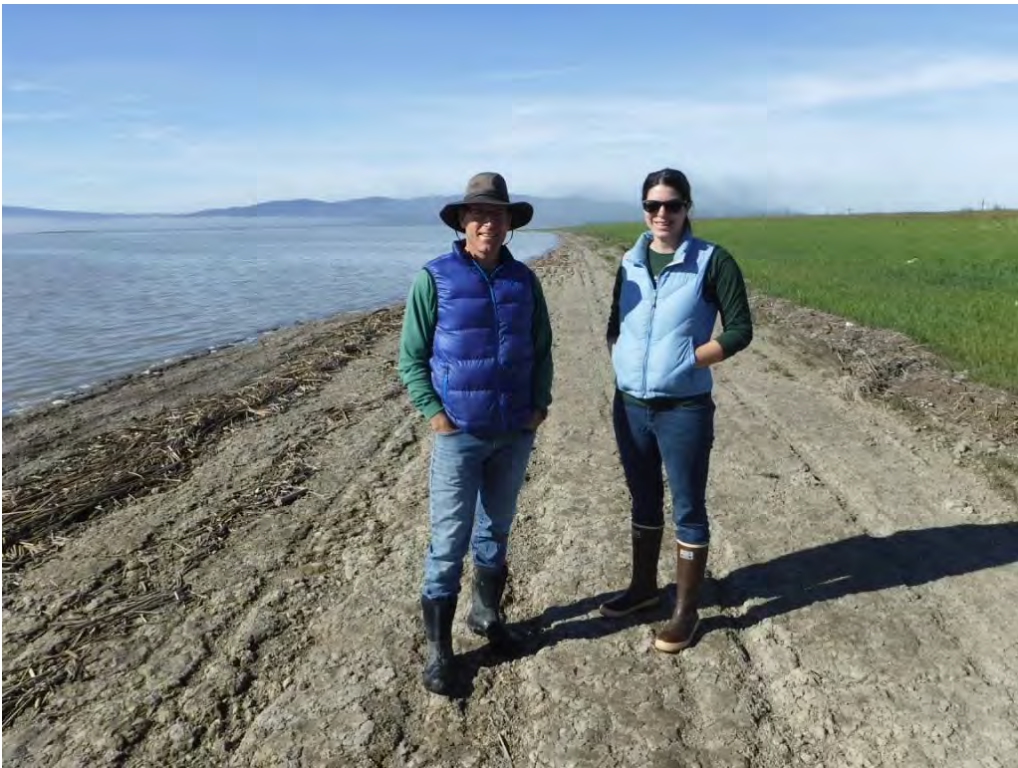
Fig. 2. Julian Meisler (SLT) and Anna Deck (SF Bay NERR) on clay pan scoured by wind-wave action. The *E. triticoides* plantings did not survive wind-wave disturbance (March 8, 2017)

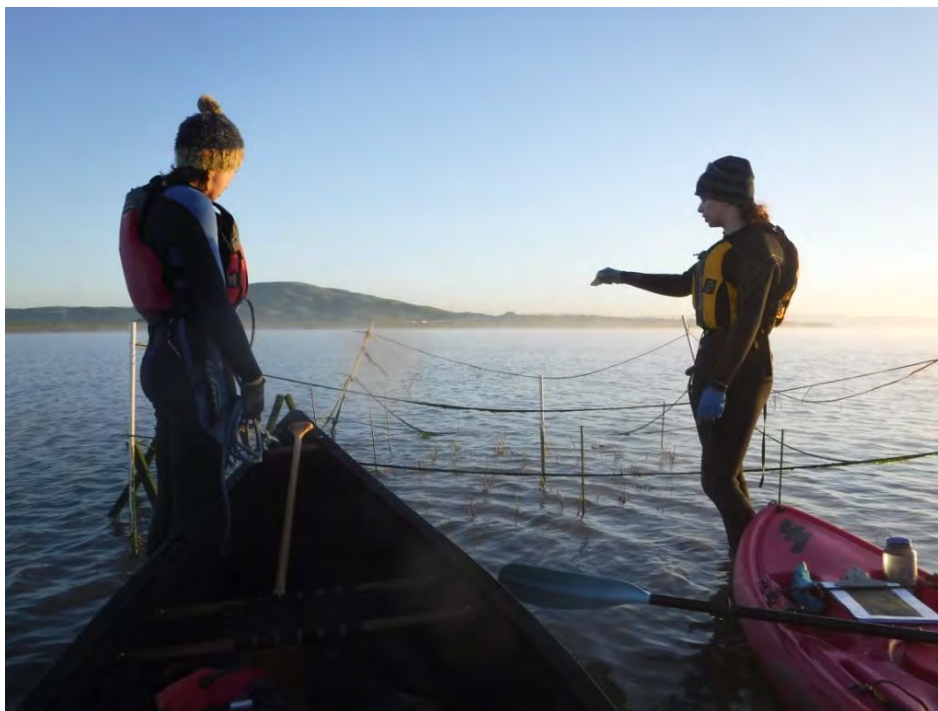
Fig. 3. Anna Deck and Margo Buchbinder on experimental mound observing planting of *Spartina foliosa*, a sediment pin (in the middle of the mound), and a Canada goose enclosure to protect *Spartina* planting from goose grazing (March 16, 2017)

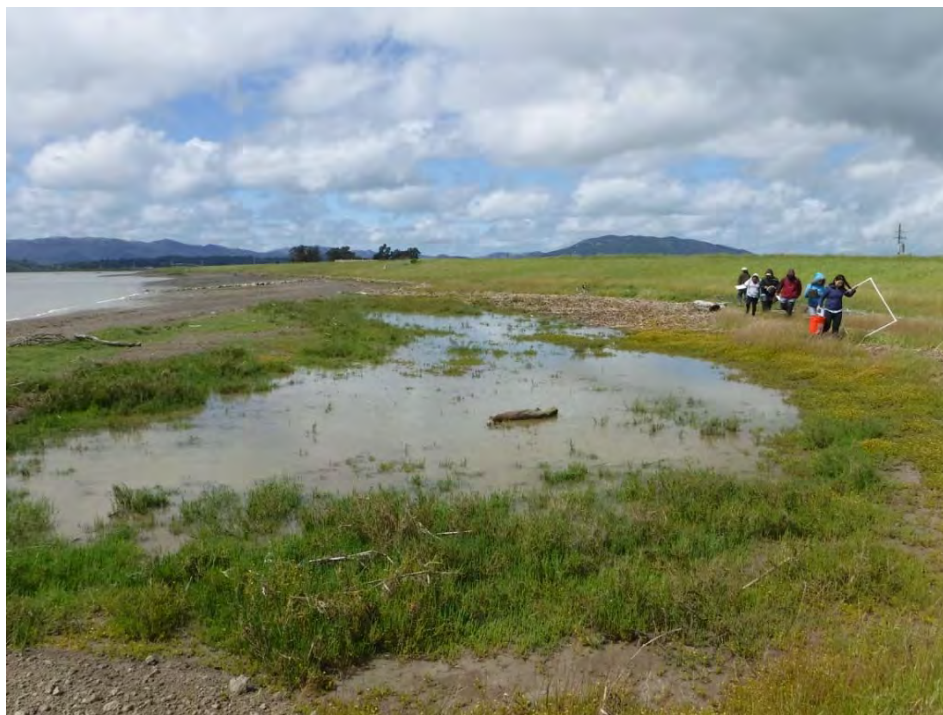
Fig. 4. Vegetation sampling on constructed panne. Note zoned vegetation patterns (April 11, 2017)

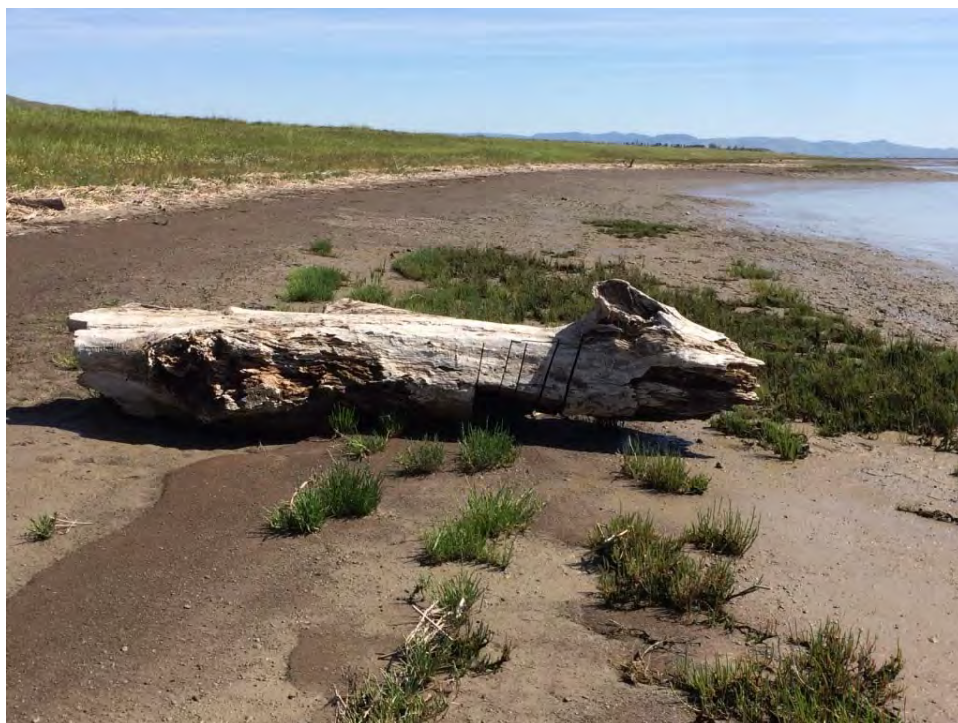
Fig. 5. *Salicornia pacifica* establishing in coarse deposits onto clay pan and especially in wind-protected area on the lee side of the drift log. (April 28, 2017)

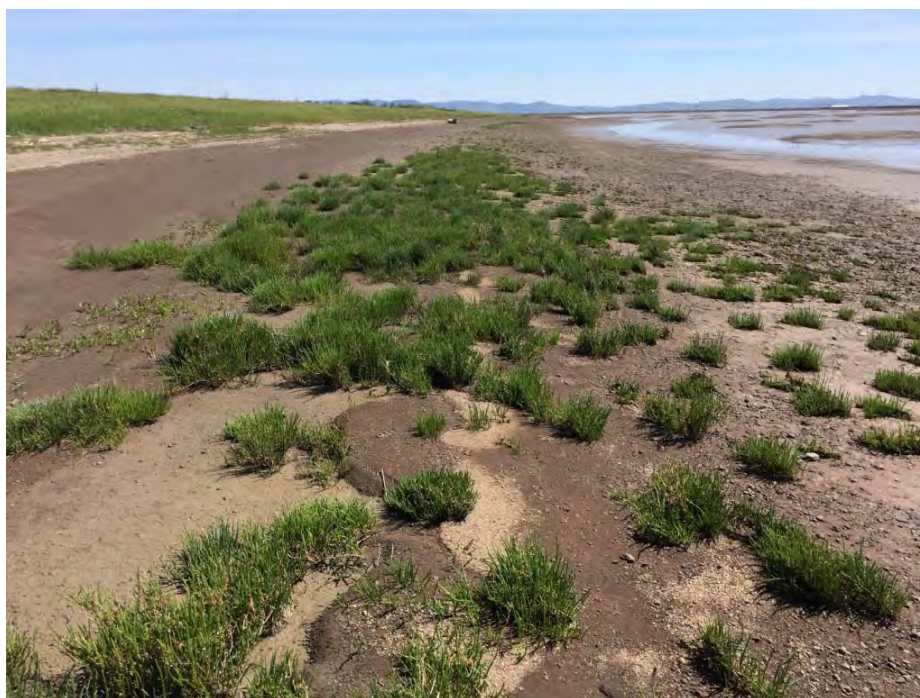
Fig. 6. *Salicornia pacifica* in coarse sediments overlying clay pan with associates such as *Atriplex prostrata* and *Cotula coronopifolia*. West end of northern levee. (April 28, 2017)

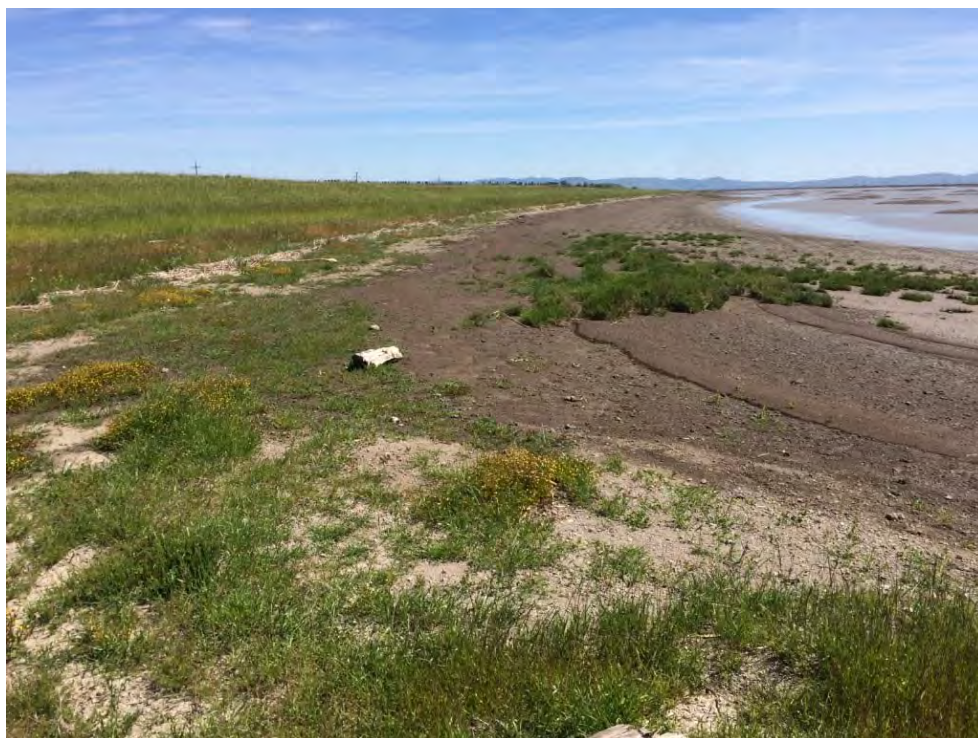
Fig. 7 Buildup of sediments and vegetation establishment on the lee side of the constructed pannes (April 28, 2017)

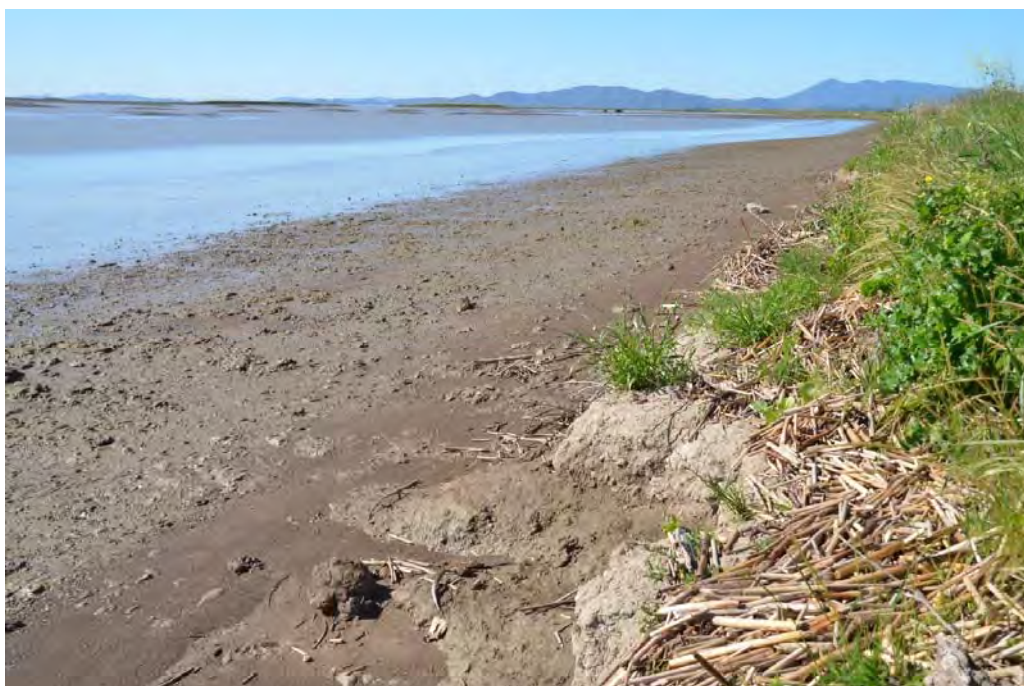
Fig. 8. Levee scour between high tide wrack and low tide zone (April 29, 2017)
Photo by Stuart Siegel
