Sears Point Tidal Marsh Restoration Project

Monitoring and Management Status Report

October 2015 to June 2017

Sears Point Tidal Marsh Restoration Project
Monitoring and Management Status Report, Year 1
October 2015 to June 2017

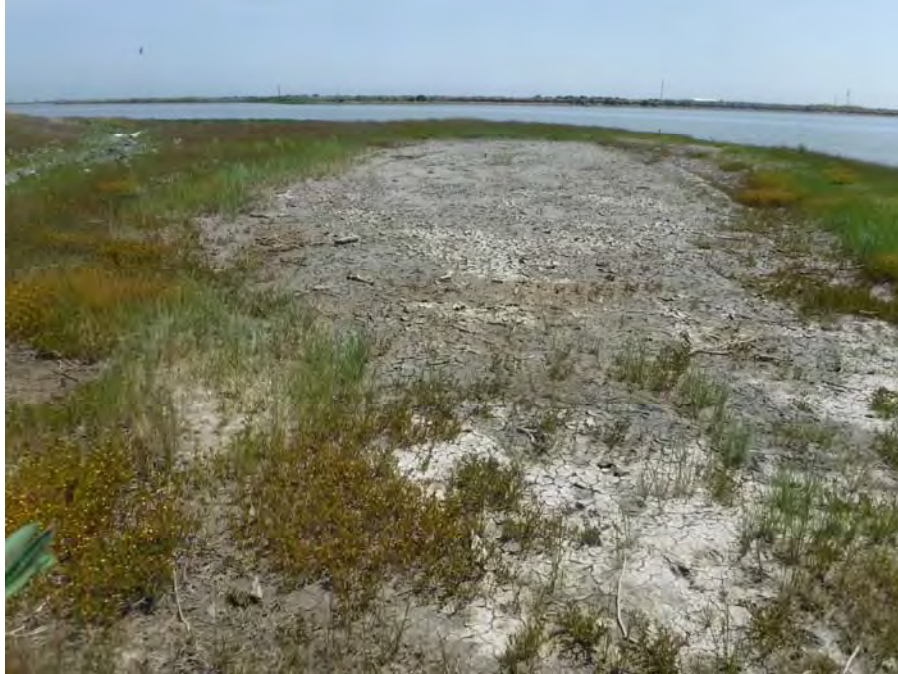
Fig. 9. Constructed panne with pool evaporated. Note ring of *Cotula coronopifolia* in middle zone above pool and what appears to be *Spartina foliosa* along the northern edge of the pool. (May 7, 2017)

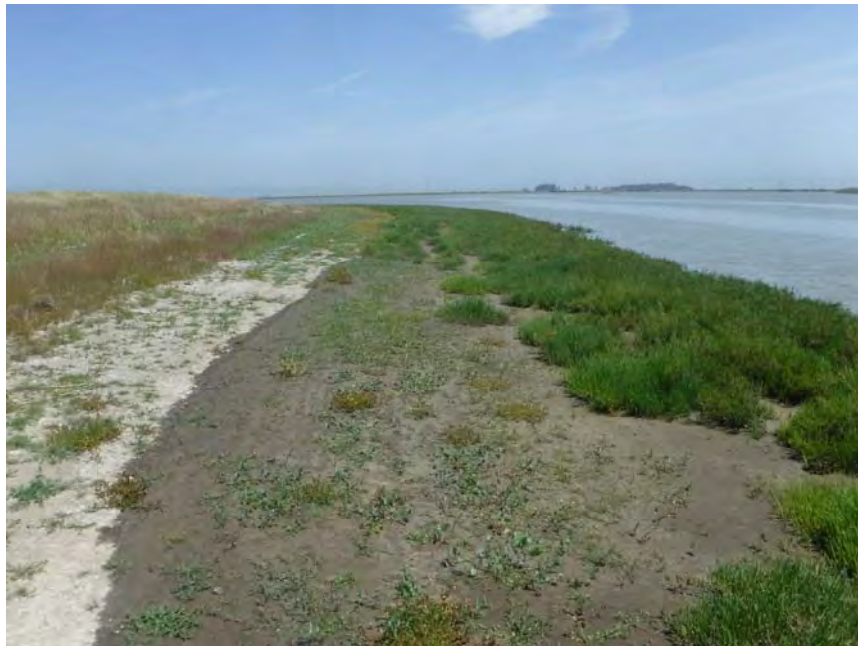
Fig. 10. Northeastern intertidal zone where wind-wave activity is dampened. Note extensive stand of *Salicornia pacifica* as well as *Atriplex prostrata*, *Polygonum aviculare*, *Lythrum hysoppifolia* and occasional *Jaumea carnosa*, *Frankenia salina*, and *Grindelia stricta* var. *angustifolia* (May 7, 2017).

In the northeastern stretch of shoreline that is more protected from currents and wind-wave action, there is extensive establishment of *Salicornia pacifica*, *Atriplex prostrate*, and *C. coronopifolia*, with occasional shrubs of *Grindelia stricta* var. *angustifolia*, and recruiting *Frankenia salina* and seedlings of *Jaumea carnosa*. These are classic high marsh species and their presence in this region is very encouraging (Appendix E Figure 10).

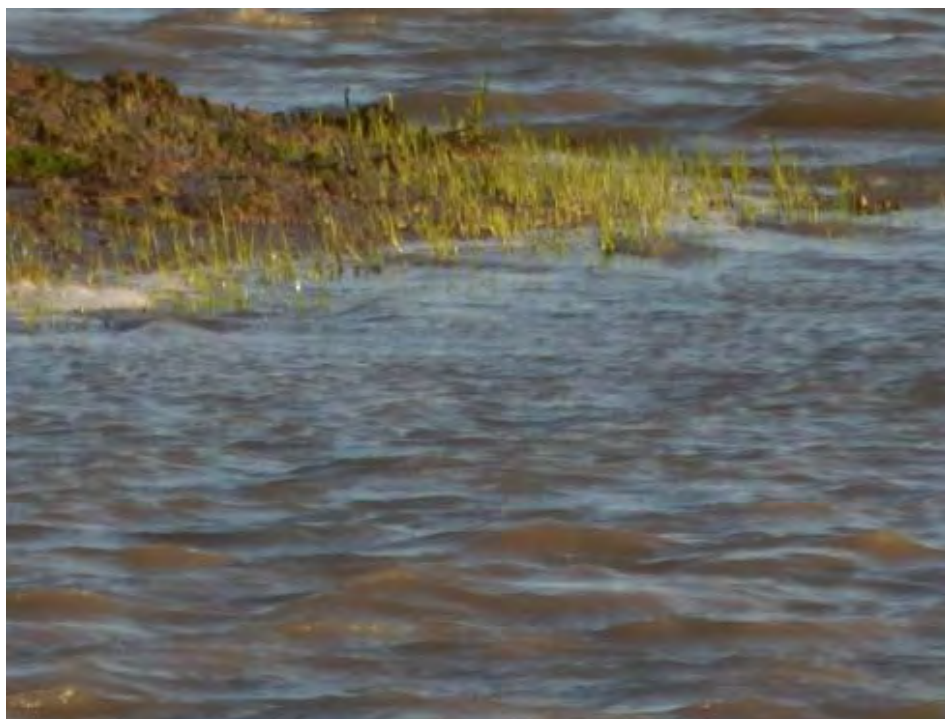
Fig. 11 Alkali bulrush (*Bolboschoenus maritimus*) spontaneously establishing at base of mound in the low intertidal zone (May 9, 2017) Photo by Peter Baye.

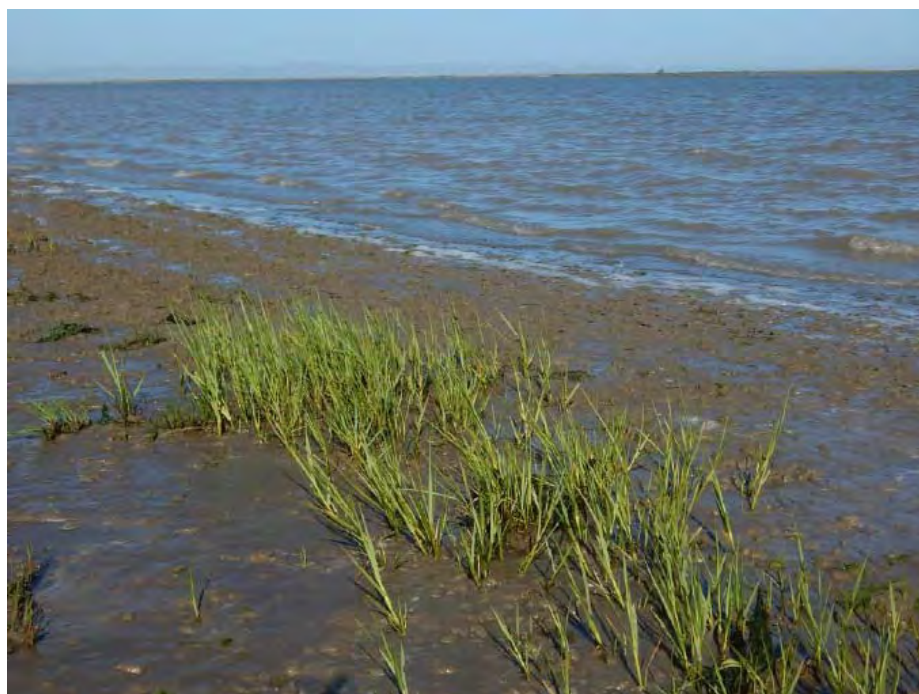
Fig. 12. *Spartina foliosa* establishing at lower intertidal zone along the T-zone levee (May 9, 2017) Photo by Peter Baye.

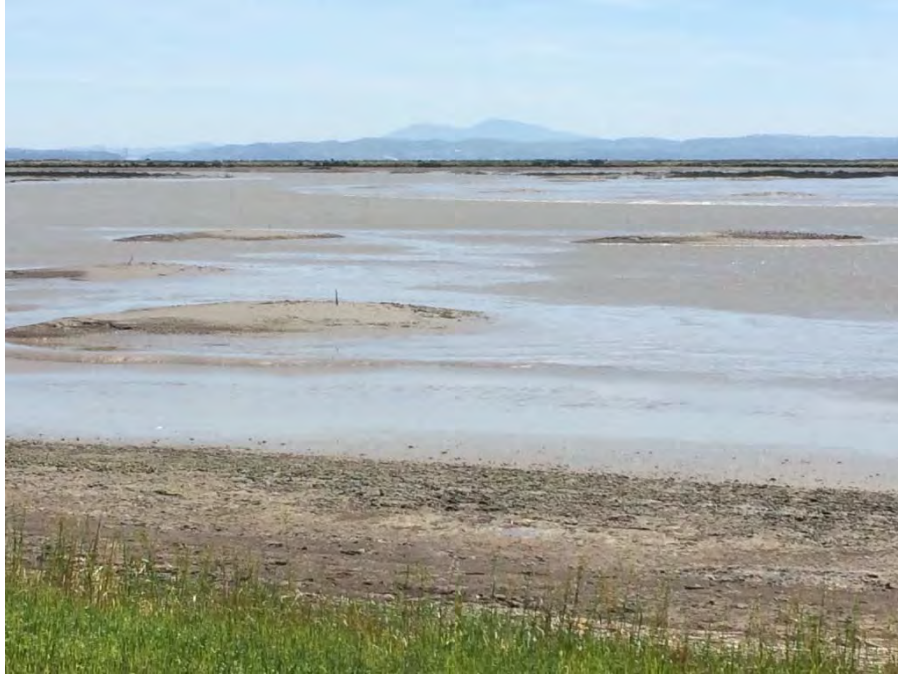
Fig. 13. Mud flat shoaling on and around eroded mound. Rapid accretion of sediments around eroded mounds and side-cast ridges is developing a low intertidal plain that should present significant heterogeneity that promotes future marsh plant diversity (April 28, 2017)

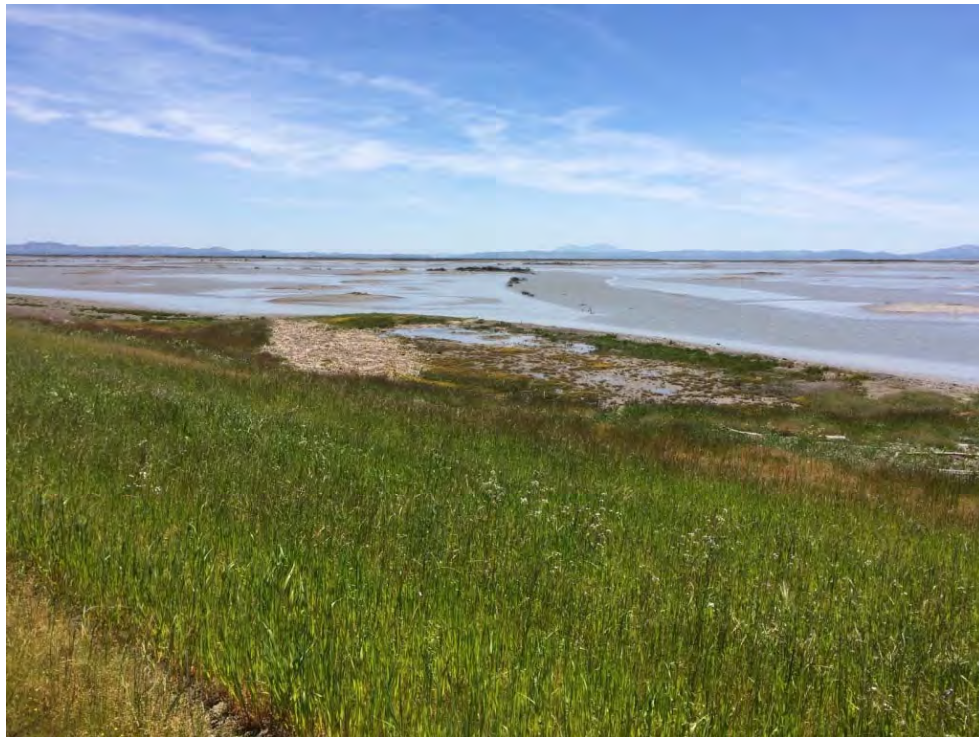
Fig. 14. View over an constructed panne showing deeper water to the right (dark band) and evolving mudflat shoals to the left punctuated by eroding mounds (April 28, 2017)
