## **Appendix E. Levee Erosion Data**

## **Levee Erosion Data**

| <b>SEARS POINT<br/>WETLAND RESTORATION<br/>EROSION ANALYSIS</b> | | DRAWN BY: <b>JS</b> |

Levee Erosion  
Adaptive Management Project  
Sears Point Tidal Marsh Restoration Project  
Sonoma County, CA

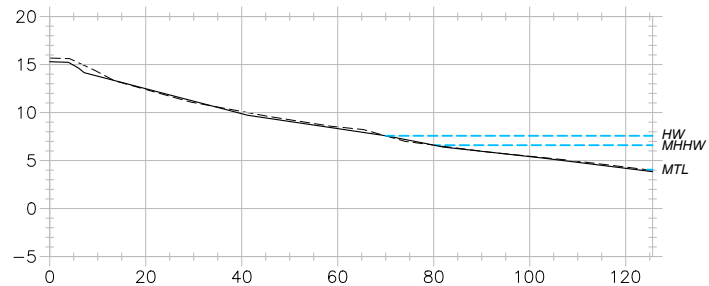
SECTION 25

- Inspection survey (October, 2018)
- - - Post breach survey (May 2017, 18 months after the site was breached)
- - - Water Surface
- 1.5' Approximate height of scarp as dimensioned from the plans

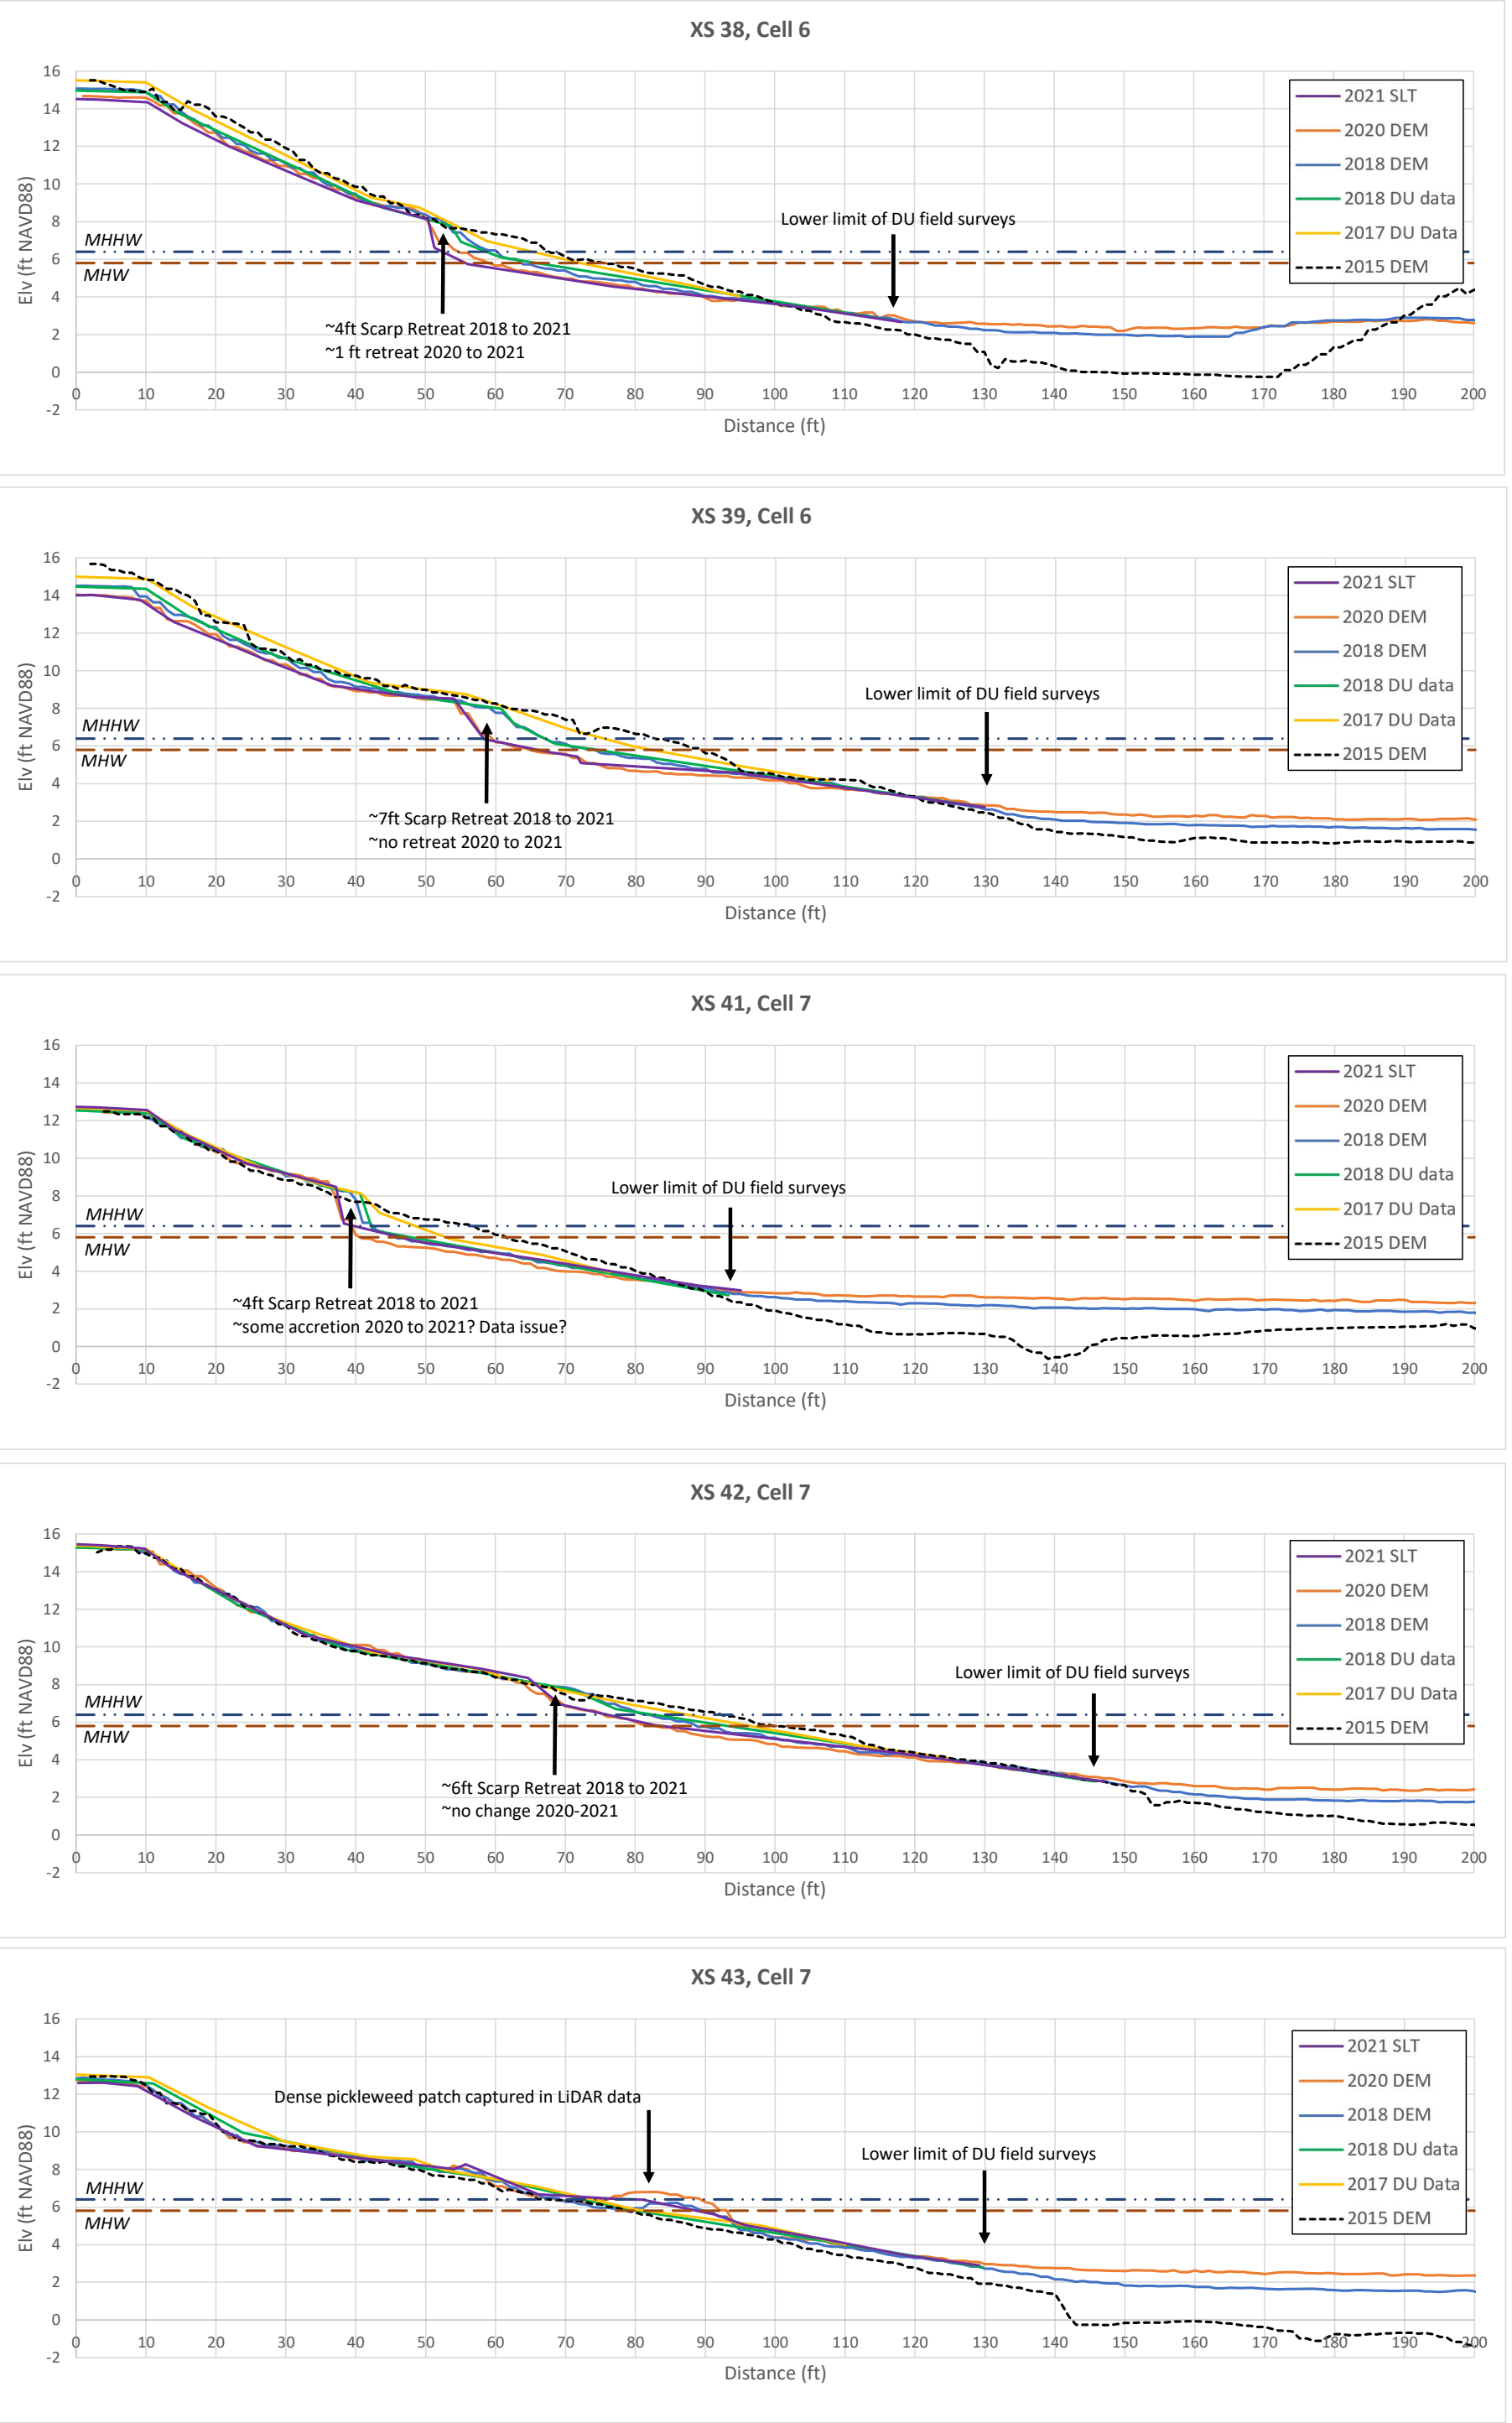
Topographic Transects in Cells 6 and 7: 2015 As-built, 2017 and 2018 DU field data, 2018 and 2020 LiDAR DEM, 2021 SLT field data

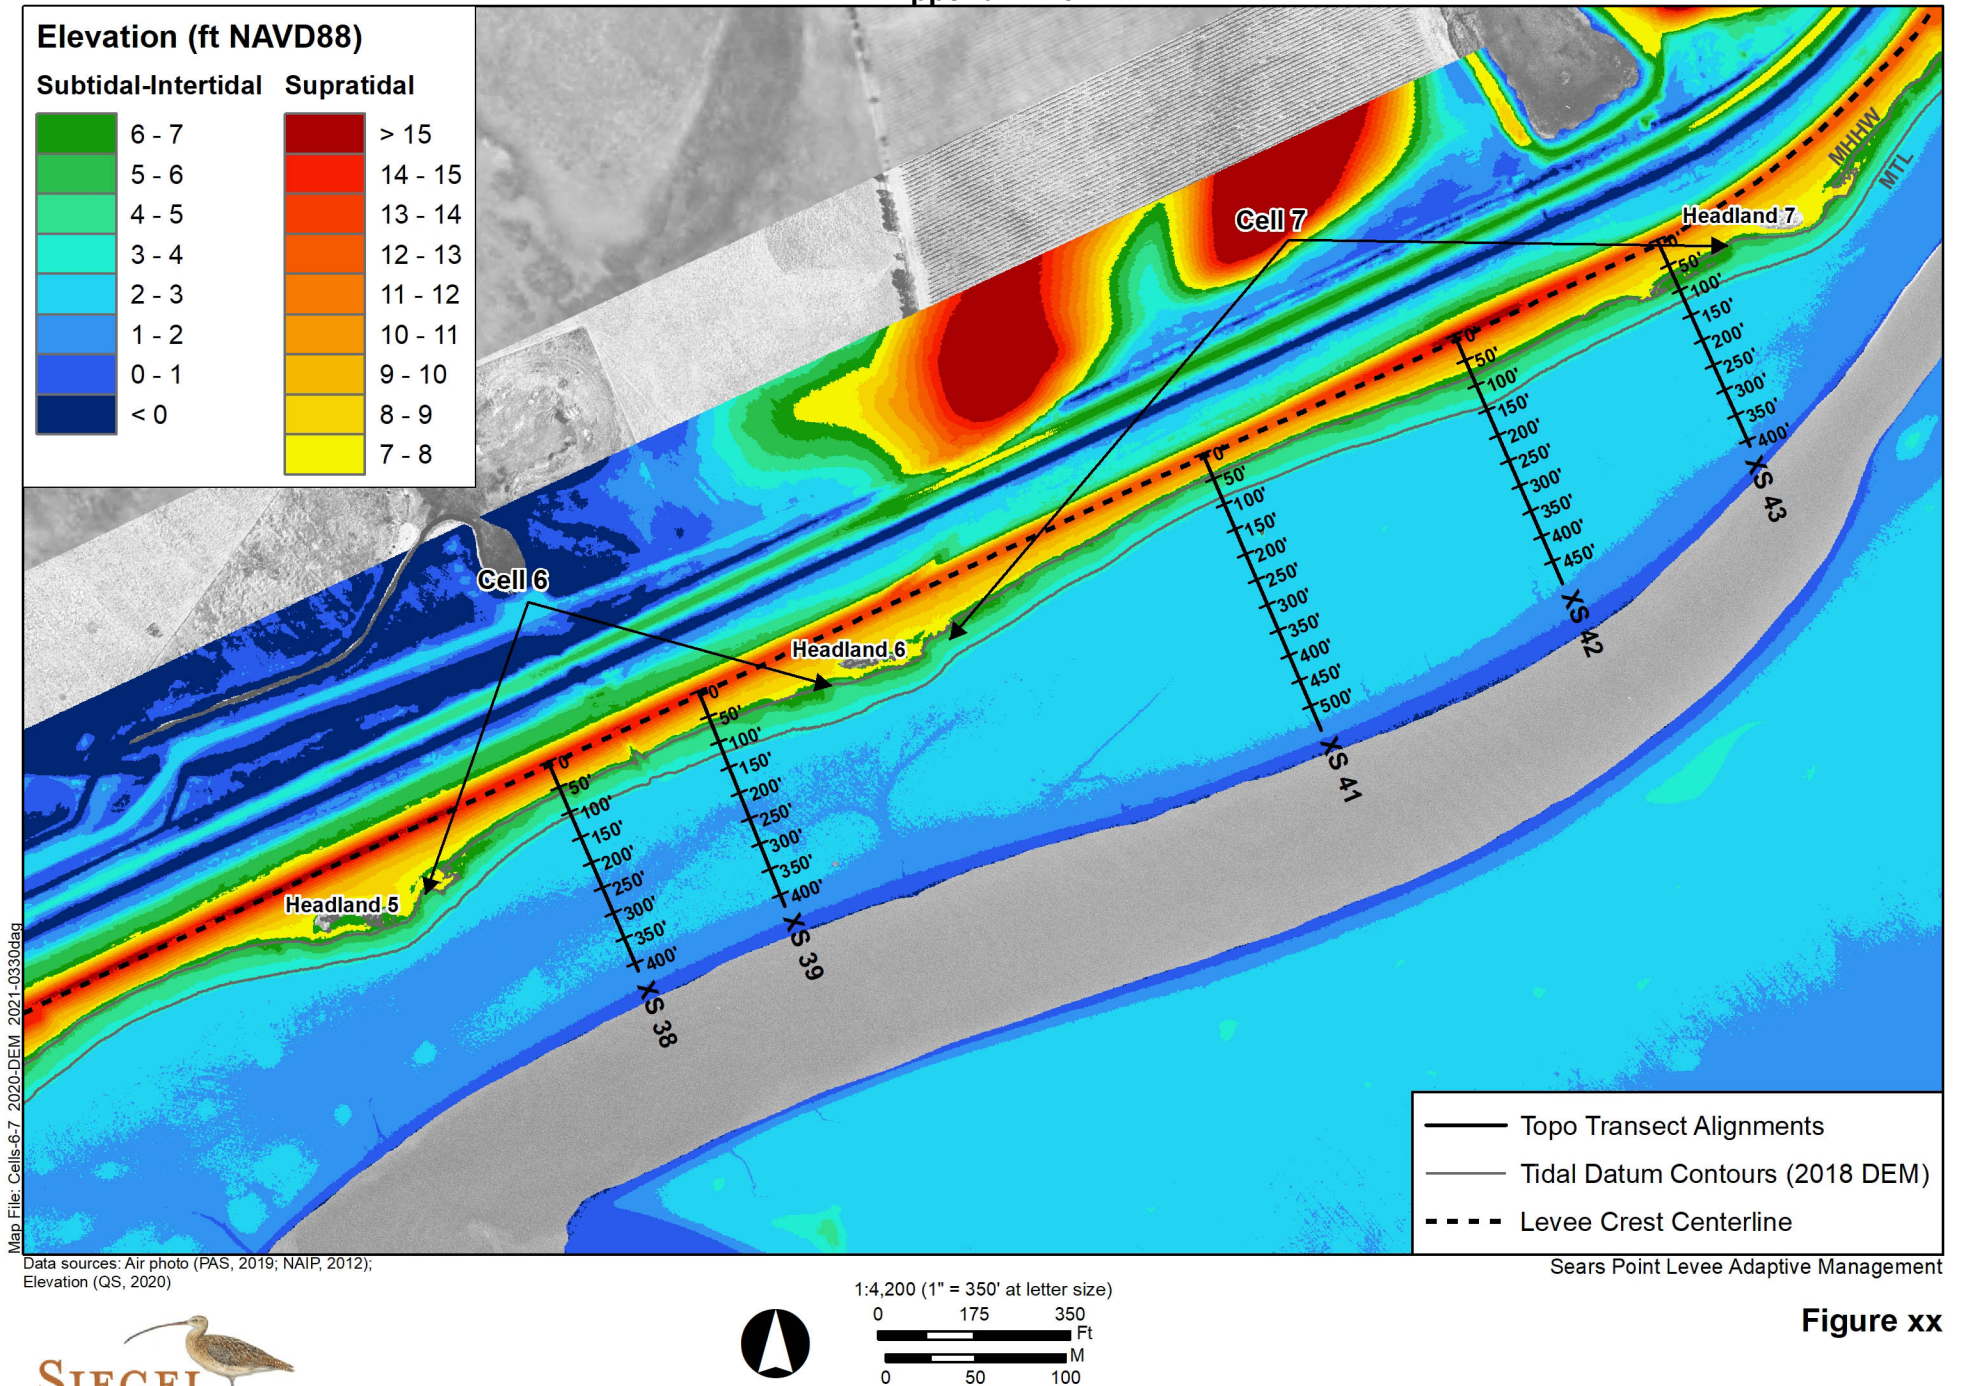
Figure xx

Cell 6-7 Intertidal Basin Elevation: 2020

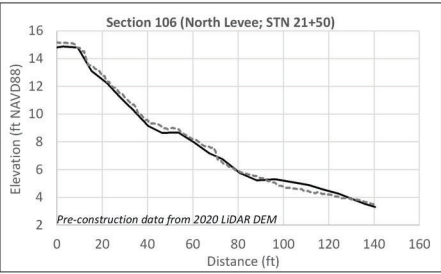
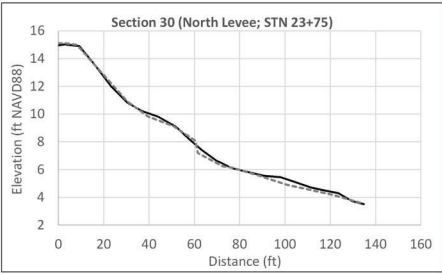
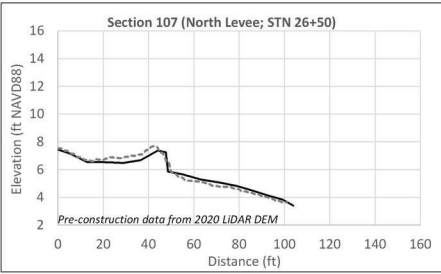
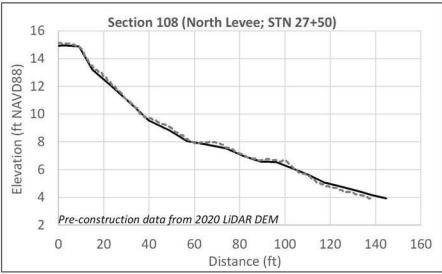
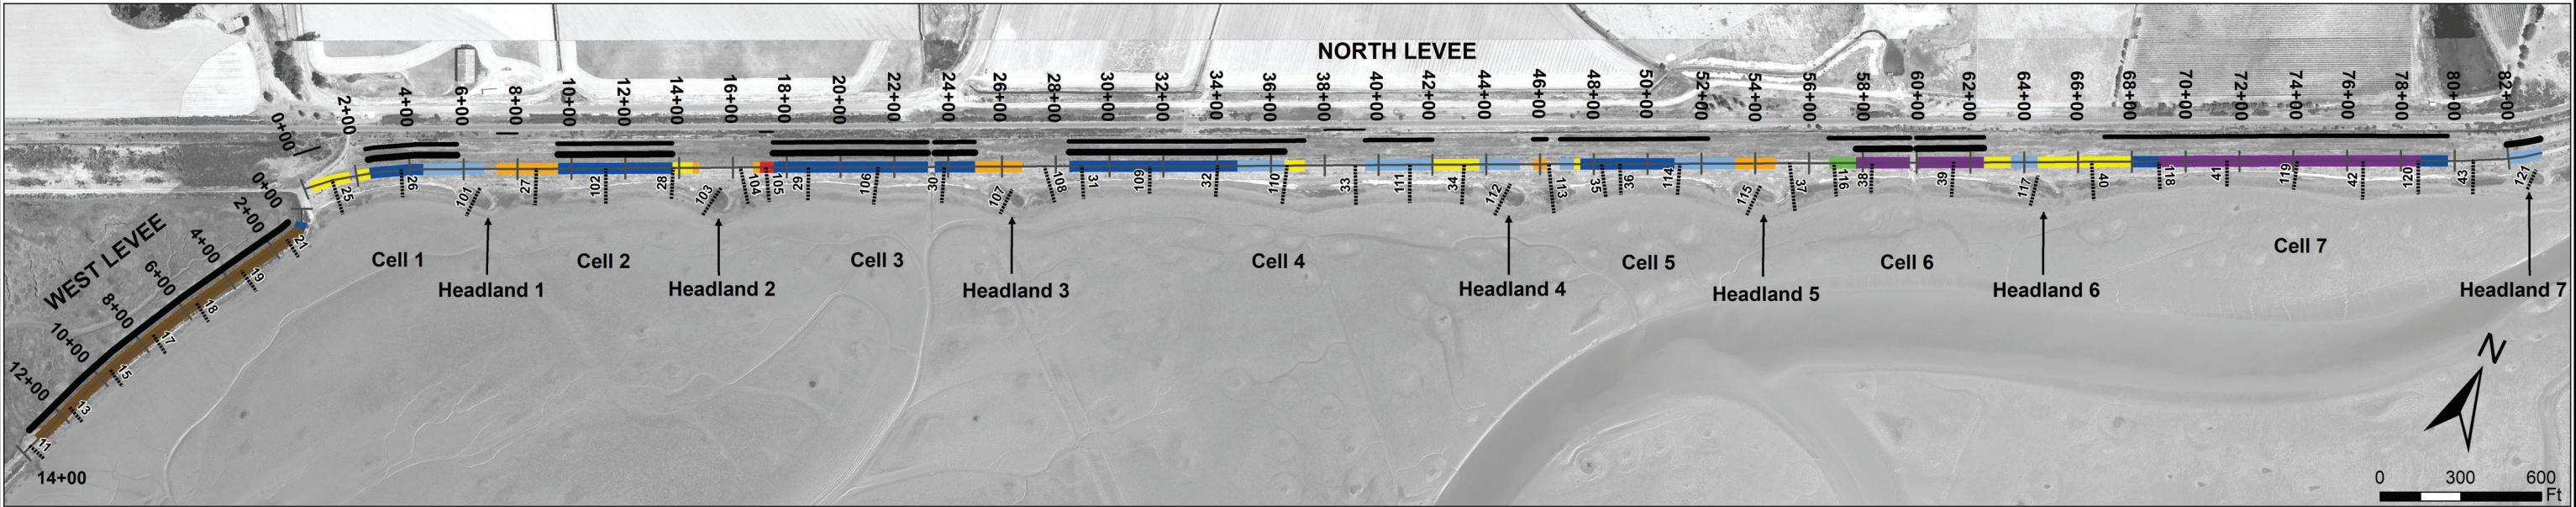
- Post-construction (as-built) topography surveyed by Dixon Marine Services between November 5 and 26, 2021 using RTK GPS.
- Pre-construction topography is from the following sources:
  - Sections 11 - 47: May 6, 2021 topographic survey performed by Daniel Harris of SFSU using RTK GPS.
  - Sections 101 - 121: June 2020 LiDAR digital elevation model (DEM) of Sears Pt Restoration Project site by Quantum Spatial.
- Topographic survey data are held to the benchmark network shown on Sheet 2
- Considerations for 2020 LiDAR data:
  - Data gaps along sections are due to the presense of standing water at the time of LiDAR acquisition.
  - Vegetation interference may be present in some locations, resulting in artificially high elevations.

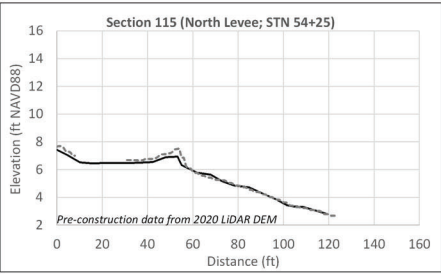
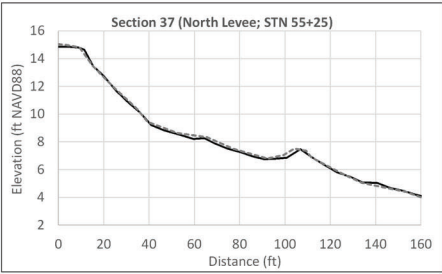
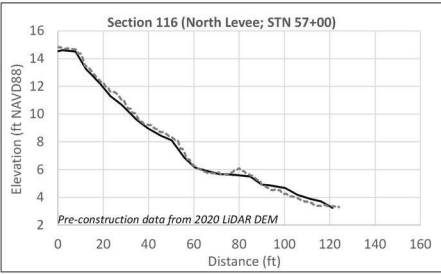
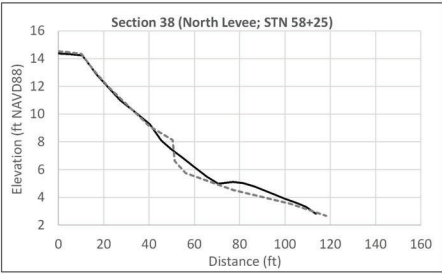
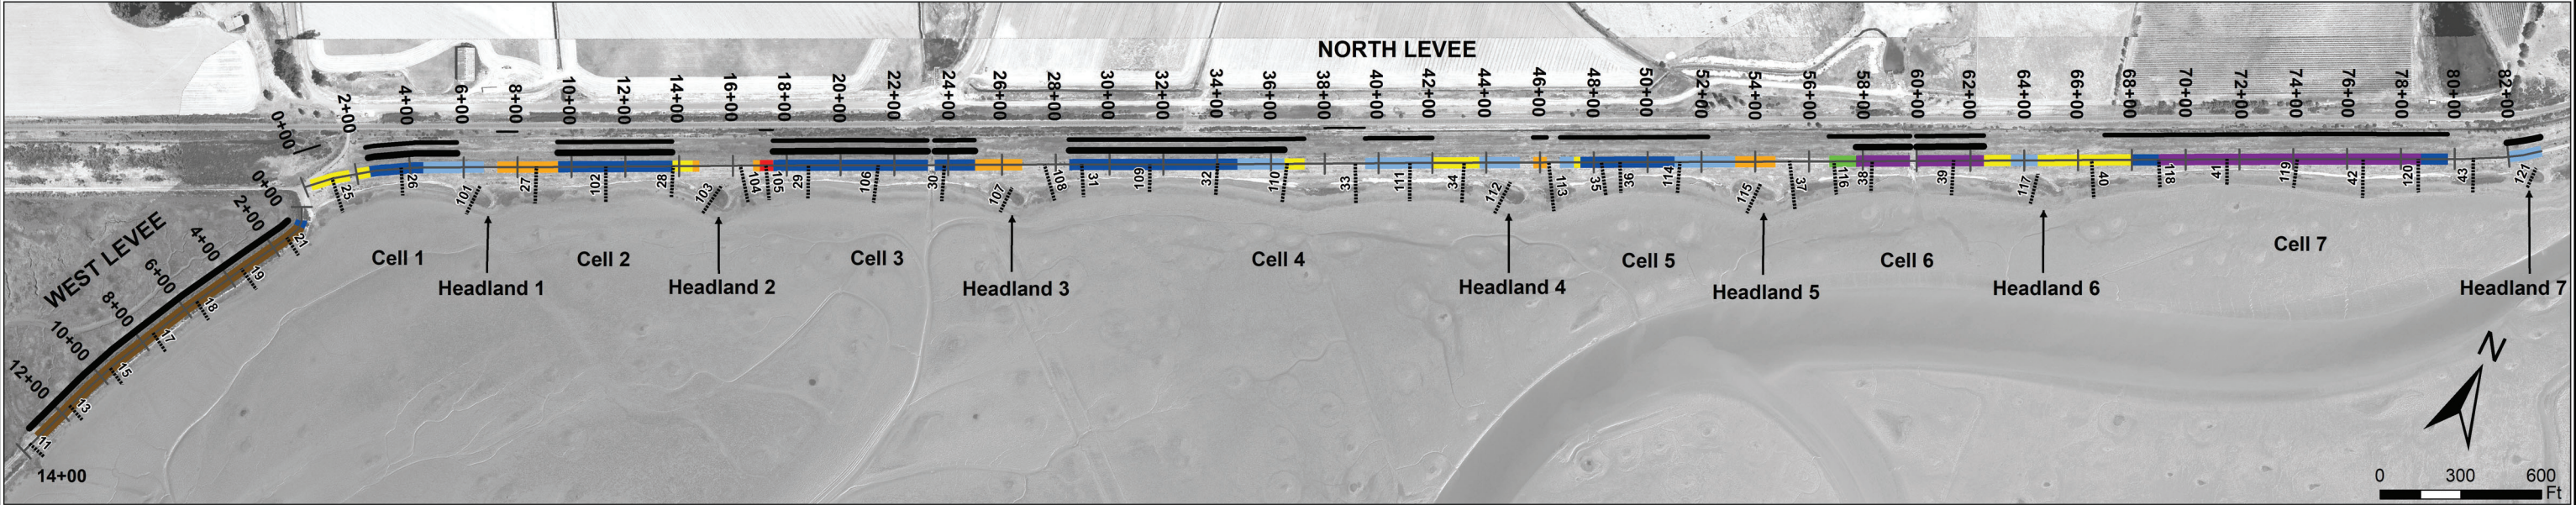
AS-BUILT TOPOGRAPHIC  
SECTIONS (3)

- Post-construction (as-built) topography surveyed by Dixon Marine Services between November 5 and 26, 2021 using RTK GPS.
- Pre-construction topography is from the following sources:
  - Sections 11 - 47: May 6, 2021 topographic survey performed by Daniel Harris of SFSU using RTK GPS.
  - Sections 101 - 121: June 2020 LiDAR digital elevation model (DEM) of Sears Pt Restoration Project site by Quantum Spatial.
- Topographic survey data are held to the benchmark network shown on Sheet 2
- Considerations for 2020 LiDAR data:
  - Data gaps along sections are due to the presense of standing water at the time of LiDAR acquisition.
  - Vegetation interference may be present in some locations, resulting in artificially high elevations.
