## **Appendix F. Northern Levee Cordgrass Planting**

### **Northern Levee Cordgrass Planting**

Subject: Sears Point Levee Planting Project Memo

# Sears Point Spartina Planting, Phase 2 Project Summary Report

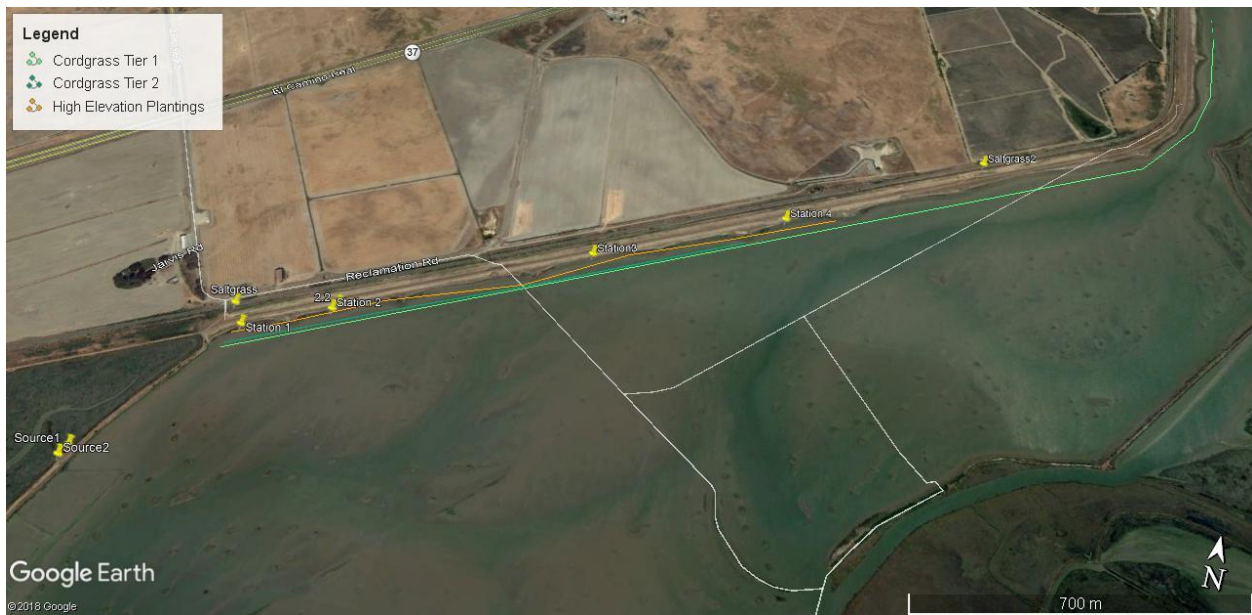
Figure 2 This Google Earth image highlights project key features with yellow pins. Source 1 and Source 2 on the western edge of the project area (Sonoma Baylands Marsh) are cordgrass harvest locations. Stations 1–4 indicate photo monitoring points. Saltgrass pins show saltgrass harvest locations. Orange, teal and green lines along the shore of the north levee represent the extent of three transplant zones: high elevation, cordgrass tier 2, and cordgrass tier 1, respectively.

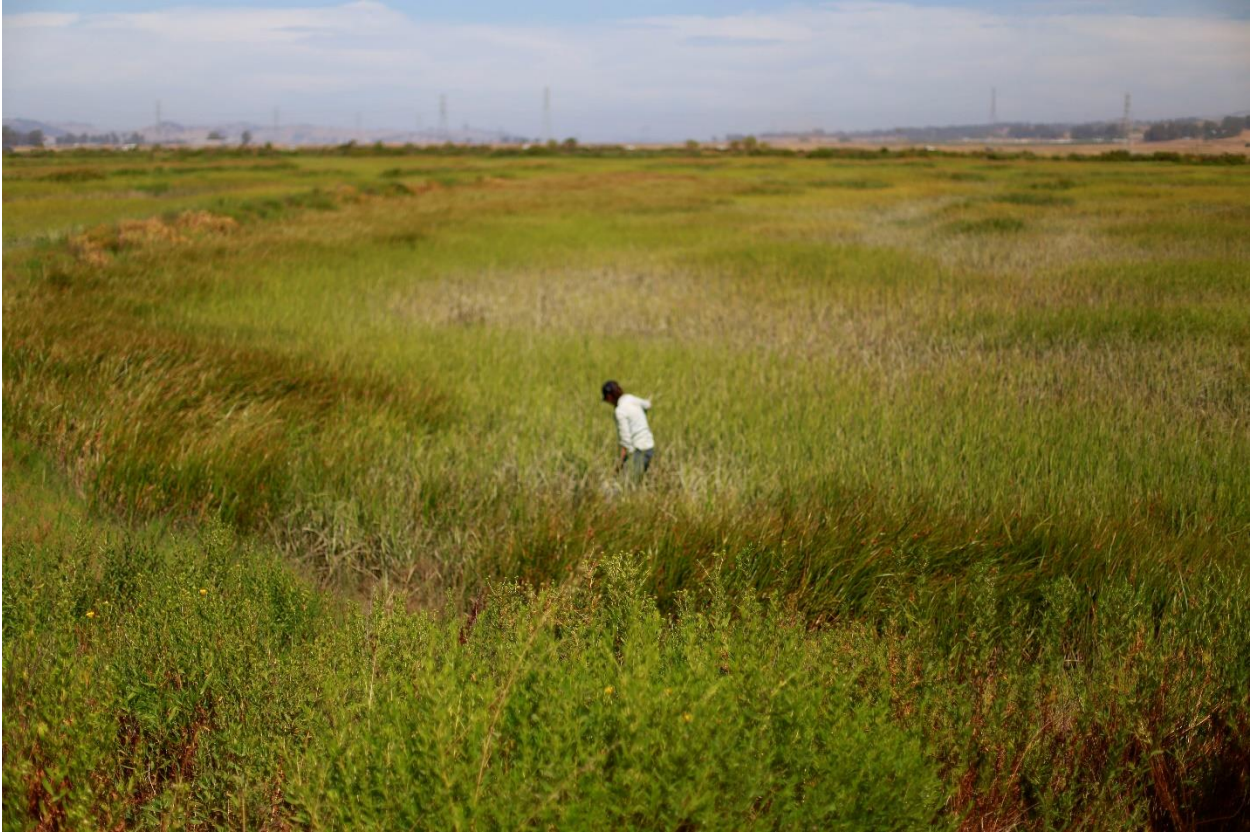
Figure 3 shows the cordgrass harvest source location in the Sonoma Baylands Marsh. The field technician in the center of the photograph is harvesting cordgrass from Source 1 (N 38.12441° W 122.47339°).

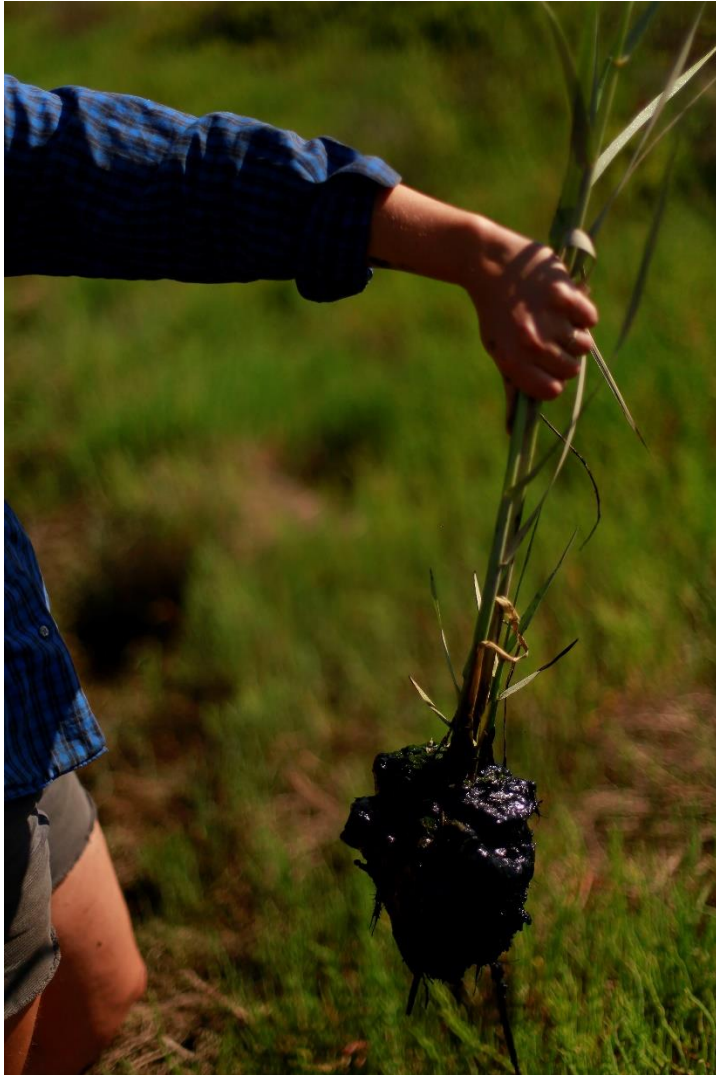
Figure 4 —This photograph shows an example of one cordgrass transplant, or plug. There are 2–3 vegetative stalks with rhizomes attached, which are covered in dark, silty marsh mud.

cordgrass plugs by digging into the mud using a drain spade to extract 1–3 vegetative shoot clusters with roots intact, leaving mud around the base (Figure 4). We collected plugs in 5-gal buckets with a small amount of water in the bottom to keep roots wet. Each crew member harvested approximately 2 buckets of cordgrass plugs per harvest session. We then transferred plants into wetted white nylon debris bags for translocation. Bags were stored in the shade until transplant—typically a 2–4 hour window.

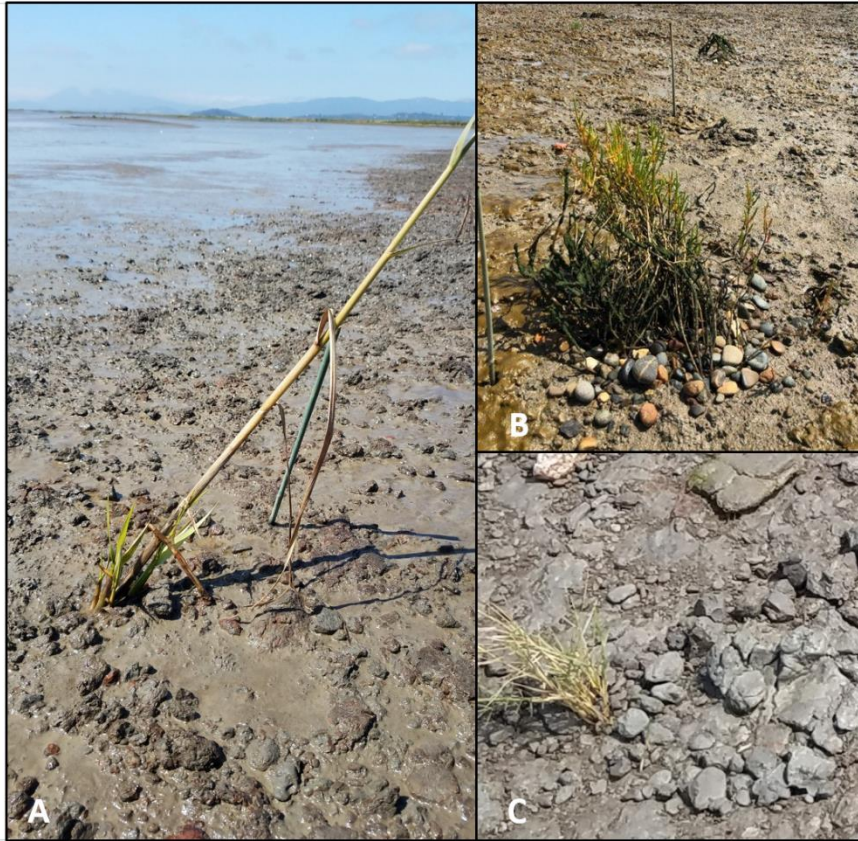
Figure 5 shows examples of each focal species once transplanted. A) cordgrass planted at 45° angle, with new daughter tillers emerging around base; B) pickleweed transplant with rock baffle around base of plant for added wave protection; C) saltgrass planted almost horizontally with 3 inches of vegetative tips exposed.

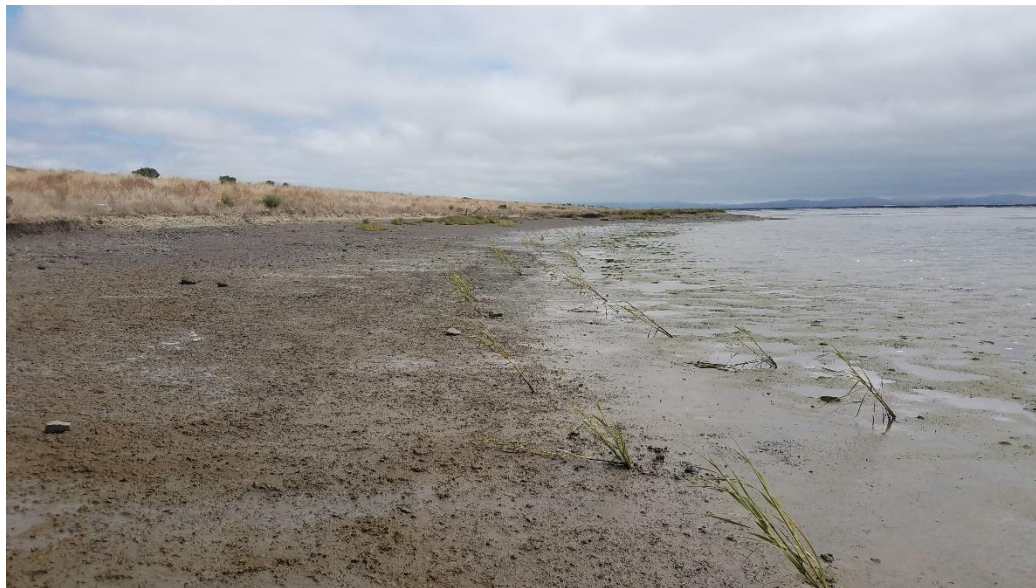
1 . 1

Standing in first cell on west end of levee, looking northeast. View shows two tiers of cordgrass transplants with new tillers on most plants.

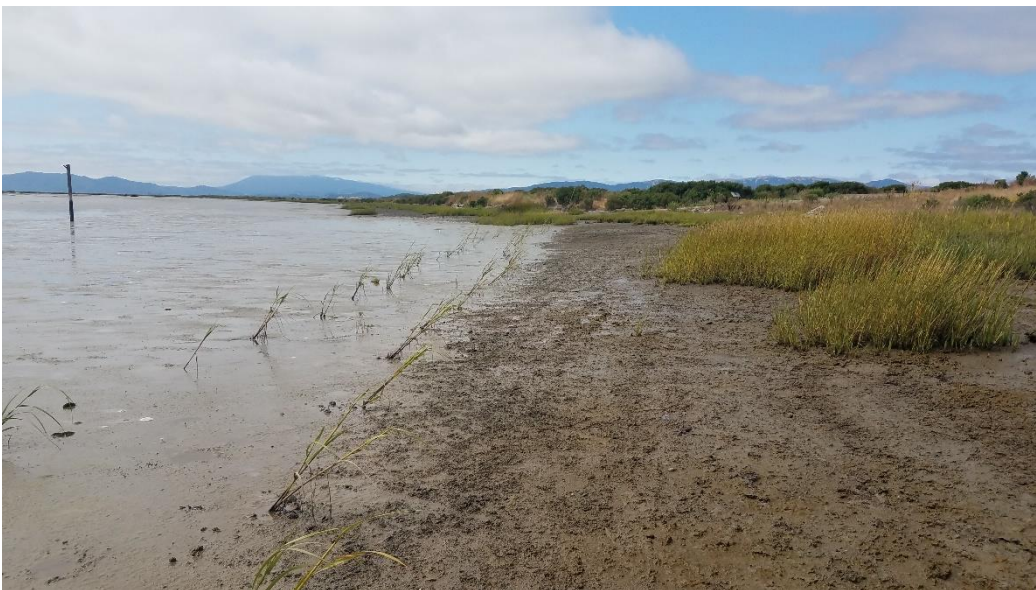
1 . 2

Standing in first cell looking SW. Two tiers of cordgrass plantings are shown in sheer/soft mudflat. Note local colony of *Spartina* flowering in right side of photo.

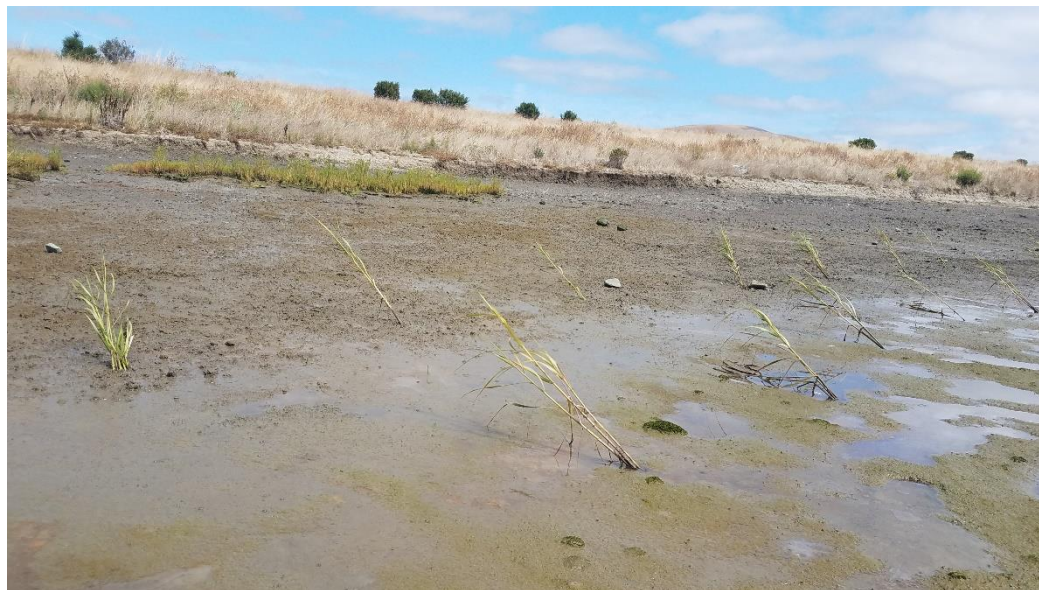
1 . 3

Standing aligned with lower tier of cordgrass transplants in first cell, looking north at levee. Higher elevation transplants are in background.

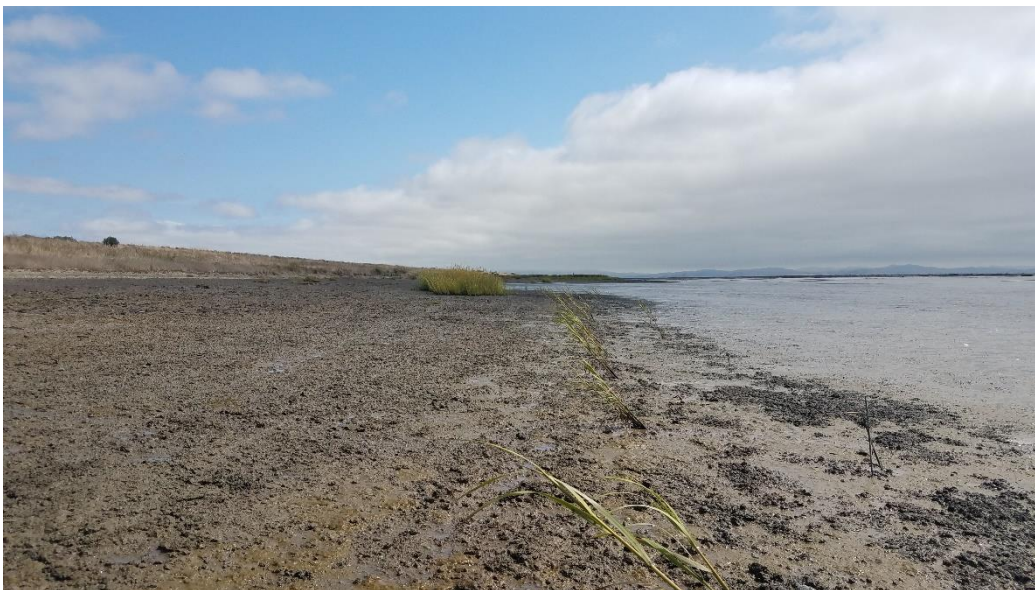
2 . 1

Standing in Cell 2, looking east. Two tiers of cordgrass transplants showing new growth.

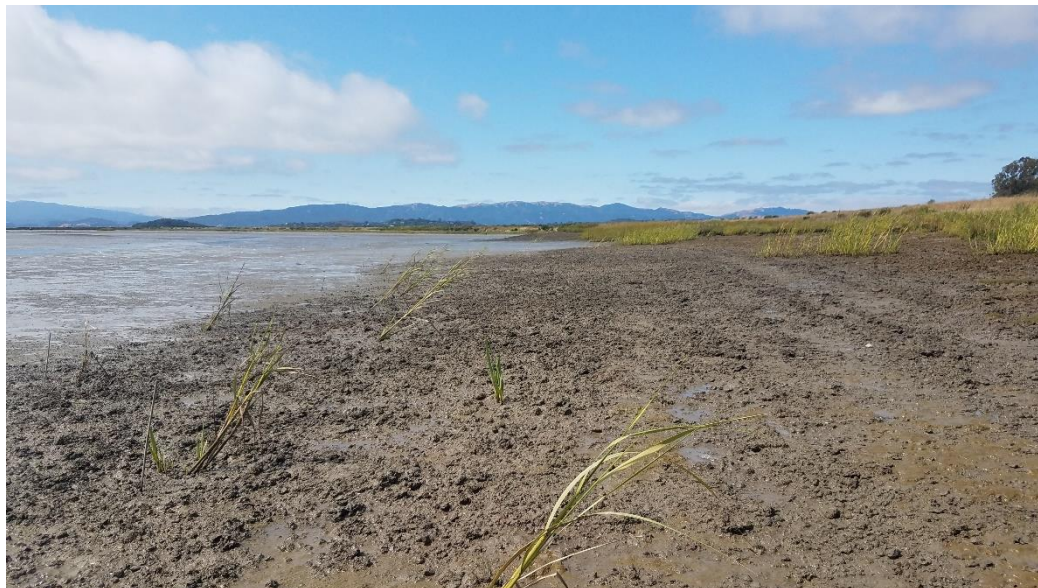
2 . 2

Standing in bay pan of second cell, looking SW. Two tiers of cordgrass transplants can be seen in left side of photograph. Saltgrass transplants can be seen 2m above on right.

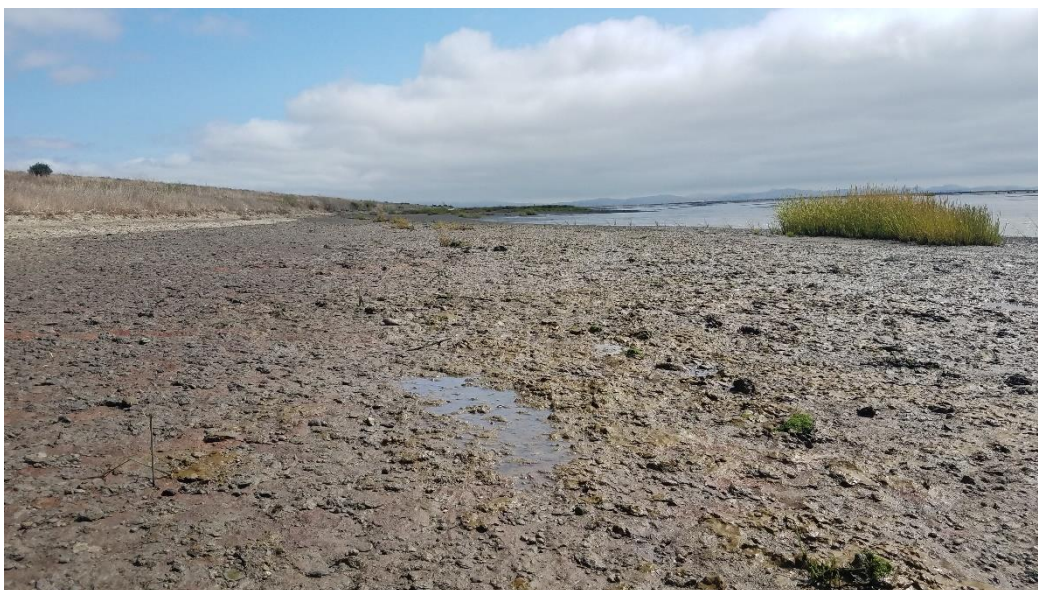
2 . 3

Standing in Cell 2, slightly east and higher in elevation than photo 2.2. Photo shows pickleweed & saltgrass plantings in foreground (indicated by bamboo stakes) and cordgrass transplants in background.

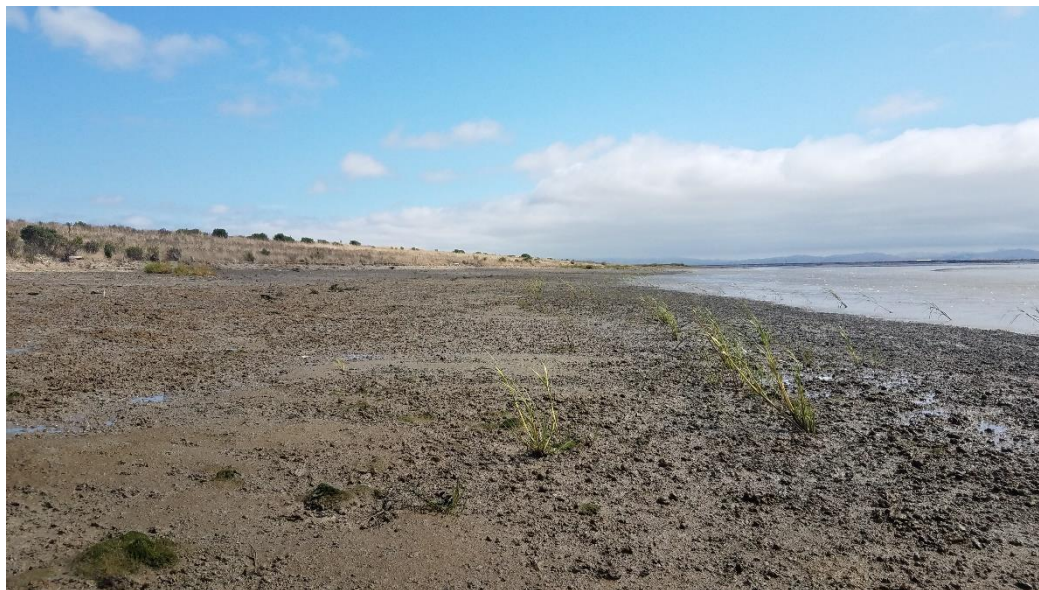
3 . 1

Standing in bay pan of Cell 4 looking NE. Cordgrass transplants in foreground with lots of new daughter shoots. Bigger plants appear healthier than smaller plants.

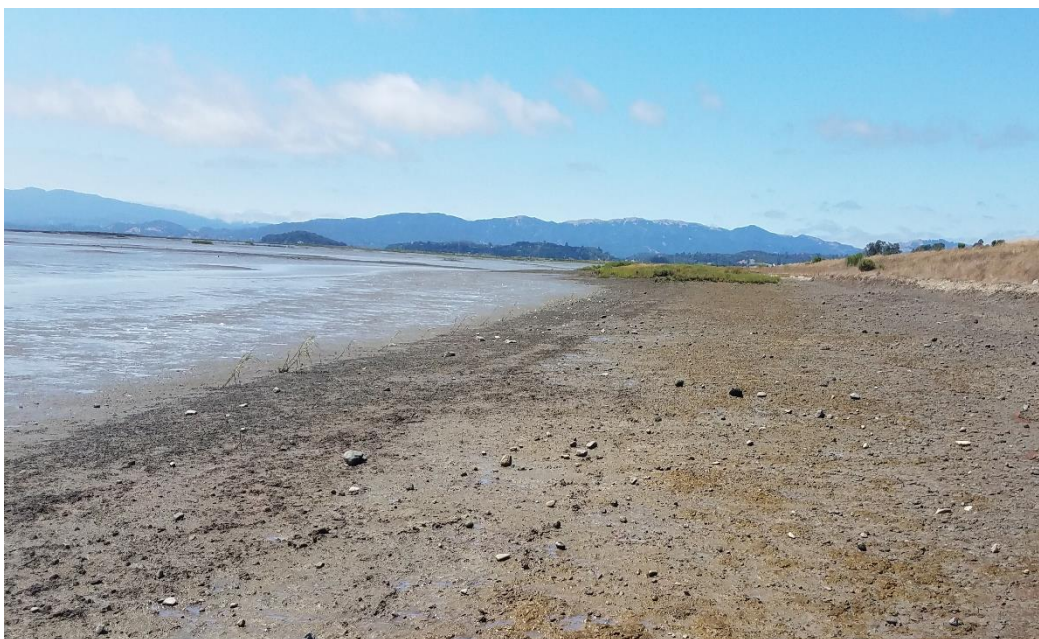
3 . 2

Standing in Cell 4 looking west. Cordgrass transplants are along shear edge of mudflat on left of photograph.

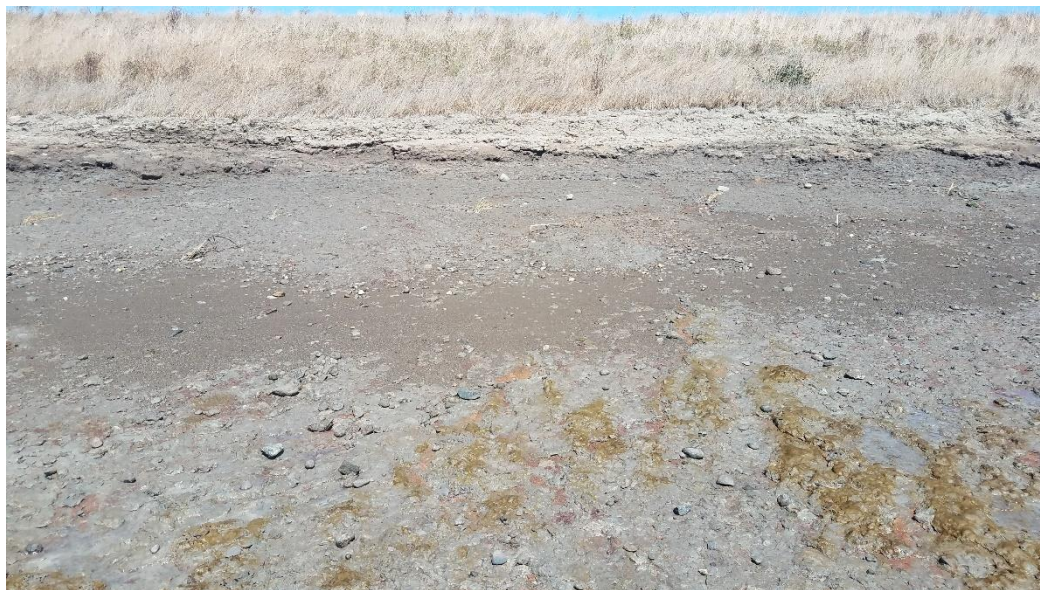
3 . 3

Facing N towards levee scarp in Cell 4, showing upper elevation saltgrass, pickleweed, and bulrush transplants. Many are dormant and brown, but not dead.

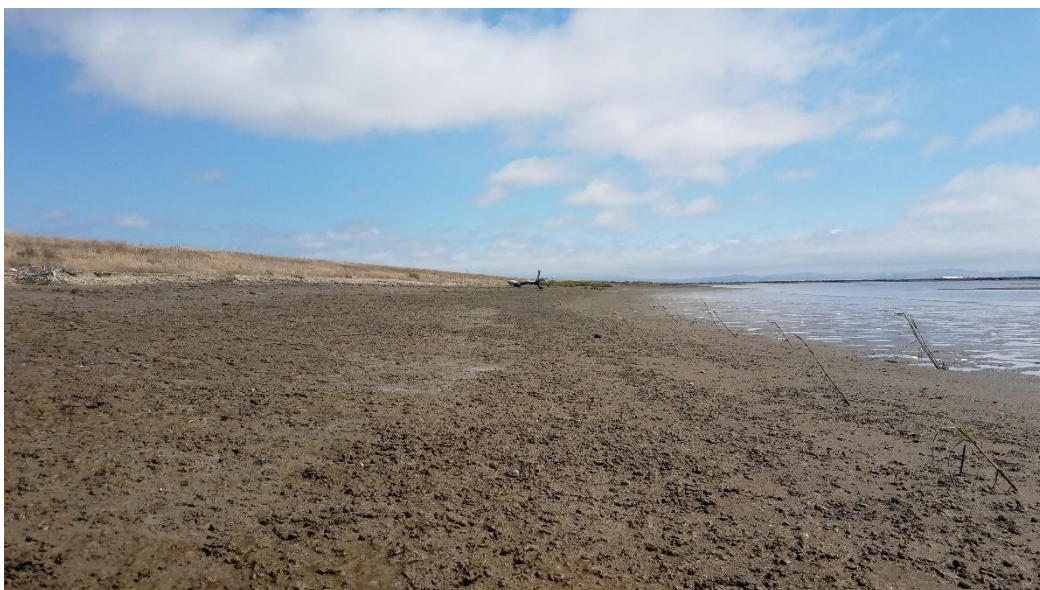
4 . 1

Standing in cell 6 looking NE. One row of cordgrass transplants are to right of photograph.

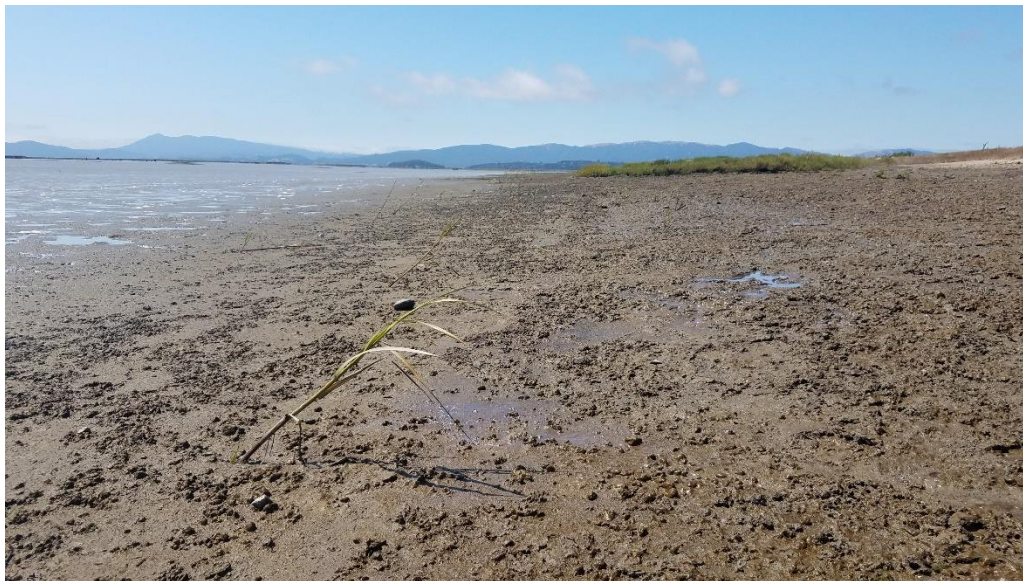
4 . 2

Standing in Cell 6 looking west at one tier of cordgrass transplants in rough-surfaced wave scoured mudflat.

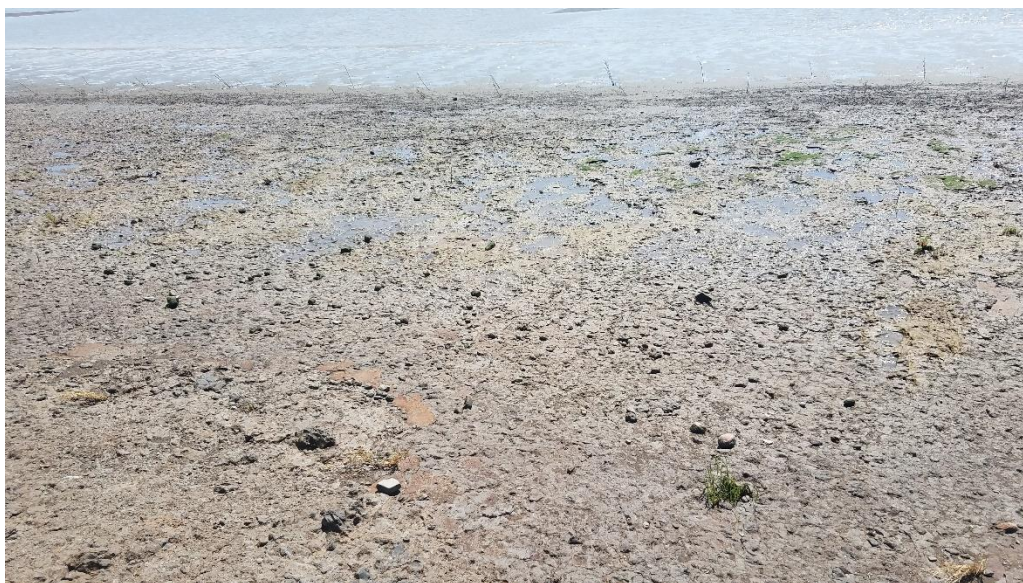
4 . 3

Standing on escarpment of Cell 6 (5 m inland from previous point) looking S at cordgrass plantings.

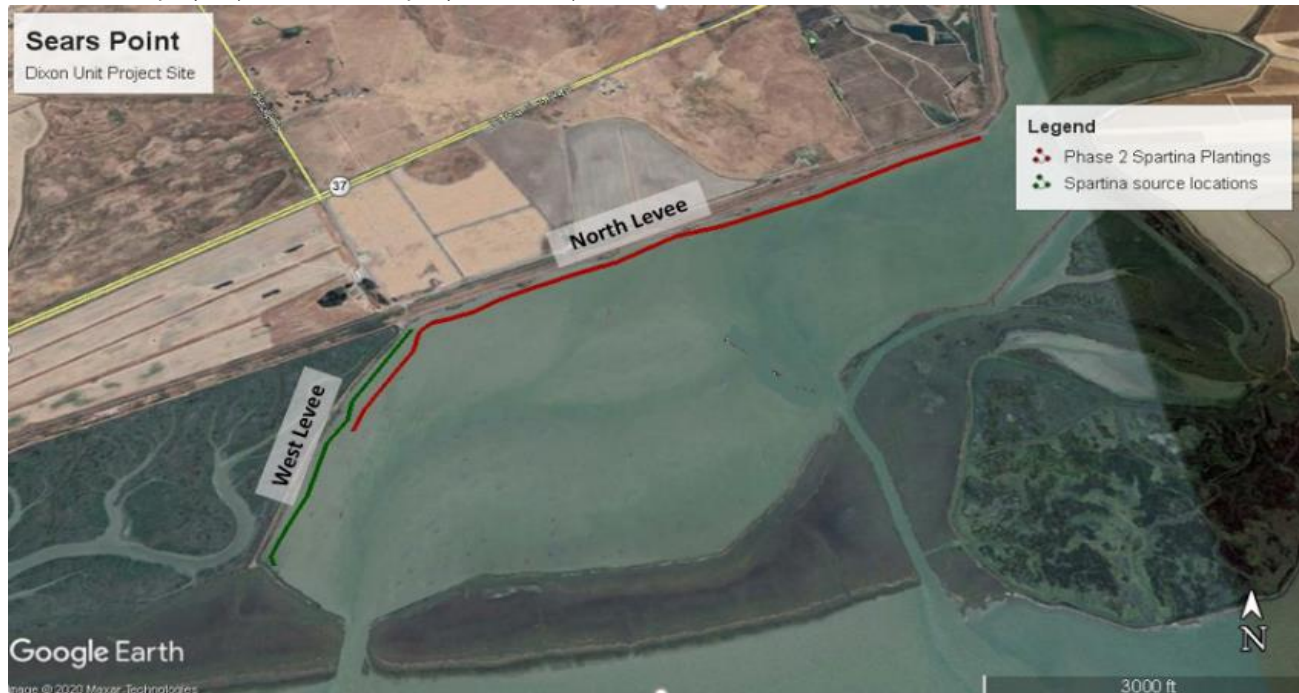
**Figure 1** Google Earth Image highlighting the source location (green line) and transplant area (red line) for Phase 2 *Spartina* plantings within Sears Point Tidal Wetland Restoration site.

Phase 2 of this work took place along the northern and western shores of SPRA, in the northern reaches of San Pablo Bay (Figure 1). Planting commenced on 31 July 2020 and continued 2–3 days per week through 28 August 2020. Timing of planting varied daily with the tides—executing the work around low tide was necessary to effectively bury transplants at low elevations. The time spent planting was consistently 7–8 hours per day, including time for prepping, harvesting, cleaning and transport. Our planting crew spent 280 total hours in the field. Personnel included Kate Freeman (DU), Taj Hittenberg (DU), Eric Riordan (DU), Michael Zehyr (DU), and Steve Pye (volunteer).

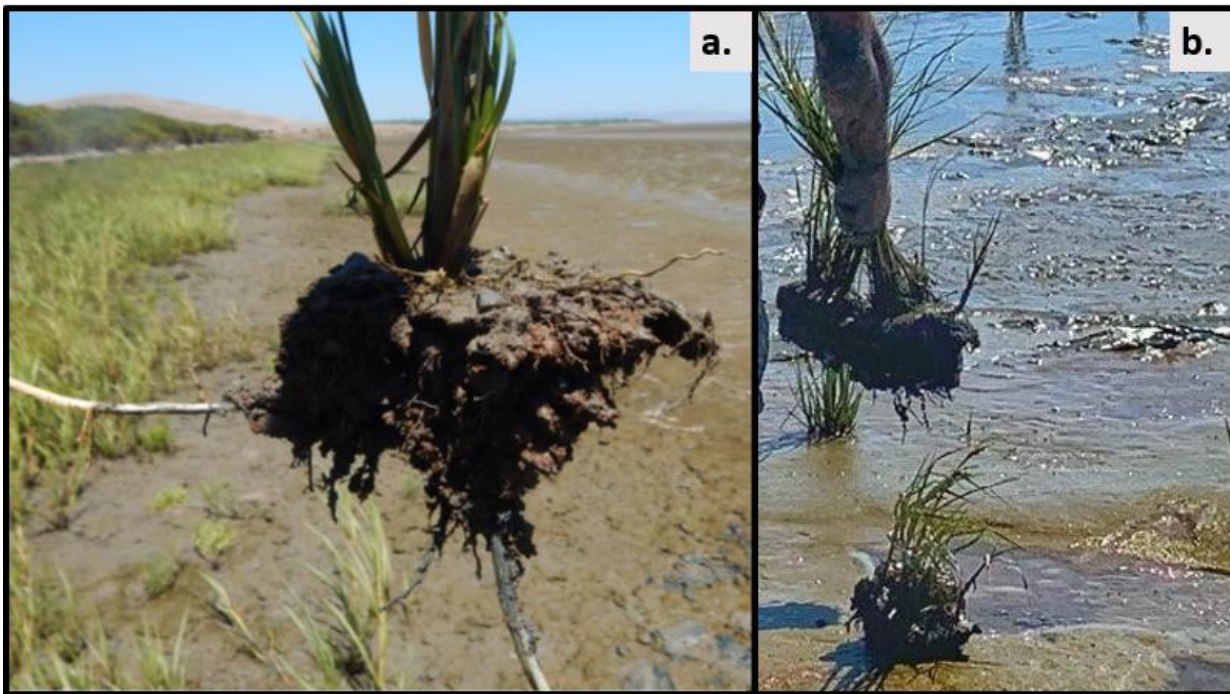
**Figure 2** Photos of *Spartina foliosa* propagules, or sod plugs, used for transplanting. Panel a. shows propagule close-up with cohesive mud surrounding roots and white rhizomes sticking out of the bottom. In Panel b., a crew member holds several plugs by the vegetative shoots, ready to plant.

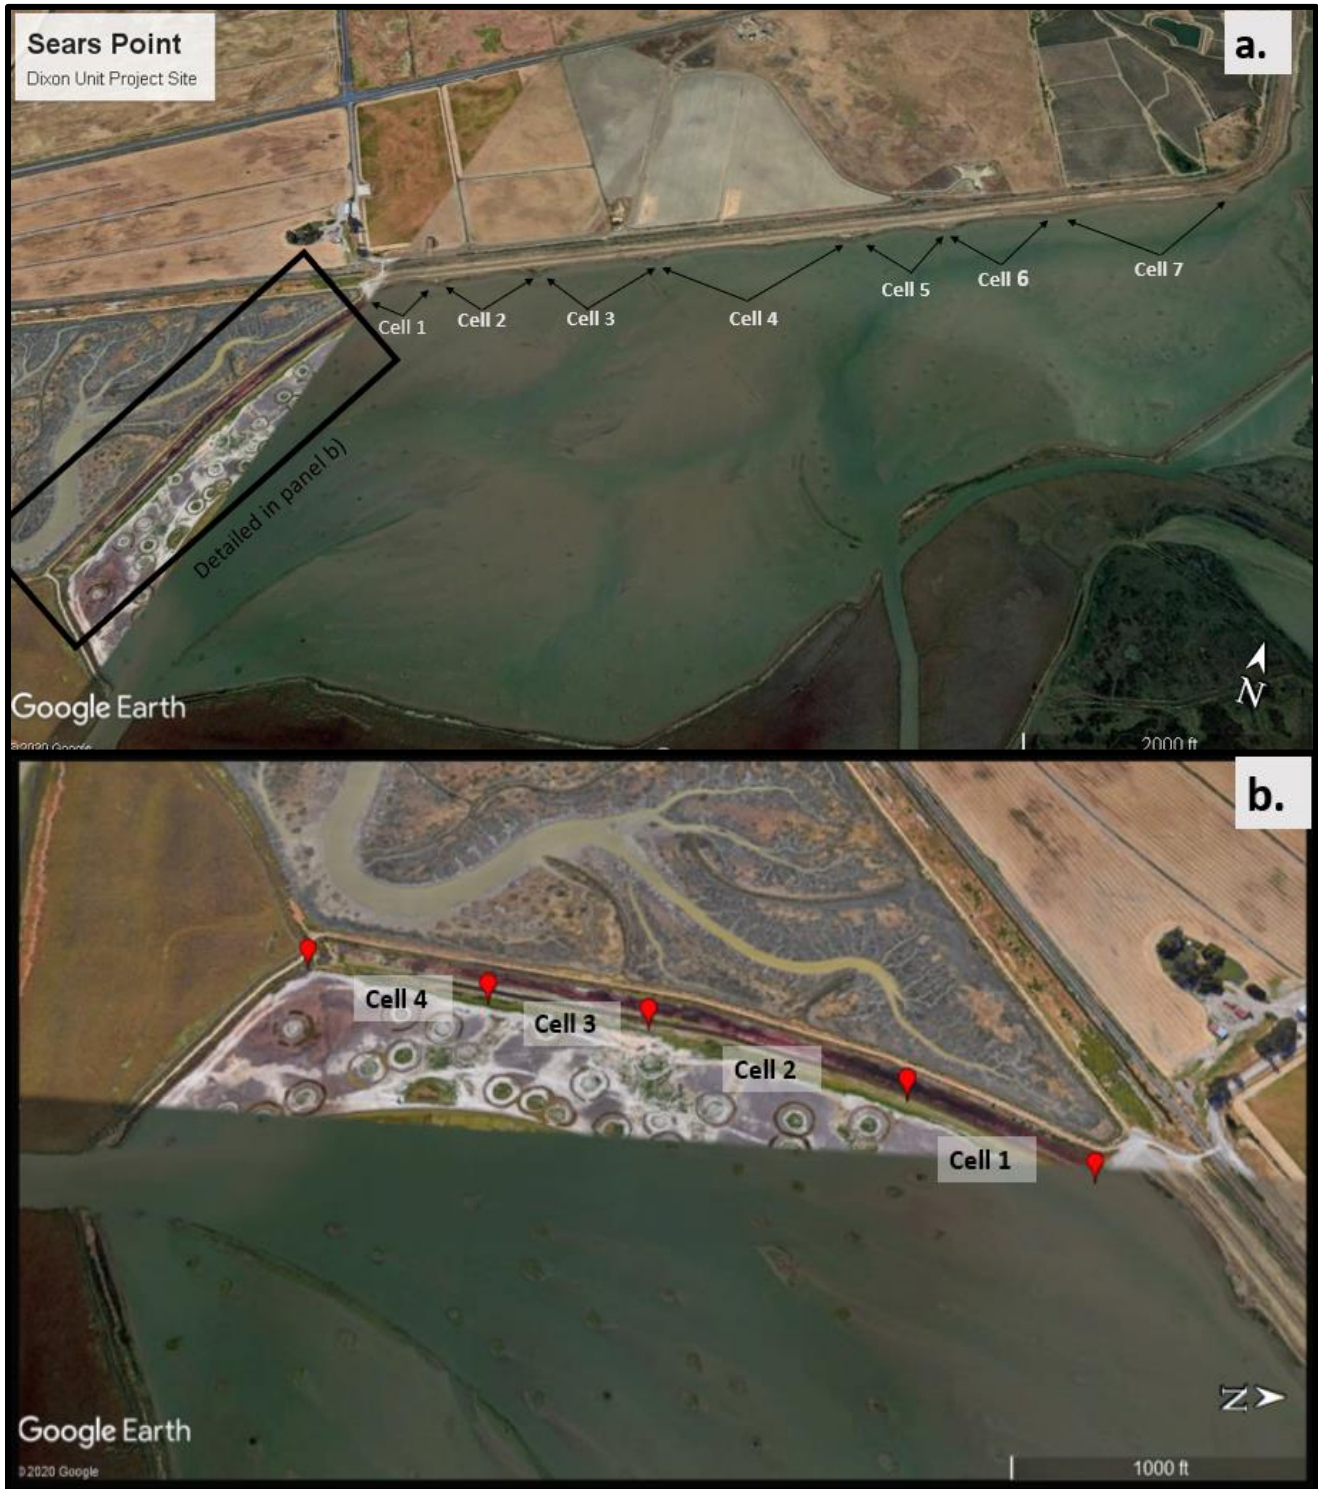
**Figure 3** Google Earth imagery gives an overview of the functional planting and harvest units for *S. foliosa* planting within Sears Point Restoration Area. Panel a. shows the North levee labeled with Cells 1 through 7. Below, Panel b. highlights the borrow cells (1 through 4) of the West levee. *Note the difference in orientation and scale between panels a. and b.*

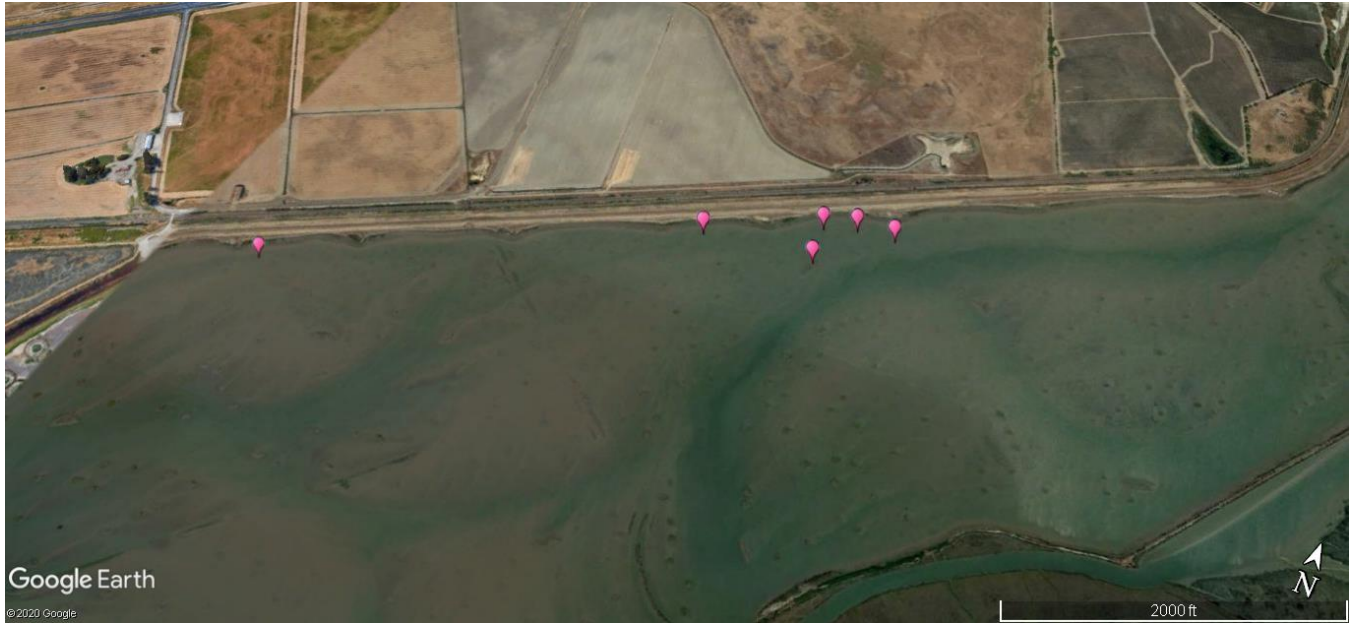
**Figure 4** Google Earth image shows locations (pink marker) for *S. foliosa* planting on six nearshore mounds.

Lastly, we planted cordgrass on several unvegetated marsh mounds to verify whether sod fragments can establish on mounds or accreted mudflats. We transplanted 3–6 sod plugs on mounds in cells 2, 4 and 5 as well as one accreted mudflat in Cell 5 (Figure 4). Mound planted method is depicted in Figure 5.

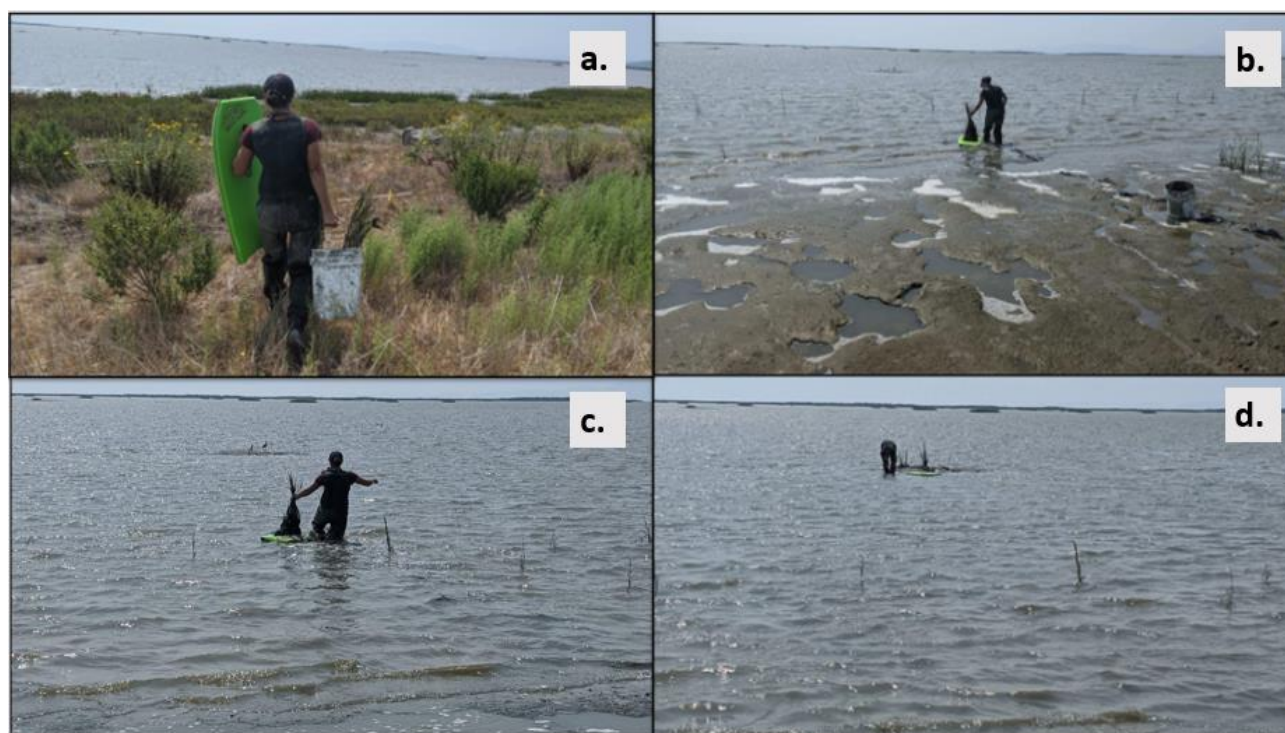
**Figure 5**—This photo series illustrates the process of planting *S. foliosa* on nearshore marsh mounds. Near high tide we: **a.** prepared boogie board and bucket of sod plugs; **b.** loaded plugs onto boogie board; **c.** floated boogie board out to marsh mound; **d.** planted plugs in soft mud of bare mounds.

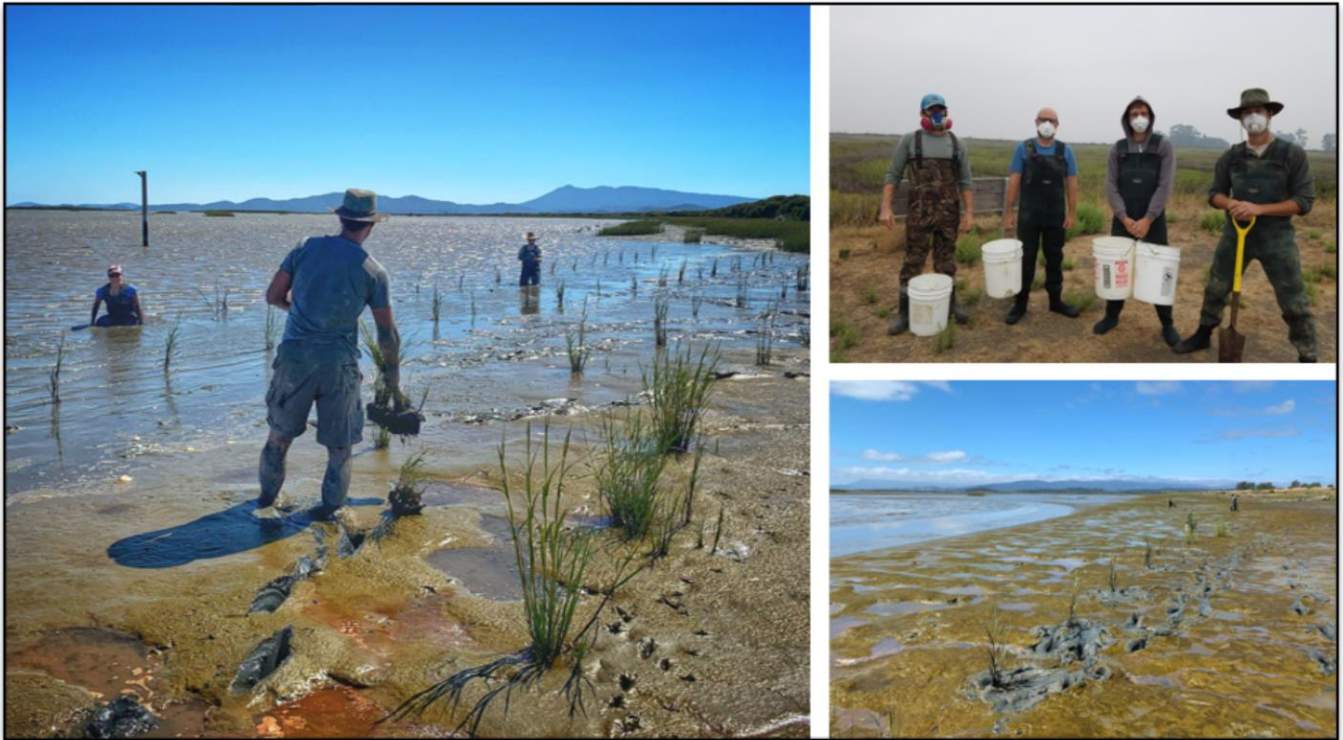
**Figure 6—** Snapshots of the *S. foliosa* planting process. The left-hand photo shows crew members planting cordgrass plugs in Cell 1 during an outgoing tide. *Spartina* plants in the foreground are from 2019 plantings. Submerged plants in the lower elevation are 2020 plantings. The upper right-hand photo shows crew members and volunteers clad in waders (and masks for COVID/smoke safety). The lower left-hand image shows planting in soft mud during low tide.

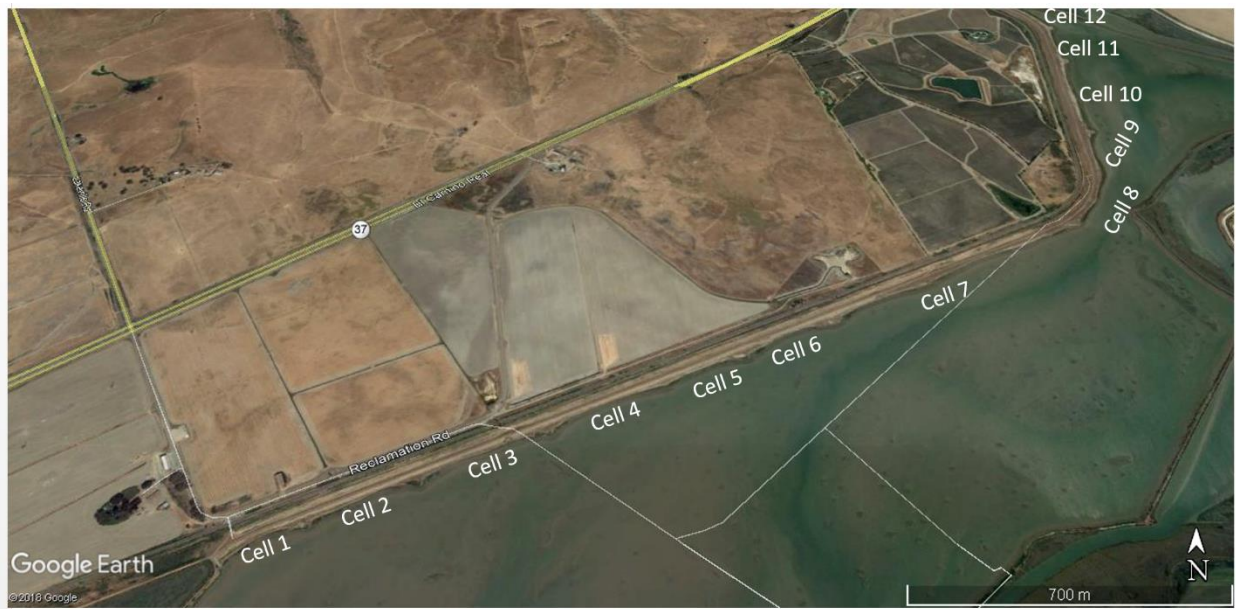
Figure 1 Google Earth image of project area with functional planting units—cells—labeled 1 through 12.

**Methods:** I conducted the monitoring visit on November 6, 2019 during low tide (approximately 1300 to 1530h). During this time I observed *Spartina* mortality and survival in Cells 1 through 8 on the north shore levee (Figure 1). Monitoring began with Cell 8 and progressed in a westward direction to cell 1. In each cell I sampled 30% of *Spartina* originally planted to estimate differences in survival per cell. Sampling began at randomly selected locations within each cell, and moved in a westward direction from the starting point. From the random start location, I counted each consecutive plant until the count reached 30%. In cells with two tiers of transplants (and a low-elevation row and a mid-elevation row  $\approx$  2 meters landward) both tiers were counted in the sample. A transplant was counted as alive if it showed new growth (daughter tillers). Plants were counted as dead if there was no evidence of new growth or if the plant had eroded, leaving only a bamboo stake. I estimated survival rate as the total number of plants alive divided by the total sample size (see table).

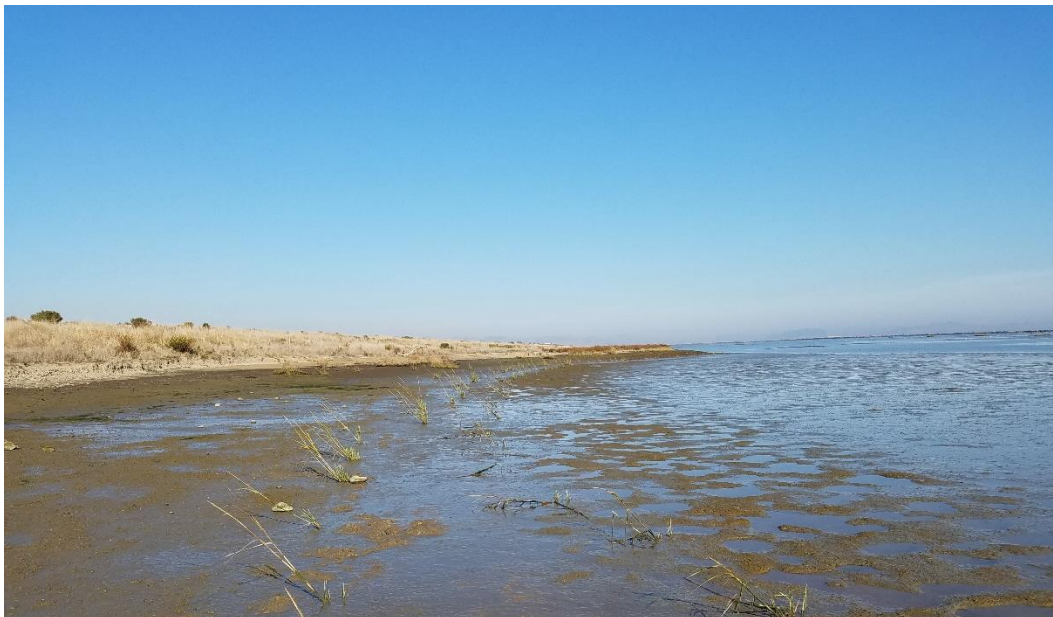
1 . 1

Standing in first cell on west end of levee, looking northeast. View shows two tiers of cordgrass transplants with new growth and high survival rates.

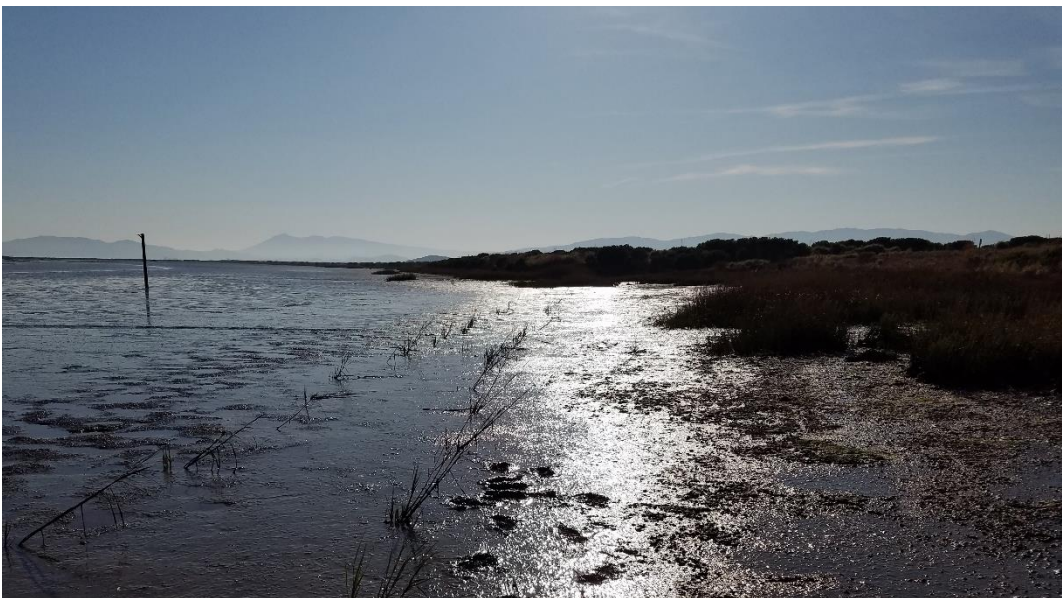
1 . 2

Standing in first cell looking SW. Two tiers of cordgrass plantings are shown in sheer/soft mudflat.

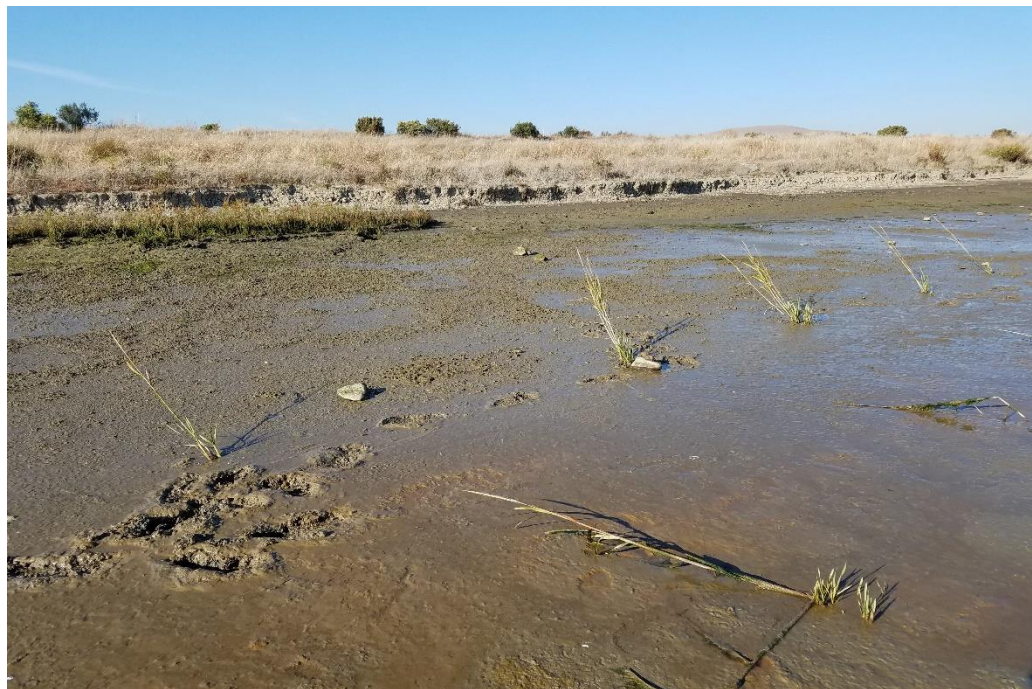
1 . 3

Standing aligned with lower tier of cordgrass transplants in first cell, looking north at levee. Higher elevation transplants are in background.

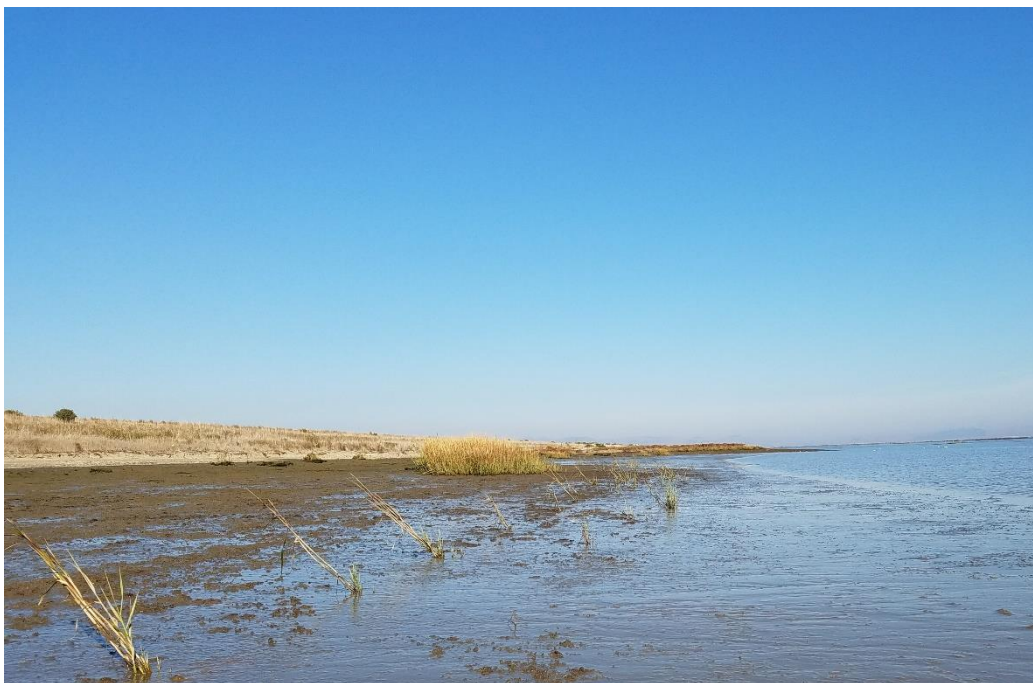
2 . 1

Standing in Cell 2, looking east. Two tiers of cordgrass transplants sustaining new growth and relatively high survival in this cell.
