## **Appendix F. Northern Levee Cordgrass Planting**

### **Northern Levee Cordgrass Planting**

Subject: Sears Point Levee Planting Project Memo

# Sears Point Spartina Planting, Phase 2 Project Summary Report

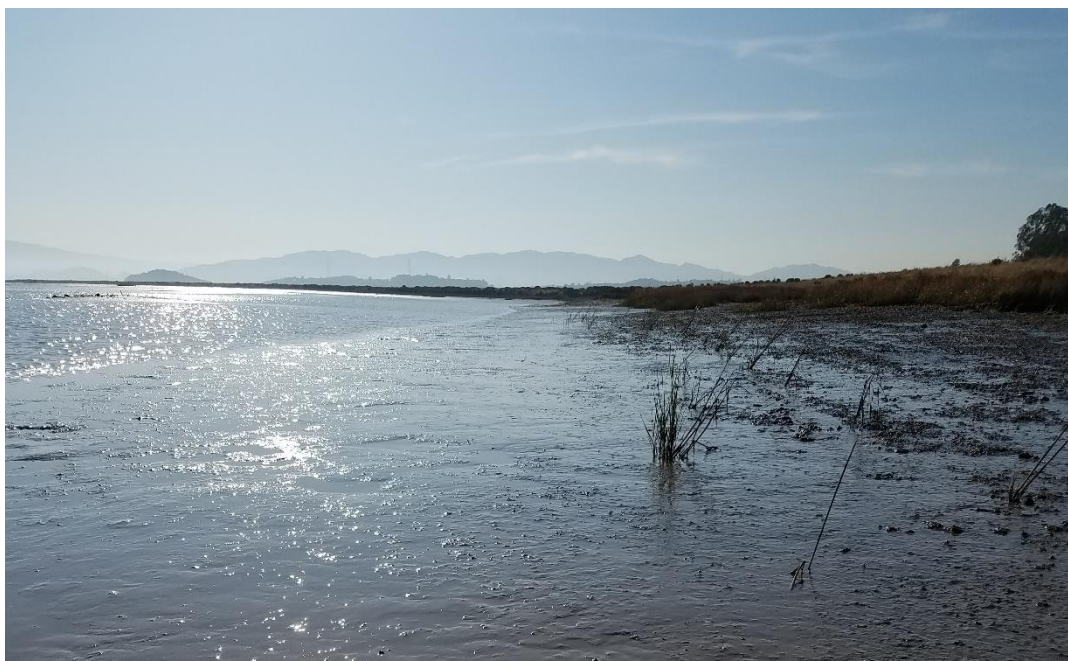
2 . 2

Standing in bay pan of second cell, looking SW. Two tiers of cordgrass transplants can be seen with new growth on many plants.

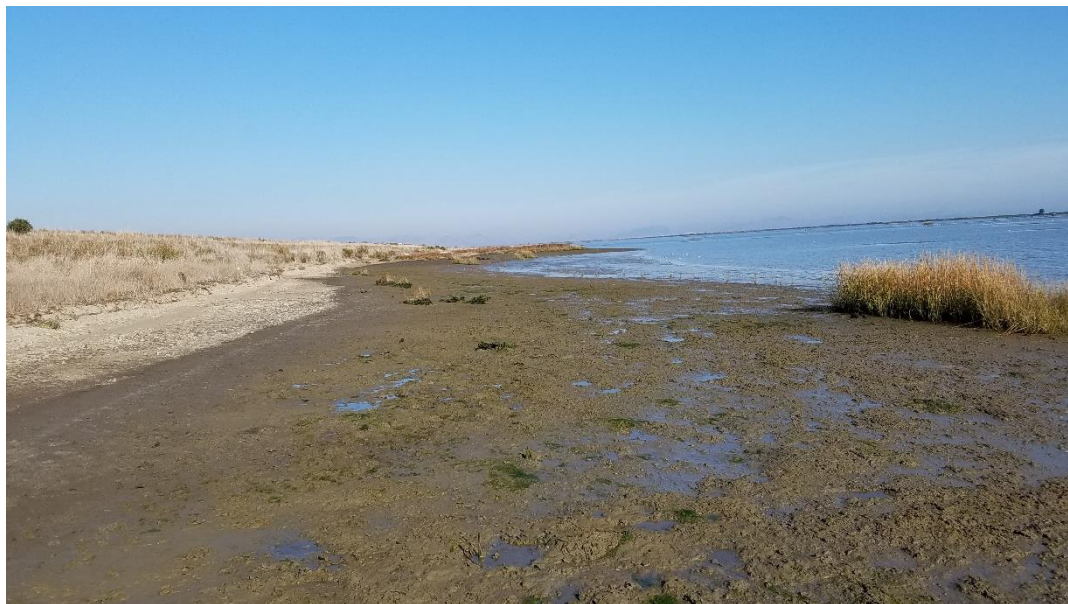
2 . 3

Standing in Cell 2, slightly east and higher in elevation than photo 2.2. Photo shows pickleweed & saltgrass plantings mostly washed away and no longer present in foreground.

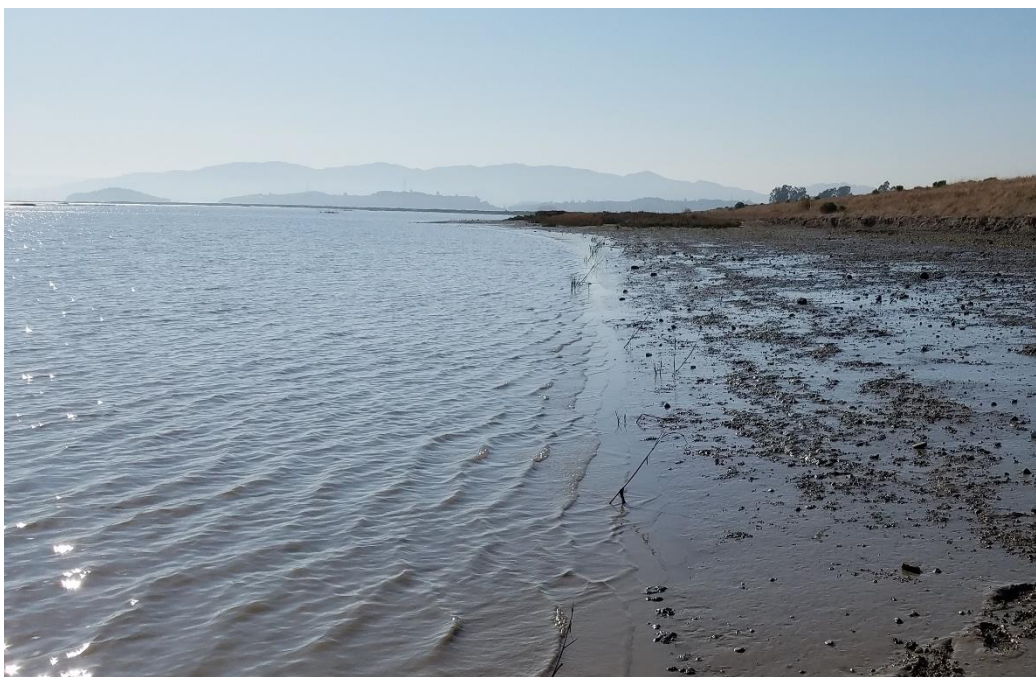
3 . 2

Standing in Cell 4 looking west. Cordgrass transplants are along shear edge of mudflat. Transplants have fewer new tillers in this cell.

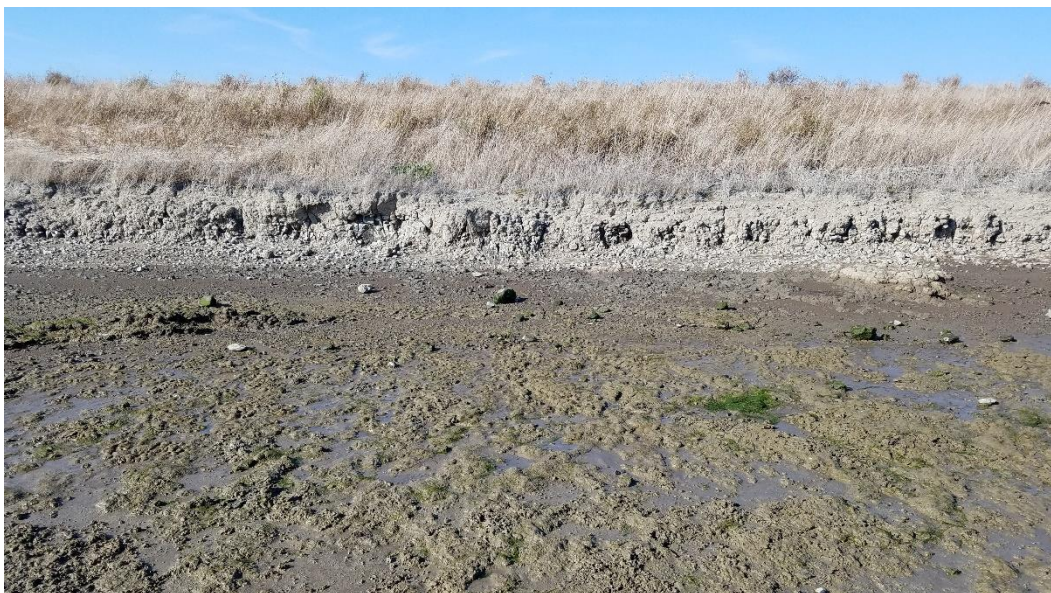
3 . 3

Facing N towards levee scarp in Cell 4, showing upper elevation saltgrass, pickleweed, and bulrush transplants. Many have eroded or died.

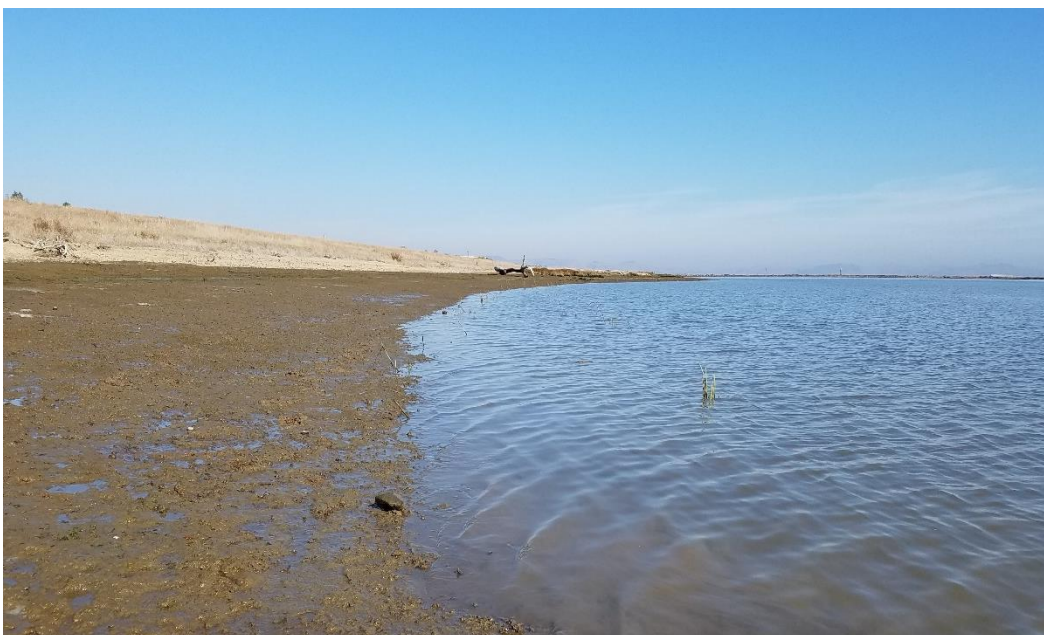
4 . 1

Standing in cell 6 looking NE. One row of cordgrass transplants is apparent at water's edge, while a second is submerged.

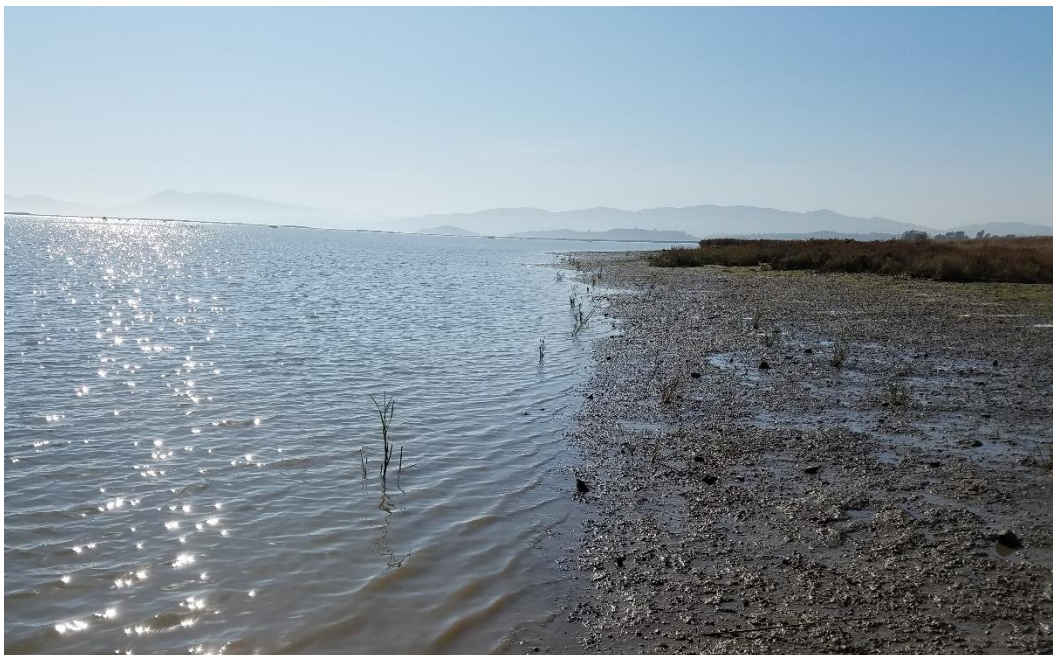
4 . 2

Standing in Cell 6 looking west at tow tiers of cordgrass transplants in rough-surfaced wave scoured mudflat. Plants with new growth and relatively high survival.

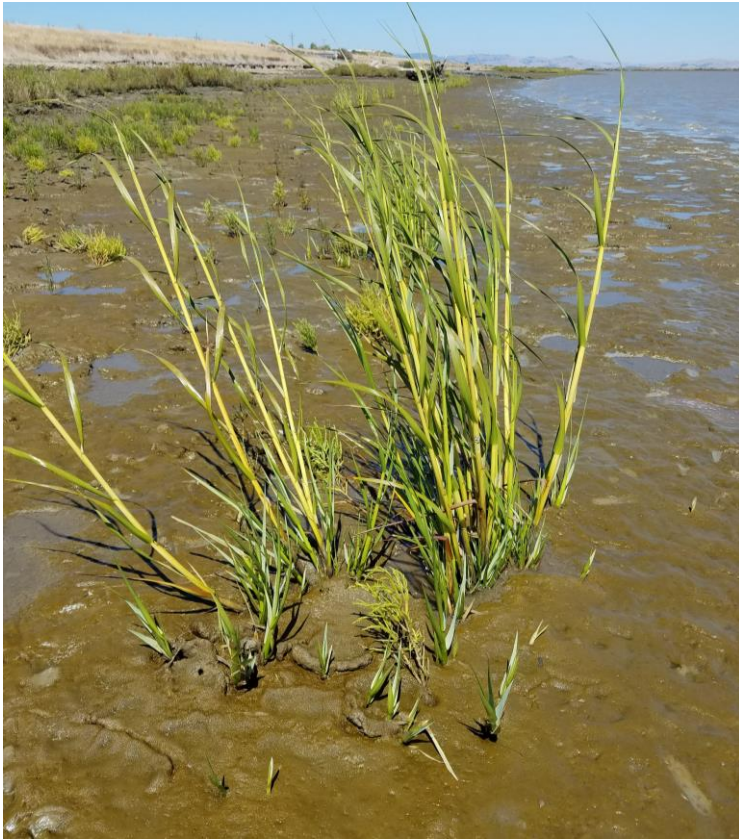
Observations: The cordgrass survival rate estimate, one year post-transplanting, is promising. The mean survival rate of cells 1–8 is 42% as of July 2020. While this rate is lower than the 77% survivorship observed in November 2019, transplant units that are alive overall appear robust and well established. Propagule units are notably denser than last summer. Many units have 8 or more  $\approx$ 2 ft tall vegetative stalks from last season, surrounded by a dozen or more new tillers (2–10 inches in height; Figure 1). The stalks of larger plants have turned a pale-yellow color, while

the newer shoots remain entirely green. Many cordgrass transplants are flowering, concurrent with resident stands.

Figure 1 Propagule unit in Cell 6 with new growth (smaller green tillers).  
Photo taken July 30, 2020.

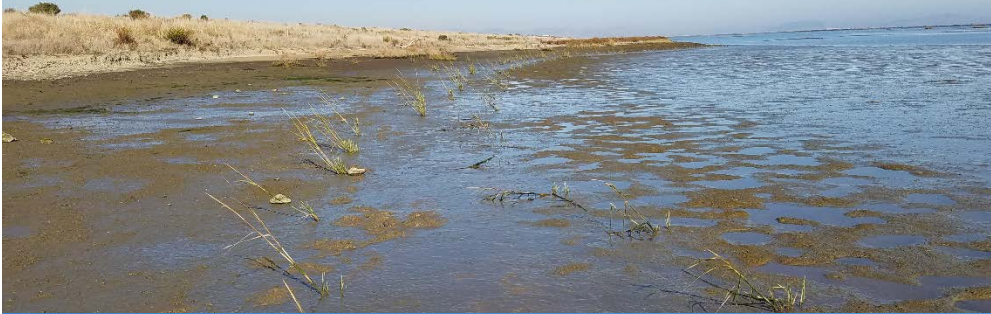
1 . 1

Standing in first cell on west end of levee, looking northeast. View shows two tiers of cordgrass transplants with new growth and high survival rates.

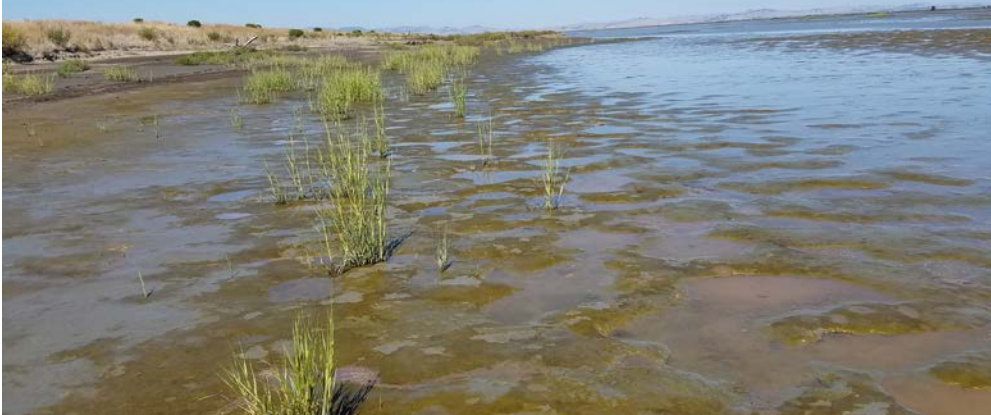
1 . 1

Standing in first cell on west end of levee, looking northeast.

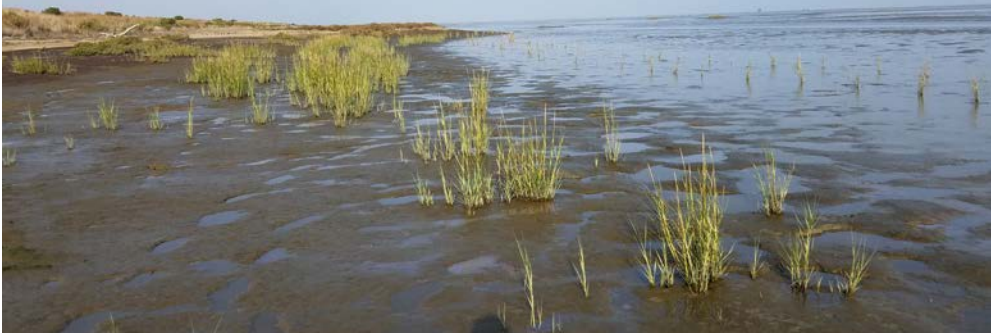
1.1

Standing in first cell on west end of levee, looking northeast. View shows four tiers of *Spartina* plugs from 2019 and 2020 (outer right).

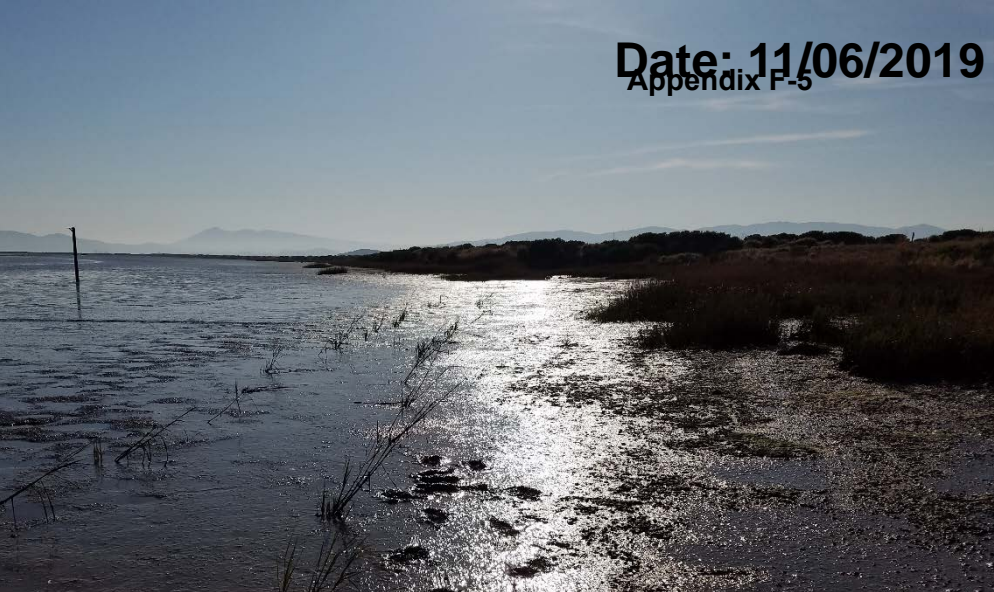
1 . 2

Standing in first cell looking SW. Two tiers of cordgrass plantings are shown in sheer/soft mudflat.

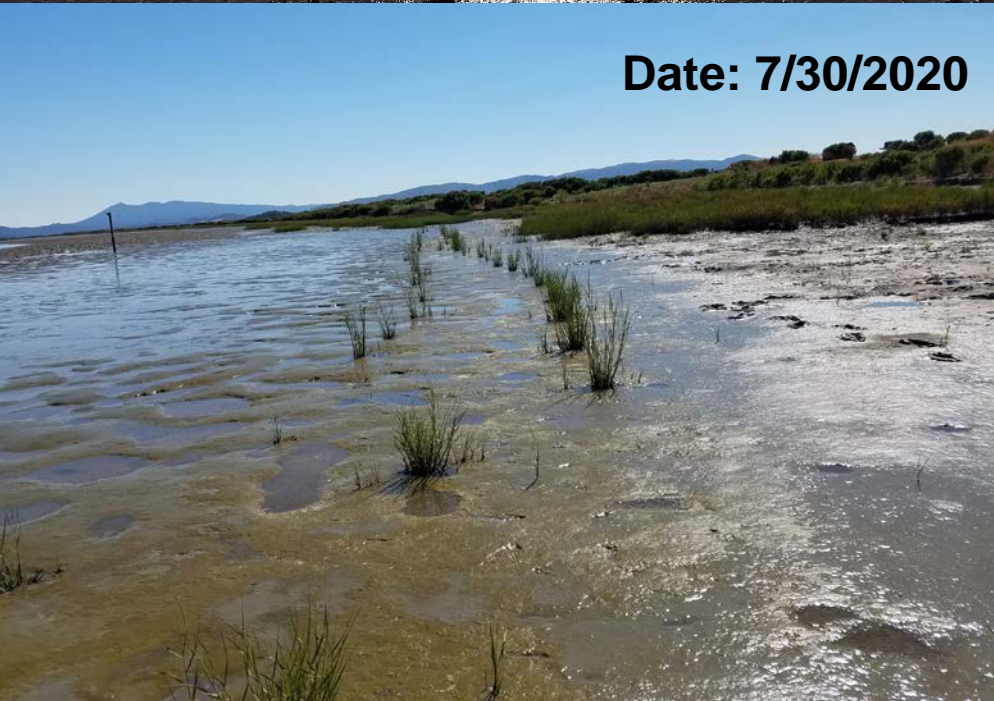
1 . 2

Standing in first cell looking SW. Two tiers of cordgrass plantings are shown in sheer/soft mudflat. Plugs are denser, with more vegetative shoots than seen in Nov 2019.

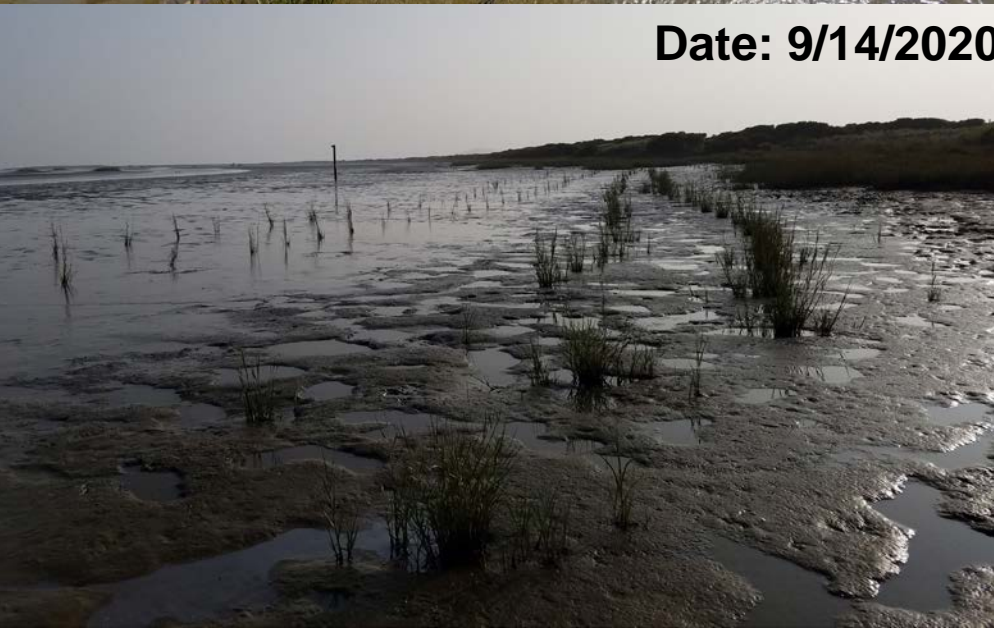
1.2

Standing in Cell 1 looking SW at four rows of cordgrass plantings. The far right are from 2019. The two lower/bayward rows were planted Aug 2020). *Hazy sky is due to regional wildfire smoke.*

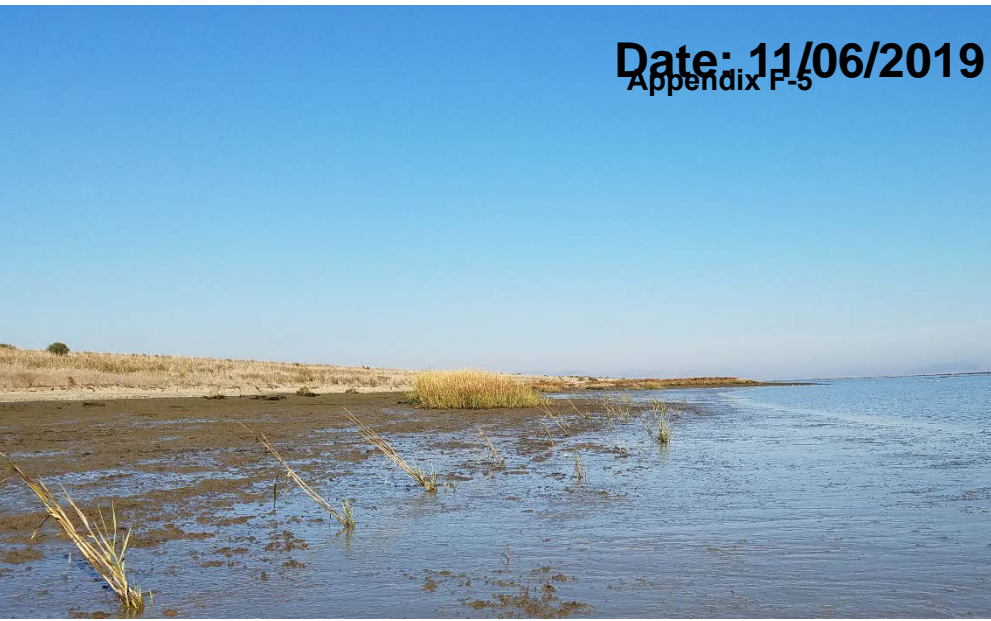
2 . 1

Standing in Cell 2, looking east.  
Two tiers of cordgrass  
transplants sustaining new  
growth and relatively high  
survival in this cell.

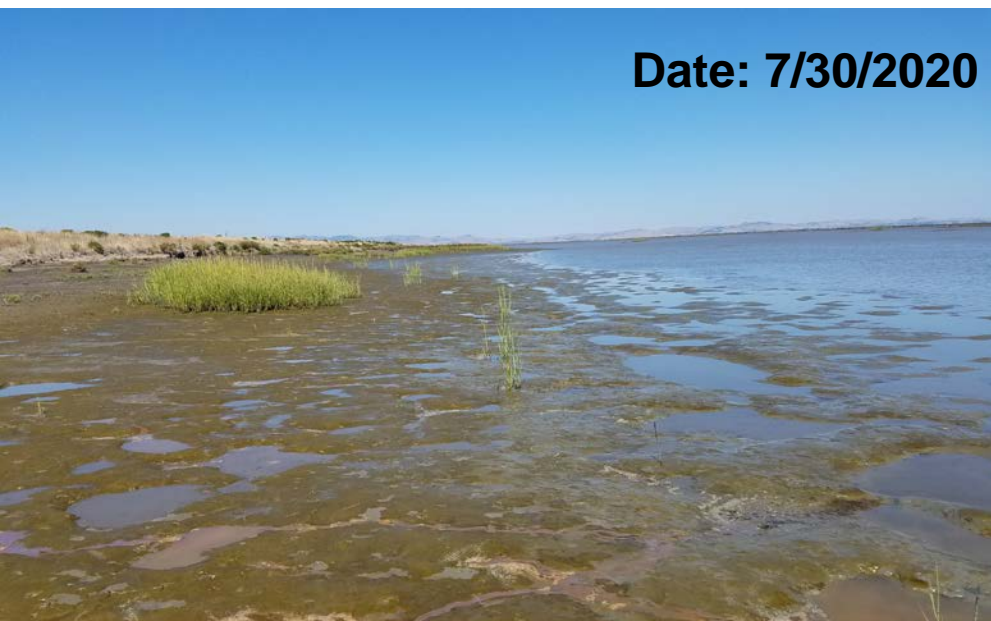
2 . 1

Standing in Cell 2, looking east.  
Two tiers of cordgrass  
transplants sustaining new  
growth and relatively high  
survival in this cell.

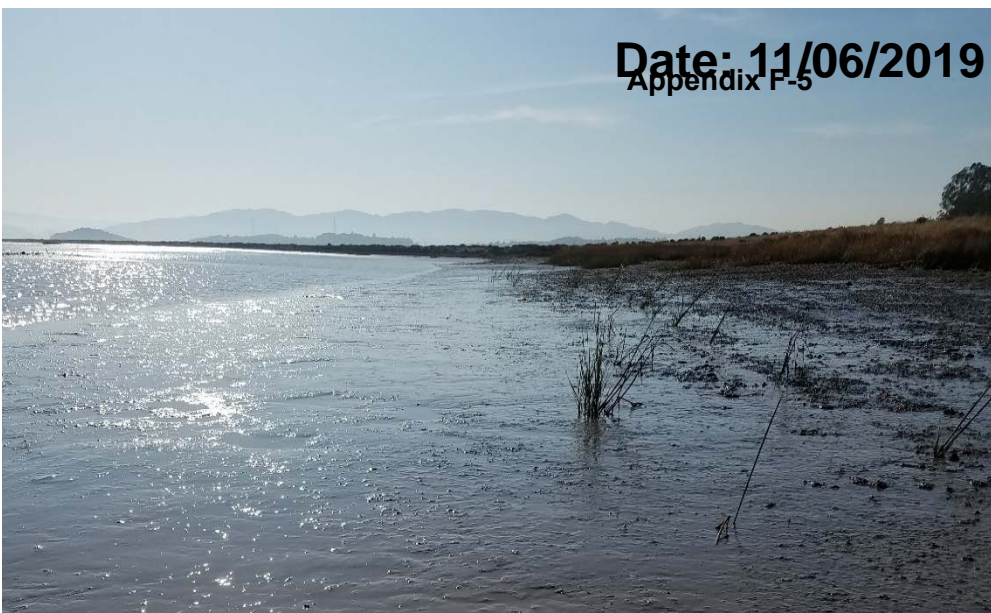
2 . 2

Standing in bay pan of second cell, looking SW. Two tiers of cordgrass transplants can be seen with new growth on many plants.

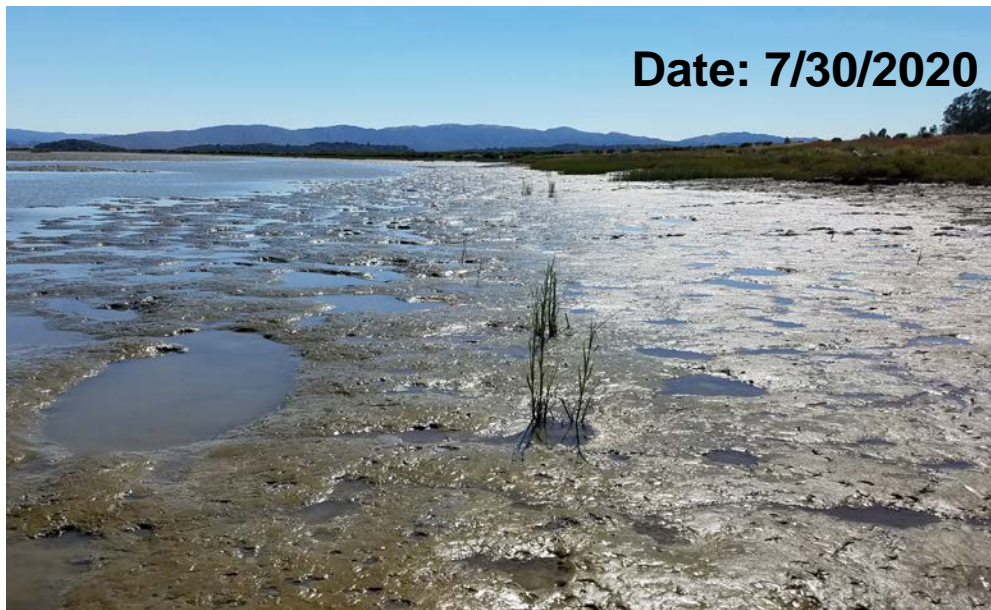
2 . 2

Standing in bay pan of second cell, looking SW. Two tiers of cordgrass transplants with some recruitment between plugs.

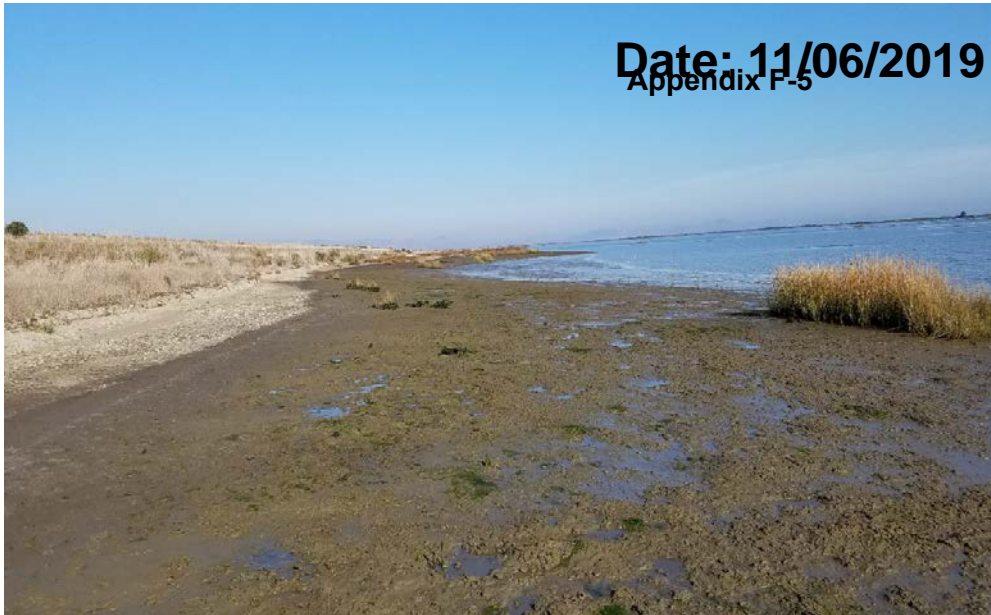
2 . 3

Standing in Cell 2, slightly east and higher in elevation than photo 2.2. Photo shows pickleweed & saltgrass plantings mostly washed away and no longer present in foreground.

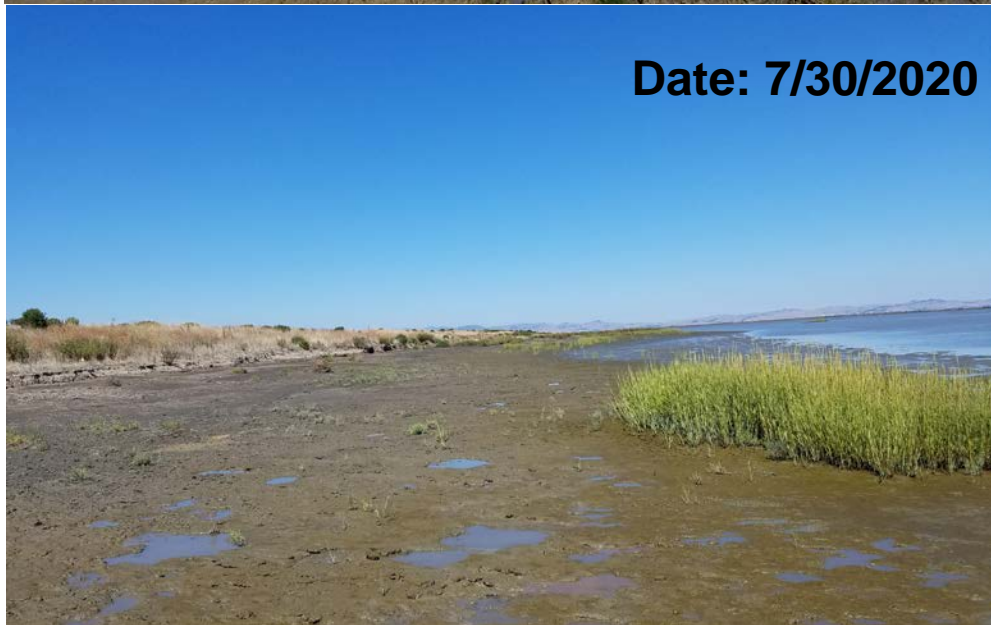
2 . 3

Standing in Cell 2, slightly east and higher in elevation than photo 2.2. Resident *Spartina* stand (right foreground) flowering.

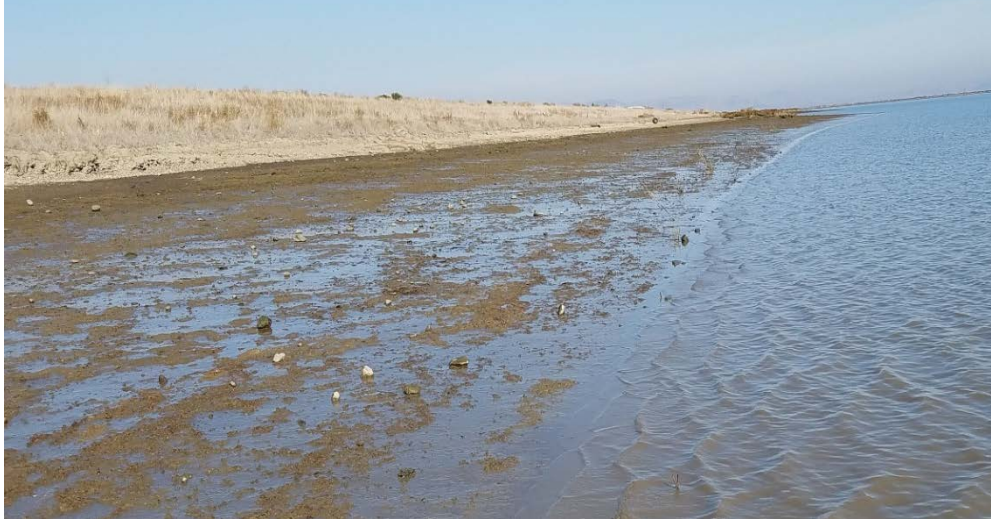
3 . 1

Cell 4 had markedly fewer established *Spartina* than others. This could be due to unintended placement of more single-shoot plugs in this cell; however, other variables such as soil condition, wind erosion, and elevation should not be ruled out. In contrast to Cell 4, transplants in cell 1 seemed especially vigorous, with abundant new growth in both tiers.

Standing in bay pan of Cell 4 looking NE. Cordgrass transplants show relatively low survival here. Plugs (along water's edge) are hard to discern in photograph .

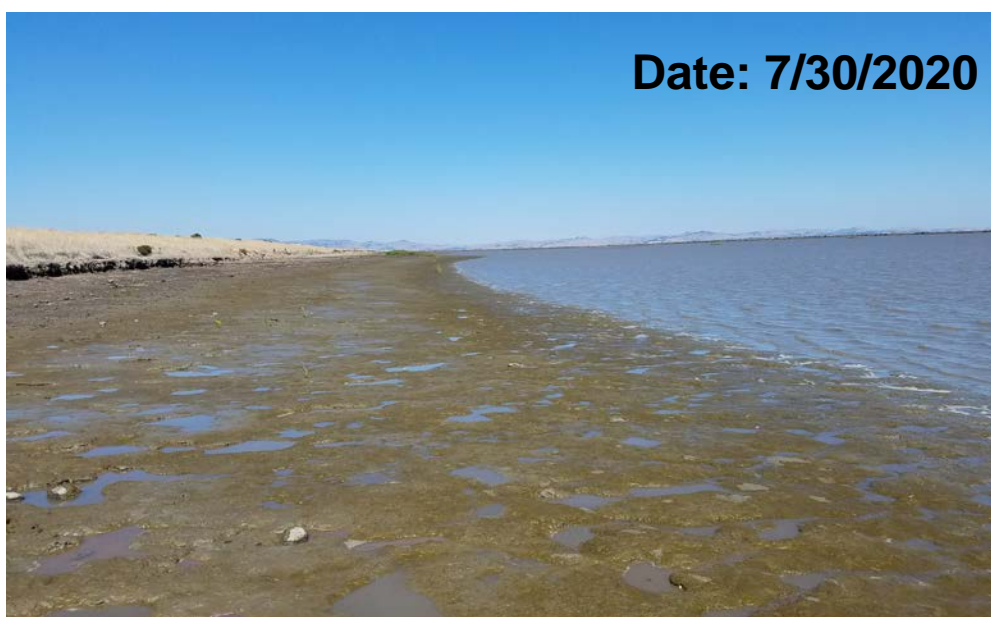
3 . 1

Standing in bay pan of Cell 4 looking NE. Cordgrass transplants show relatively low survival here, especially in the middle of the cell. Plugs (along water's edge) are hard to discern in photograph.

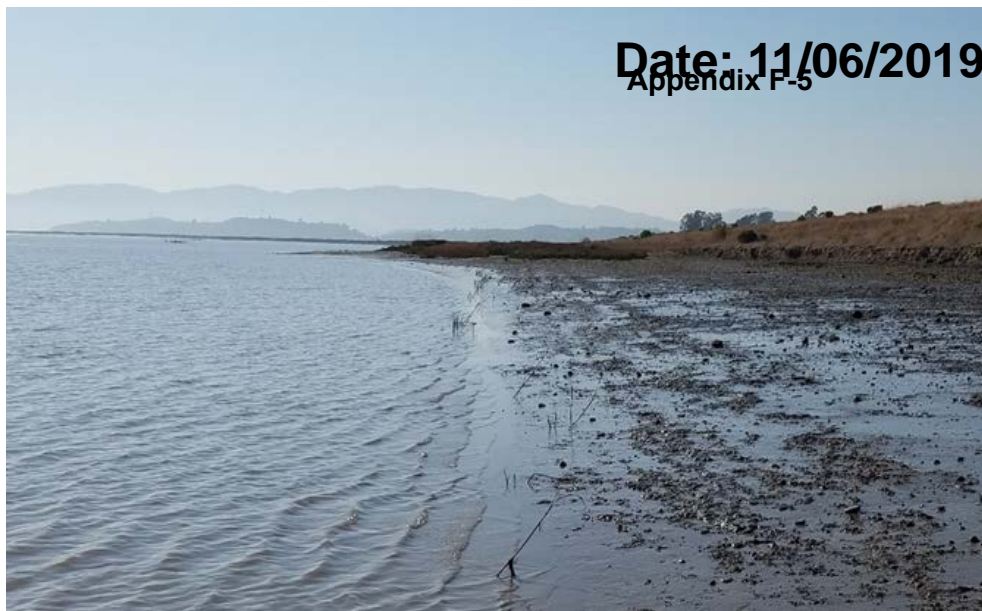
3 . 2

Standing in Cell 4 looking west. Cordgrass transplants are along sheer edge of mudflat. Transplants have fewer new tillers in this cell.

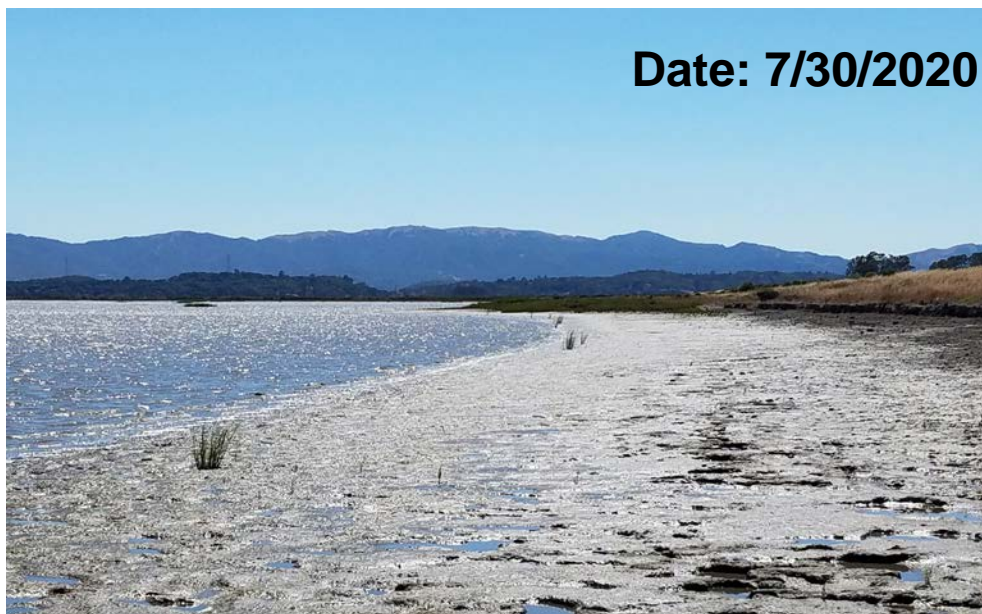
3 . 2

Standing in Cell 4 looking west. Spartina survival was low in this cell, although there are many small seedlings coming up in the same elevational range as transplants (visible on the sheer mud).

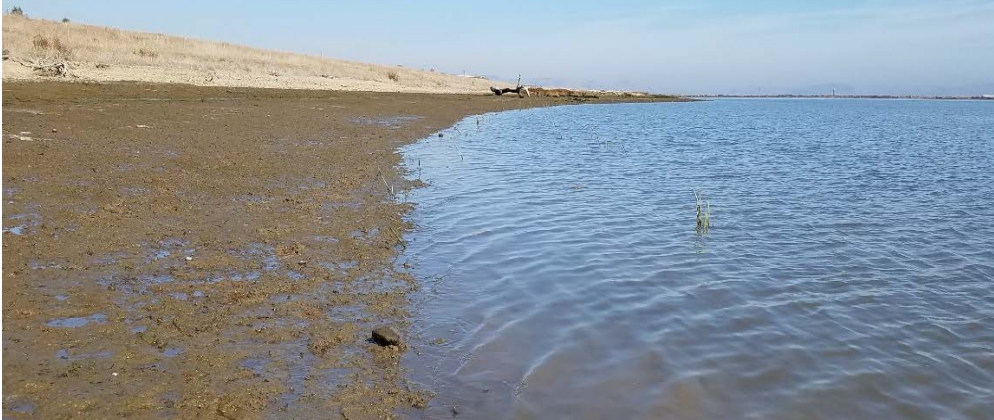
4 . 1

Standing in cell 5 looking NE. One row of cordgrass transplants is apparent at water's edge, while a second is submerged.

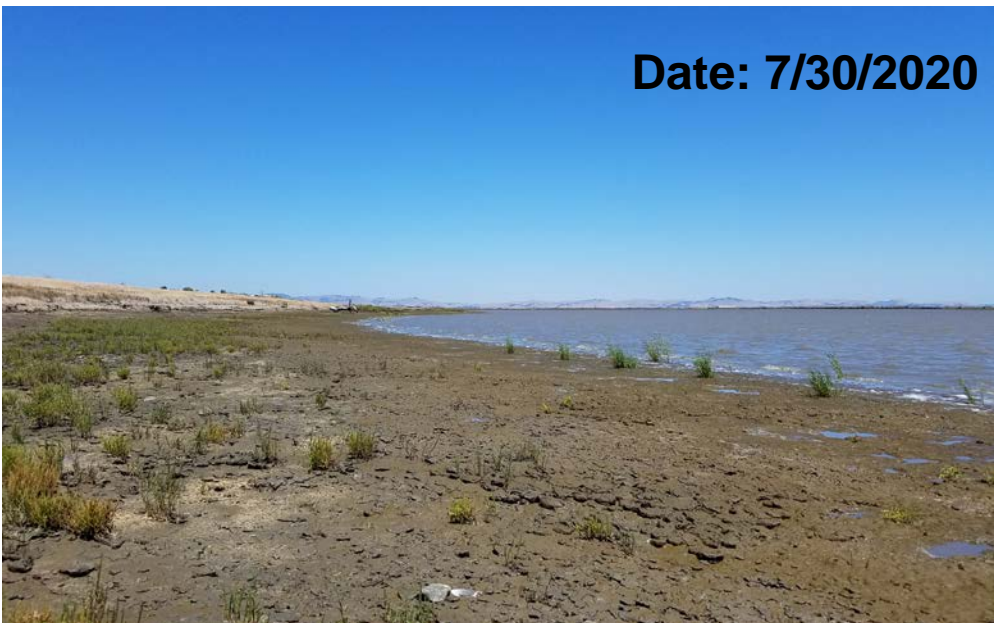
4 . 1

Standing in cell 5 looking NE. Two rows of Spartina transplants appear to be robust, with new growth. There has been ample pickleweed growth in this cell since Nov 2019.

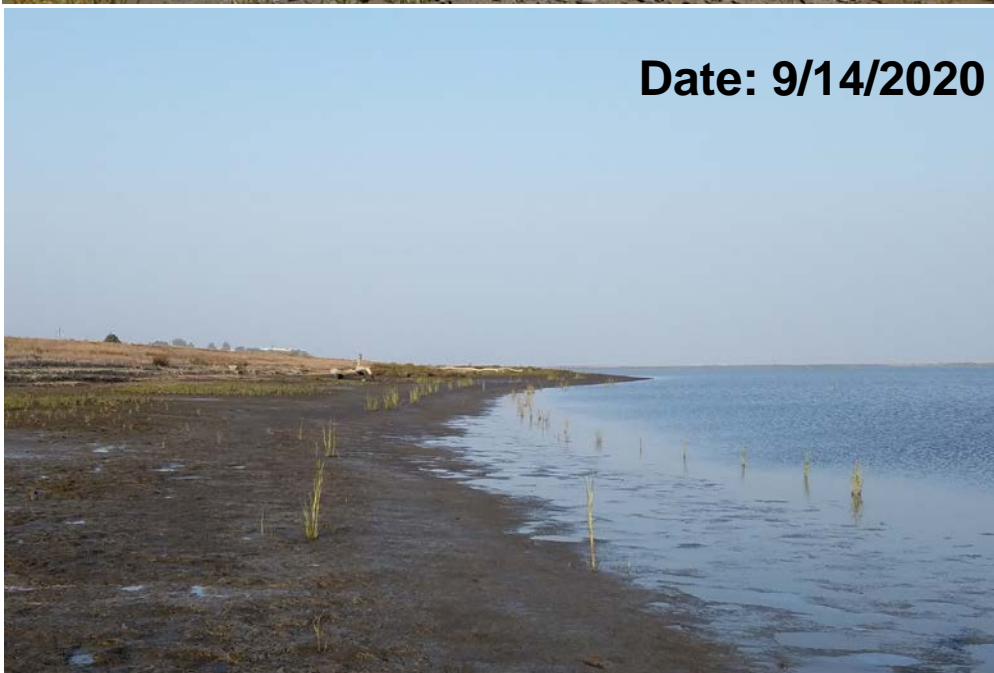
4.1

Standing in Cell 5 looking NE. Lowest elevation cordgrass row is from new 2020 plantings. Upper two 2019 rows have high survival and are spreading horizontally.

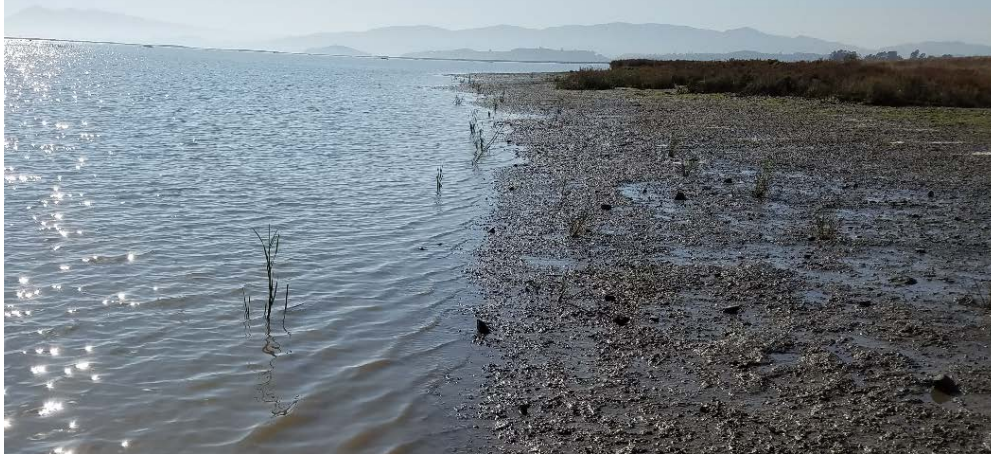
4 . 2

Standing in Cell 5 looking west at tow tiers of cordgrass transplants in rough-surfaced wave scoured mudflat. Plants with new growth and relatively high survival.

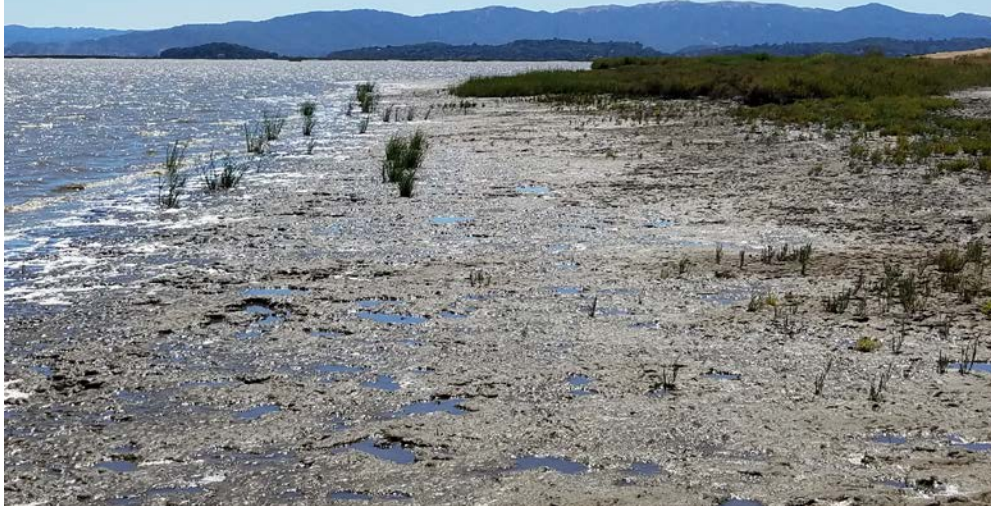
4 . 2

Standing in Cell 5 looking west at two tiers of cordgrass transplants in rough-surfaced wave scoured mudflat. Plants show new growth and some vertical and lateral spread since Nov 2019.

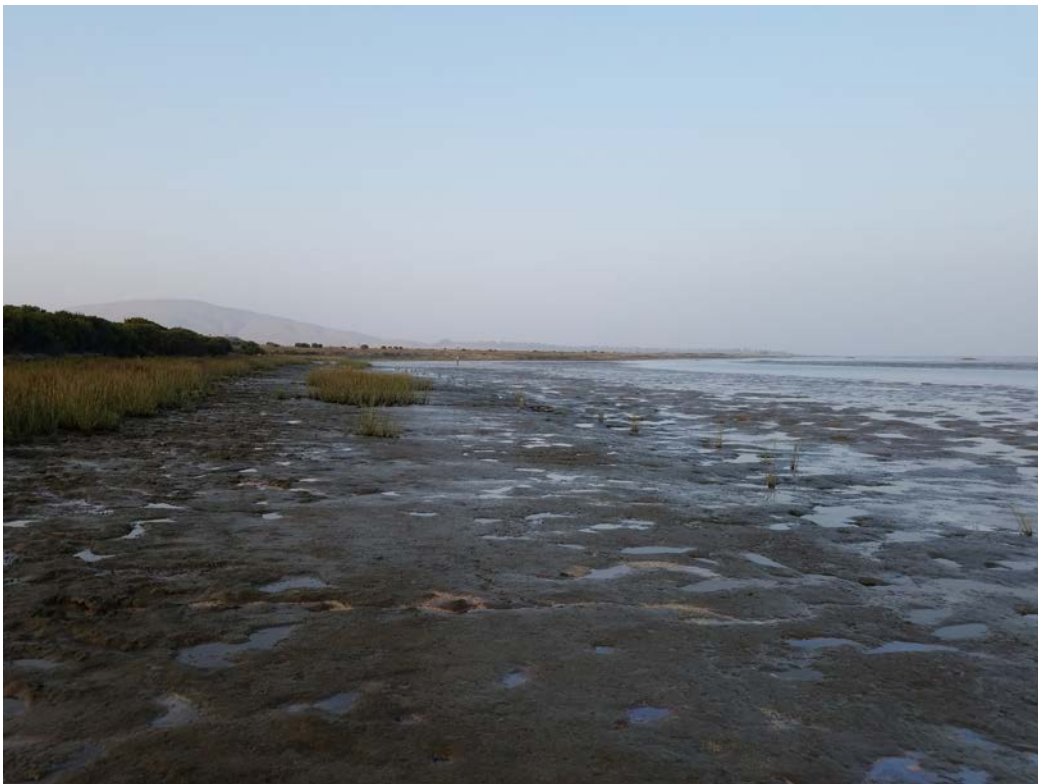
**Station/Photo #:**

Standing below west shore levee, looking N (towards boat ramp). New 2020 cordgrass transplants are visible in sheer mud just below resident colonies.

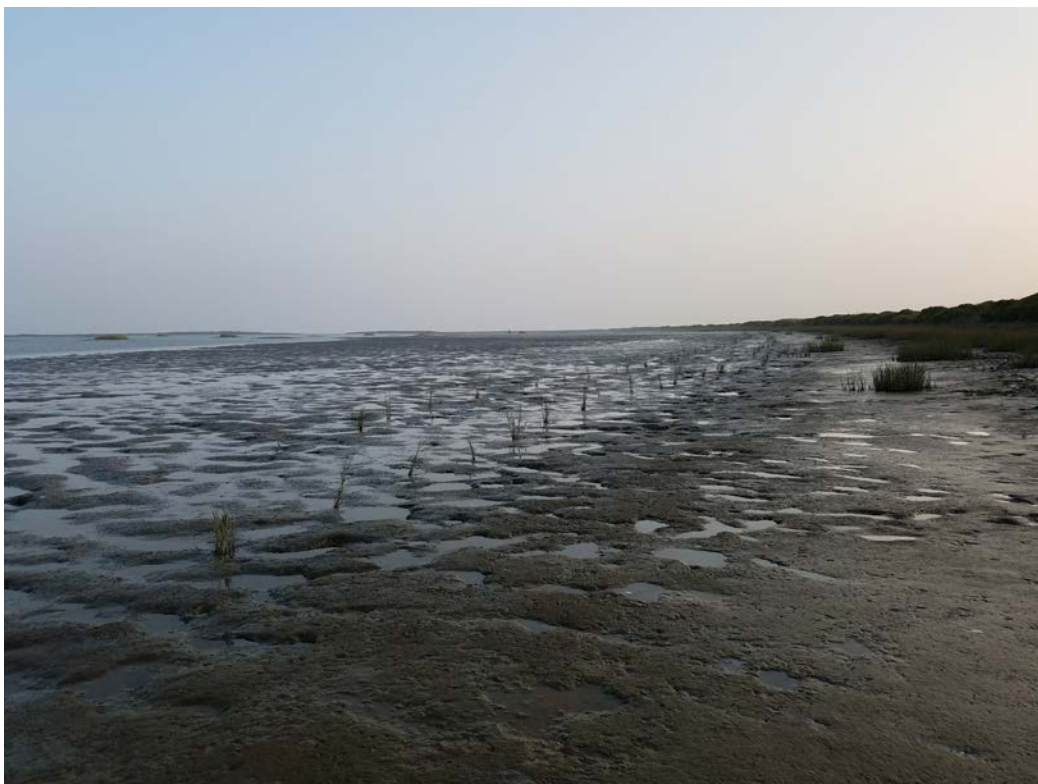
**Station/Photo #:**

Standing below west shore levee, looking south at lower and upper elevation rows of 2020 cordgrass plugs (in sheer mud to the left of photograph).

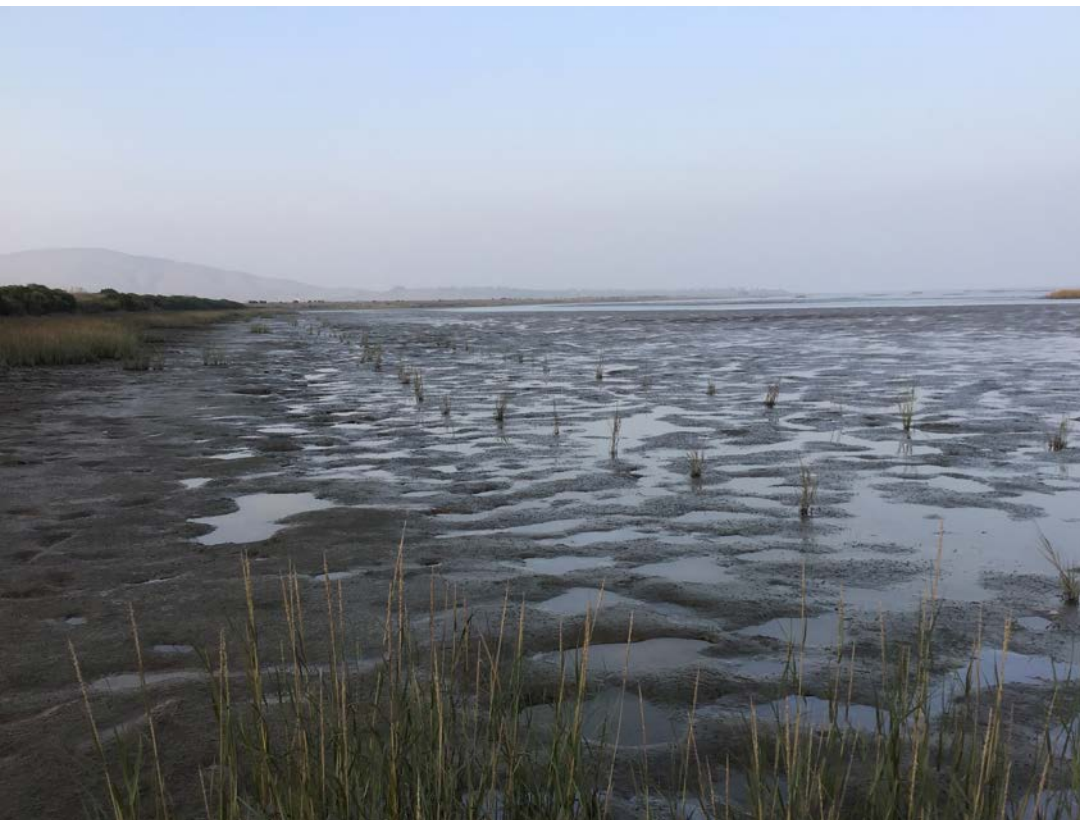
**Station/Photo #:**

Standing below west shore levee, halfway down 2020 plantings. Photo looking N at two rows of cordgrass planted at lowest elevation of resident stands.
