Appendix I. Annotated Construction Photographs

Annotated Construction Photographs

This appendix was prepared by Peter Baye.

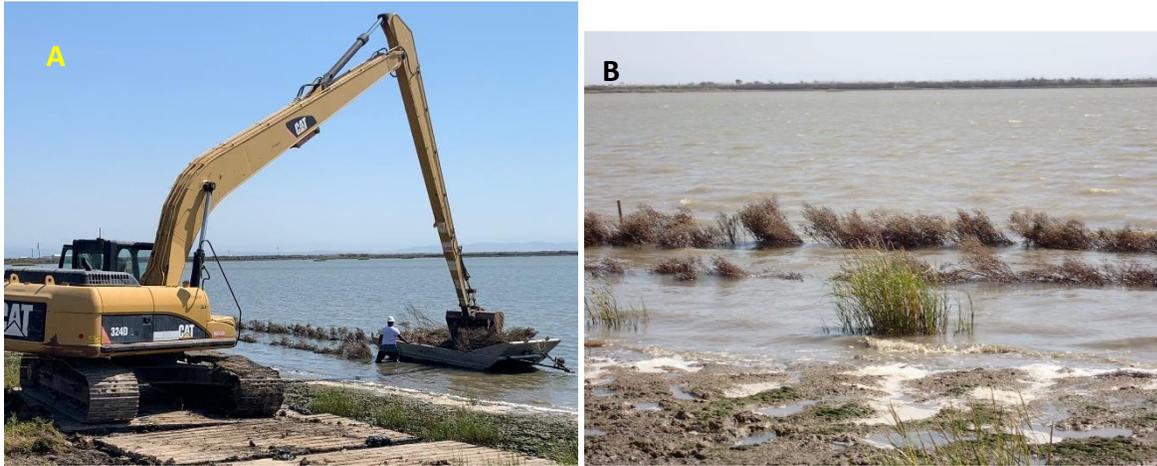
Photograph 1. Brush fence installation on inner mudflat cordgrass transplant zones

(A) Aluminum sled mobilized at shoreline for loading with cut brush; moved by long-reach excavator along brush fence alignment on mudflat. (B) Two lines of newly installed brush fence, half-submerged mid-tide, bayward of previously established transplanted cordgrass. Note flattening of wind-waves landward of brush fence compared with open water bayward. August 30, 2021

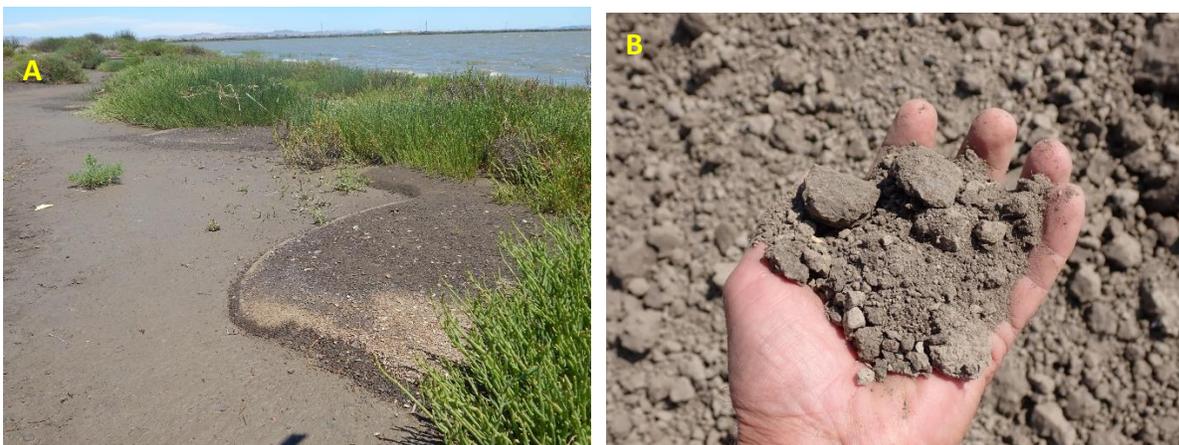
Photograph 4. Naturally formed and artificial (aggregate) bay mud clasts

(A) Swash bar composed of flakes and “pebbles” of dried bay mud naturally eroded from upper intertidal levee bench. Bar about 1 ft high is deposited through pickleweed vegetation, migrating landward prior to project construction. June 24, 2021 (B) Artificial dry mud clasts (crushed old drained clay-silt dredged material from Port Sonoma) ranging from coarse gravel to sand-sized clasts, formed by excavation, handling, and transport to stockpile at the project site.

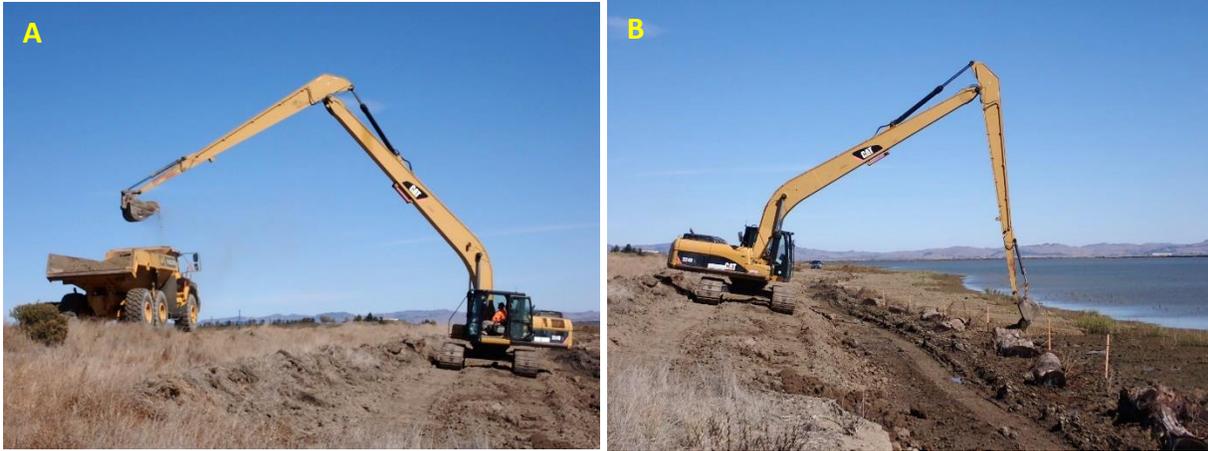
Photograph 5. Placement of aggregate bay mud on eroded wave-cut levee bench

(A) Truckload of aggregate bay mud delivered to reach of excavator on levee road. Long-reach excavator bucket scoops aggregate bay mud directly from truck. (B) Excavator swings around to place aggregate bay mud on eroded surface by slowly lifting moving bucket with precision, avoiding remnant or new patches of pioneer salt marsh vegetation. Oct 12, 2021.

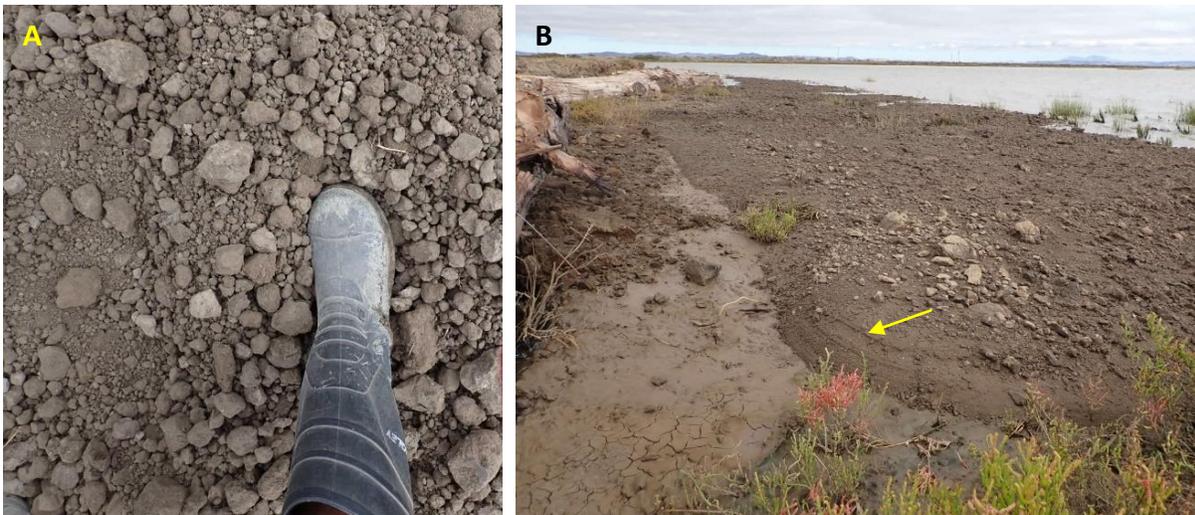
Photograph 6. Aggregate bay mud mound before and after tidal submergence and wind-wave exposure

(A) Heterogeneous clast size of dry aggregate bay mud, small cobble to gravel and sand-sized. Sept 15, 2021. (B) Sorting and onshore transport of broad aggregate bay mud mound (platform) after over a week of moderate wind-wave exposure: coarser lag of cobble and gravel-sized mud aggregates at flat top of mound, with onshore transport and deposition of small gravel to sand-size mud clasts at the landward edge (incipient bar slip face), Sept 27, 2021.

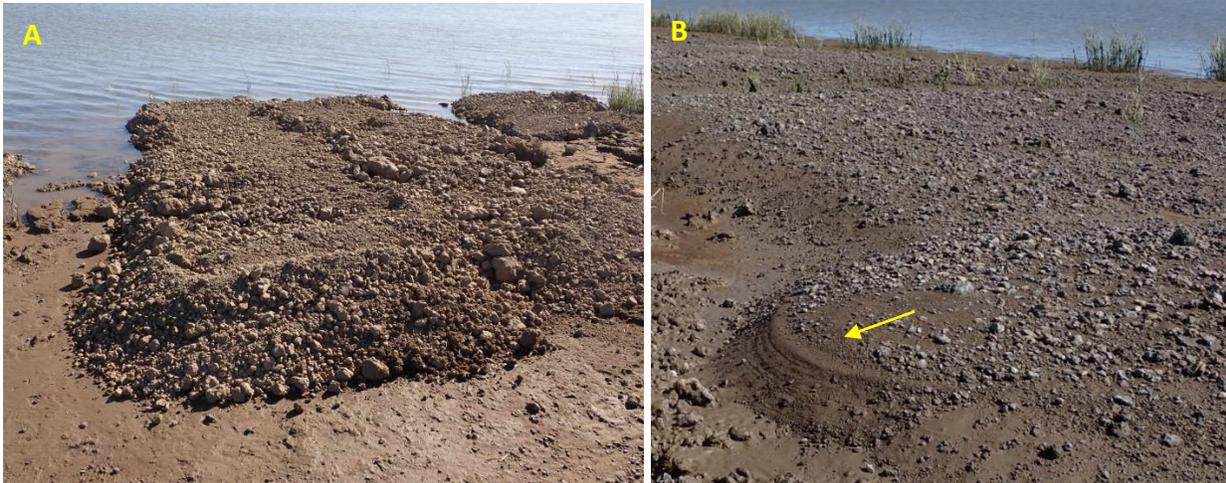
Photograph 7. Freshly deposited and wave-reworked aggregate bay mud mounds

(A) Freshly deposited aggregate bay mud mound, showing “footprint” of excavator bucket line of movement. Initial thickness prior to consolidation and settlement is less than 1 ft over eroded levee bench. (B) Aggregate bay mud mound partially reworked by wind-waves, forming incipient leading edge of swash bar with delta-like slipface lobe composed of more mobile, smaller sand to small gravel-sized particles winnowed from the surface of the mound, leaving a lag of coarser clasts. Oct 12, 2021.

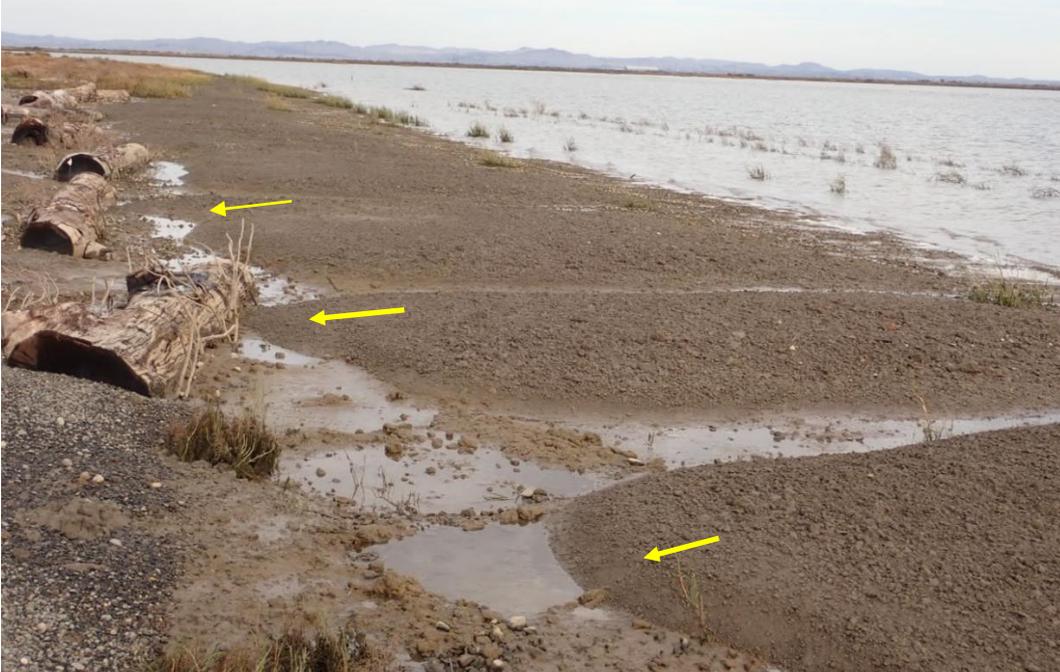
Photograph 9. Rapid wave-reworking and drifting of aggregate bay mud mound deposits into swash bars during construction (2)

Shoreward migration of incipient swash bars extending landward from placed mounds, coinciding with flattening and settling of consolidating aggregate bay mud mounds. The landward edges of onshore-migrating incipient bars is reaching logs, and forming shallow runnels. Note drainage gaps draining runnels between logs and onshore-migrating leading margins of bars. October 19, 2021.

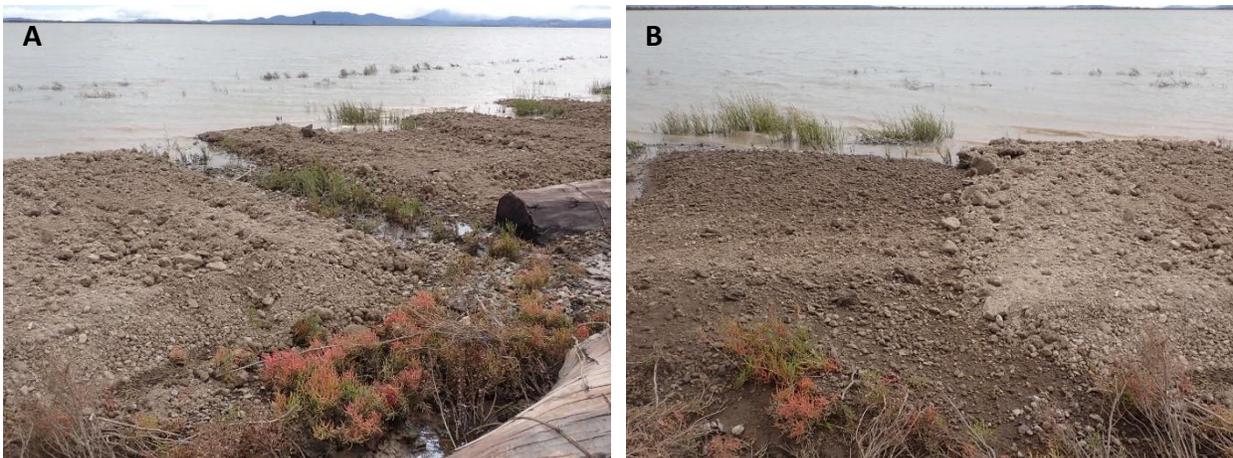
Photograph 10. Tidal drainage and consolidation of newly deposited aggregate bay mud mounds

(A) Freshly deposited dry flat-topped aggregate bay mud mound, with shore-normal gaps left around larger patches of pioneer salt marsh vegetation (perennial pickleweed, green; annual pickleweed, reddish), serving as tidal drainage and wind-wave rip circulation outlets for runnels

(troughs) between mounds and logs. (B) Adjacent successive mounds showing rapid consolidation and settlement after tidal wetting under low wind-wave action. Darker mound at left is a day older than the dry, freshly deposited mound at right. Compare mound height with height of cordgrass immediately bayward.

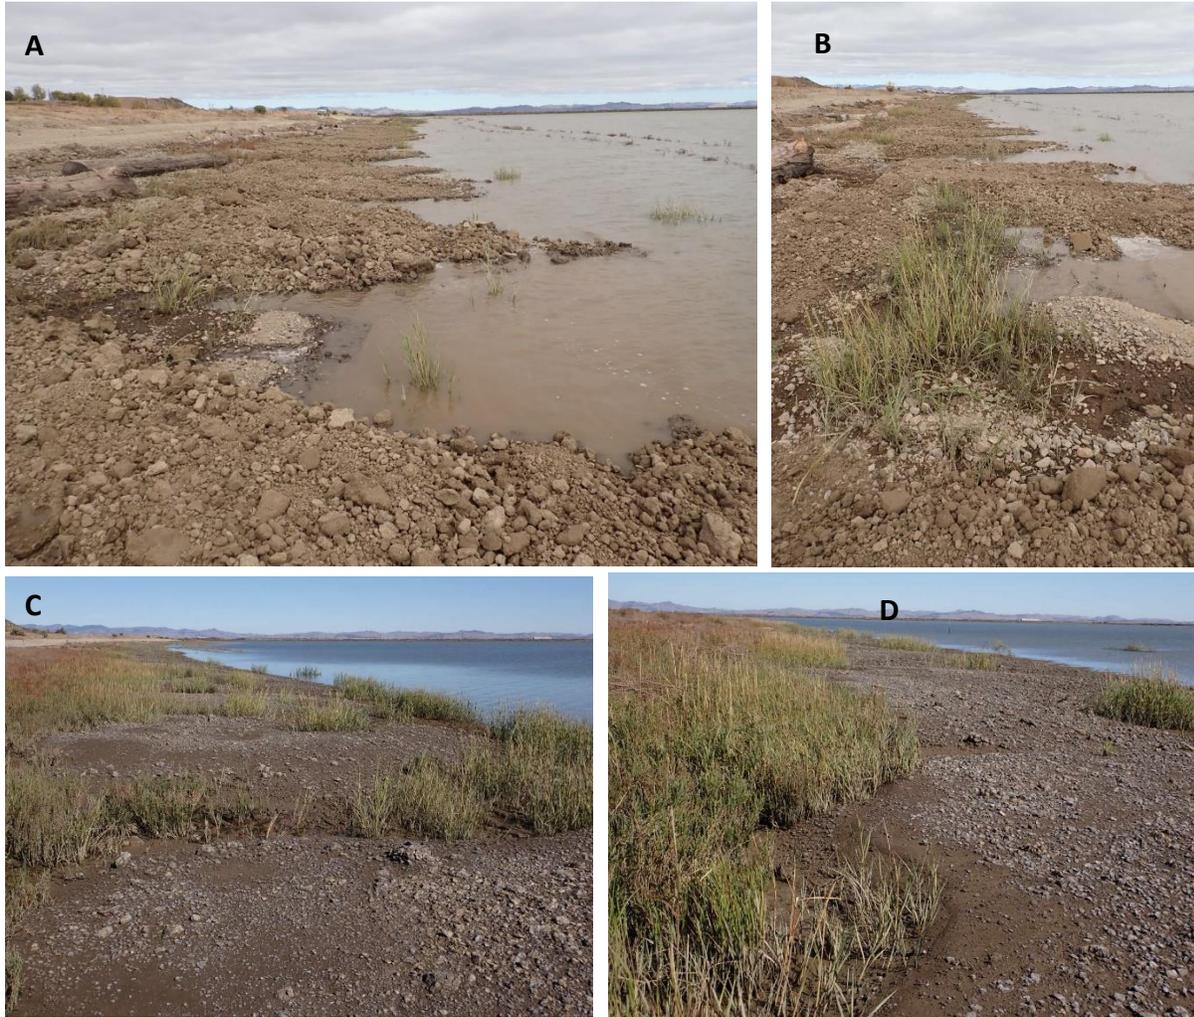
Photograph 11. Fine-scale minimization and avoidance of pioneer salt marsh vegetation by precise mechanical placement of aggregate mud mounds

(A-B) Freshly deposited dry aggregate bay mud placed mostly around pioneer patches of cordgrass (mostly current year seedling-juvenile transition), but also over standing live vegetation which remains upright during grainfall deposition (precipitation of dry mud clasts) from gradual excavator bucket release. Note relative height of aggregate mud mounds and cordgrass shoots. September 27, 2021. (B) Incipient onshore migration of mud clast swash bars derived from wave-reworked aggregate mud mounds, transported into stands of mixed mature cordgrass and pickleweed. Non-destructive partial burial of upright salt marsh vegetation to about one half shoot height or less (mostly emergent canopy) is evident. October 12, 2021.

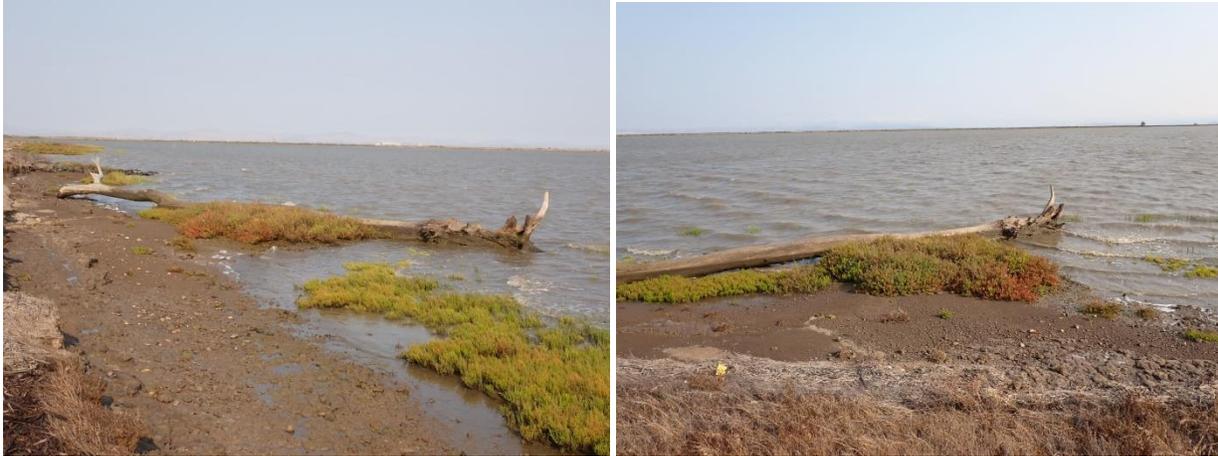
Photograph 12. Natural, pre-construction model examples of embedded driftwood on site
Driftwood sedimentation-erosion dynamic patterns are shown: log acts as local wavebreak with mud clast sediment deposition in wave-shadow, forming high salt marsh mounds. Deposition occurs in sheltered wave-shadow of driftwood, contrasting with erosional scour around ends. The embedded rootwad (trunk) anchored the windward end of the driftwood. August 30, 2021

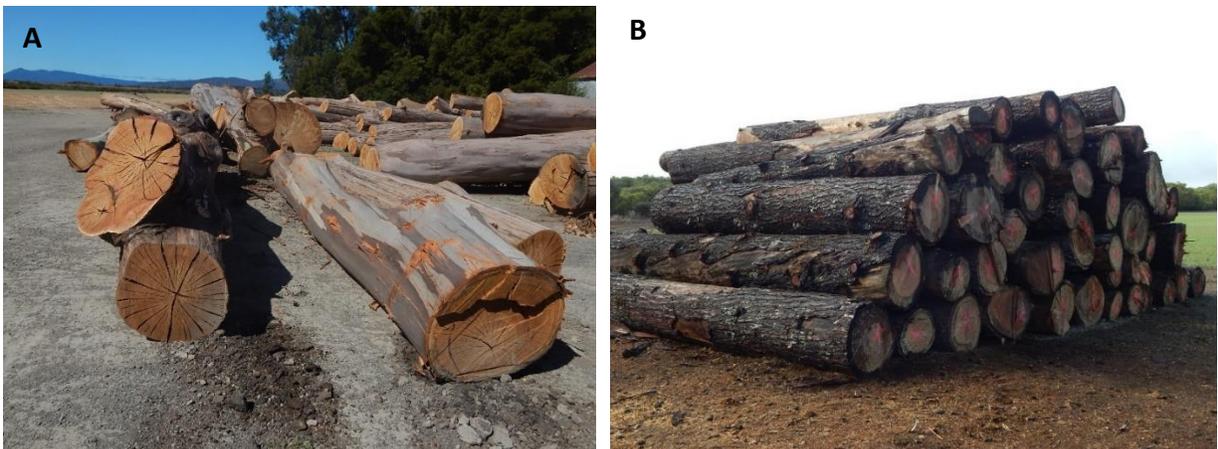
Photograph 13. Raw logs stockpiled on-site for shoreline placement as artificial analogs of driftwood

(A) drying blue gum eucalyptus logs 1-2 (3) ft diameter. July 27, 2021. (B) douglas-fir logs 1-2 ft diameter. March 19, 2021.

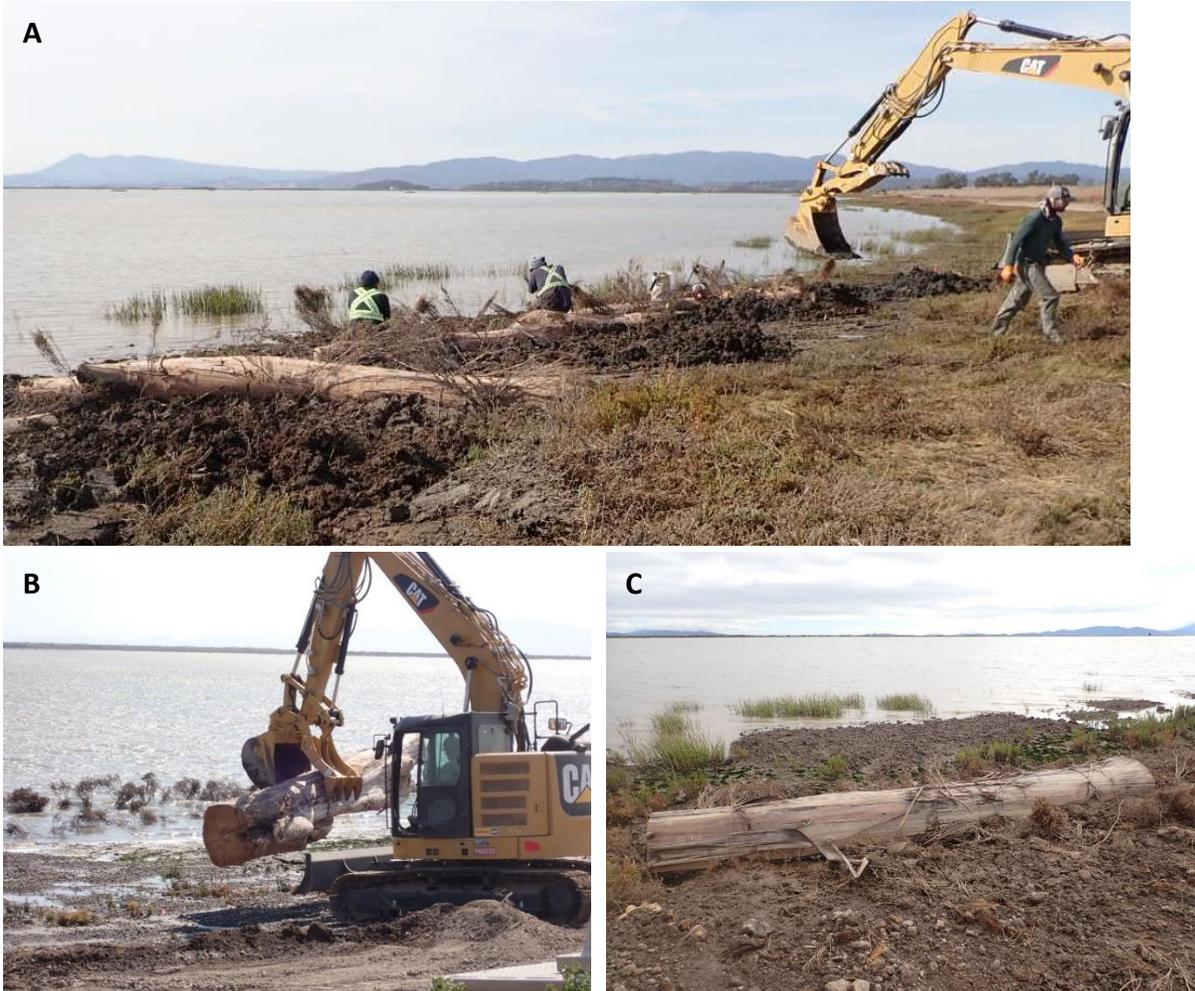
Photograph 14. Placement operations for embedded logs

(A) Short-reach excavator working from wood mats excavates shallow trenches along flagged positions of logs, while crews place brush and anchor newly placed logs with cables and duckbills. Oct 5, 2021. (B) Excavator bucket with “thumb” directly places log in shallow trench. Sept 15, 2021. (C) Individual installed eucalyptus log with brush (roughness), cabled and anchored in place, and backfilled with additional dry aggregate bay mud. September 27, 2021.

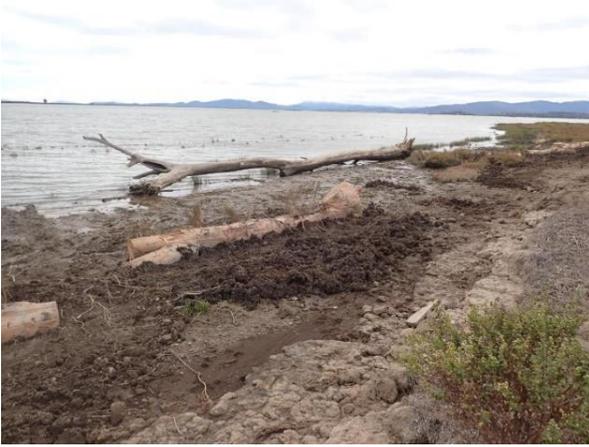
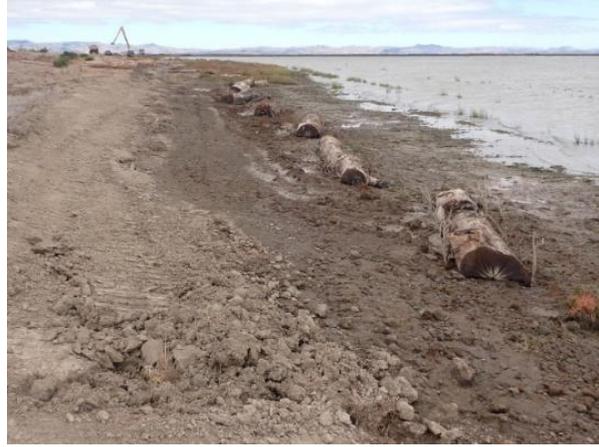
Photograph 15. Series of installed embedded logs

Series of installed embedded logs, backfilled, cabled, and anchored, with gaps between them. Note slight shore-oblique orientation, parallel with prevailing wind-wave crests. September 27, 2021

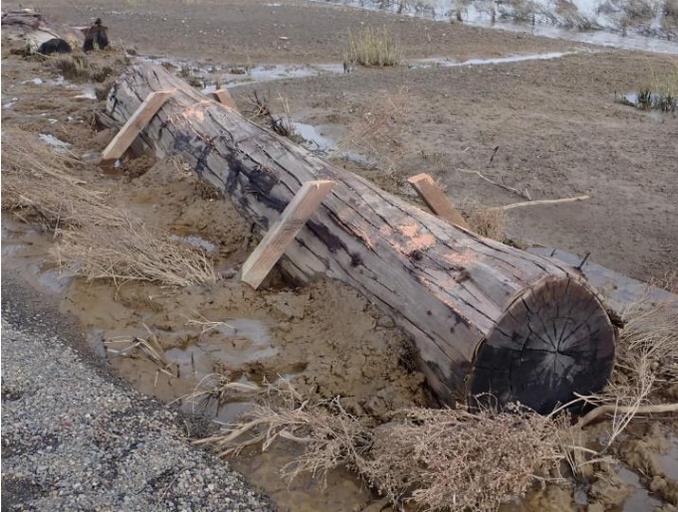
Photograph 17. Staked embedded eucalyptus log
Stake tops are cut to minimize potential attractiveness of raptor (harrier) perches.

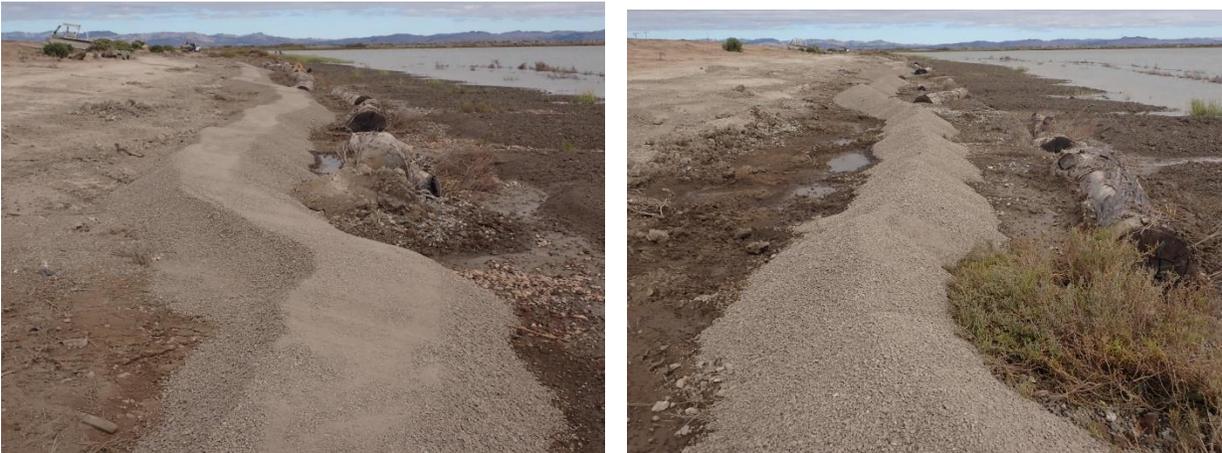
Photograph 18. Freshly deposited, dry, unconsolidated sacrificial gravel berms
Berms are placed along the recent high tide line (wave runup zone of spring high tides) to be eroded and re-deposited by wind-waves at high tides, to form natural onshore-migrating gravel swash bars. September 27, 2021.

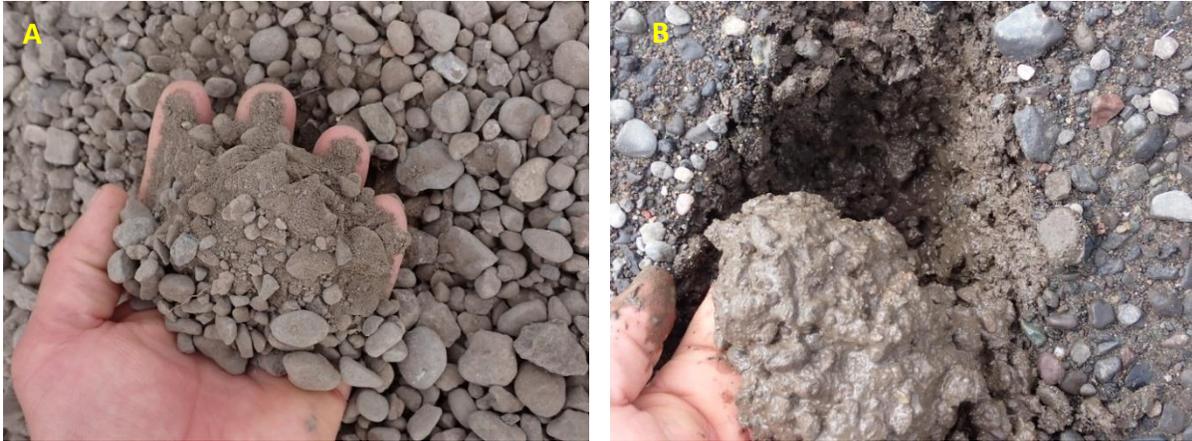
Photograph 19. Dry and wet pea gravel with interstitial sand and mud (fines) composing gravel berms

(A) dry pea gravel and silty sand interstitial matrix. (B) Pea gravel mix wetted at first high tide, forming muddy gravel sorted by wave action (concentrating coarse sediment, dispersing suspended silt). Initial swash slopes formed by muddy gravel are flatter than pure gravel because pore spaces (voids) are saturated with mud, inhibiting infiltration of backwash. Sept 27, 2021.

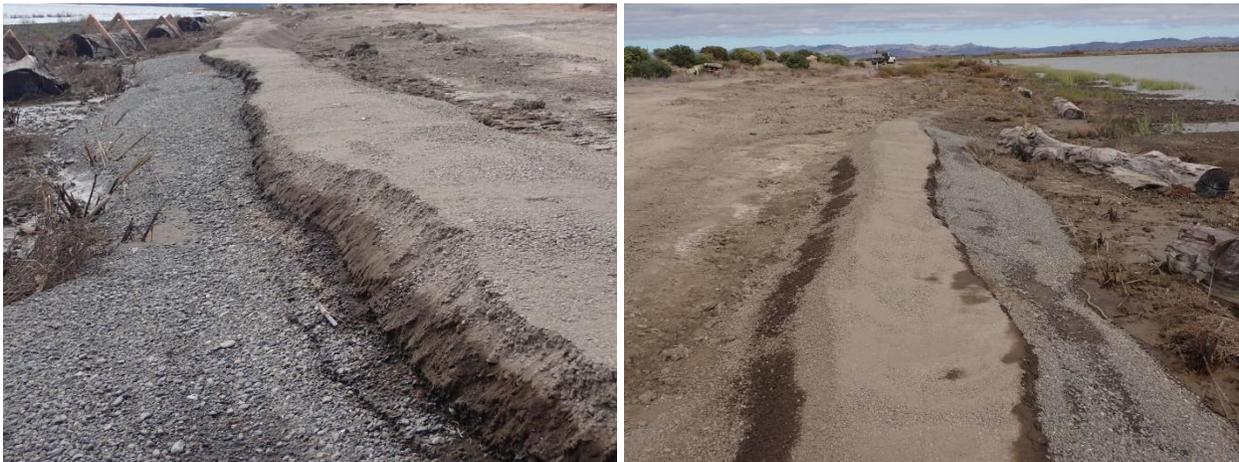
Photograph 20. Initial partial wave-reworking of sacrificial gravel berms

Incipient evolution of gravel swash bars from sacrificial berms days after placement. Bayward sides are eroded by waves, forming flatter swash slope, concentrating pea gravel and sand at the surface, winnowing fines. Sept 27, 2021

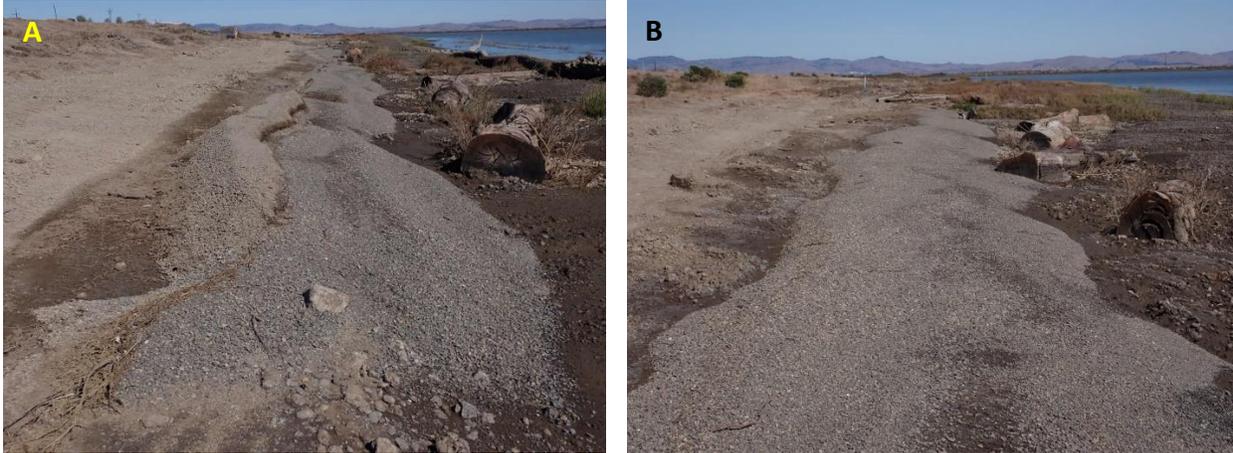
Photograph 21. Near-complete wave-reworking of sacrificial gravel berms into swash bars
Within two weeks of placement (A, September 27, B October 5, 2021), artificial gravel berms near the high tide line evolve into natural gravel swash bars with natural wave-deposited morphology.

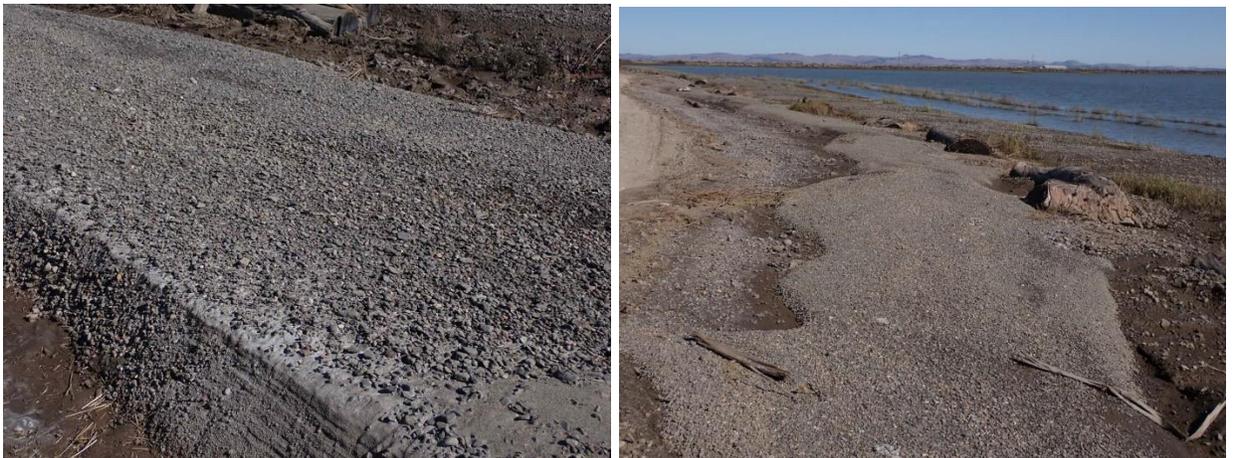
Photograph 22. Rapid onshore migration of gravel swash bars
Newly formed gravel swash bars undergo “rollover” migration landward (bayward erosion, landward deposition). Landward depositional edges exhibit slipfaces (angle of repose) where troughs pool water at high tide, or convex lobes where backwash flows through the bar (infiltration) or over the bar crest. October 12, 2021.

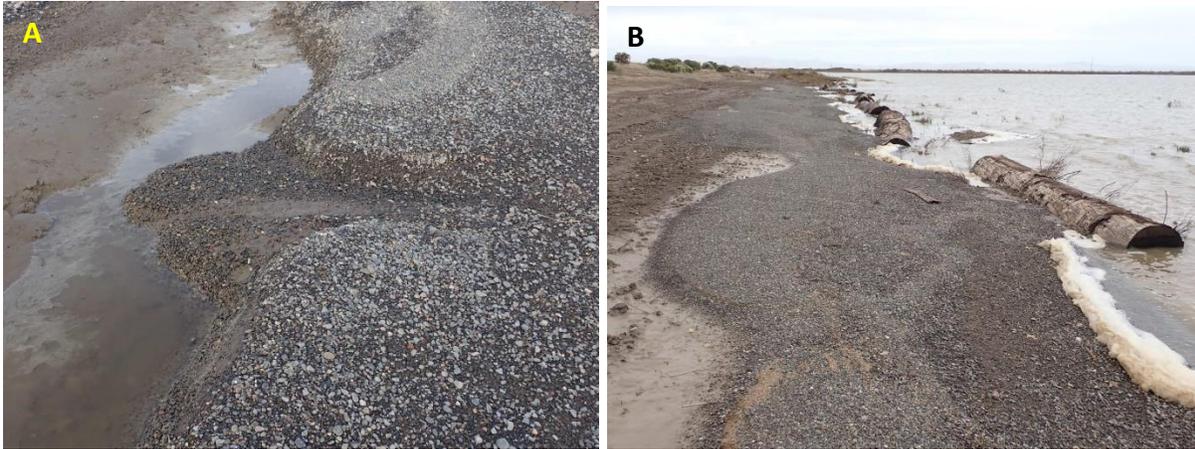
Photograph 23. Morphology of gravel swash bars during rapid initial onshore migration
Deltaic fans, washover lobes, and spit-like bar ends form during rapid onshore migration occurring in high tide cycles with significant wind-wave action (visually estimated 6-8 inch breaking wave height at shore). (A) October 19, 2021. (B) November 5, 2021.

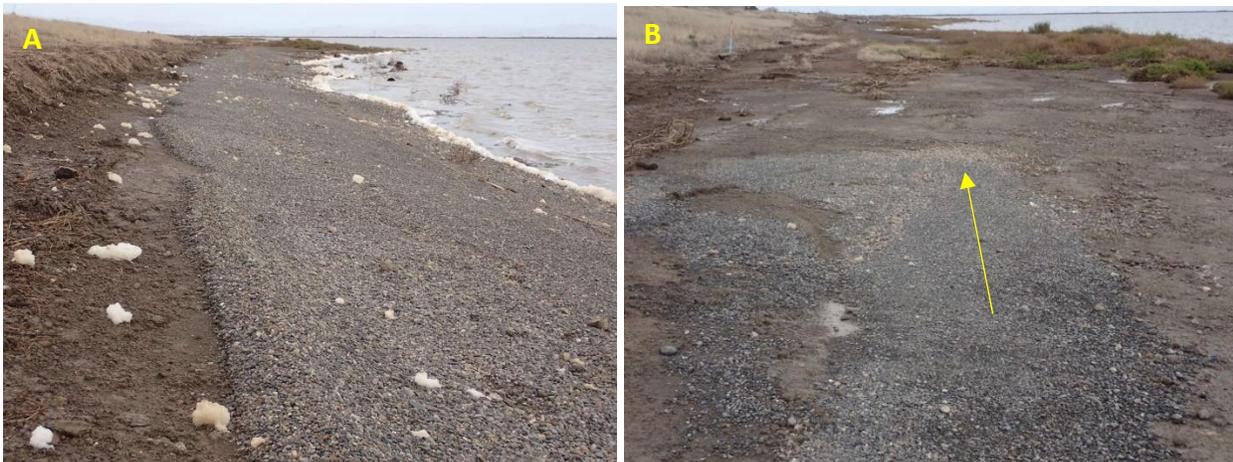
Photograph 24. Evolution of gravel swash bars in late fall, weeks after gravel placement
Longshore drift and flattening of gravel bar swash slopes occur during late fall wind-wave action and onshore migration. November 5, 2021. (A) low-angle landward edge of thin gravel swash bar spread over widened swash zone after high tide series with high wind-waves. (B) drift of thin spit-like swash bar eastward where no gravel was mechanically placed.

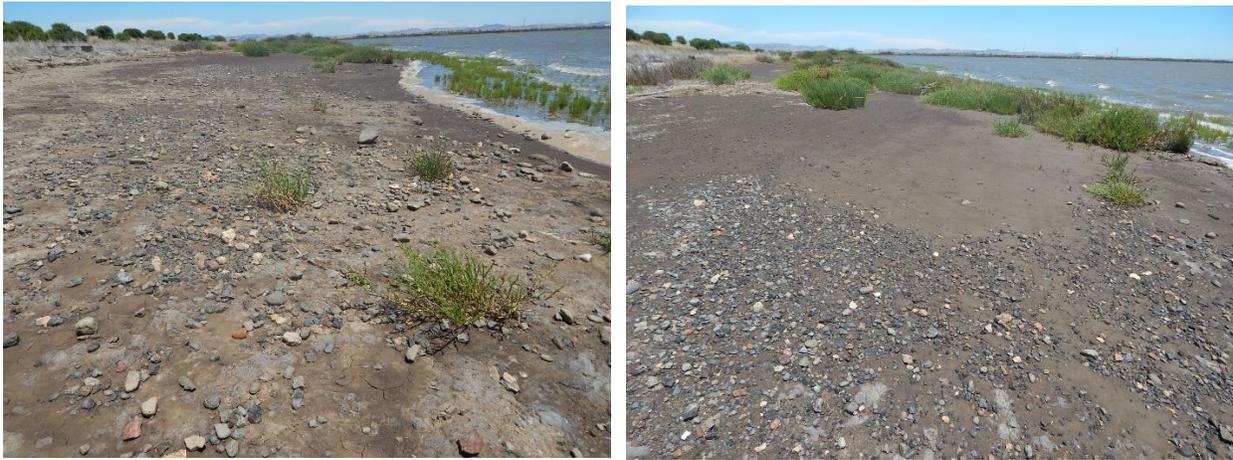
Photograph 25. Pre-existing examples of gravel lag armor shoreline features

Wave erosion of levee exposed remnants of old road base entrained in levee grading. Relatively immobile gravel and small cobbles are concentrated at the surface (resistant lag armor) as mobile fine sediment is winnowed out by wave action. These spontaneous lag armor features were models for artificial gravel lag veneer. July 27, 2021.

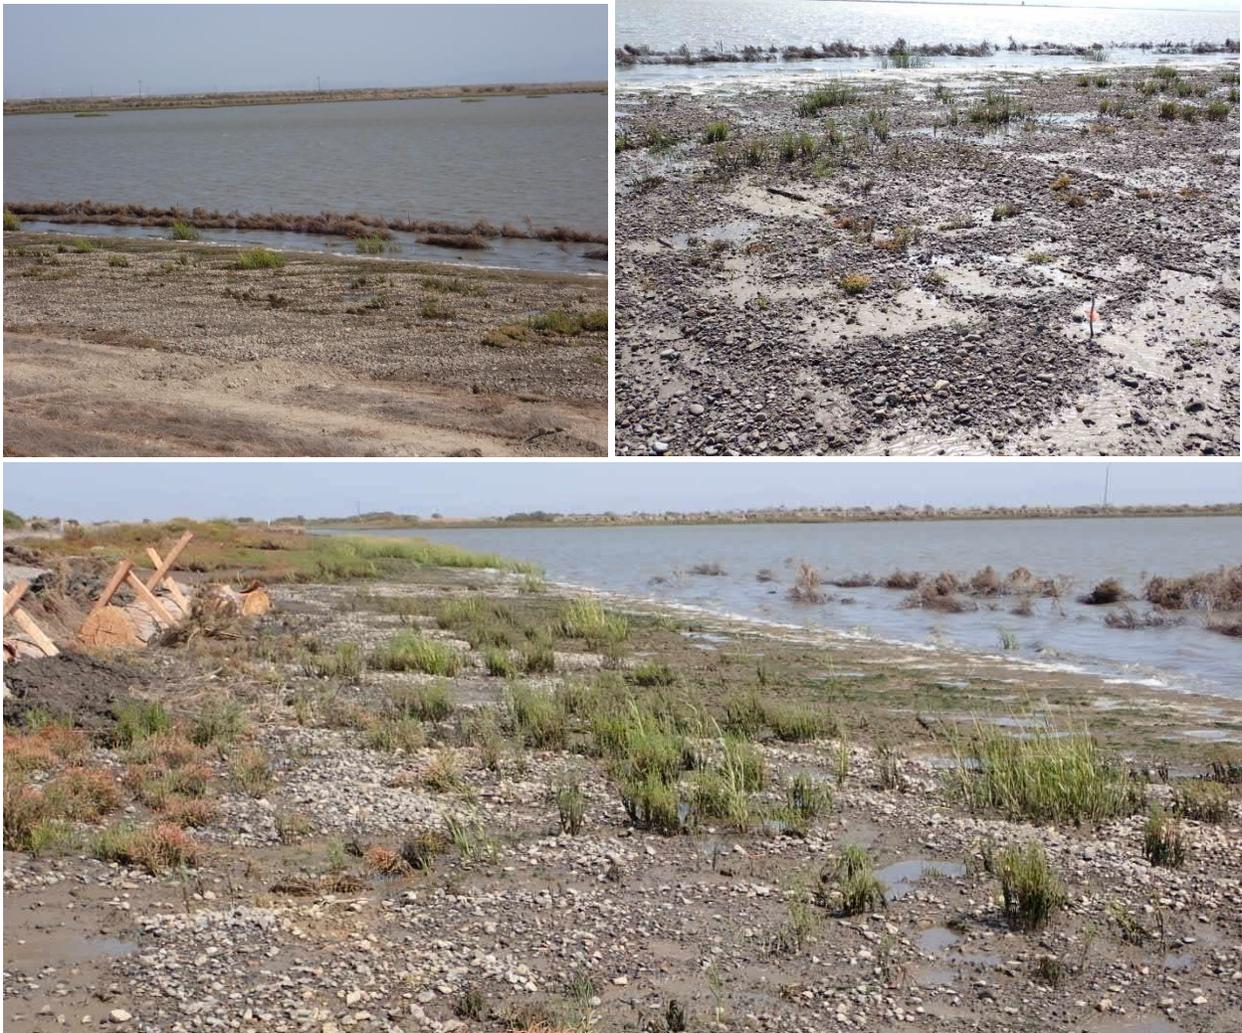
Photograph 26. Newly placed lower gravel lag veneer

Angular gravel (drain rock) was placed in thin (mostly 1 clast thick) veneers over wave-eroded levee bench surfaces to increase resistance to wave erosion and establish safe sites (surface stability) for salt marsh pioneer seedlings to develop anchor roots and clonal spread before they are excavated by waves. Note the retention of upright, intact seedling plants and established salt marsh vegetation patches, and the extent of residual interspersion of mud substrates for seedling colonization within the gravel veneer. Veneer underlies subsequently placed sacrificial aggregate bay mud. September 15, 2021.

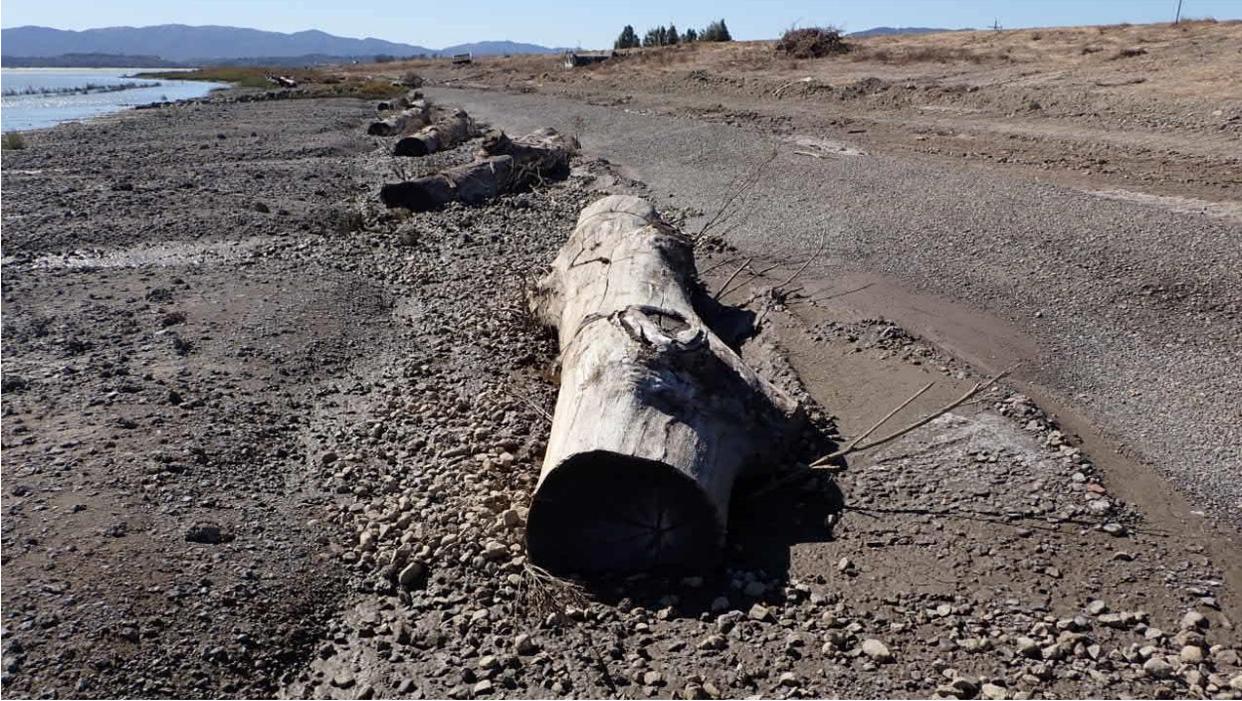
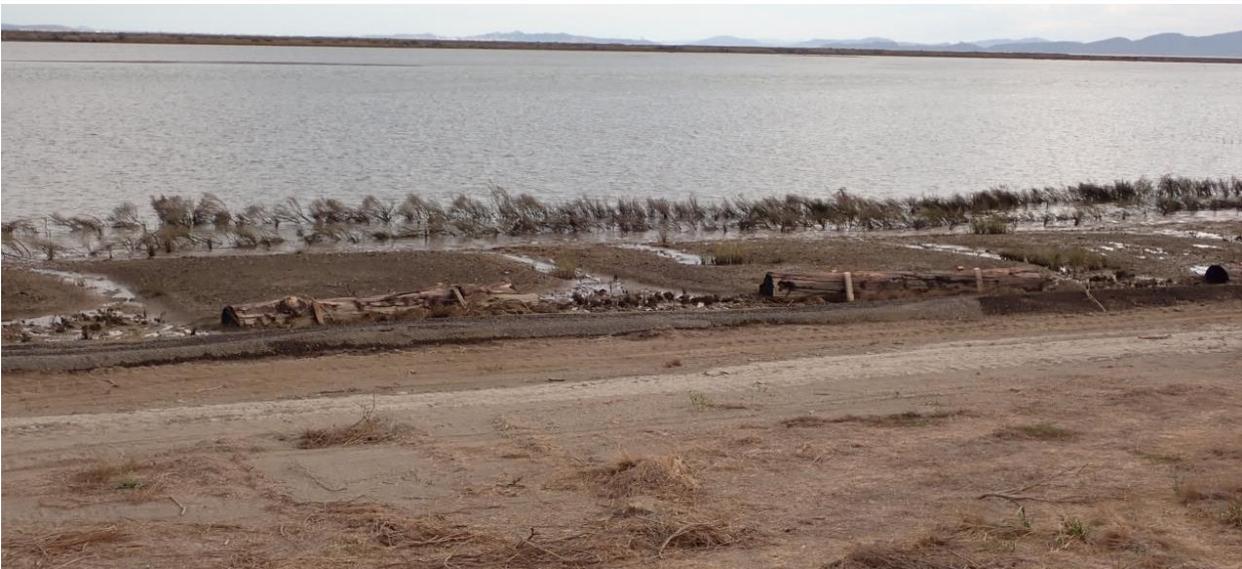
Photograph 27. Cross-shore distribution of all dynamic, interacting “nature-based” shoreline stabilization elements in Cell 6 with completed construction

Bay to shore: brush fence, cordgrass transplants, sacrificial aggregate bay mud mounds, embedded logs and gravel veneer (buried under mounds), gravel berm/swash bar. Oct 19, 2021.

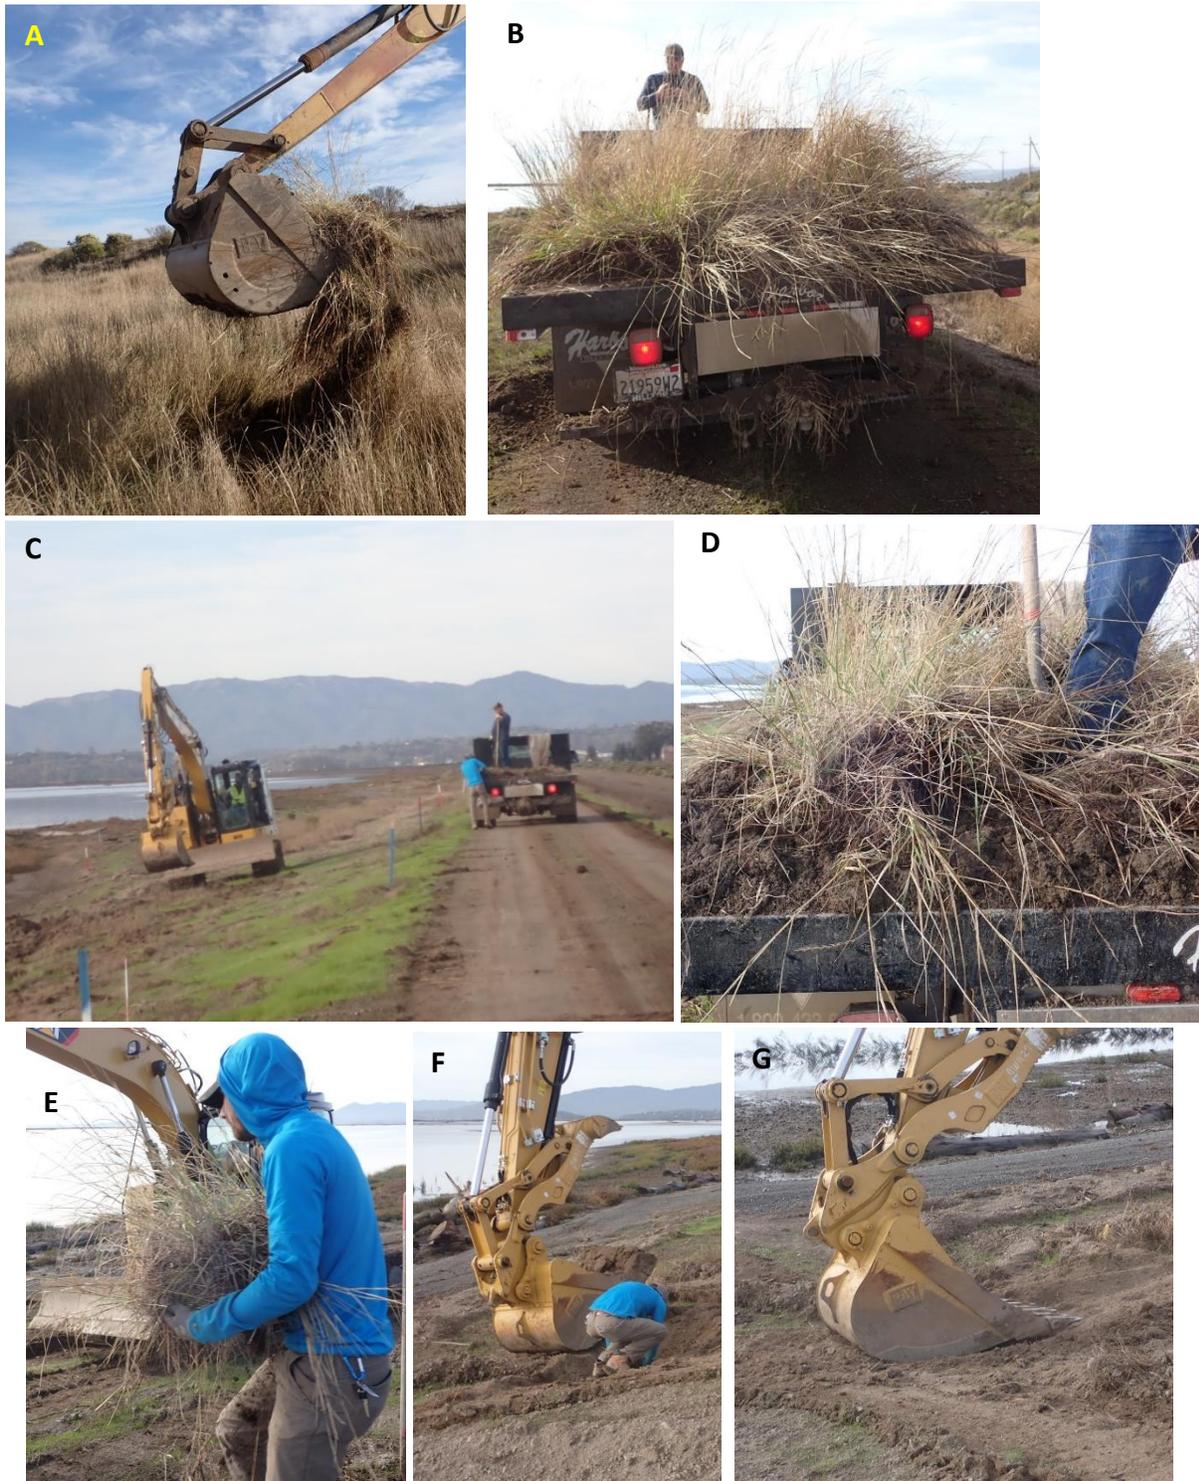
Photograph 28. Creeping wildrye sod harvest and placement

(A-B) Long-reach excavator mechanically harvests 6 inch thick dormant sods of creeping wildrye from extensive dense borrow stands at the east end of the site, and loads them on a flatbed

truck. (C-D) Fresh wildrye sods are transported within minutes to transplant sites during cool weather to minimize desiccation injury to roots. Short-reach excavator has worked ahead of delivery excavating series of shallow pits for sodding. (E-F) Crews manually place 1.5-2 ft wide sod mat fragments into pit. (G) Excavator bucket backfills shallow (4-6 inch) soil deposit over sod and tamps (pounds) to ensure root and rhizome contact with surrounding soil, and minimize voids that result in injurious root desiccation during winter-spring droughts. November 5, 2021.

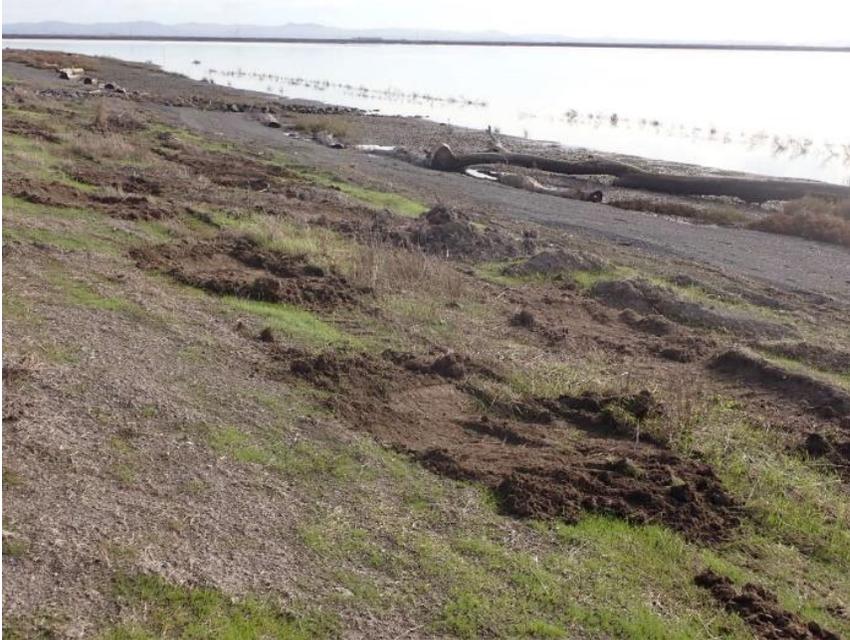
Photograph 29. Staggered series of planted, buried large creeping wildrye sod mat fragments on levee slope above the high tide line

Clonal spread from these patches will stabilize soil (sod) upslope and downslope below the high tide line. Nov 5, 2021

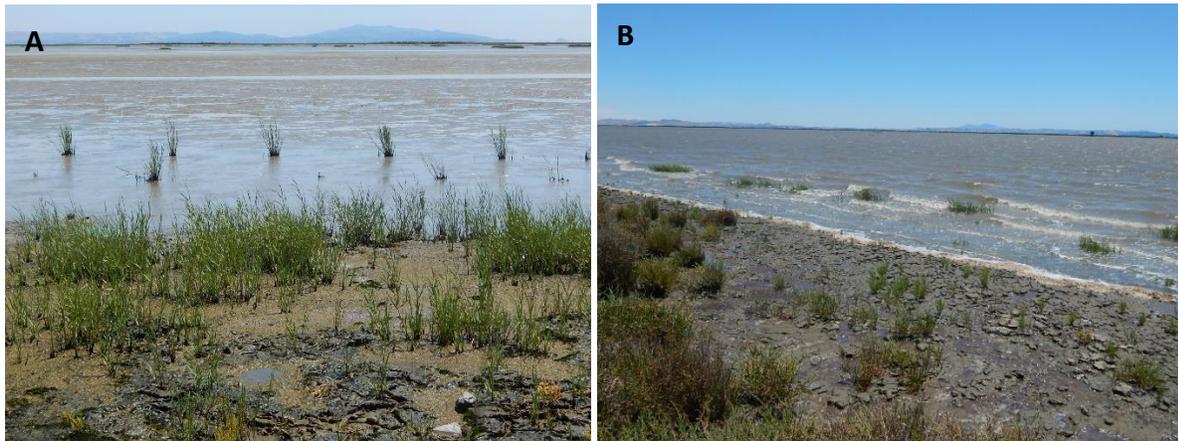
Photograph 30. Pre-construction cordgrass plug transplanted colonies

Cordgrass plugs planted at about 6-7 ft intervals on mudflats near Mean Tide Level, below the natural local limit (tidal elevation) of colonization. Large, tall cordgrass plug transplants established 1 year old incipient colonies (A; July 27, 2021) and approximately 2- to 3-year old colonies (B; June 24, 2021). Note the local wave-shadows (damped wave zones) in the lee of establishing colonies in (B), contrasting with spilling waves adjacent to them.

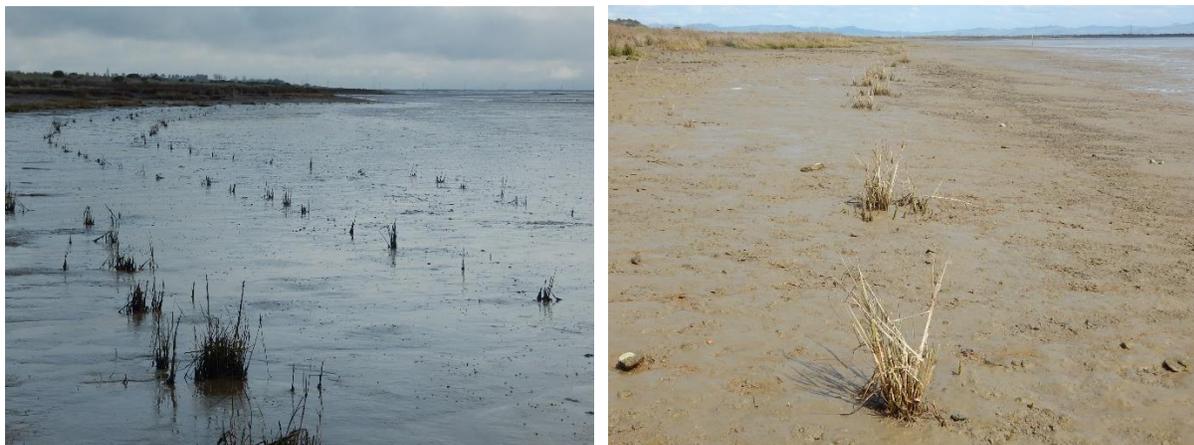
Photograph 31. Pre-construction cordgrass plug transplants

(A) Cordgrass plugs planted at about 6-7 ft intervals on mudflats near Mean Tide Level, below the natural local limit (tidal elevation) of colonization, are aimed at accelerating the development of critical width of fringing cordgrass zones to attenuate wave energy, at cell 1. Note the spread of daughter shoots around the older (year 3) shoreward line transplants in March 19, 2021. (B) Wave-exposed cordgrass plug transplants on the lower edge of the eroded levee bench, slightly above (lower wave energy) mudflat elevation. March 19, 2021.
