Appendix I. Annotated Construction Photographs

Annotated Construction Photographs

This appendix was prepared by Peter Baye.

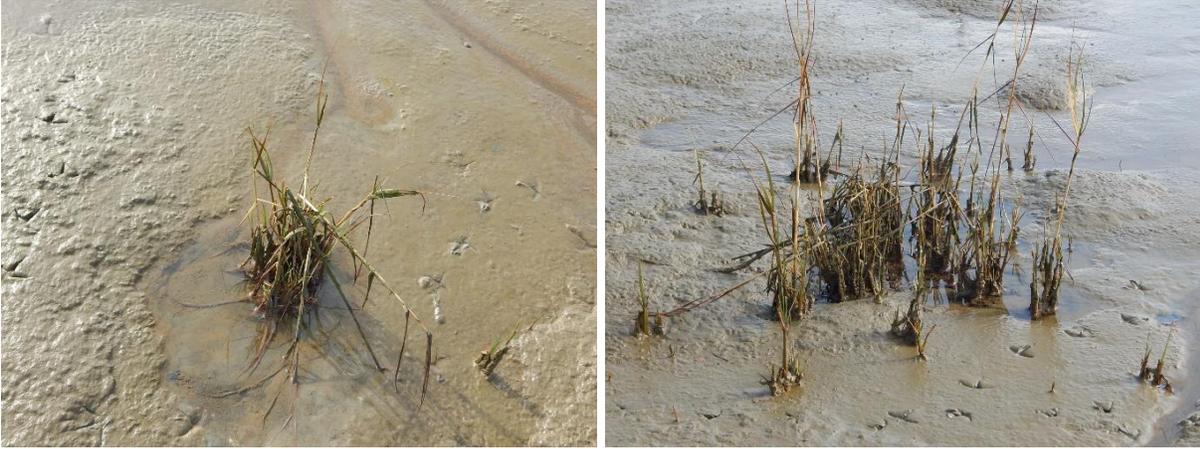
Photograph 32. Pre-construction pioneer cordgrass plug transplant colony clonal spread on mudflats

March 19, 2021. Daughter shoots connected to mother transplants by rhizomes formed the previous growing season begin shoot emergence in spring, at mudflat elevations near Mean Tide Line, below natural observed local tidal elevation range for seedling establishment of cordgrass, and below the line of established local natural fringing cordgrass marsh.
