## **Appendix L. Conference Posters**

# The Sears Point experience: Early returns on a state-of-the-art tidal wetland restoration project

# Preliminary Hydrology, Geomorphic Processes, and Vegetation at the Sears Point Tidal Wetland Restoration Project

# Early-Stage Outcomes at the Innovative Sears Point Tidal Marsh Restoration Project

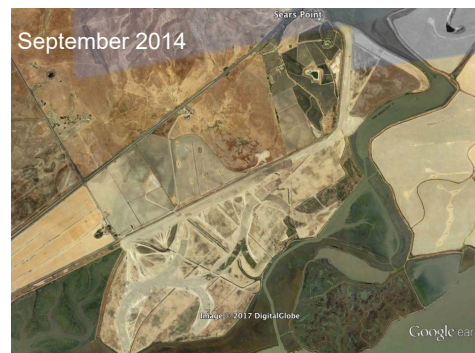
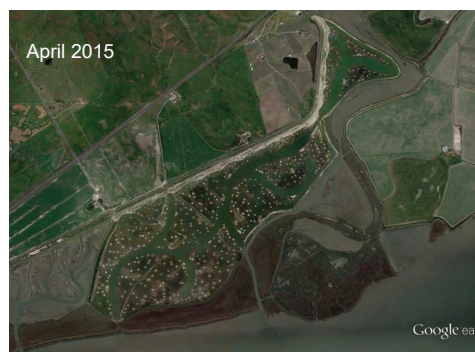
The EIR/EIS was approved in **2012** and Ducks Unlimited was awarded the contract to construct the project. The Google Images to the left show the active construction which took place in 2014. Winter rainwater pooled in the constructed channels making the many mounds visible. Two breaches were accomplished in **October 2015**. No planting was done on the mounds pre-breach. Implementation challenges are detailed in the poster by Ducks Unlimited which describes the construction of the project.

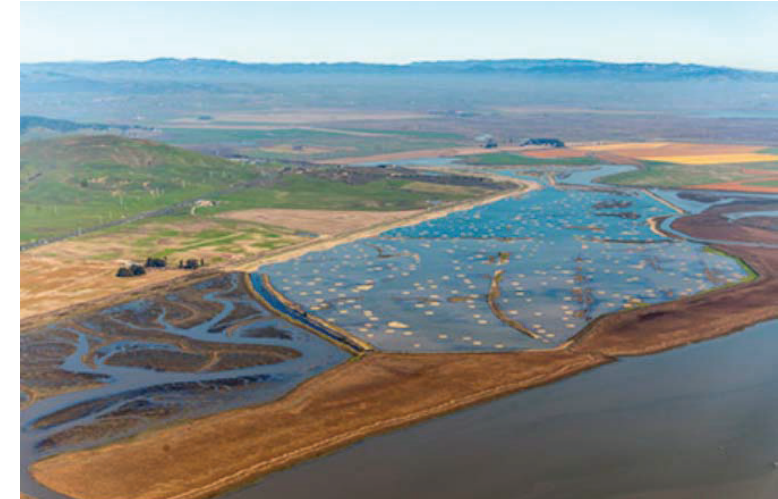
## The Challenge

While large areas of relatively undeveloped former tidal marsh occur in the North Bay, major constraints include transportation infrastructure, private ownership of these agricultural lands, and subsidence of diked baylands. The Sonoma Land Trust has been very successful at land acquisition for conservation and public recreation, however, railroad right-of-way and Highway 37 are barriers to broadening the “swath” of tidal wetlands needed to accommodate sea-level rise.

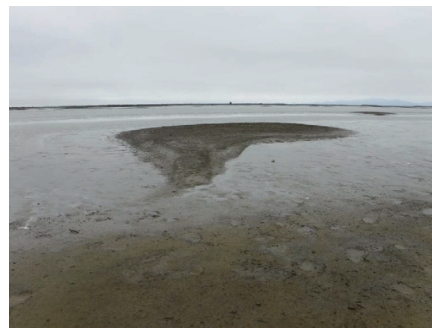
Note the “tear drop” shape of this wind-wave eroded mound. As mounds erode, wave energy deposits sediment on protected sides of the mounds.

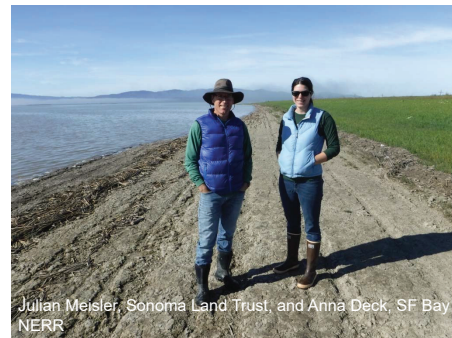
Wind wave erosion scoured the shore of the transition levee leaving a pavement-like surface in March 2017

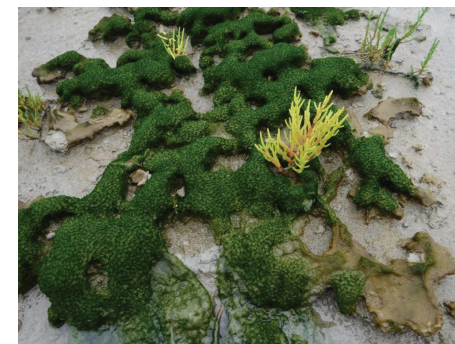
Wind waves erode “potholes” in transition levee, these fill with coarse sediment and provide footholds for intertidal plants.

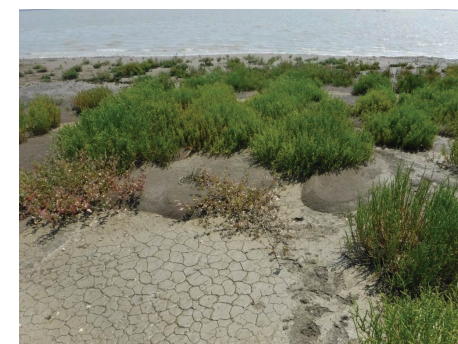
Waves and tidal currents deposit coarse sediment on wind protected shore providing recruitment sites for intertidal plants

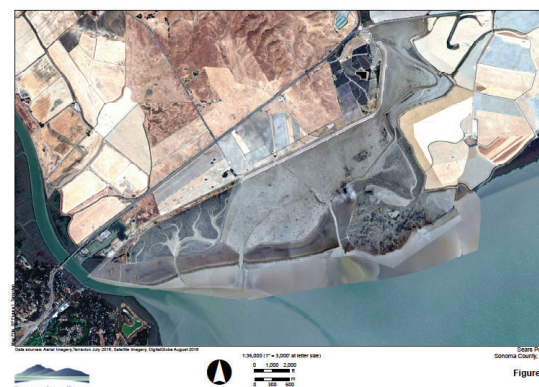
The main breach connects with the Petaluma River channel and there is a robust tidal prism. Wind waves mobilize sediments from nearby mudflat shoals. The result is an excellent supply of suspended sediments.

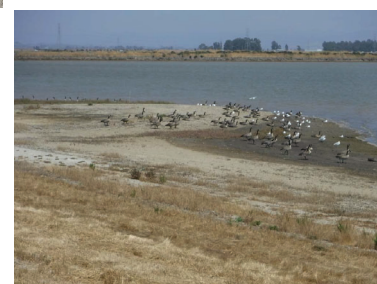
Canada geese roost on the edge of a panne in the eastern “whale’s tail” section of the restoration. This area is protected from wind and seems to also get less sediment supply, perhaps because it is farthest from the main breach

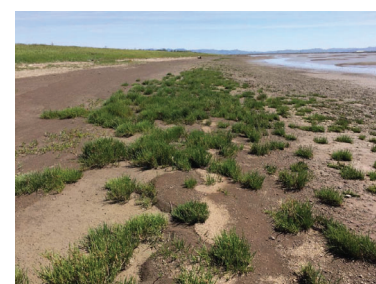
Coarse sediment deposits, possibly derived from eroded mounds, create ideal habitat for pickleweed recruitment.

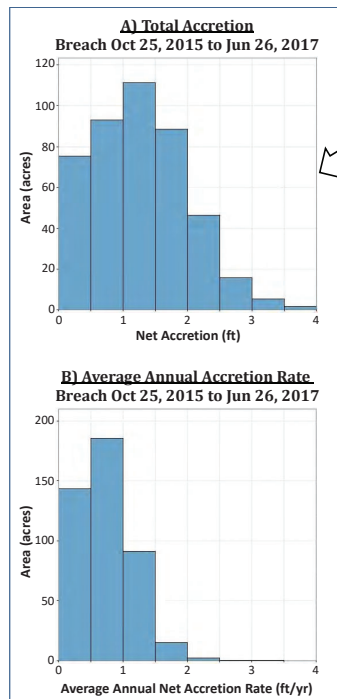
Figure 4: Net Accretion  
(Total, Average Annual Rate)

At Year 1.7, total net accretion was nearly 4 ft maximum, with a median accretion of 1-1.5 ft (Figure 4A), translating to average annual rates of 0.5-1 ft/yr median and 3-3.5 ft/yr maximum. Net accretion reflects elevation change only and combines all processes of deposition, consolidation, and compaction that intertidally deposited sediment undergoes. These rates are anticipated based on earlier findings from nearby Carl's Marsh (Siegel 2002).

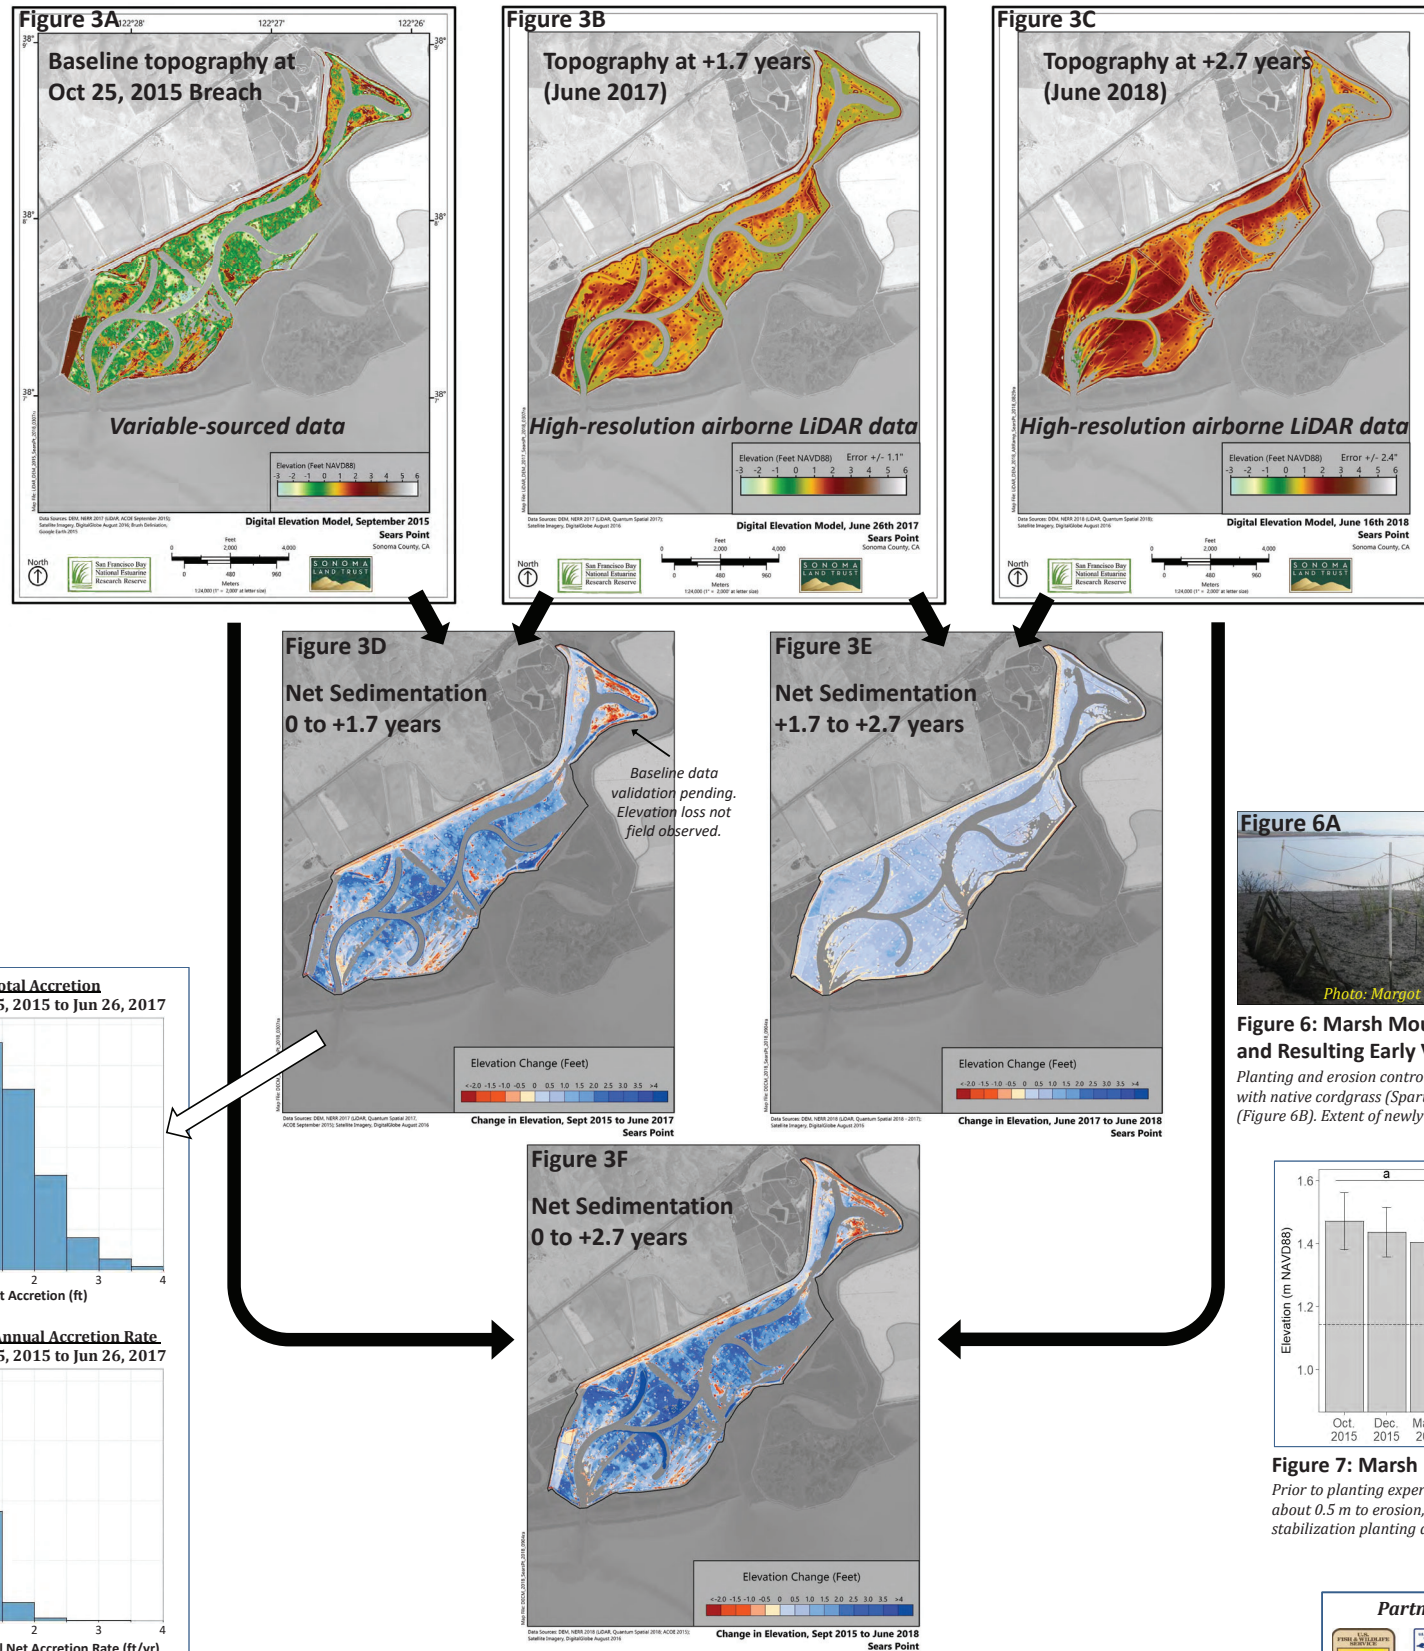
Figure 3: Topography and Net Sedimentation, Baseline to June 2018

Sears Point has undergone a significant amount of natural sedimentation in its first three years of restoration. Figure 3A shows the as-built topography (comprised of mixture of ground-based LiDAR and engineering design elevations). Figure 3B shows the airborne LiDAR data for 1.7 years after breach, June 2017. Figure 3C shows the airborne LiDAR data for 2.7 years after breach, June 2018. Figures 3D through 3F show the *change* in elevation from baseline to Year 1.7, Year 1.7 to Year 2.7, and baseline to Year 2.7, respectively. To date, we have analyzed the 2017 LiDAR data and elevation change, and Figures 4A and 4B present the total accretion and average annual accretion rates, respectively.

Spatial distribution of accretion also followed general predictions of the "prograding delta" concept wherein more deposition occurs near the inlets and along channel banks as flow velocities reduce and less sediment remains in the water column to deposit in the farthest areas from tidal connections (Siegel 2002, WWR 2007). Figure 2 shows the generalized design prediction and Figures 3B and 3C show the site patterns. Actual patterns reflect interaction of flows through the two breaches.

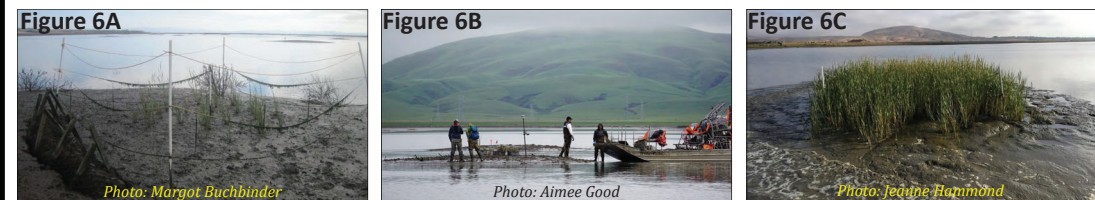
Figure 6: Marsh Mound Experimental Plantings 2016 (A), Plantings by Invasive Spartina Project March 2018 (B), and Resulting Early Vegetation Establishment August 2018 (C)

Planting and erosion control experiments conducted by Margot Buchbinder (SFSU EOS Center graduate student) in 2016 to test mound stabilization approaches with native cordgrass (*Spartina foliosa*) and coir rolls (Figure 6A). Planting of native cordgrass by the Invasive Spartina Project on ~30 mounds in March 2018 (Figure 6B). Extent of newly establishing native cordgrass on planted mounds as of August 2018 (Figure 6C).

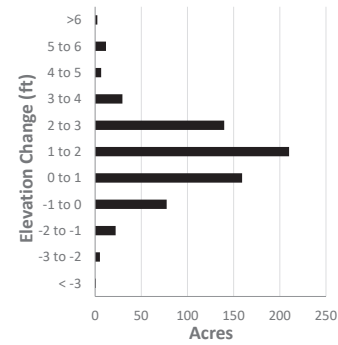
Figure 4: Net Accretion

At Year 2.7, total net accretion averaged around 2 ft, with maximum accretion 6 ft. Net accretion reflects elevation change only and combines all processes of deposition, consolidation, and compaction that intertidally deposited sediment undergoes. These rates are anticipated based on earlier findings from nearby Carl's Marsh (Siegel 2002).

**Total accretion volume  
breach to June 2018 (2.7 yr)  
~2 million cubic yards**
