Sears Point Levee Adaptive Management Project

Monitoring Plan

Updated: March 22, 2022

Sonoma Land Trust

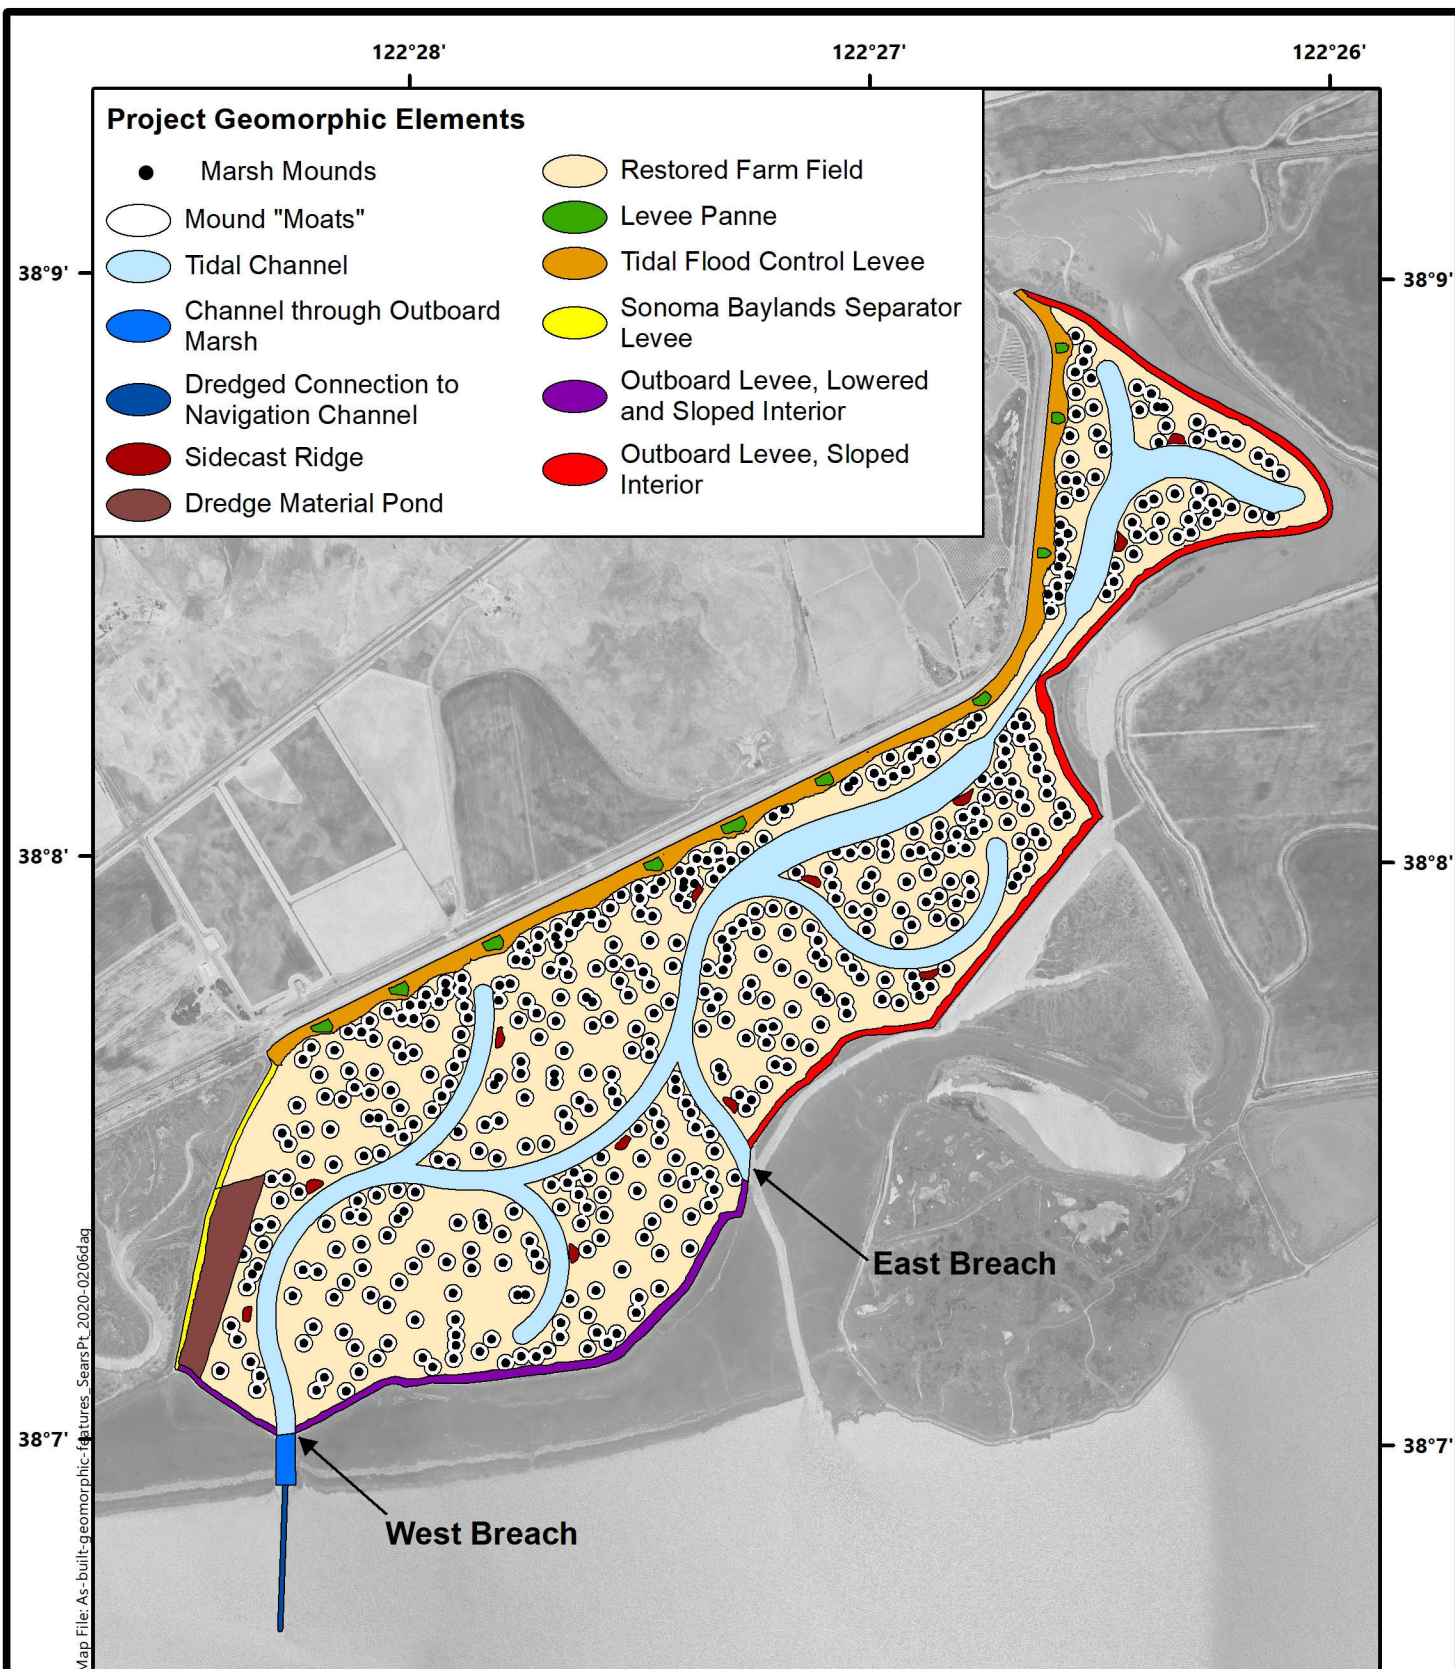
Figure 2

Data Sources: Photo (NAIP, 2016); Geomorphic Features (NERR, 2020)

As-Built Project Geomorphic Elements

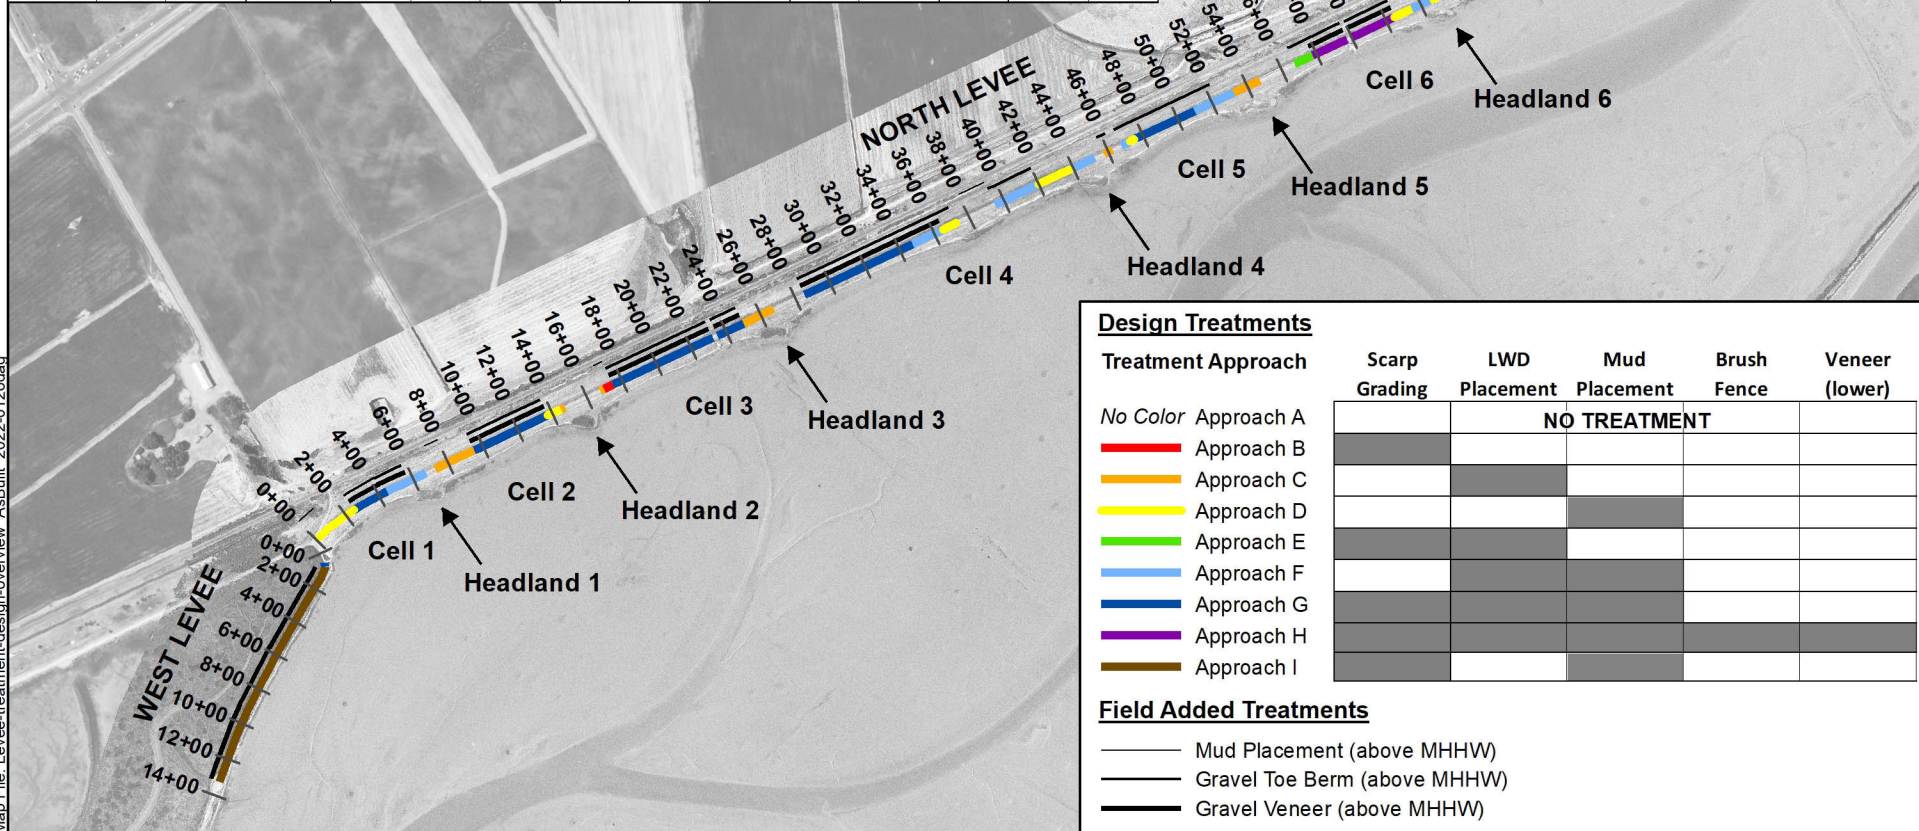
Figure 3

Treatment Unit	Length (LF)	Scarp Grading Length (LF)	LWD Placement No. Logs	Mud Placement (below MHHW)		Mud Placement (above MHHW)		Brush Fence Length (LF)	Veneer (below MHHW)		Veneer (above MHHW)		Toe Berm	
				Length (LF)	Vol (CY)	Length (LF)	Vol (CY)		Length (LF)	Vol (CY)	Length (LF)	Vol (CY)	Length (LF)	Vol (CY)
Cell 1	575	200	16	525	330	100	63	0	0	0	325	25	325	43
Cell 2	725	425	18	500	315	75	47	0	0	0	425	33	425	57
Cell 3	925	775	29	725	456	50	31	0	0	0	725	57	725	97
Cell 4	1725	625	37	1350	849	150	94	0	0	0	800	62	1175	156
Cell 5	750	350	30	650	409	0	0	0	0	0	0	0	600	80
Cell 6	825	550	18	550	346	0	0	450	450	69	450	35	550	73
Cell 7	1650	1175	44	1425	897	0	0	975	975	151	0	0	1275	170
Headland 1	150	0	5	100	63	0	0	0	0	0	0	0	0	0
Headland 2	125	0	1	0	0	0	0	0	0	0	0	0	0	0
Headland 3	150	0	8	0	0	0	0	0	0	0	0	0	0	0
Headland 4	200	0	8	150	94	0	0	0	0	0	0	0	0	0
Headland 5	200	0	9	0	0	0	0	0	0	0	0	0	0	0
Headland 6	200	0	6	200	126	0	0	0	0	0	0	0	0	0

Headland 7	125	0	10	125	79	0	0	0	0	0	125	10	0	0
West Levee	1325	1325	1	1325	834	0	0	0	0	0	1250	98	0	0
TOTAL	9650	5425	240	7625	4797	375	236	1425	1425	220	4100	320	5075	676

Adaptive Management Treatment Overview

The “living shoreline” approach to erosion control aims to restore the eroding transition zone by utilizing “nature-based strategies” – the incorporation of dynamic natural ecosystem processes and materials to the greatest extent practicable. The project includes the following design elements (Table 1), with their placement locations shown in Figure 3.

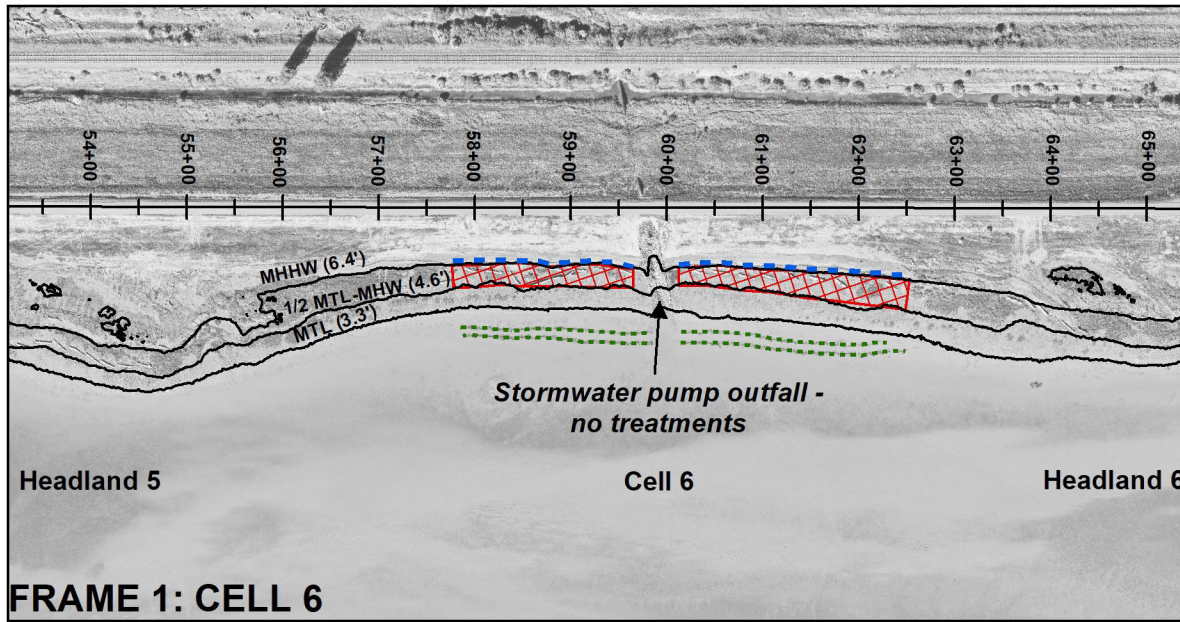
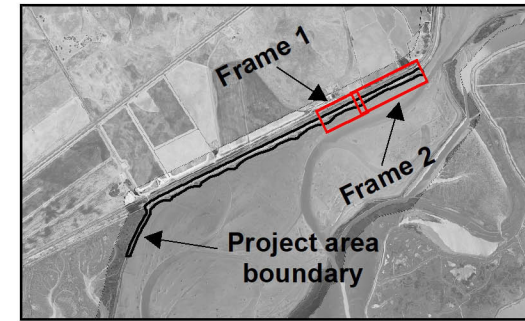
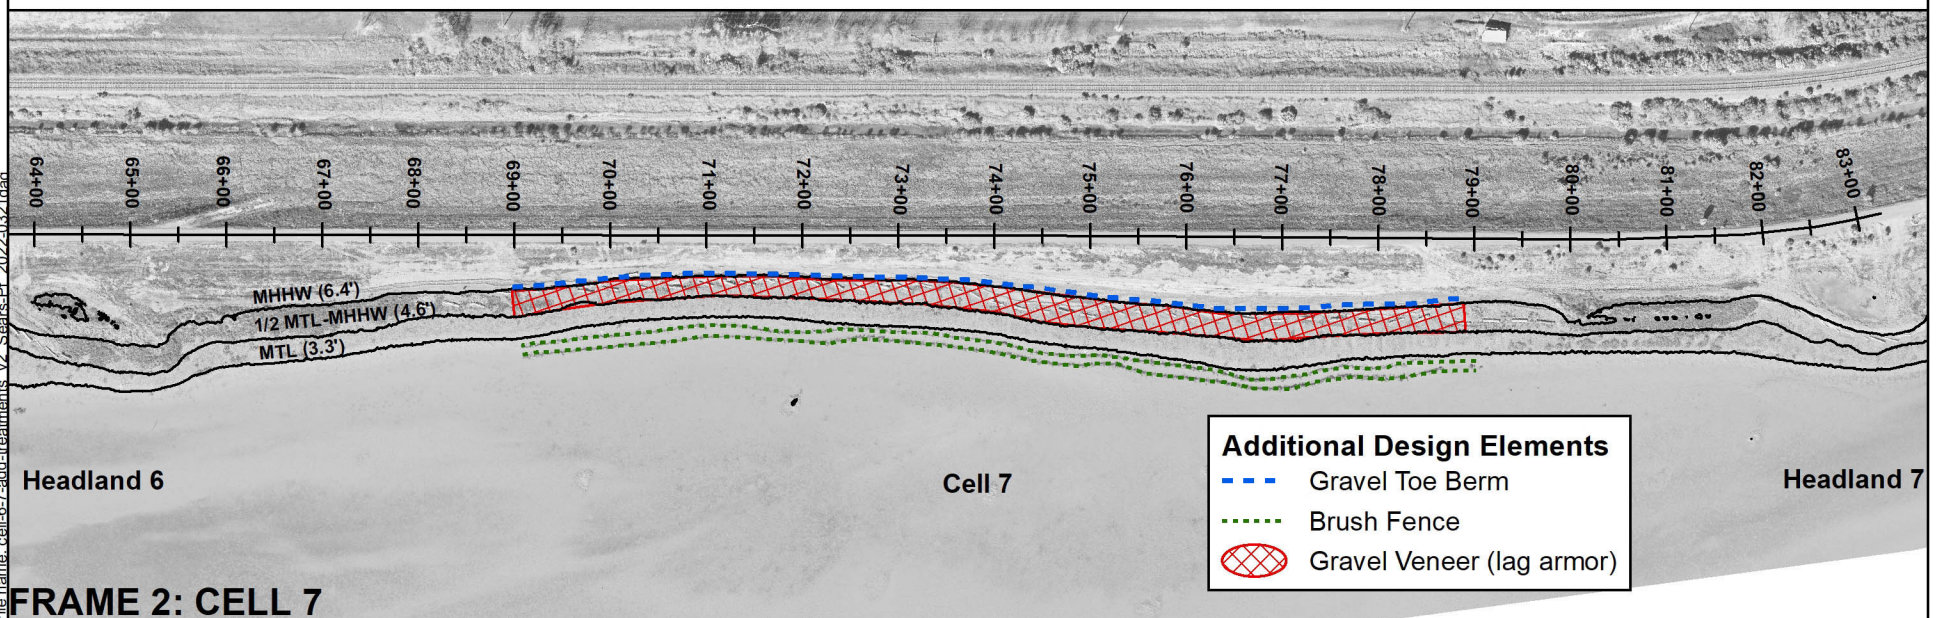
Figure 4

CONSTRUCTION QUANTITIES						
Design Element	Elevation Range	Length (ft)	Area (ft ²)	Excavation Vol (CY)	New Fill Vol (CY)	Replaced Fill Vol (CY)
Gravel Toe Berm	MHHW - HTL ¹	1,825	10,040	-	243	-
Gravel Veneer	1/2 MTL-MHW ² - MHHW	1,450	35,270	-	220	-
Brush Fences (2 rows)	MTL - 1/2 MTL-MHW	2,900	5,800	860	-	860

¹ High tide line: ~8' NAVD88

² Mid point between the elevation of MTL and MHW (4.6' NAVD88)

Constructed Additional Cell 6 & 7 Treatments

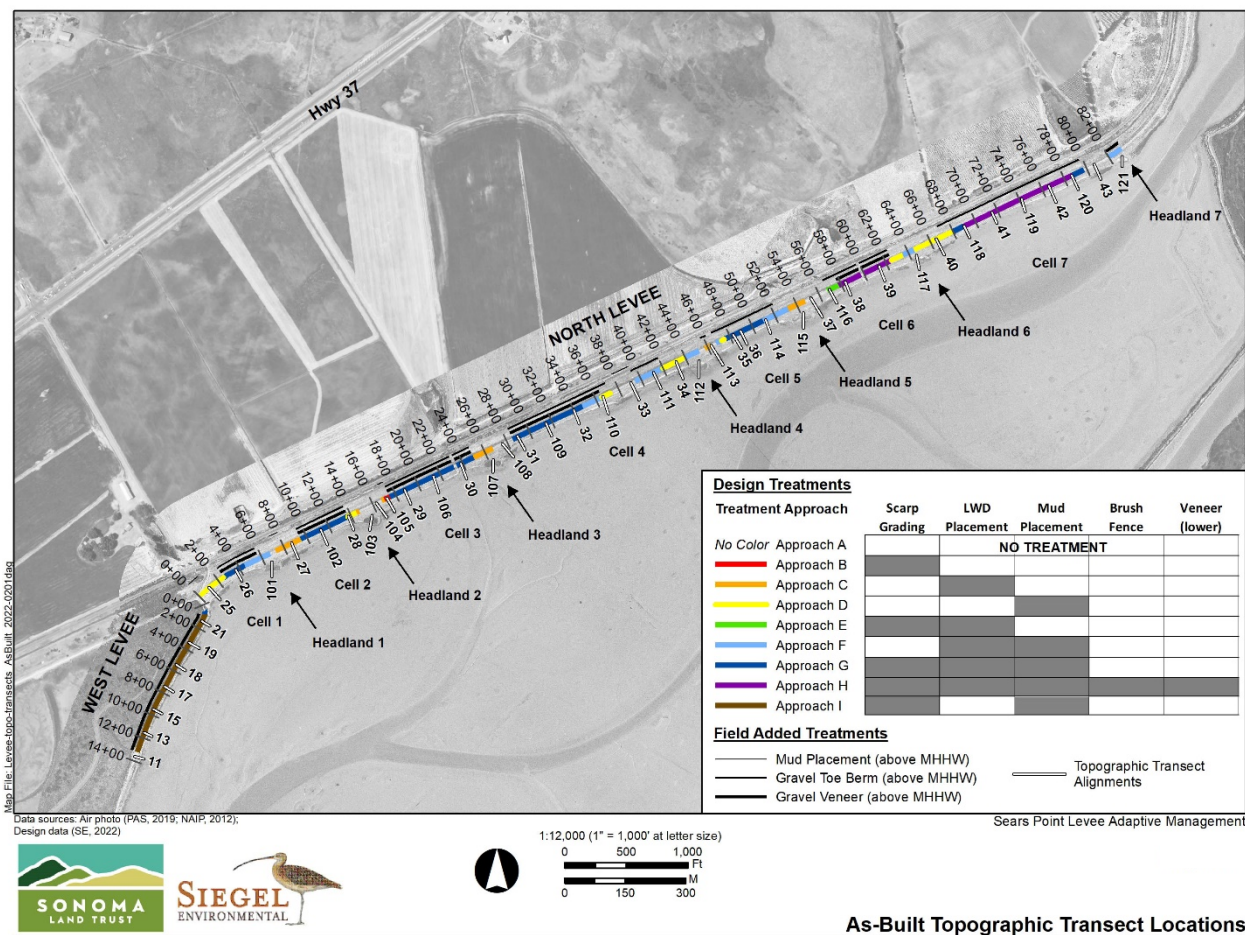
Figure 6. Topographic Survey Transects to Be Reoccupied

Double-digit transect numbers correspond to original numbers established by Ducks Unlimited in its post-construction surveys. Triple-digit transect numbers added for the as-built survey. For this monitoring plan, all identified transects will be surveyed. Primary reference benchmark is JT9545 shown in Figure 5.

- Reoccupy a minimum of 26 transects established by Ducks Unlimited with 2017 and 2018 surveys and an additional 22 transects surveyed as part of the as-built survey (Figure 6)
- RTK or total station surveys of these transects
- Geodetic elevations tied to nearby NGS geodetic benchmark JT9545 at a minimum
- Data plotted alongside prior transect data
- As vegetation establishes and obscures the ground surface, this method will be increasingly important
