Sears Point Levee Adaptive Management Project

As-Built Report

March 23, 2022

Sonoma Land Trust

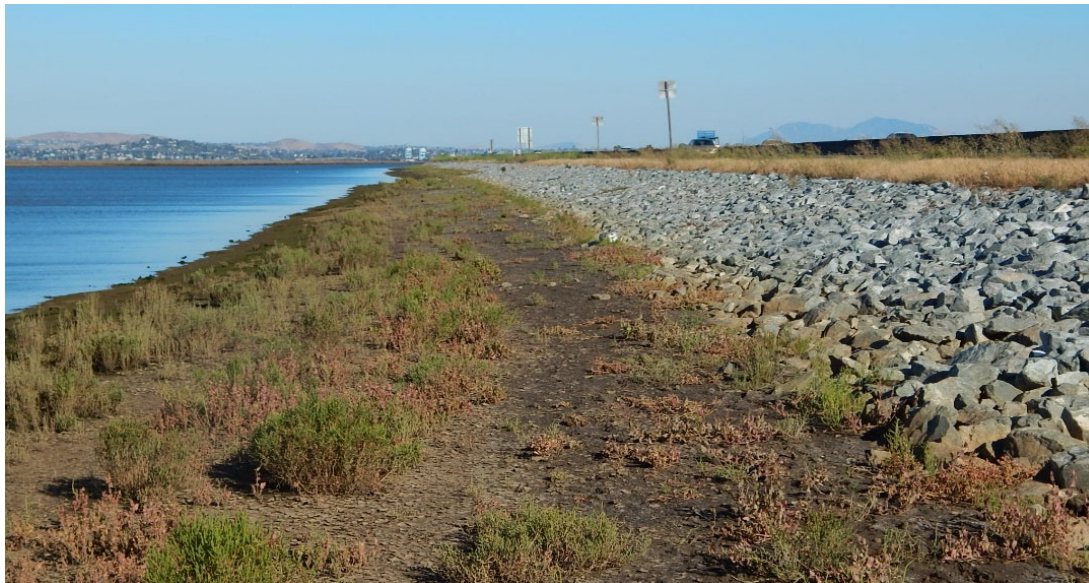
Photograph 2. Shoreline stabilization by armoring (not desired for Sears Point)

Shoreline stabilization by armoring (rip-rap, rock slope protection) eliminates the high salt marsh-terrestrial transition zone and high tide refuge habitat for marsh wildlife. Armoring or other stabilization techniques that impede or exclude continuous transition zone vegetation would be incompatible with Sears Point Wetland Restoration Project ecological objectives.

protection) and the importance of restoring a dynamic, continuous transition zone (ecotone) supporting native vegetation gradients between high salt marsh and the highest tides (Photograph 2). This “living shoreline” approach also seeks to avoid to the maximum extent possible other artificial stabilization materials and structures for erosion control that are sometimes included in “soft” shoreline stabilization or “living shoreline” methods, such as erosion control geotextile fabric, wave-break berms, rock sills, geotextile tubes, fences, etc. Conventional artificial stabilization materials would likely require both costly installation and post-stabilization removal along the extensive length of proposed erosional shoreline treatment (about 2 miles in total), or it would risk leaving persistent, intrusive, adverse influences in the stabilized transition zone if their remnants were left in place. The only such material used here were metal anchors used for placed logs.

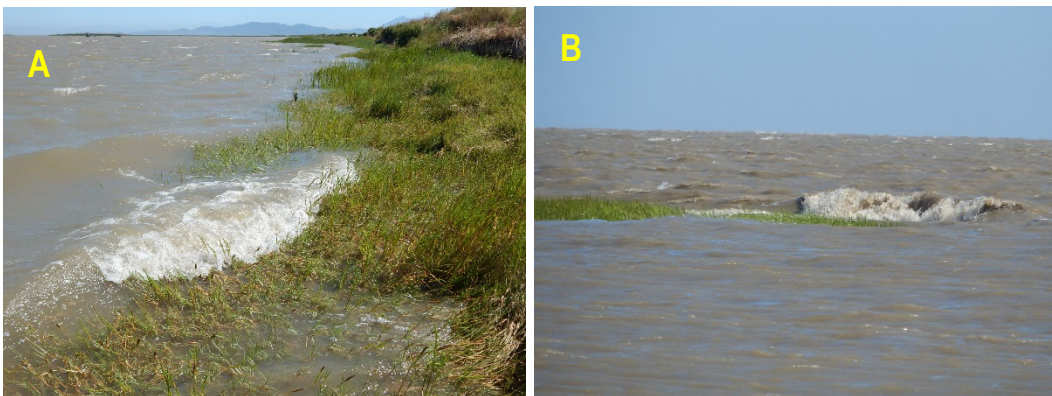
Photograph 3. Observed Wave Damping Benefits of Vegetation at Sears Point

Even narrow marsh belts of flexible, dense shoots of established saltgrass and cordgrass (A, Sears Point southwestern levee), or pure cordgrass (B, Sears Point tidal inlet) cause significant damping of erosional wave energy over short distances of 10-20 ft.

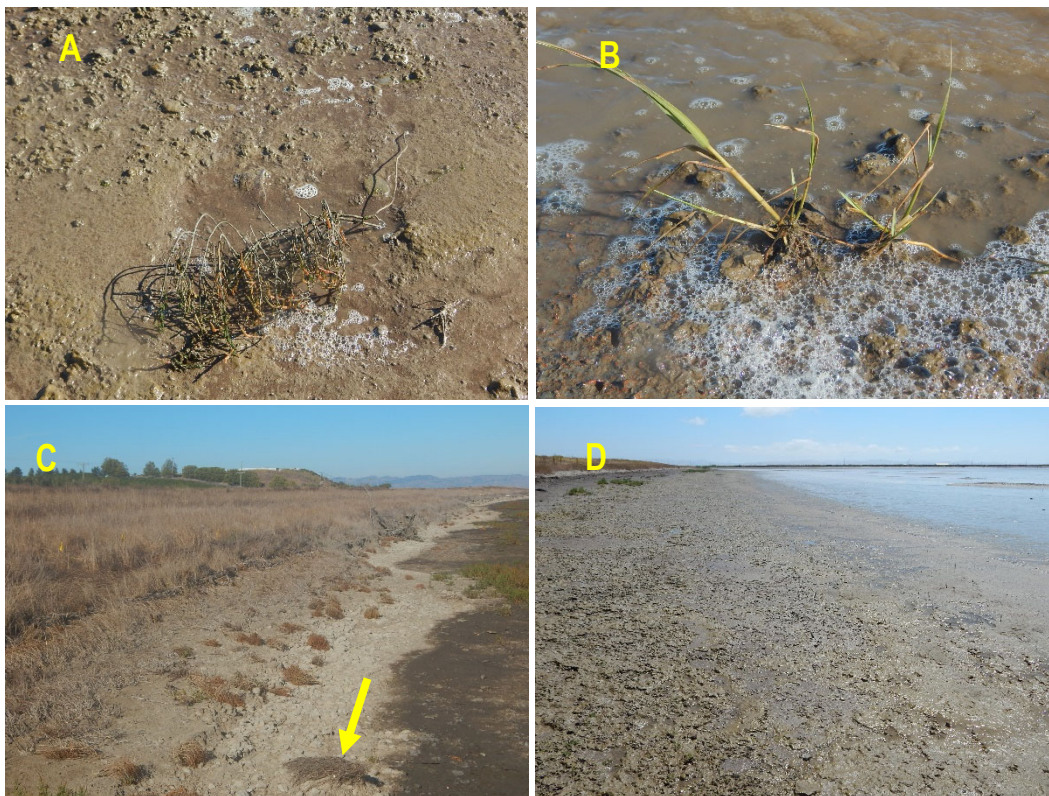
Photograph 4. Root systems and uprooted plants

At Sears Point, initiation of wave-attenuating fringing salt marsh above MTL has been repeatedly interrupted by cycles of wind-wave erosion during the growing season as well as in the winter storm season. To establish fringing salt marsh, seedling and juvenile plant growth and development must reach critical size (root anchoring and spread) by the end of the growing season to outpace the rate of surface erosion or undermining by waves (Photograph 4).

Root systems of pioneer salt marsh plants (A - pickleweed, B - cordgrass) are exposed by rates of erosion that uproot them during the growing season, before plants can establish, anchor themselves, and spread. Uprooted plants wash up on shore (C), leaving exposed, scoured compacted levee foundations that resist root penetration (D) and promote vulnerable, shallow seedling root systems. Summer 2018.

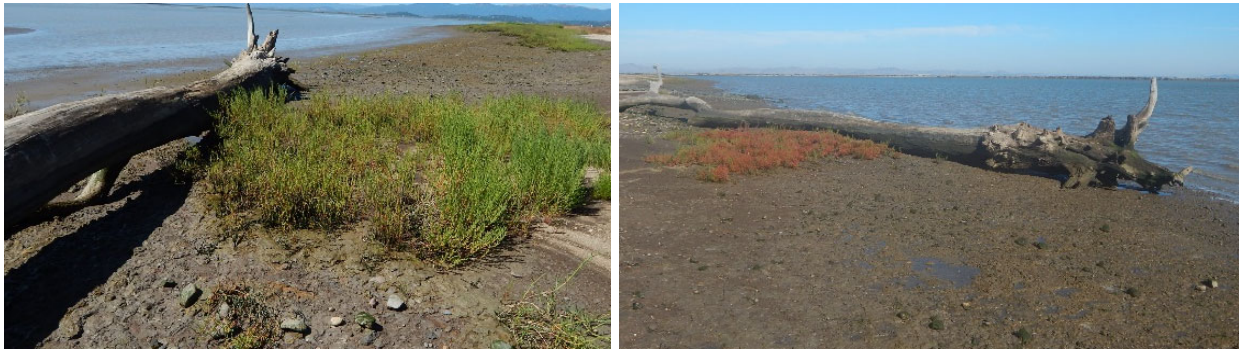
Photograph 5. Vegetated sediment deposits behind large driftwood

A half dozen or so large driftwood logs have arrived at Sears Point over the past few years. These embedded coarse woody debris in the upper intertidal zone create “wave shadow” shelter zones in their lee, which act as local traps for coarse sediment and local nurseries for pioneer salt marsh seedlings (seed deposition among debris, sheltered “safe sites” for seedling growth and establishment during long intervals between potential erosion). These are observed nuclei for primary salt marsh succession and development of wave-attenuating marsh zones (Photograph 5). Large driftwood is currently scarce and local in the high intertidal zone. Augmentation of driftwood (individual pieces and jams or aggregates) in the high marsh zone is a mechanism for enhancing marsh nucleation (centers of pioneer marsh colonization and accretion) and providing habitat complexity (shelter, moisture refuge, predator refuge, and support for climbing marsh plant canopies).

Vegetated sediment deposits form locally in wave shadows behind large driftwood, north shore, Sears Point, 2019.

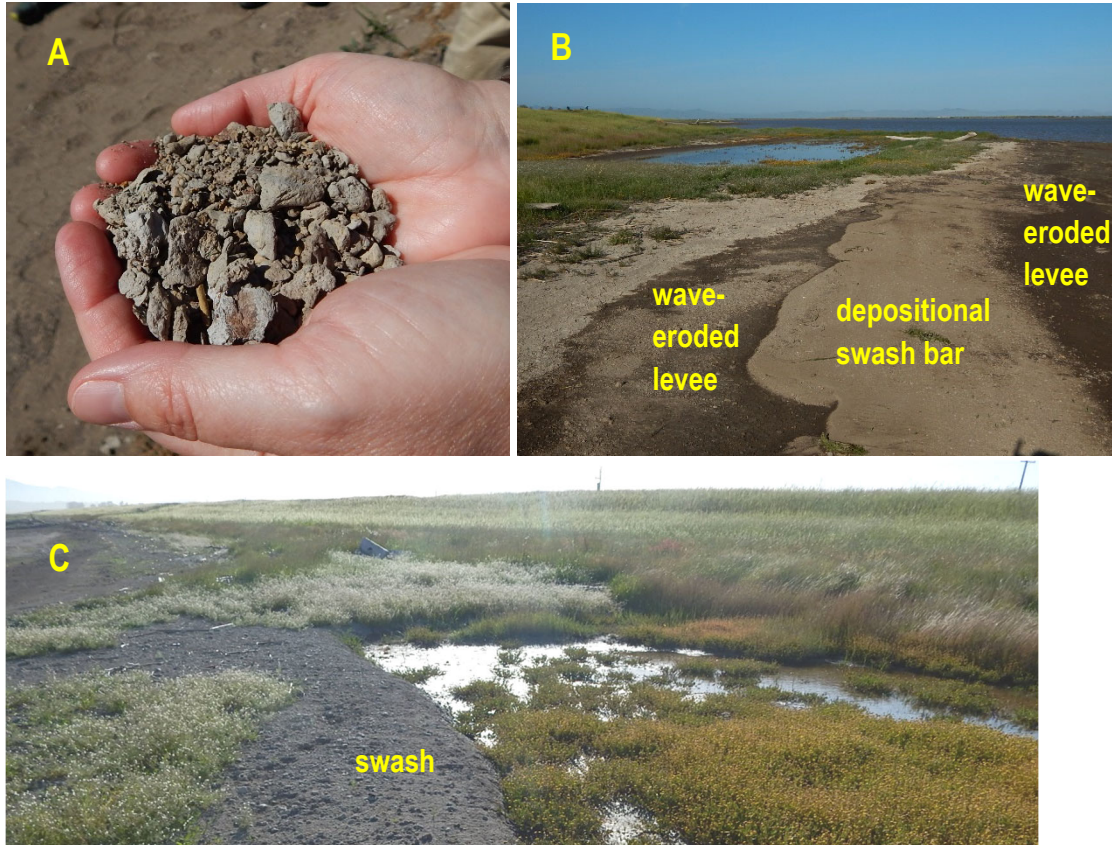
Photograph 6. Aggregates of cohesive, dried clay-silt bay mud sediment

Aggregates of cohesive, dried clay-silt bay mud sediment (A) erode from compacted Sears Point northern levee in the uppermost spring intertidal zone (near or above MHW, where they are subject to drying during neap tides in summer). Eroded aggregates are subsequently deposited by wind-waves as shoreward-migrating swash bars (small upper intertidal to supratidal beach ridges); B-C) up to about 0.5 ft thick, composed of particles equivalent to sand or gravels.

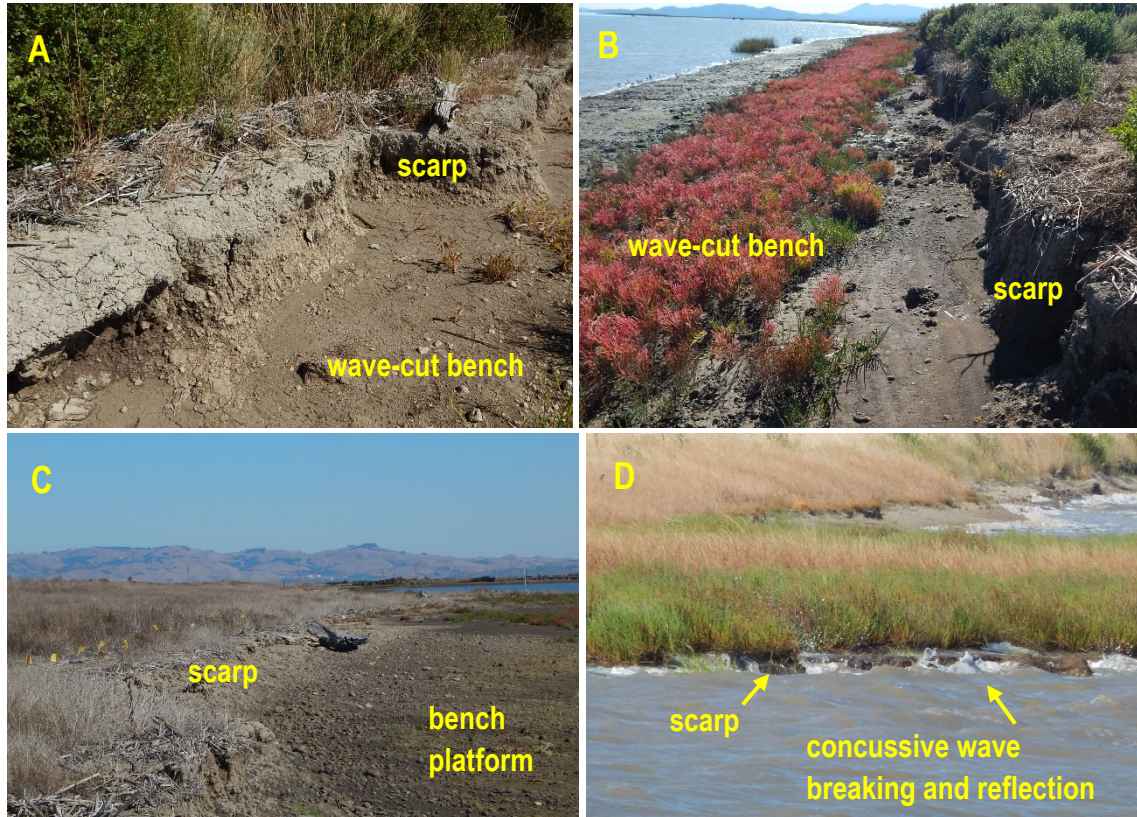
Photograph 7. Actively retreating vertical wave-cut scarps

Once a cliffed wave-cut bench (near-vertical scarp) forms by severe backshore erosion in weakly consolidated sediments (Photograph 7, A-B), waves at mid-tide stages break on a more dissipative gently-sloped bench. At the highest tides, waves break on the steepest, most intensively wave-reflective profile, concentrating erosional wave energy at the scarp toe (undermining the base, triggering slope failure) or on the scarp wall itself, where concussive wave breaking and reflection occurs (Photograph 7, C-D). The scarp profile creates a positive feedback for intensive erosion until scarp retreat (progressive erosion toward the shore) flattens the profile to a dissipative one. This positive erosional feedback also creates a turbulent, barren, unvegetated scour zone where waves are reflected (Photograph 7 A-C). Re-grading the steep profile to a gentler slope, combined with additional measures to damp wave

energy seaward of the scarp and initiate vegetative stabilization (Photograph 7 A-D above), can interrupt the positive erosion feedback of wave-reflective scarp profiles.

Actively retreating vertical wave-cut scarps about 0.5-2 ft high form in the northern segment of the western levee (A), and along most reaches of the northern levee at and between constructed pan berms (B, C). Once this steep “cliff” profile develops, erosional wave energy concentrates at the scarp and its toe (scour zone) at high tides, when concussive wave breaking and reflection occurs (D).

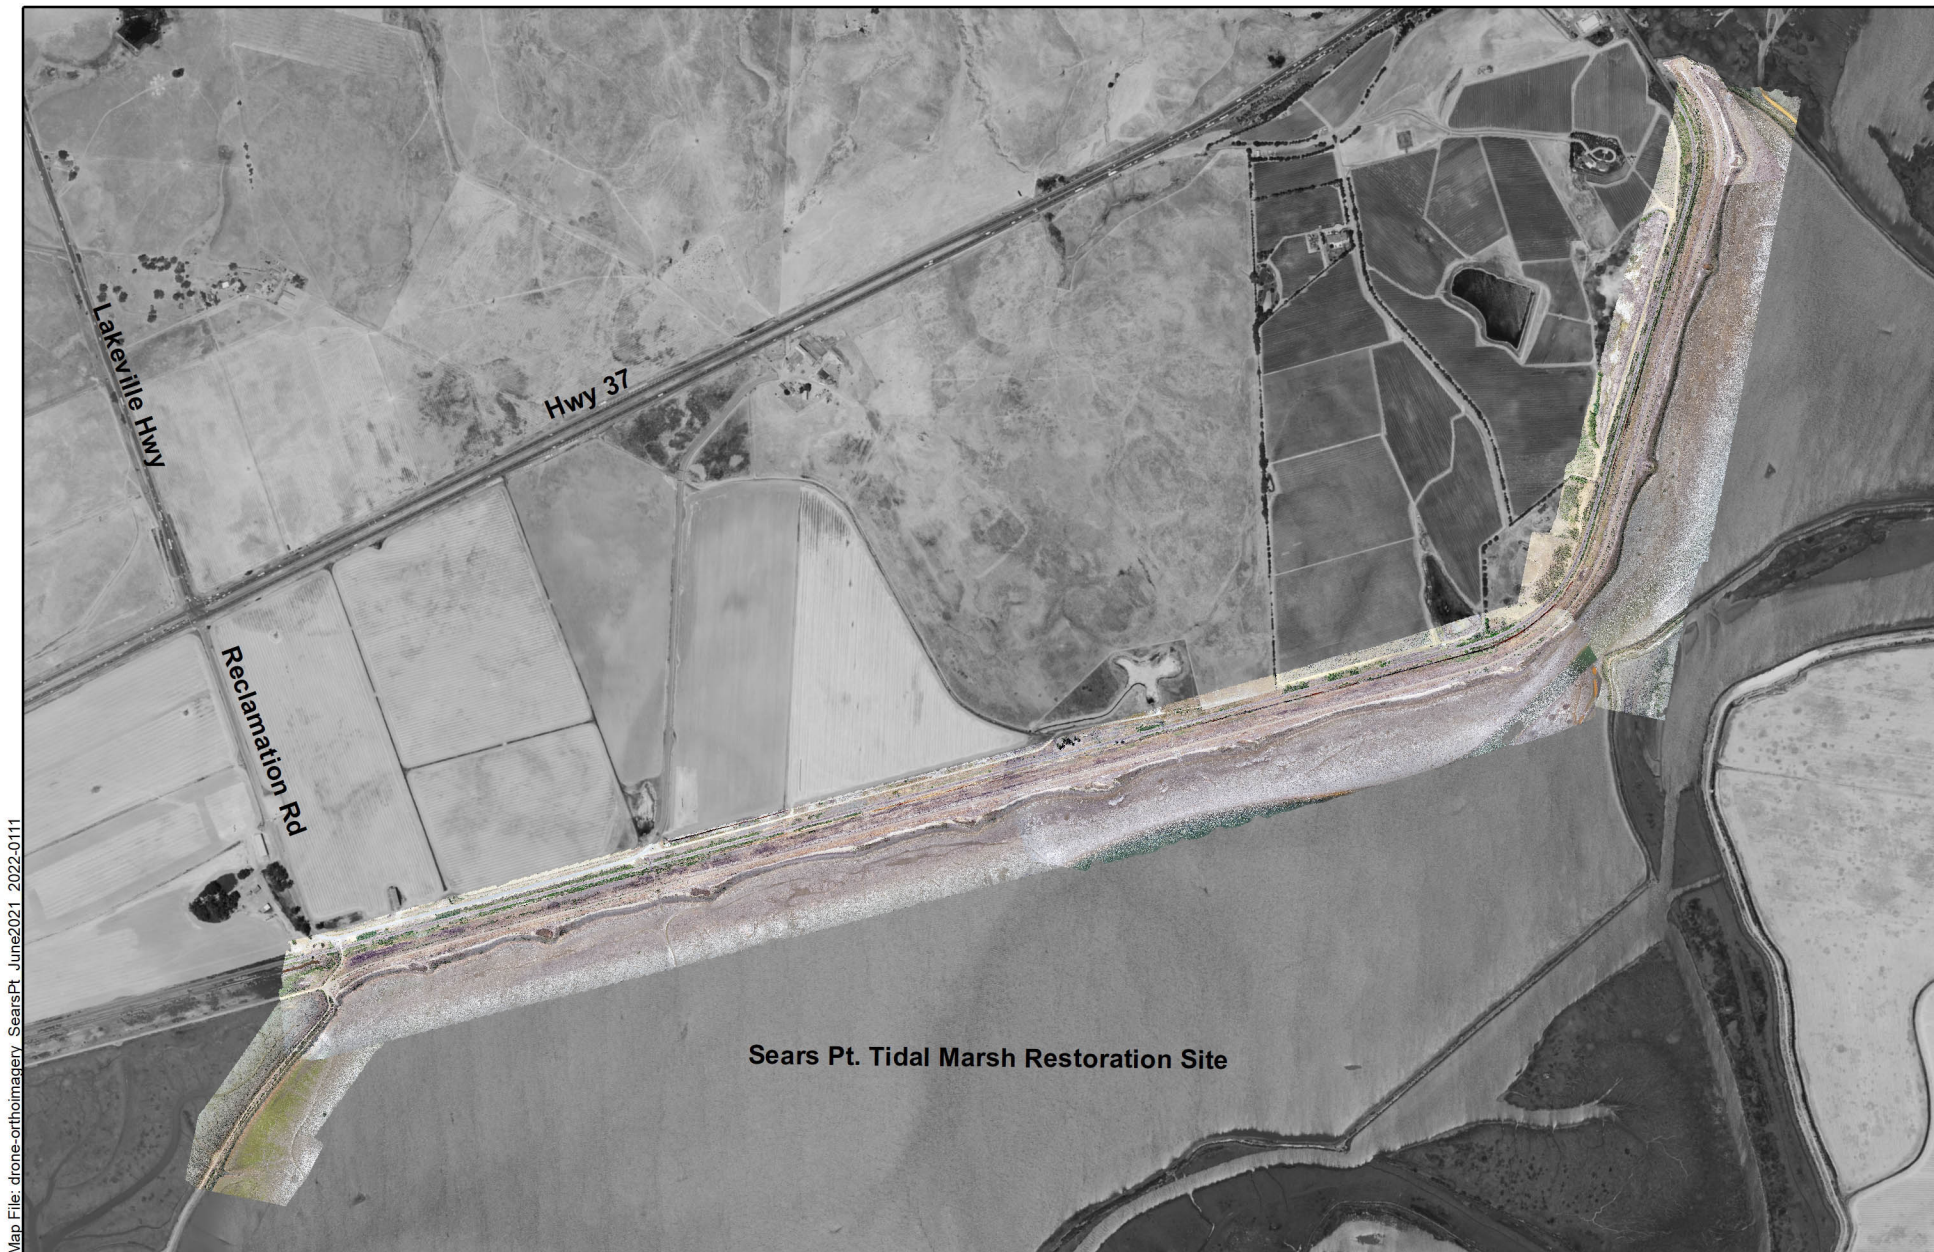
June 16 and 30, 2021 (Pre-Construction) Orthomosaic Imagery

- 1) Figure 6 provides the baseline imagery for the entire Project area
- 2) Figure 7 provides the as-built imagery for the entire Project area
- 3) Appendix C provides the baseline and as-built imagery “close up” views, consisting of 11 frames to cover the Project area in detail
- 4) Appendix D provides the baseline and as-built photogrammetry-derived topography “close up” views, consisting of 11 frames to cover the Project area in detail

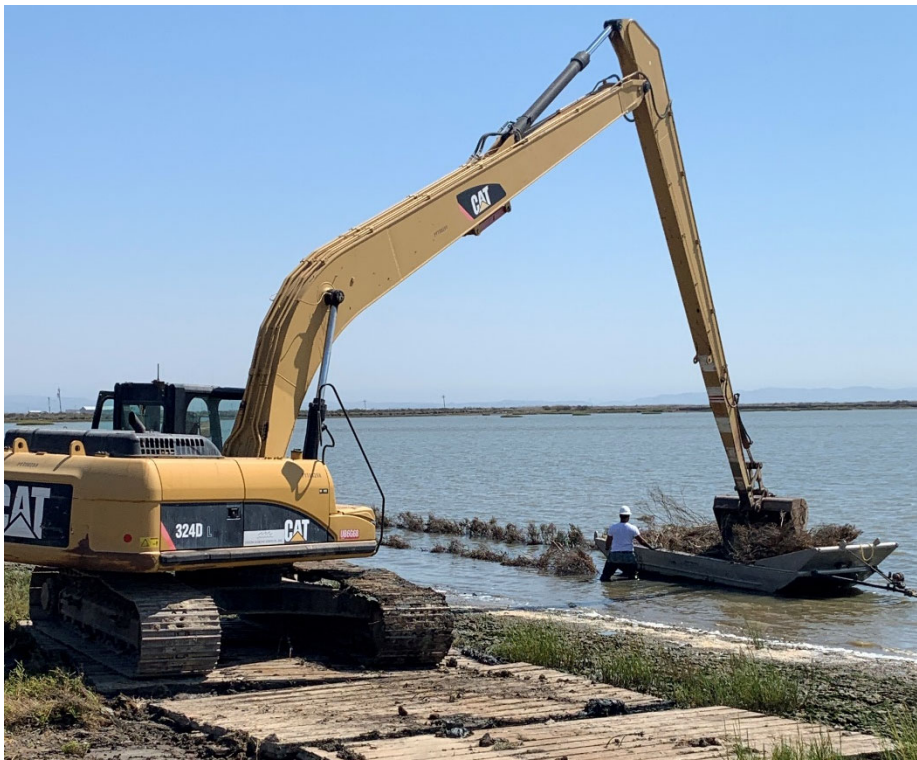
Photograph 8. Brush Fence Installation

Coyote brush branches were manually cut from trunks on shrubs in designated areas (dense, decadent stands) bordering railroad tracks in between Sonoma Baylands and Sears Point project site. Cut brush was stacked and hauled by truck to the shoreline for installation by field crews. Cut brush was loaded on a large aluminum mud sled which was pulled into position near the MTL by a long-reach excavator. The sled was dragged on the mud surface in pace with installation sites (**Error! Reference source not found.**). The cut end of branches was manually inserted into deep (approximately 2 ft) soft, semi-fluid mud at oblique angles, with brush ends facing east, away from the predominant wave approach direction. Alternating branches were crisscrossed and overlapped, interlocking tangled successive branches (braided pattern). Branch bases were inserted at least 1 foot below mud surface level. Two brush fence rows, about 5-7 ft apart, were installed on mudflats near the toe of the sloping levee bench, where some previous cordgrass transplants survived, and where supplemental cordgrass plugs were transplanted following brush fence placement.

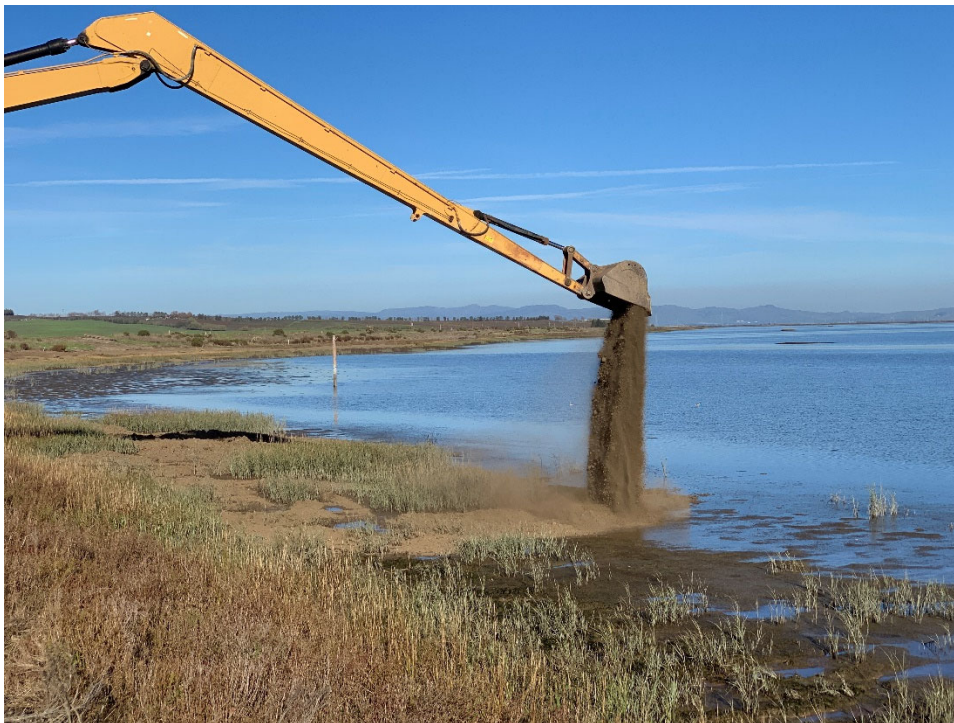
Photograph 9. Placement of Dry Aggregate Bay Mud Around Vegetation

The design placement zone for aggregate bay mud was from MHW (5.8 ft NAVD88) down to mid-point between MHW and MTL (4.6 ft NAVD88), below placed logs. By the time of construction, some of these mud placement areas remained unvegetated accreted mud, but others had been colonized by cordgrass and/or pickleweed in variable density and patch sizes. Since the basic purpose was to facilitate vegetative stabilization, avoidance of direct smothering of the new salt marsh patches was a priority for adapting the design during construction (Photograph 9).

The long-reach excavator worked carefully around emergent vegetation

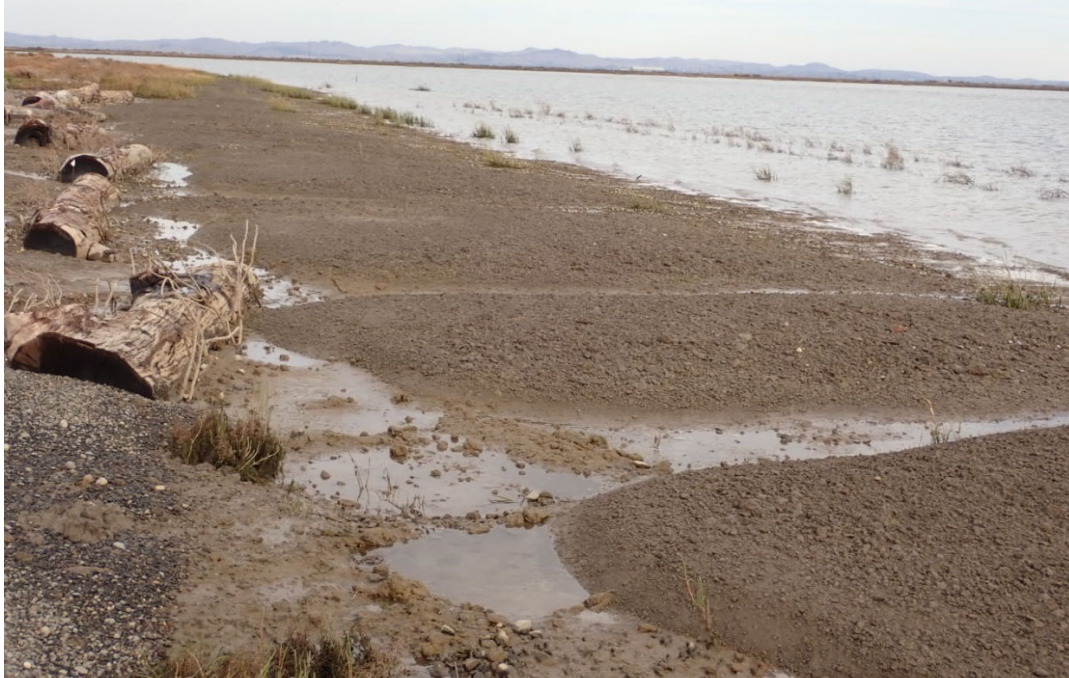
Photograph 10. Placement of Dry Aggregate Bay Mud Below Logs

On the west levee, where larger patches of cordgrass extended below the continuous salt marsh fringe, additional aggregate bay mud mound placement was more irregular, fitted around cordgrass patches instead of log gaps. Drifting aggregate mud after placement partially choked some of the gaps.

Sets of logs were selected by size and type for each cell and stockpiled on the levee near installation locations. Log end locations in the upper intertidal zone were flagged days prior to placement. Log spacing and orientation were modified to adapt to a narrower high marsh zone (MHW to MHHW closer to the scarp position, caused by recent acceleration of erosion prior to construction). Log orientations were set to align parallel with predominant wind-wave crests (S-SW) directly observed at the shore during the summer of construction (subjective visual estimation) (e.g., Photograph 10). Shallow trenches were made by a short-reach excavator

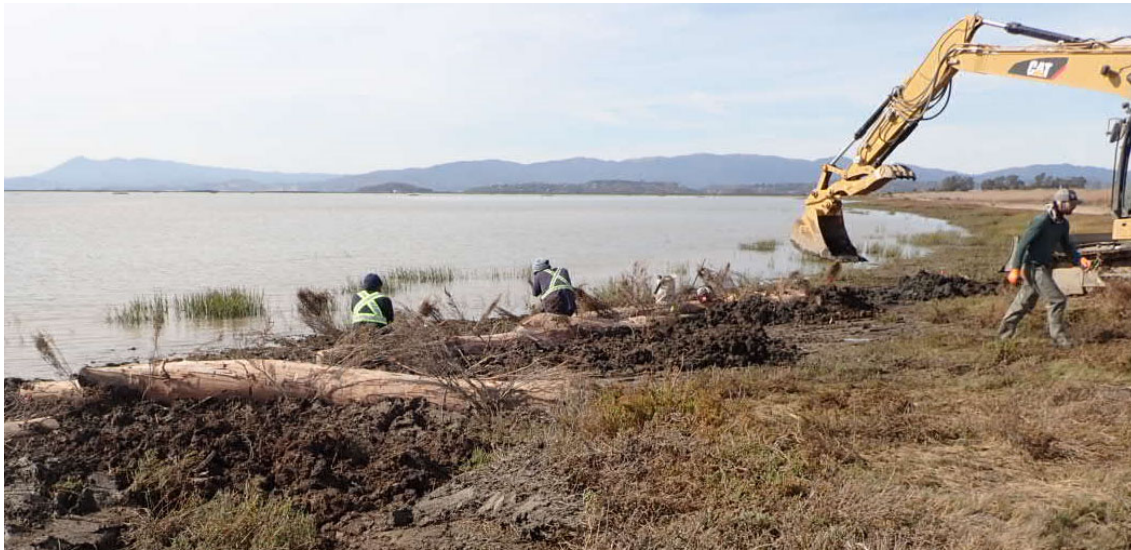
Photograph 11. Installation of logs and fringing coyote brush

working from wood mats on either firm ground on the lower levee slope, or on berms over high salt marsh (pickleweed). Logs were placed into the shallow trench by the excavator bucket with a “thumb”. The margins of the log were backfilled with mud, and logs were secured in place by metal cables anchored by “duckbills” and, for a handful of logs, with 4x4 untreated wood posts. Where wood anchors were used, the tops were cut to match the log, to avoid creating raptor perches. Coyote brush was installed to emerge from both sides of the log, to aid in promoting sediment deposition. Coyote brush placement took place before and after log installation, depending on what proved most effective. See Photograph 11.

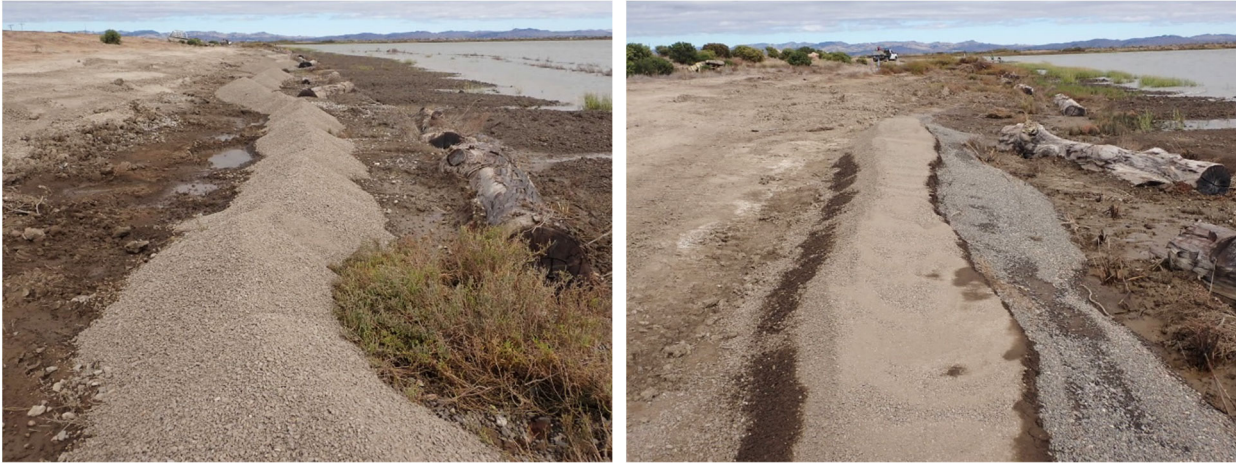
Photograph 12. Sacrificial Berm at Placement and During Wave Reworking

Coarse mixed alluvium, composed primarily of pea gravel with variable mixture of sand and mud, was trucked to the north levee. The contractor used an excavator to place immediately below the observed position of the highest winter drift-lines (maximum wave runup position during highest tides with high waves; approximately 8-9 ft NAVD88), in the form of a temporary, low, steep sacrificial berm (Photograph 12). The initial berm is intended to erode and re-deposit as a better-sorted, mobile gravel swash bar (low beach ridge and beachface deposited over the re-graded bay mud levee slope). This redistribution occurs via winter high tides with high wave action and some spring high tides in summer with high wave action. The late-stage evolution of the wave-redeposited gravel berm aimed towards high salt marsh and transition zone vegetation, following the gravel storm berm model at constructed at Aramburu Island (Gillenwater and Baye 2022, SFEI and Baye 2020). The final gravel berm and beachface formed dynamically and was not constructed to a specific location and height. The wave-deposited gravel berm is aimed at inhibiting re-initiation of scarps in underlying bay mud levee slopes and at absorbing high wave energy. Though originally included for cells 6 and 7 only, this

gravel placement was added to the remaining north levee cells during the construction phase to inhibit levee erosion and provide an additional layer of protection for higher energy events.

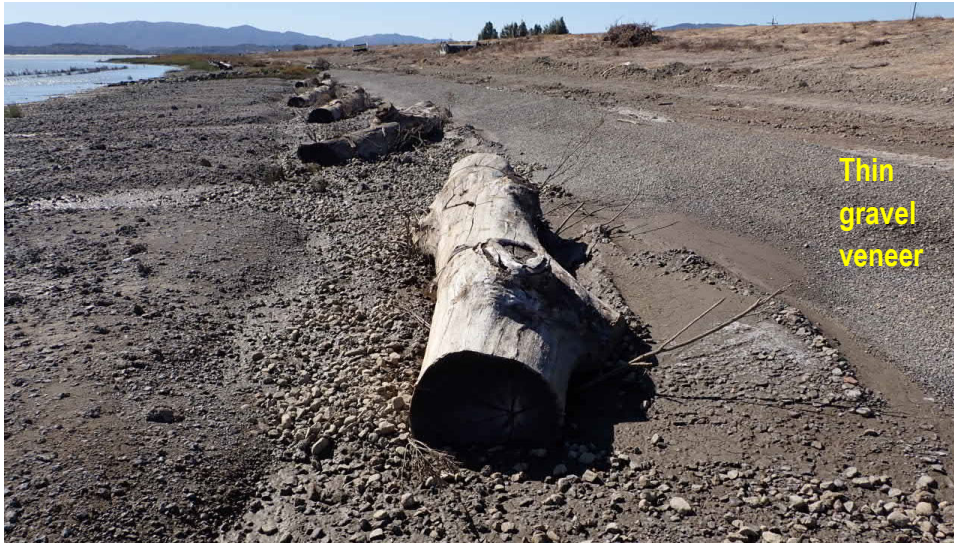
Photograph 13. Gravel veneer thin layer above logs placed before gravel toe berm

A *thin* veneer of coarse, $\frac{3}{4}$ " angular gravel (quarry drain rock) was placed over the wave-impacted upper intertidal zone and into the transition zone above the logs (Photograph 13). The purpose of this thin gravel veneer is to resist surface erosion and reduce wave exposure of seedling roots during periods of high wave action. The thickness of the armor layer was aimed at one particle, with gravel cover density allowing some exposure of underlying bay mud to facilitate interstitial salt marsh seedling establishment. This veneer is distinct from the gravel toe berm in that is intended to remain where placed as a static erosion protection feature, whereas the toe berm is intended to be wave re-deposited to place its erosion protection functions in locations to where natural processes move it. Gravel was placed by shaking the excavator bucket while slowly raising it and swinging it laterally by the skilled equipment operator, allowing fine control of how fast the bucket sprinkled the gravel. The angular gravel was gently tamped into moist mud to embed it in the surface.
