Sears Point Tidal Marsh Restoration Project

Monitoring Report, Years 1 through 5 October 2015 to October 2020

March 31, 2022

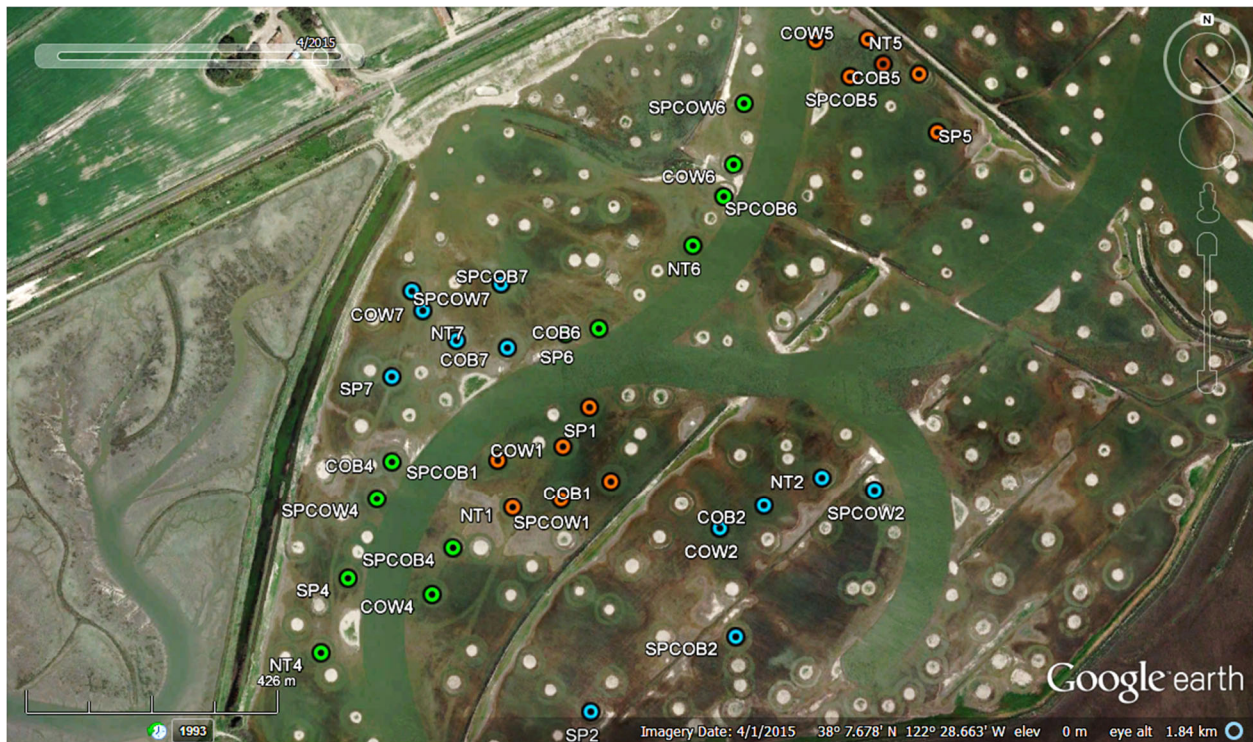
Figure 5. Map of Planted Mounds for Experiment

The installation of the experiment began in April 2016. Seven blocks of six mounds were selected via aerial imagery (Google Earth) in locations dispersed throughout the southwestern portion of the site, and treatments were randomly assigned to mounds within each block. Sediment pins, coir and *Spartina* sourced from the Invasive *Spartina* Project's (ISP) propagation beds were installed on the mounds during this period. In late April, goose exclosures were installed on vegetated mounds after herbivory was observed within plantings. At that time, it was discovered that some mounds had lost *Spartina* plugs, coir logs, or both; some of these mounds had been planted just five days prior to this observed damage. All mounds were evaluated for destructive erosion, and mounds were rearranged throughout May to locations where plantings and coir logs could persist. Through this process, two entire blocks were removed, and one new block was created in an area evaluated to be more suitable for plantings. Some new vegetated mounds were planted with plugs salvaged from failed mounds, and additional mounds were planted in early June with new plants collected and transplanted directly from the Port Sonoma Marina, which was the original collection location of the plants sourced from ISP's propagation beds.

During this time, coir logs were also reinstalled or replaced on several mounds due to degradation and relocation due to wind-waves and erosional forces. In July, one final *Spartina* mound was found to have completely eroded, and a new mound was planted adjacent to the existing block. The experimental mound map was finalized at this point (Figure 5). In August 2016, continuing degradation of some coir logs in combination plots with *Spartina* appeared to physically damage and threaten plantings, and all coir logs were removed from combination treatments with coir facing the breach. No changes were made to experimental mounds after August 2016; as such, *Spartina* densities and coir presence are subject to change into the future due to erosional forces.

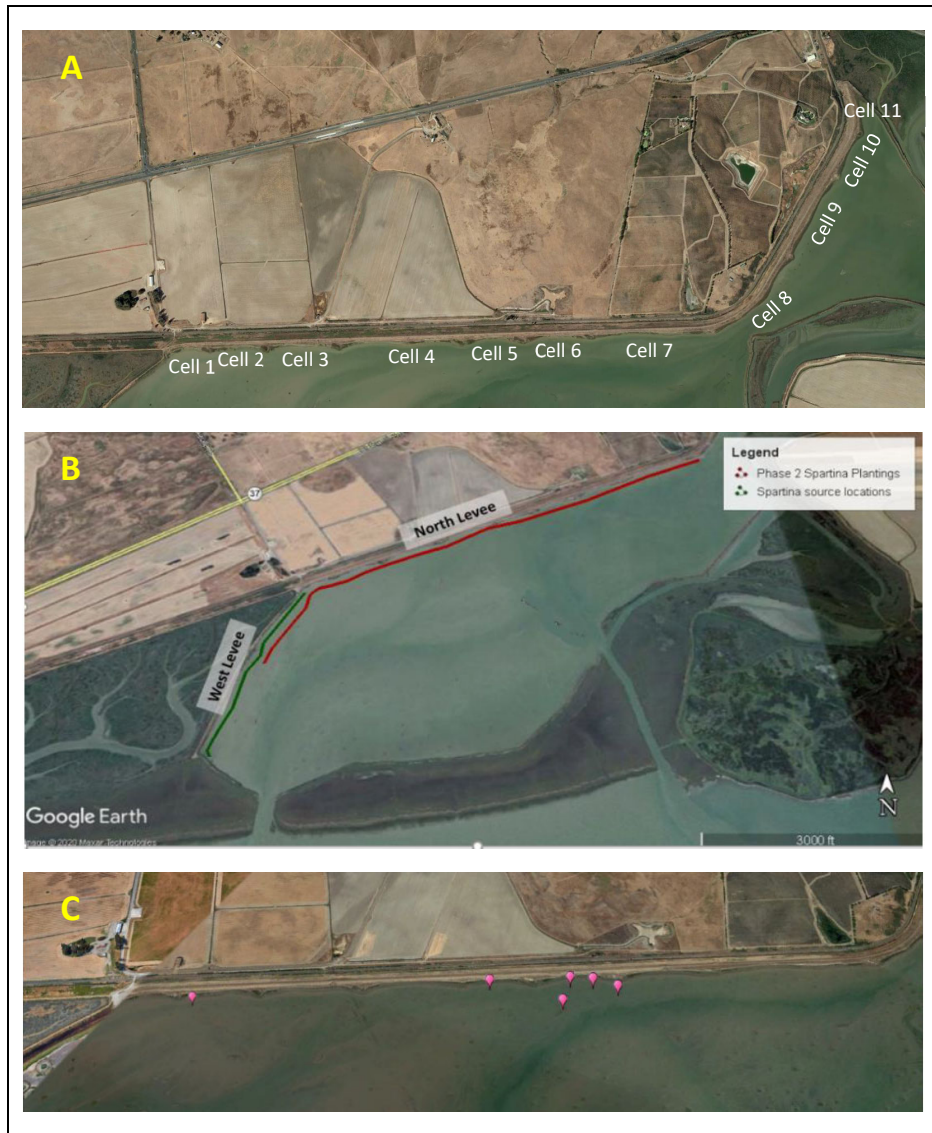
Figure 7. Planting Locations of Pacific Cordgrass Along the Northern Levee, 2019, 2020, 2021
(A) Cells planted in 2019 and some cells planted in 2021. (B) Extent of planting 2020 and source area for cordgrass transplants. (C) Locations of 2020 plantings on mounds and accreted mudflats.

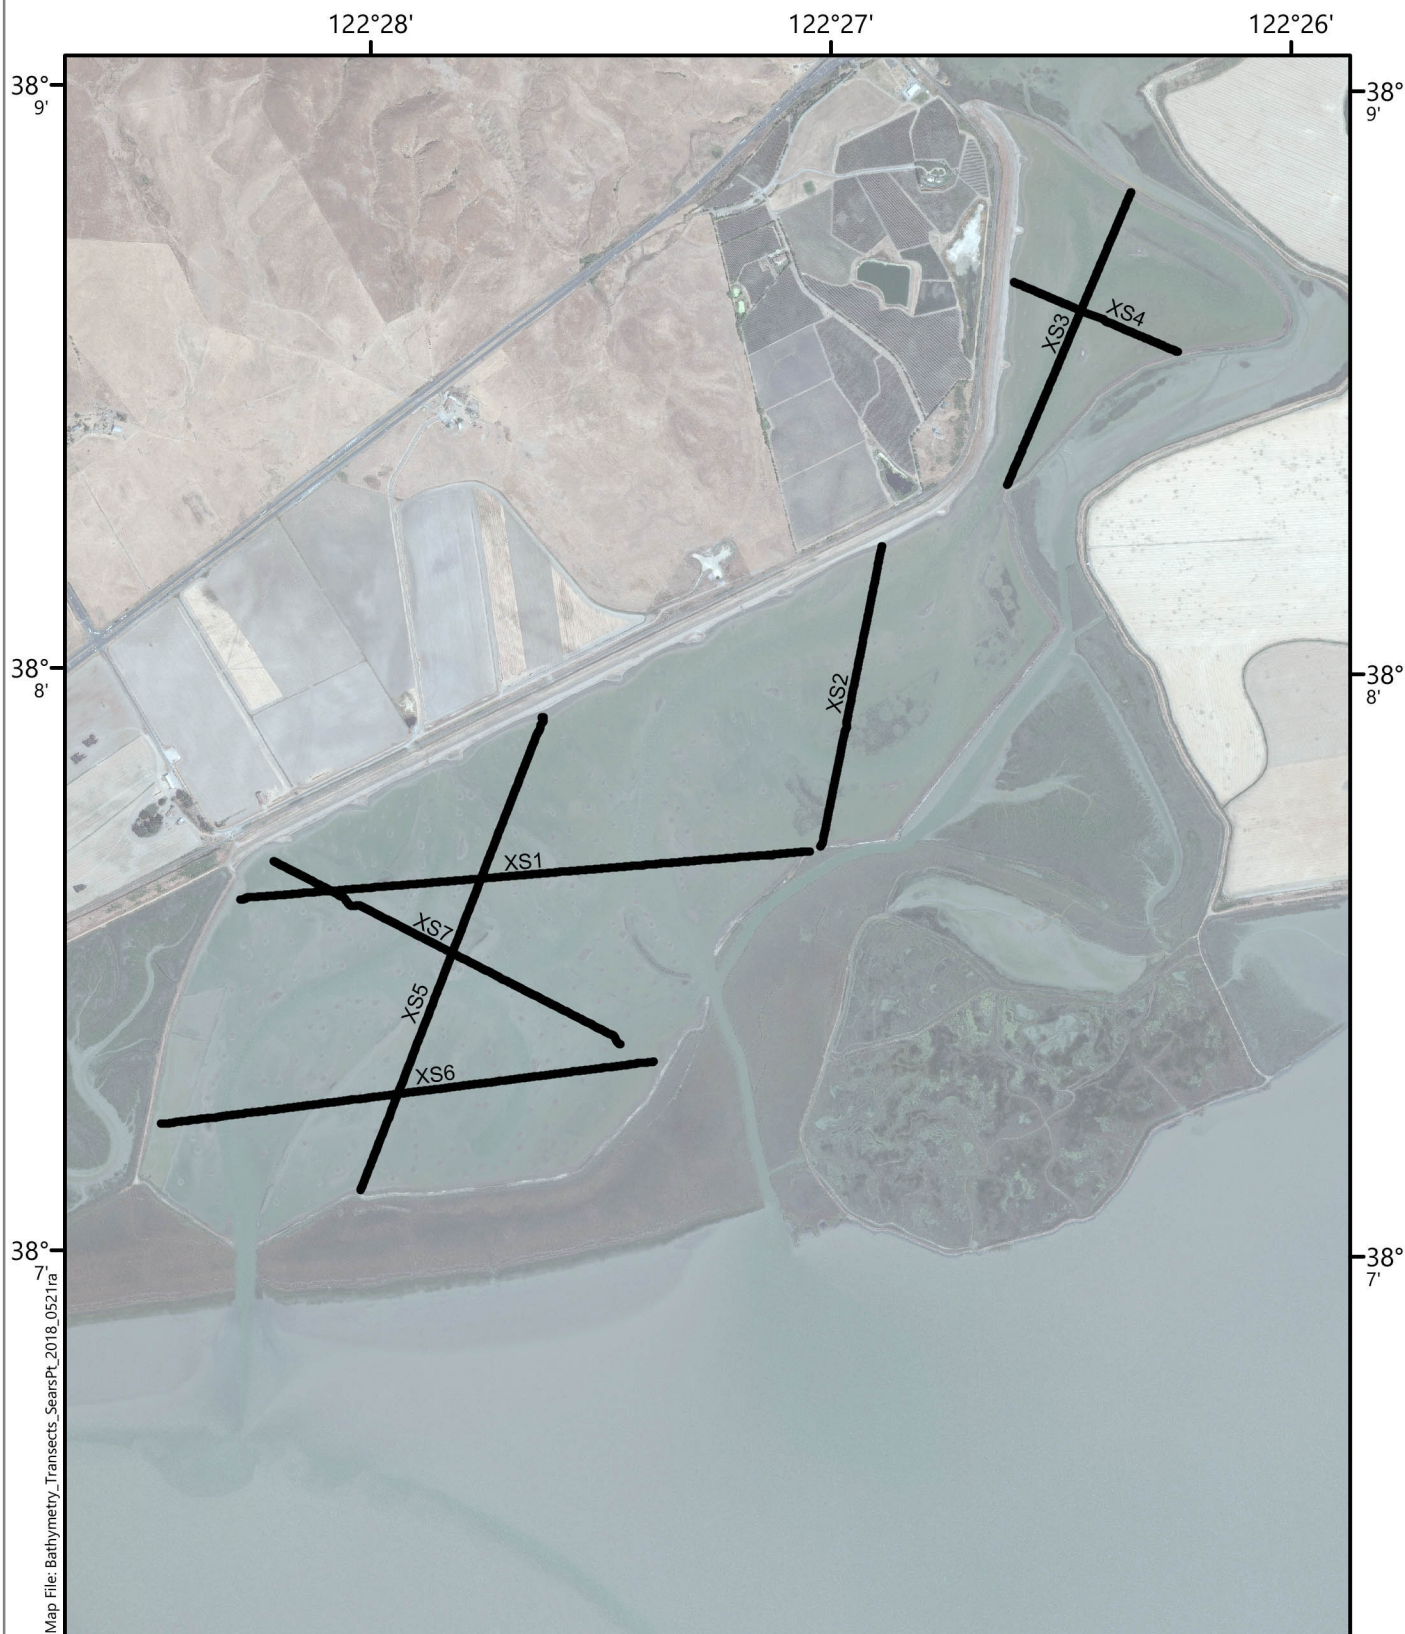
Figure 9

A small boat-based bathymetric survey of six transects across the site (Figure 9) was collected in February 2017 during the extreme high tides that took place that month. Bathymetric survey methods are presented Appendix D. Data from these transects will be compared to the USACE baseline topographic survey to yield sedimentation data.

Bathymetric Elevation Transects, Sears Point

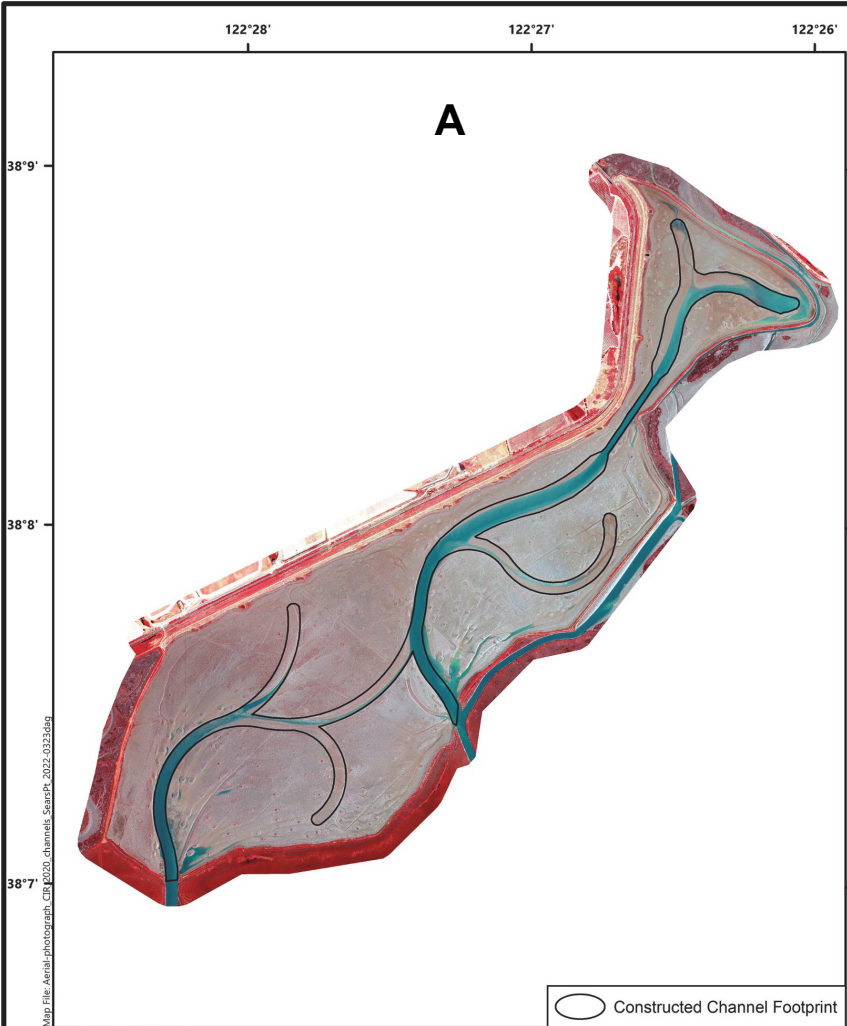
Figure 10 compiles the four data sources that can inform channel development – the natural color and color infrared (CIR) air photos, the NDVI map software-generated from the CIR image, and the LiDAR-based DEM. For each of these data sets we overlaid the outline of the large constructed subtidal channel for reference.

Mapping tidal channels during the mudflat stage of restoration is very challenging, as remote sensing automated techniques have very little spectral differences to draw from. These four data sets – the air photo in natural color (A) and color infrared (CIR) (B), the NDVI (normalized difference vegetation index) derived from the CIR (C), and the LiDAR-based DEM (D) – illustrate this challenge and guide the heads-up digitizing method if employed. Also challenged by need to decide what channel size to digitize.

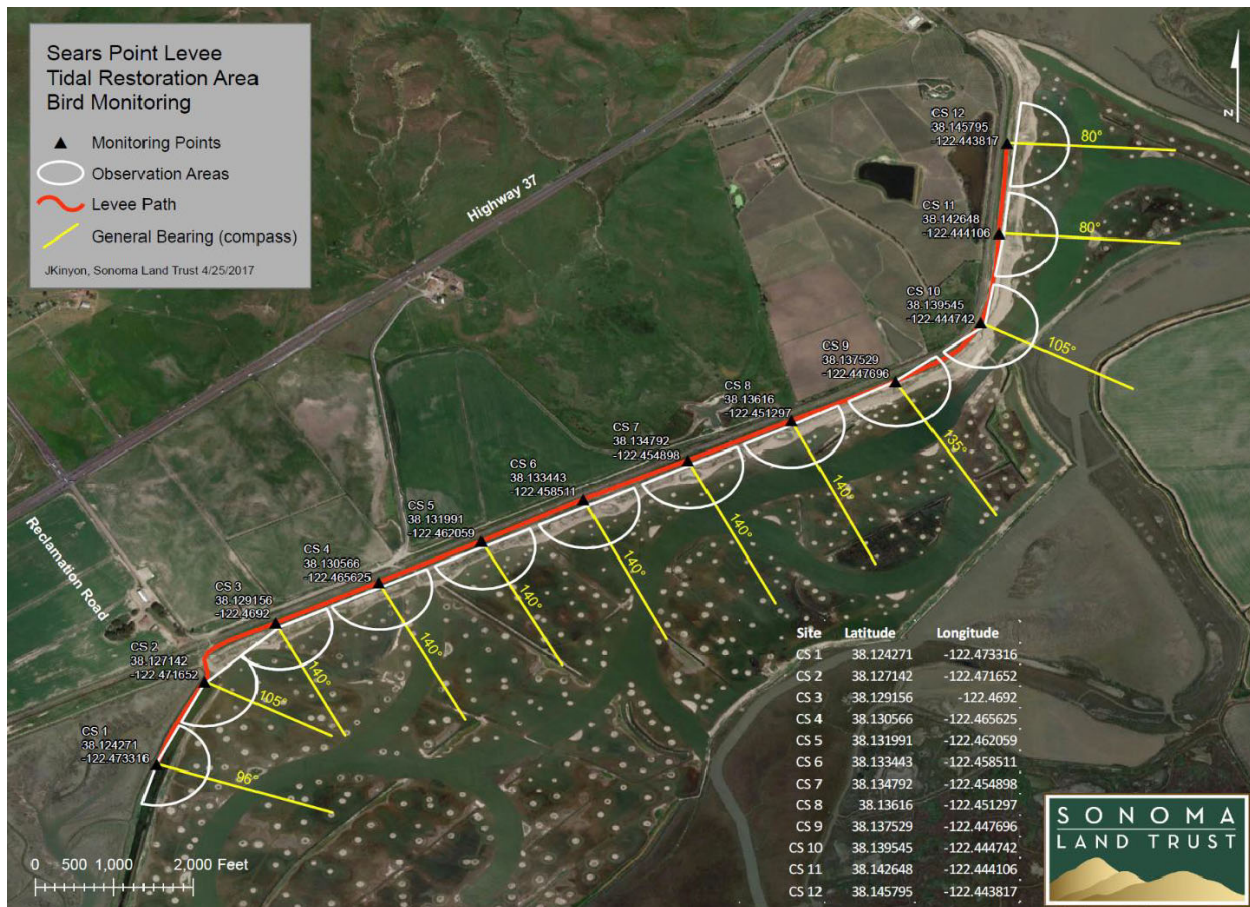
Figure 11. Avian Survey Monitoring Locations

Survey stations, affixed with permanent markers, were located at equidistant points along the site's levee (part of the San Francisco Bay Trail), paralleling the north shore of San Pablo Bay (Figure 11).

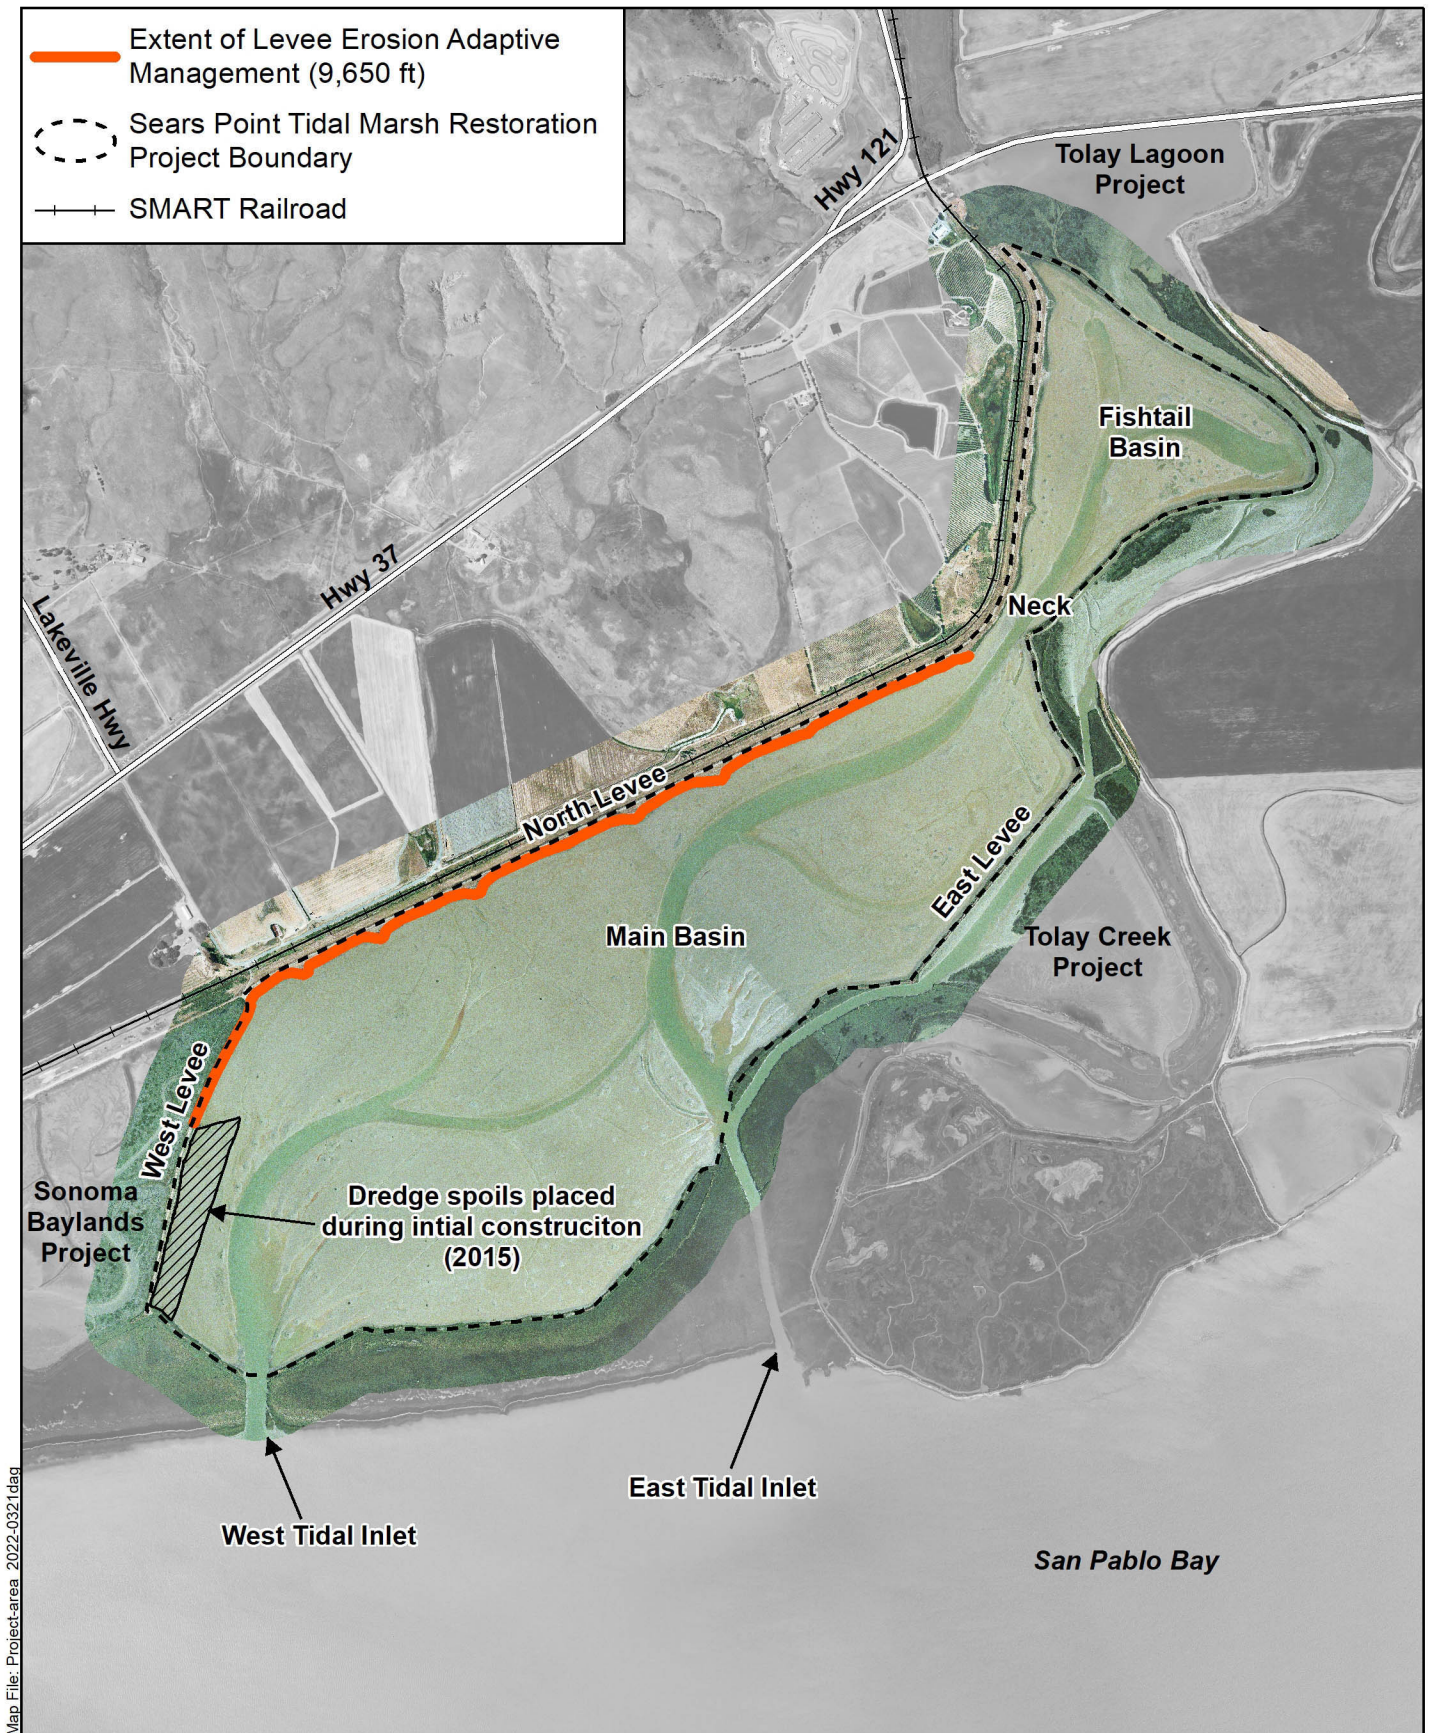
Erosion of varying degrees has taken place along much of the northern tidal flood control levee, from its west terminus heading east to where the site narrows, and the western levee separating the project from the adjacent Sonoma Baylands restoration project in the reach north of where dredged sediment had been placed during construction (Figure 21). Appendix E presents the levee erosion quantitative data (DU topographic transects and LiDAR-derived scarp locations): Ducks Unlimited surveyed levee transects in May 2017 and October 2018 to assess the extent of erosion along the western “separator” and northern levees, SF Bay NERR extracted erosion scarps from slope data derived from the June 2018 LiDAR topographic data.

Sears Point Levee Adaptive Management

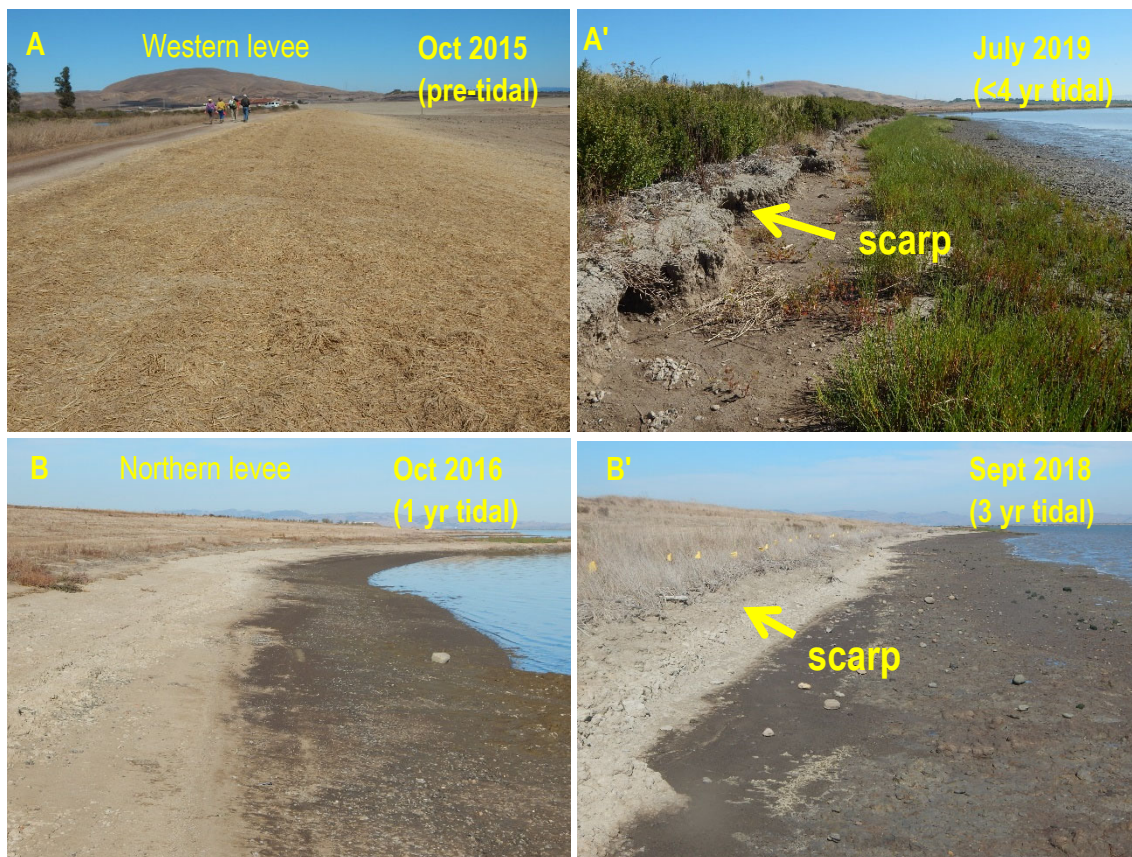
Figure 22. Levee Comparisons, Before and After Erosion

Wind-wave erosion of levee benches steepens the initially wide, gently sloping constructed transition zone platform to an enlarging, abrupt, notched (scarped) profile separating high tidal marsh and terrestrial grassland in early stages of primary succession. A-A': western levee, north end, view to northeast; profile 2015 (pre-breach)-2019 evolution shows the change from a smooth ramp profile to a near-vertical retreating scarp and scour zone above a narrow belt of fringing salt marsh. B-B', northern levee, central, view to east; barren intertidal profile 2016-2018 shows ongoing erosion and profile steepening to a wave-cut scarp and bench. Periodic wind-wave erosion during the growing season removes pioneer salt marsh plants maintains the barren profile. (Photos and descriptions by Peter Baye)

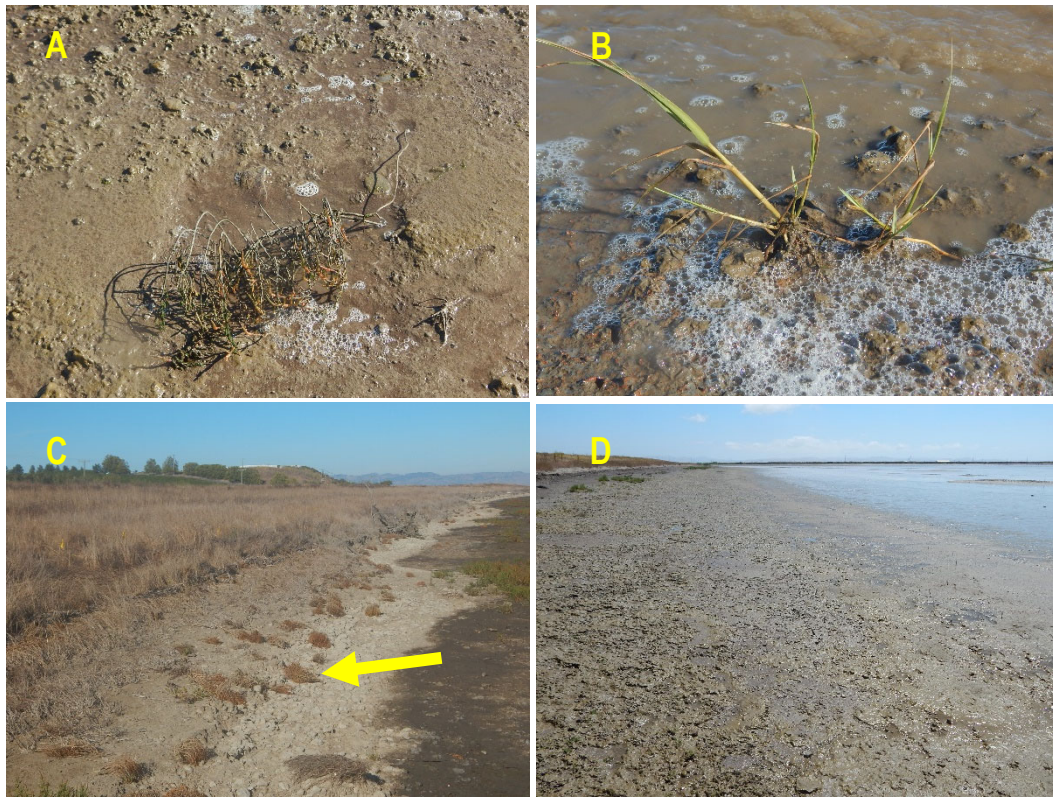
Figure 24. Impact to Pioneer Vegetation Establishment

Root systems of pioneer salt marsh plants (A - pickleweed, B - cordgrass) are exposed by rates of erosion that uproot them during the growing season, before plants can establish, anchor themselves, and spread. Uprooted plants wash up on shore (C), leaving exposed, scoured compacted levee foundations that resist root penetration (D) and promote vulnerable, shallow seedling root systems. Summer 2018. (Photos and descriptions by Peter Baye)
