Appendix F. Baseline topographic transects survey report

## Sears Point Pre-Construction Levee Transect Survey – May 2021

### **Technical Memorandum**

The Sears Point Levee Adaptive Management Project (project) on the San Pablo Bay National Wildlife Refuge in Sonoma County, CA is undergoing construction in the fall of 2021. Prior to construction, a topographic survey of the levee was required to document baseline conditions prior to project implementation. These baseline data are needed to confirm site conditions immediately prior to construction and to serve as the basis for comparison to as-built conditions and post-project conditions for assessing change over time and attainment of project goals and objectives. The pre-construction levee topographic surveys consisted of two independent efforts: (1) a land-based survey of pre-established topographic transect alignments, and (2) an unmanned aerial vehicle (drone)-based photogrammetry survey of the entire levee alignment. This memorandum describes the methods and results of the land-based transect survey effort.

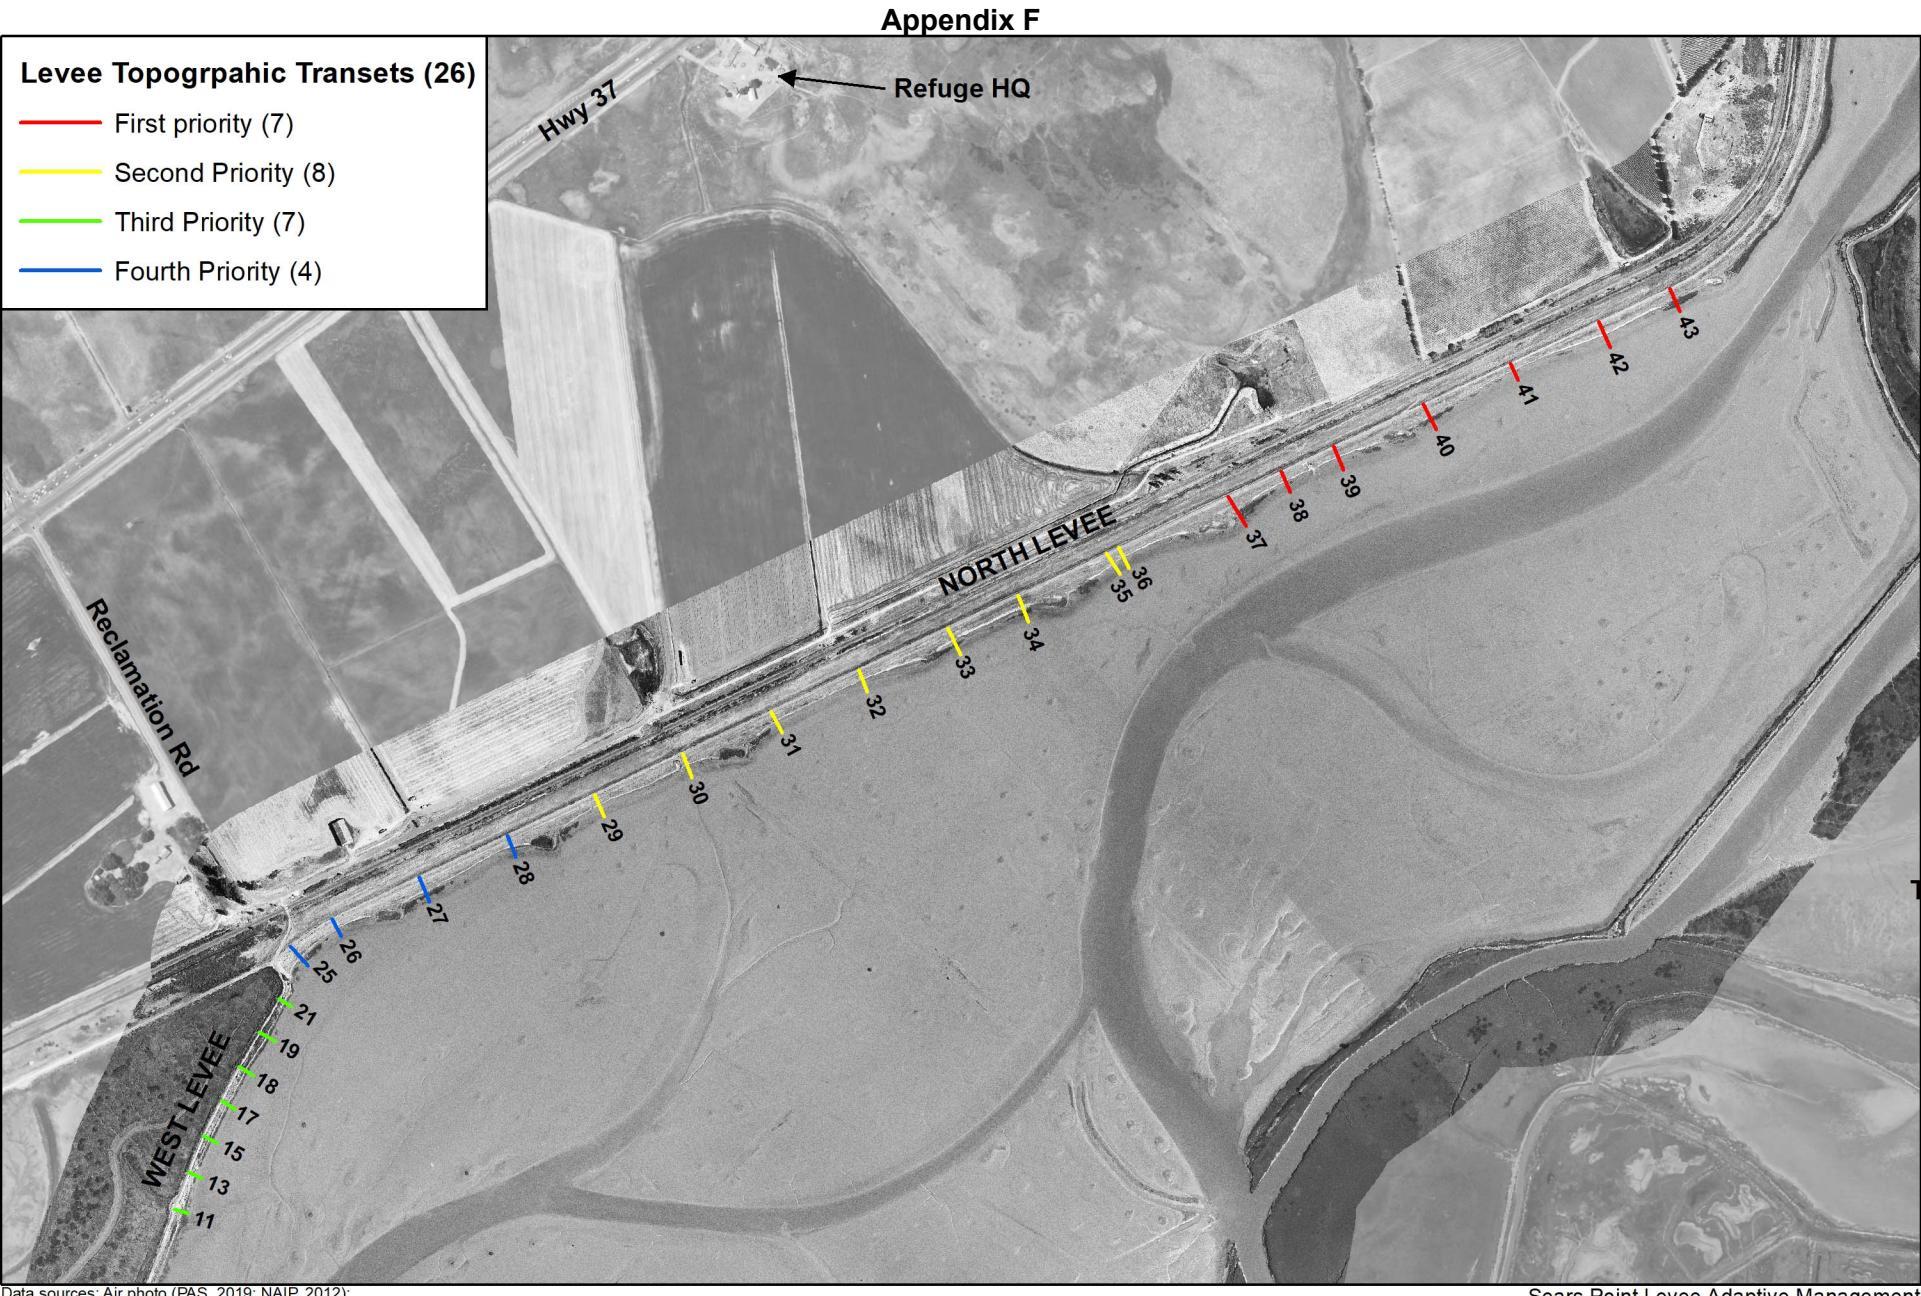
Figure 1

Ducks Unlimited (DU) established a series of topographic transect alignemnts along the north and west levees at the Sears Point Restoration Project site to track levee erosion and subsidence over time. These transects extend 75 – 100 ft from the levee crest out onto the adjacent mudflats, to an elevation of approximately mid-tide level (3.3 ft NAVD88<sup>1</sup>). Twenty-six of these transects fall within the adaptive management project area: 19 along the north levee and 7 along the west levee (Figure 1). These 26 transects were resurveyed on May 6, 2021 in the current effort.

2021 Pre-Construction Topographic Transect Locations and Priority

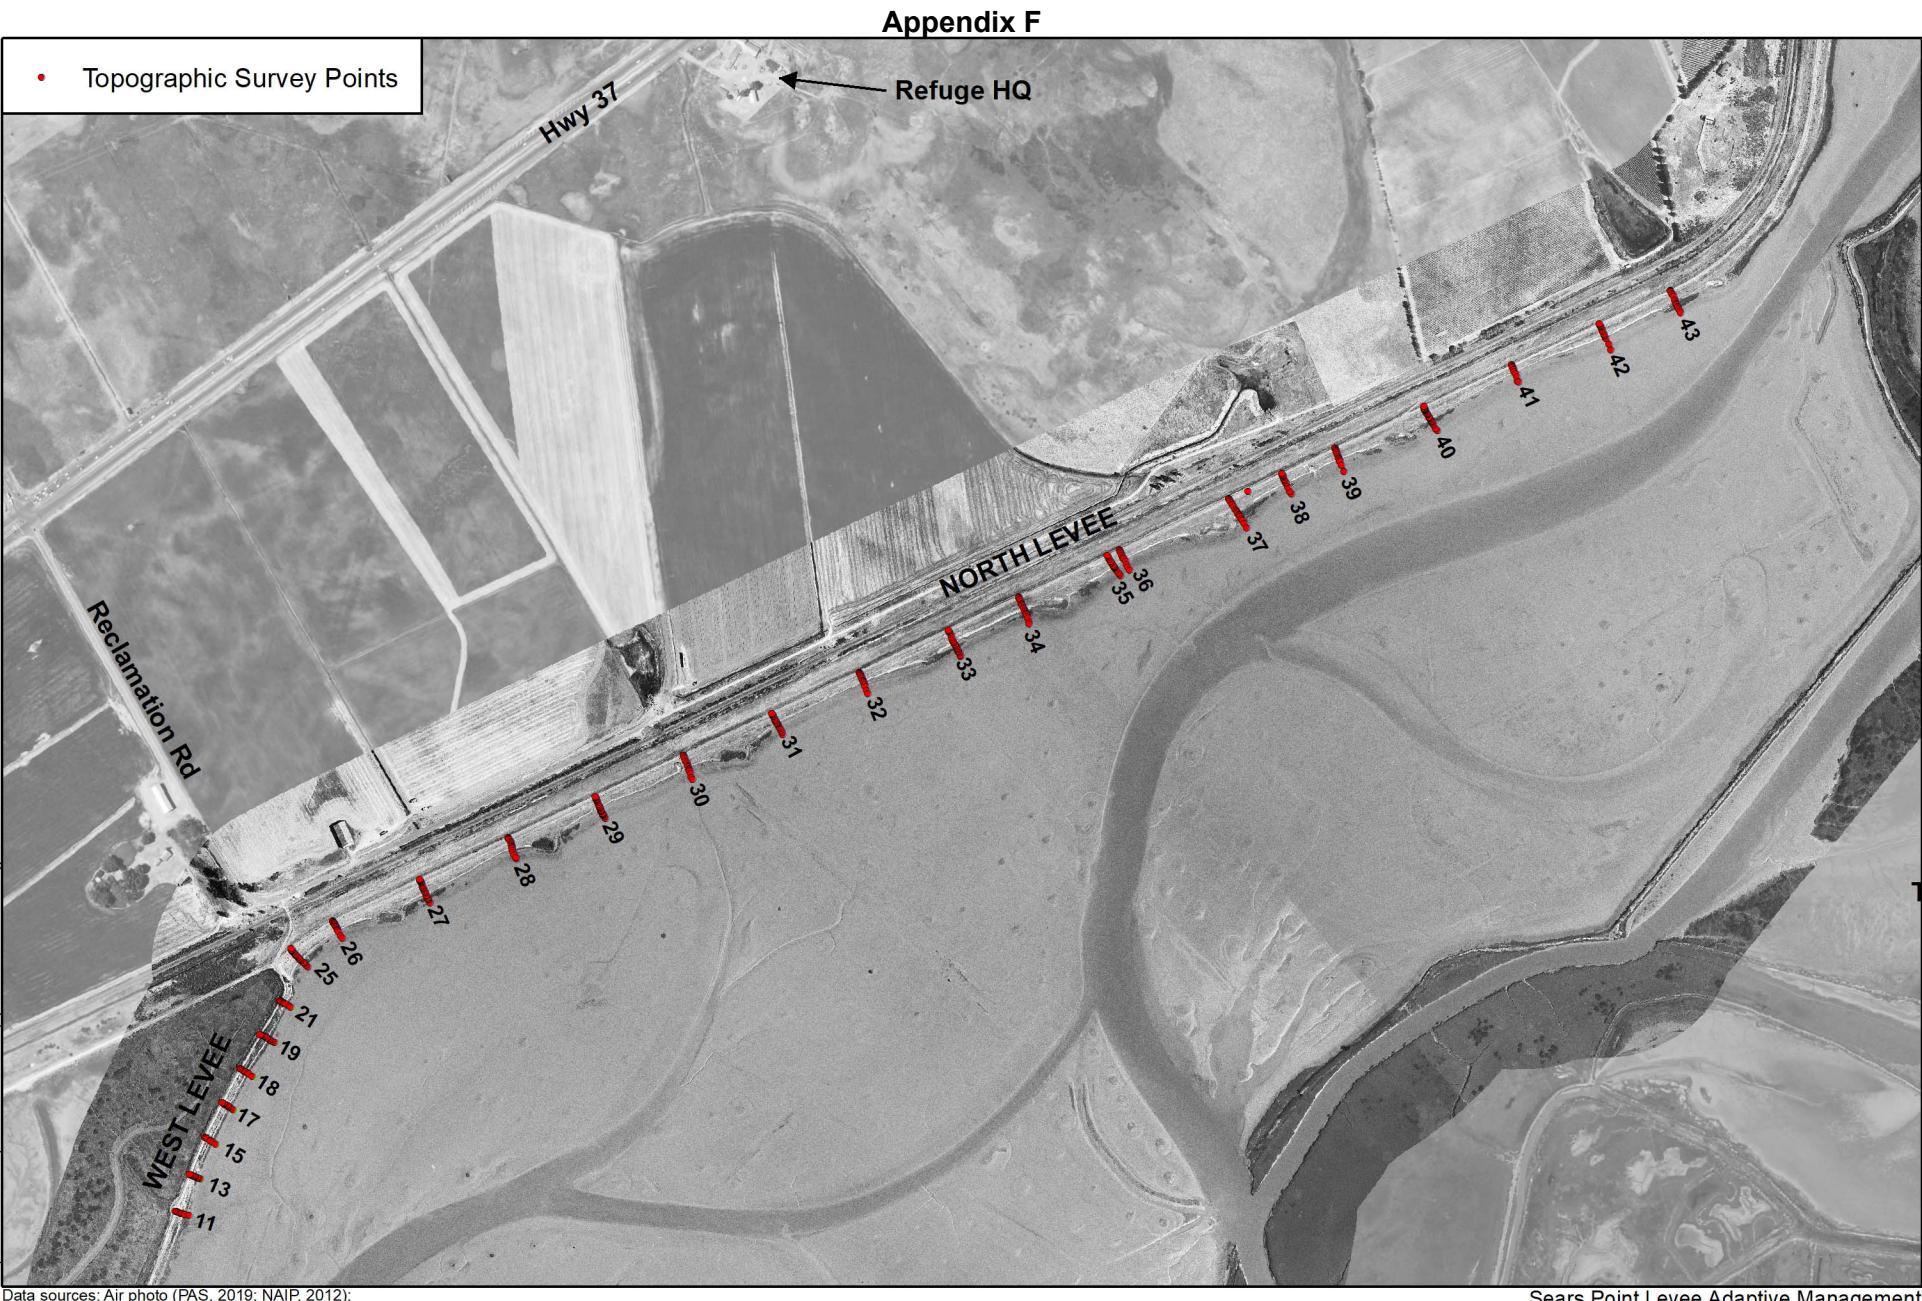
Figure 3

The topographic survey point coverage is displayed in Figure 3. Plots of the May 2021 data for the north levee topographic transects are provided in Figure 4, while plots of the May 2021 data for the west levee transects are provided in Figure 5.

2021 Pre-Construction Topographic Transect Survey Coverage

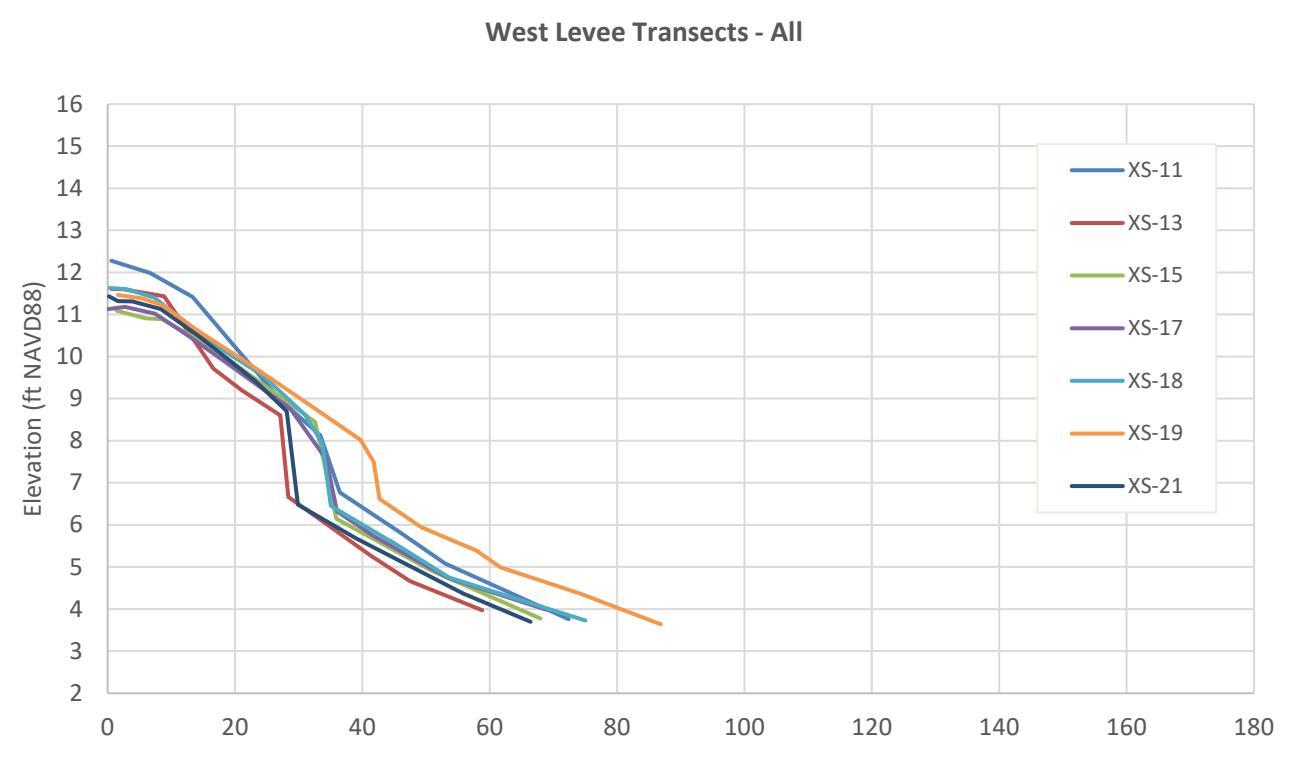
Figure 5

Distance from Levee Crest (ft)

2021 West Levee Topographic Transect Plots
